January 9, 2026

CCR Annual Inspection

Ash Ponds 1, 2A/2B, 3, Former
Pond 2 and Former Pond 4

Harding Street Station

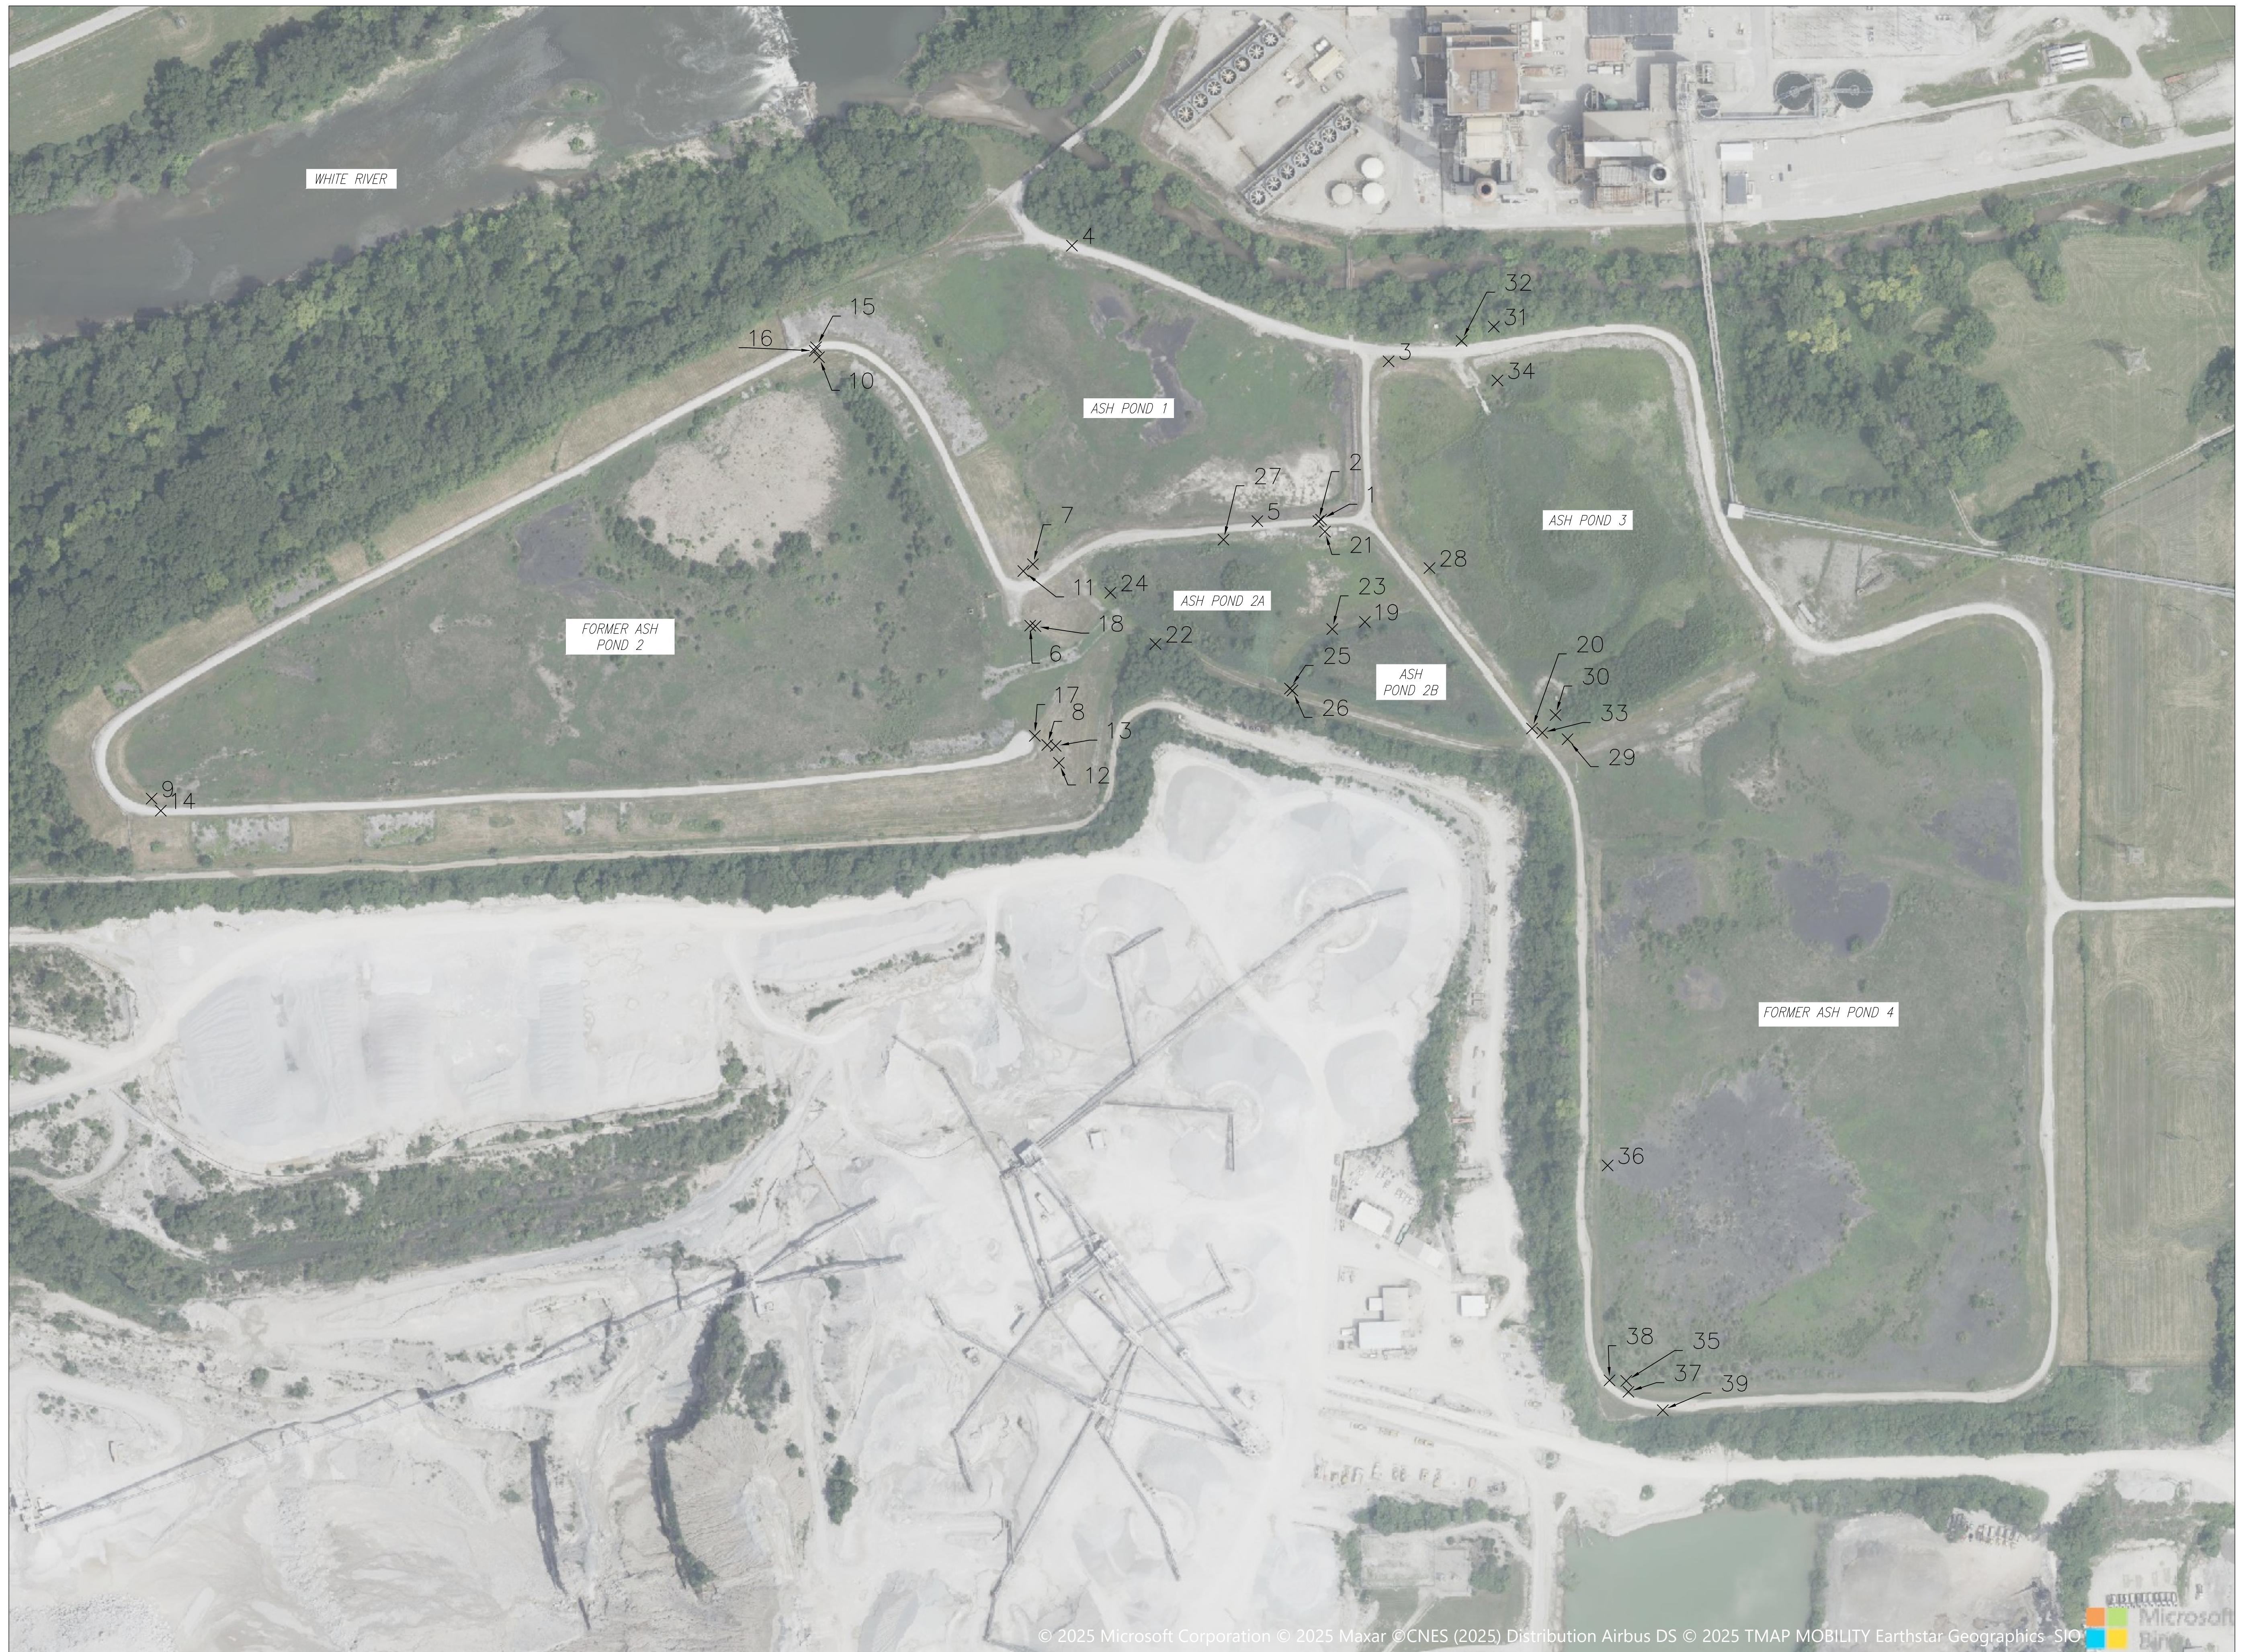
OBSERVATION
LOCATION MAP

No major areas of concern were noted during the annual inspection performed on November 25, 2025, but minor observations areas are listed below. Locations are shown on **Figure 3** and in **Appendix B** Observation Photo Log.

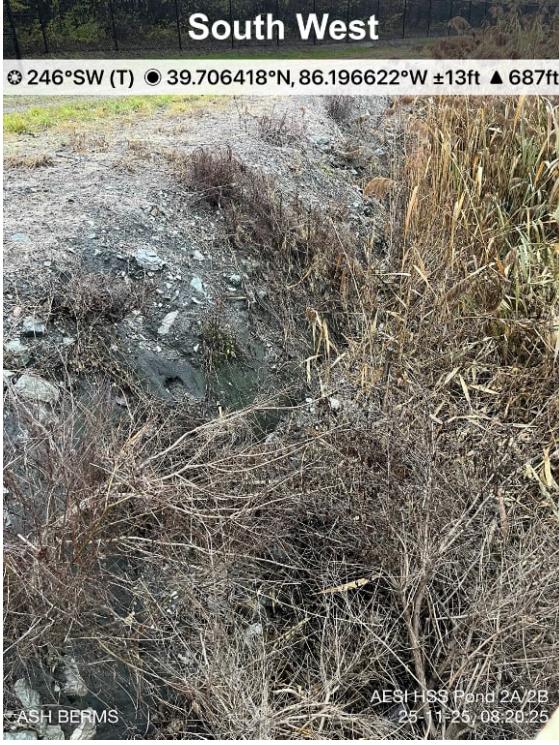
Photo 19	Date: 11/25/2025

- Berm erosion (Photo 20,21, & 27)
 - Monitor berm erosion and repair as necessary.
- Vegetation in pond (Photo 26).
 - Monitor and remove vegetation as necessary.

<p>South West</p> <p>⌚ 246°SW (T) ● 39.706418°N, 86.196622°W ±13ft ▲ 687ft</p> <p>ASH BERMS</p> <p>AESI HSS Pond 2A/2B 25-11-25, 08:20:25</p>
	Location: Harding Street Station, Indiana, Ash Pond 2A/2B	
	Description: Facing Southwest, Ash berms. Monitor berm erosion and repair as necessary.

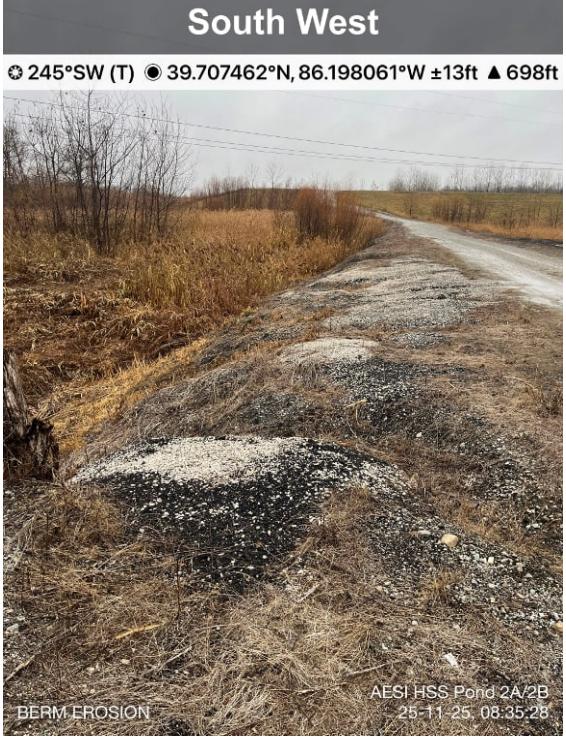
Photo 21	Date: 11/25/2025	<p>South West</p> <p>⌚ 245°SW (T) ⚩ 39.707462°N, 86.198061°W ±13ft ▲ 698ft</p>

<p>BERM EROSION</p> <p>AESI HSS Pond 2A/2B 25-11-25, 08:35:28</p>
	Location: Harding Street Station, Indiana, Ash Pond 2A/2B	
	Description: Facing Southwest, Berm erosion. Monitor berm erosion and repair as necessary.	
Photo 22	Date: 11/25/2025	<p>West Elevation</p> <p>⌚ 75°E (T) ⚩ 39.706857°N, 86.199227°W ±29ft ▲ 778ft</p>

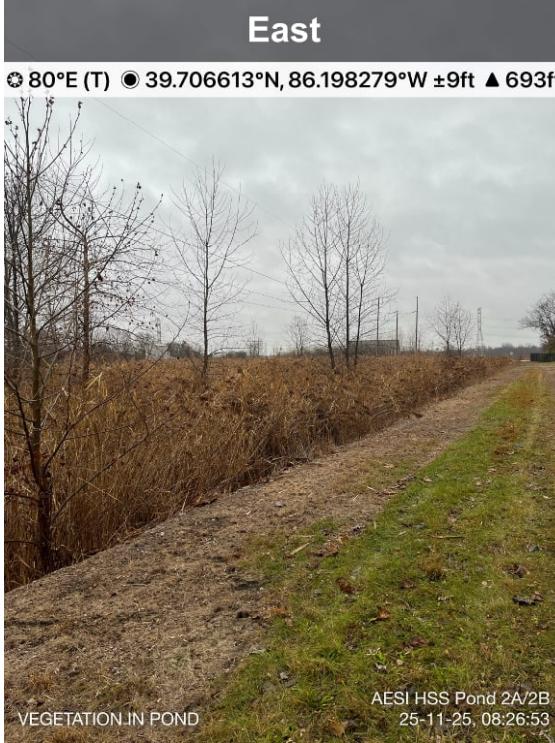
<p>North East</p> <p>23°NE (T) 39.706624°N, 86.198296°W ±16ft ▲ 691ft</p> <p>AESI HSS Pond 2A/2B 25-11-25, 08:26:22</p> <p>TRANSMISSION LINES</p>
Photo 26	Date: 11/25/2025	<p>Location: Harding Street Station, Indiana, Ash Pond 2A/2B</p> <p>Description: Facing East, vegetation in pond.</p> <p>Monitor and remove vegetation as necessary.</p>

<p>East</p> <p>80°E (T) 39.706613°N, 86.198279°W ±9ft ▲ 693ft</p> <p>AESI HSS Pond 2A/2B 25-11-25, 08:26:53</p> <p>VEGETATION IN POND</p>

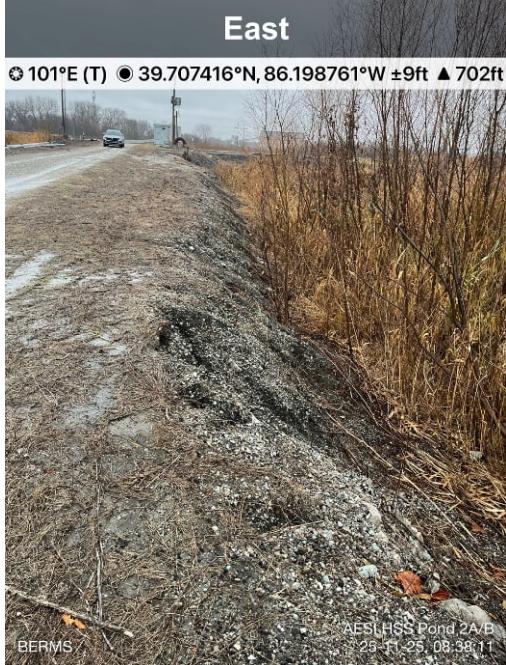
Photo 27	Date: 11/25/2025

<p>East</p> <p>● 101°E (T) ● 39.707416°N, 86.198761°W ±9ft ▲ 702ft</p> <p>AESI HSS Pond 2A/B 25-11-25 08:38:11</p> <p>BERMS</p>
	Location: Harding Street Station, Indiana, Ash Pond 2A/2B	
	Description: Facing East, Ash berms. Monitor berm erosion and repair as necessary.	
Photo 28	Date: 11/25/2025

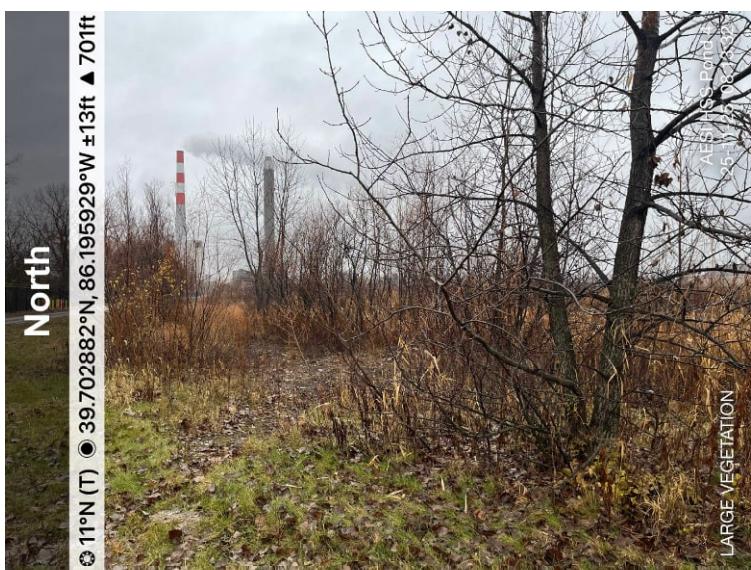
- Vegetation in pond (Photo 37 & 39).
 - Monitor and remove vegetation as necessary.

Photo 37	Date: 11/25/2025	<p>Location: Harding Street Station, Indiana, Former Pond 4</p> <p>Description: Facing North, large vegetation in pond.</p> <p>Monitor and remove vegetation as necessary.</p>

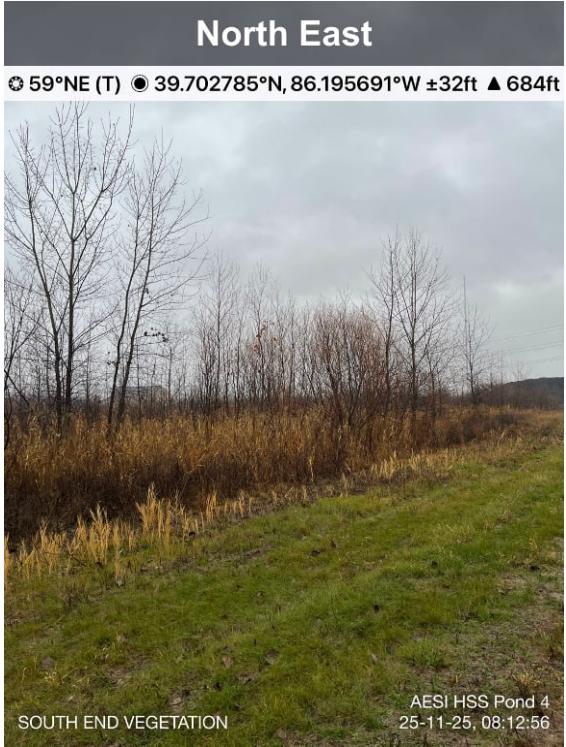
Photo 39	Date: 11/25/2025	<p>North East</p> <p>⌚ 59°NE (T) ● 39.702785°N, 86.195691°W ±32ft ▲ 684ft</p>

<p>SOUTH END VEGETATION</p> <p>AESI HSS Pond 4 25-11-25, 08:12:56</p>
Location: Harding Street Station, Indiana, Former Pond 4		
Description: Facing Northeast, south end vegetation. Monitor and remove vegetation as necessary.
