**2023 VISUAL INSPECTION OF ASH POND EMBANKMENTS  
AES PETERSBURG ASH POND SYSTEM**

AES INDIANA PETERSBURG GENERATING STATION  
6925 NORTH STATE ROAD 57  
PETERSBURG, INDIANA 47567

ATLAS PROJECT NO. 170LF01359

JANUARY 3, 2024

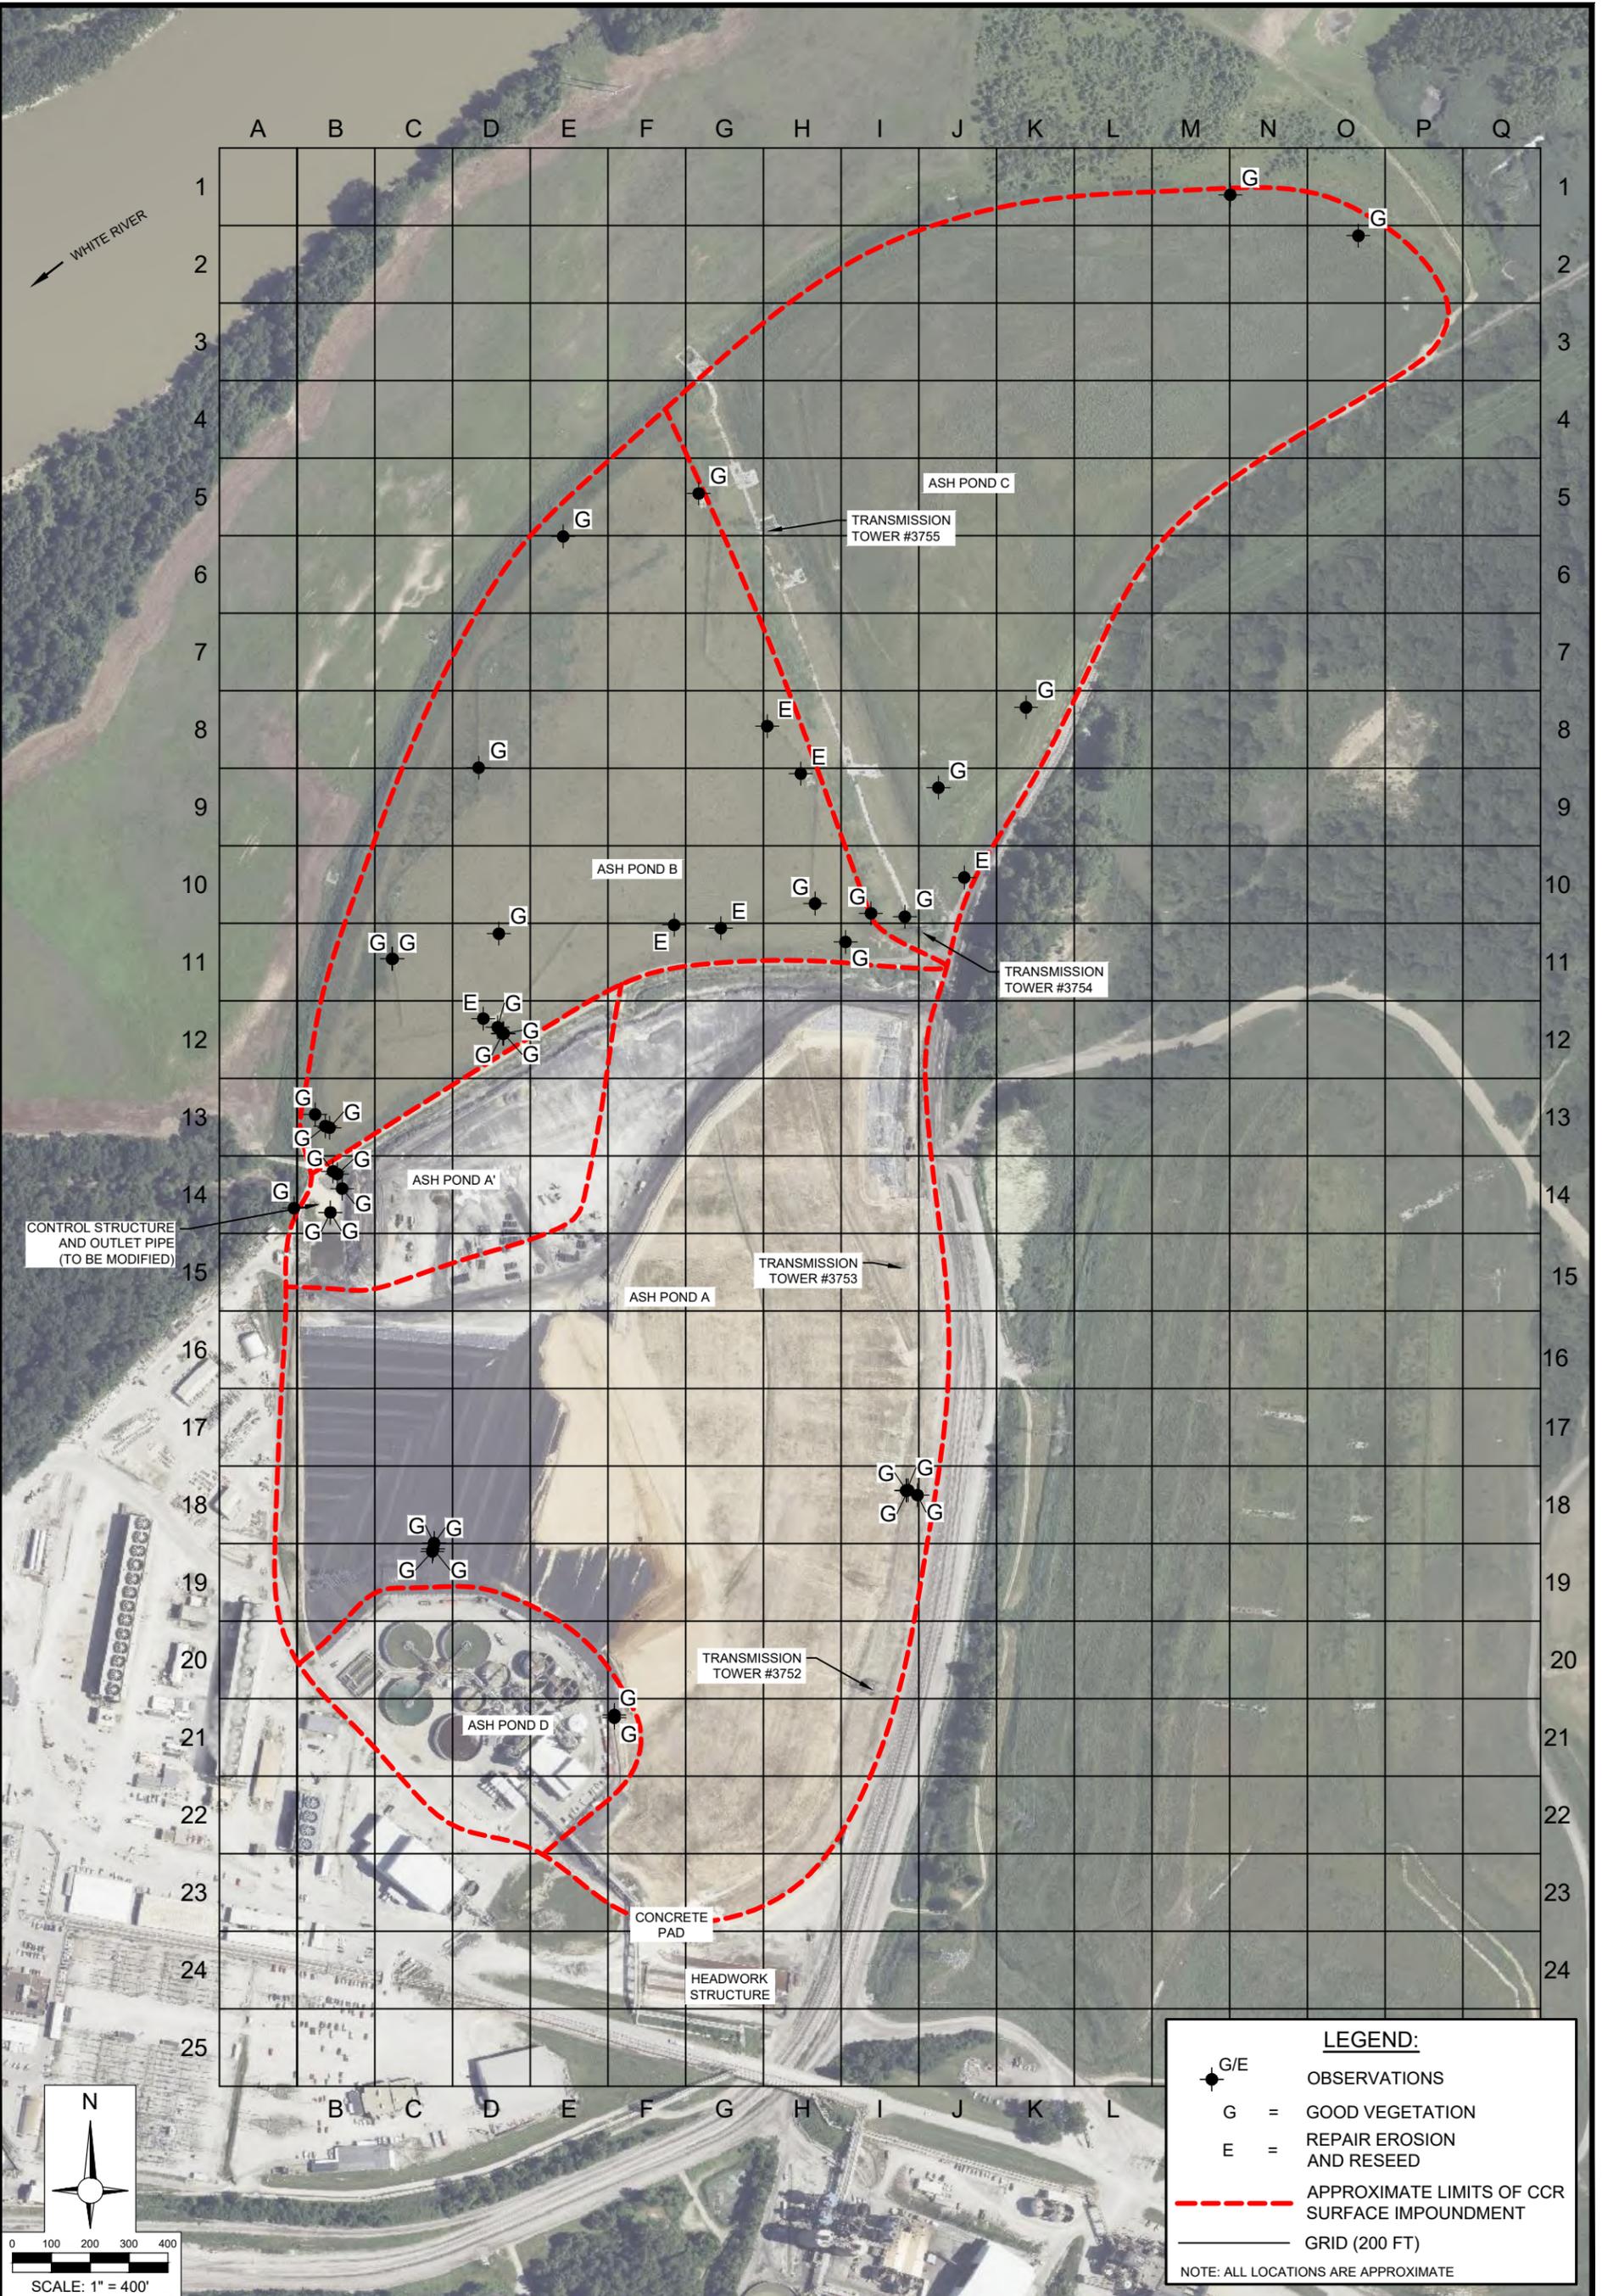
**2023 VISUAL SITE INSPECTION GRID MAP**  
 AES PETERSBURG ASH POND SYSTEM  
 AES INDIANA  
 6925 STATE ROAD 57  
 PETERSBURG, INDIANA

Engineering observations performed on December 28, 2023 are shown in Figure 3, 2023 Visual Site Inspection Grid Map. Atlas visually inspected the embankments for Ash Ponds A, A', B, C, and D and found no areas of instability. However, there were few areas with concerns relating to minor erosion on sections of Ash Pond B (Figure 3).

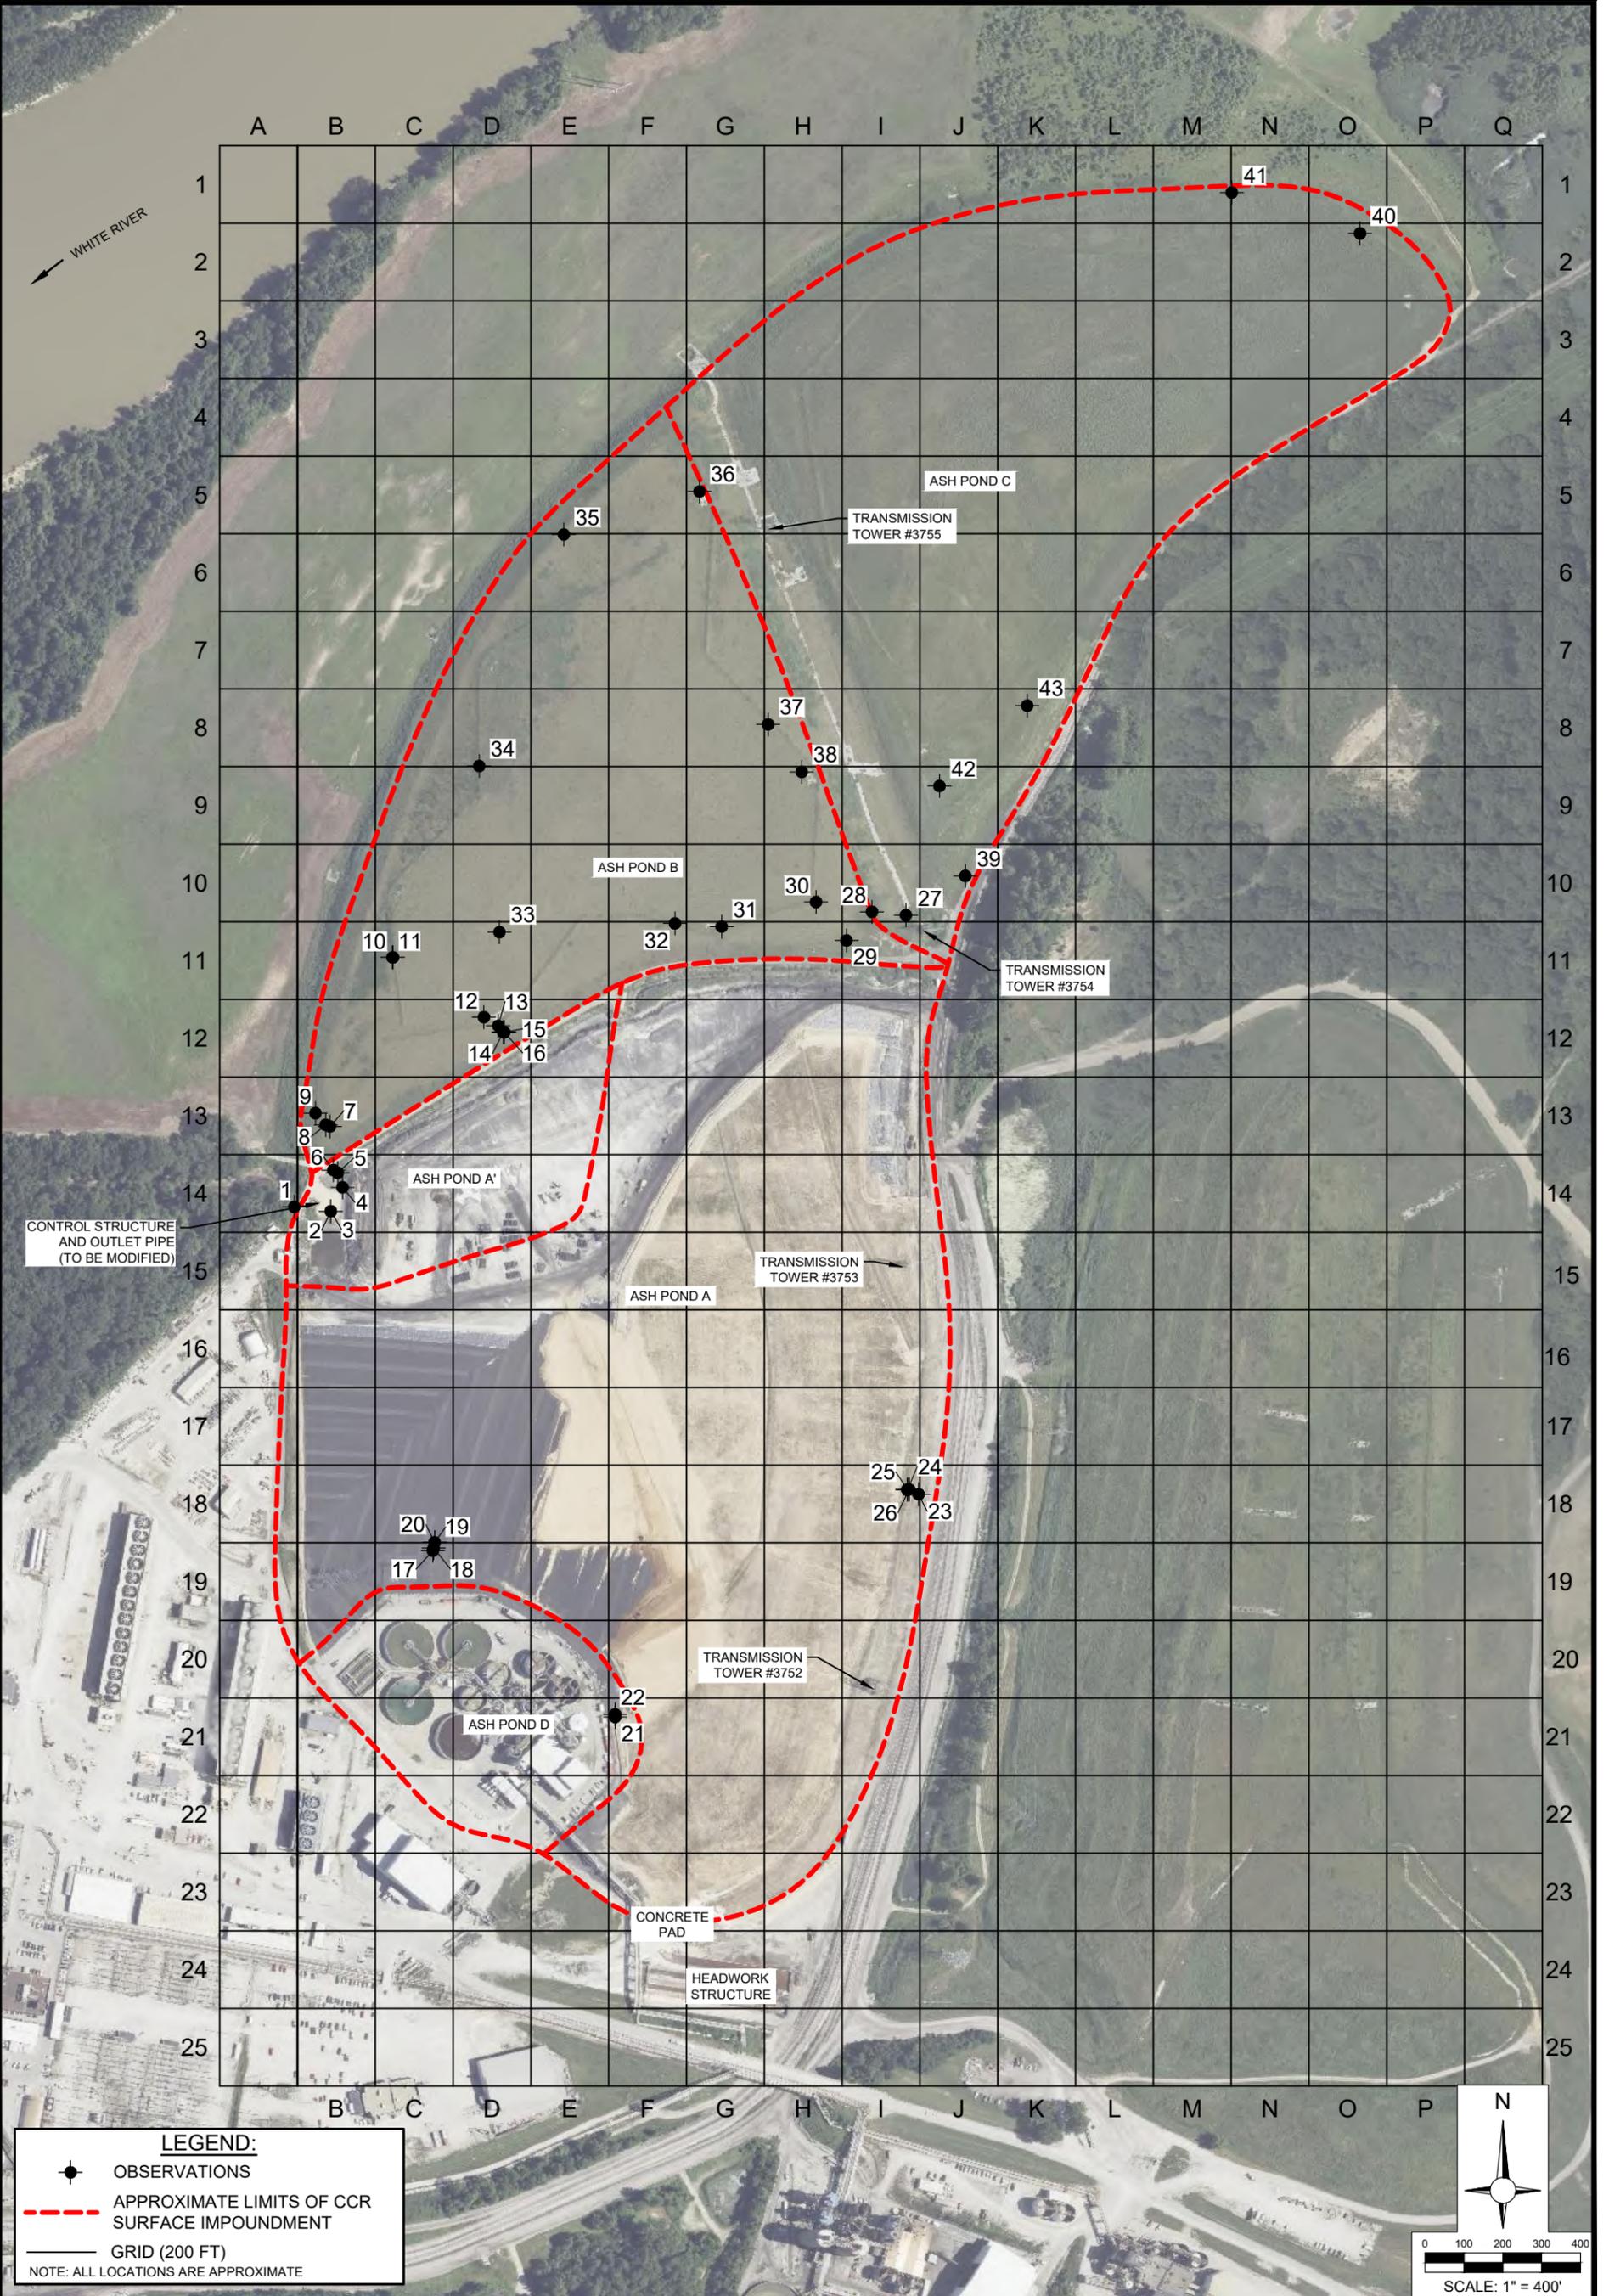
**SITE PLAN FOR PHOTO LOCATIONS**  
**DECEMBER 28, 2023**  
 AES PETERSBURG ASH POND SYSTEM  
 AES INDIANA  
 6925 STATE ROAD 57  
 PETERSBURG, INDIANA

1. Accumulated sediments/debris and/or tall vegetation observed at three separated drop inlets located on the south side of Ash Pond B (locations 12, and 31 of Figure 4) and the north side of Ash Pond B (location 38 of Figure 4).
  - o Recommendation: Remove sediments and cut down tall vegetation at drop inlets.
2. Minor erosion rills were observed at three separate locations on the top section of Ash Pond B (locations 32, 37 and 39 of Figure 4).
  - o Recommendation: Repair the soil cover and overseed these areas to establish a protective grass cover.
