**2023 VISUAL SITE INSPECTION
AES INDIANA PETERSBURG RESTRICTED WASTE TYPE III LANDFILL
SOLID WASTE FACILITY PERMIT NO. FP63-02**

ATLAS PROJECT NO. 170LF01508

**Re: 2023 Visual Site Inspection
Petersburg Restricted Waste Landfill
Solid Waste Facility Permit No. FP 63-02
AES Indiana
Petersburg Generating Station
Petersburg, Indiana
ATLAS Project No. 170LF01508**

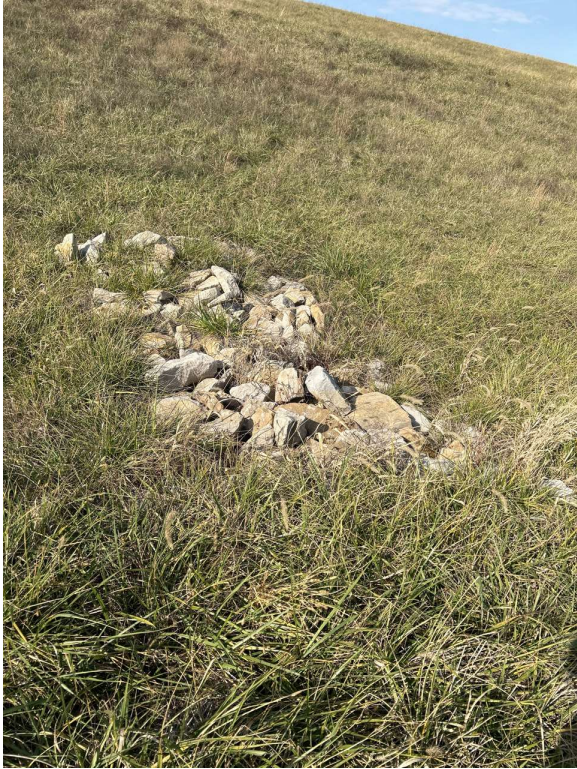
Grid ID P-21	Photo ID 5

Date November 6, 2023		
Description: Riprap and inlet looking good in the lower east slope section of the landfill. No issues observed. Photo looking west.		
Grid ID P-19	Photo ID 6

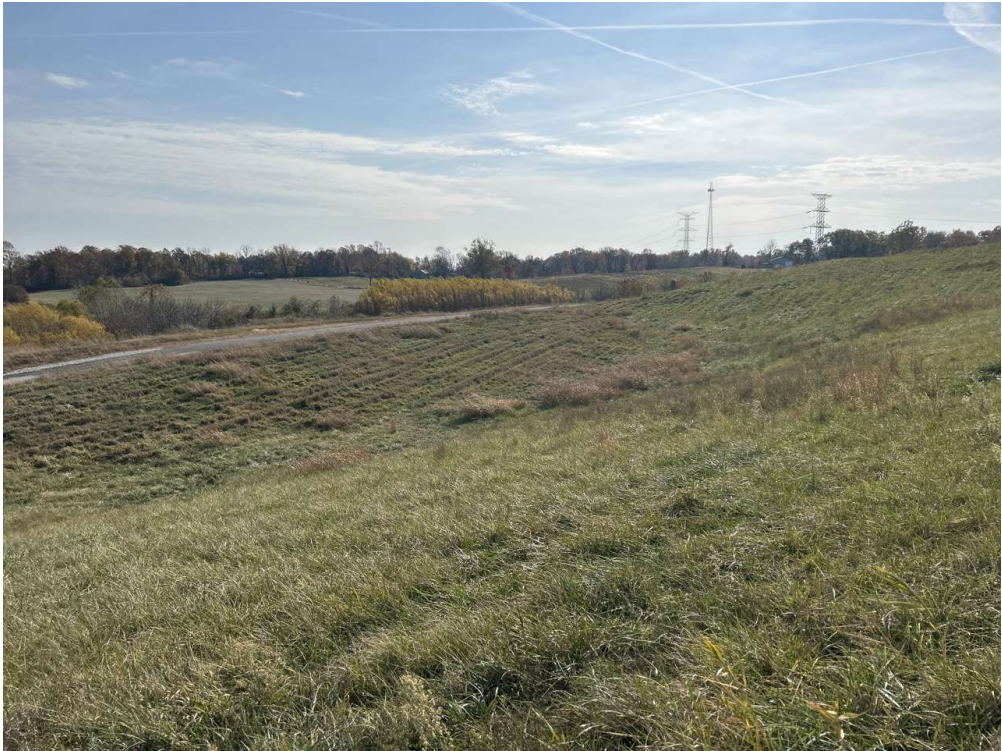
Date November 6, 2023		
Description: Vegetation well established along the lower east slope of the landfill. No issues observed. Photo looking southeast.

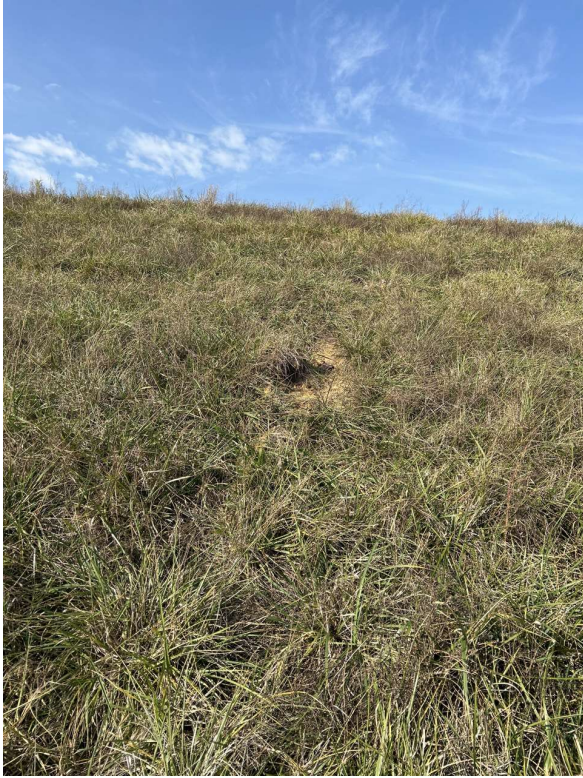
Grid ID P-21	Photo ID 7

Date November 6, 2023		
Description: Erosion gully formed on the east side of the landfill. Photo looking west. Recommend repairing erosion gully and reseeded the area to re-establish grass cover and prevent erosion.		
Grid ID O-17	Photo ID 8

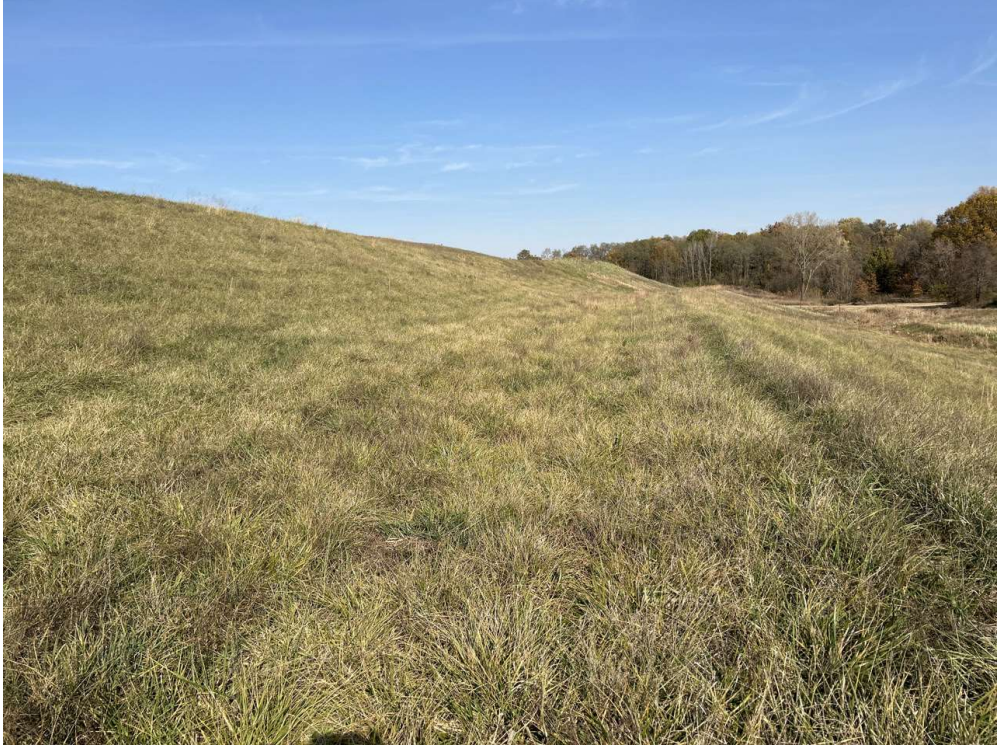
Date November 6, 2023		
Description: Vegetation well established on the east side of the landfill. No issues observed. Photo looking north.

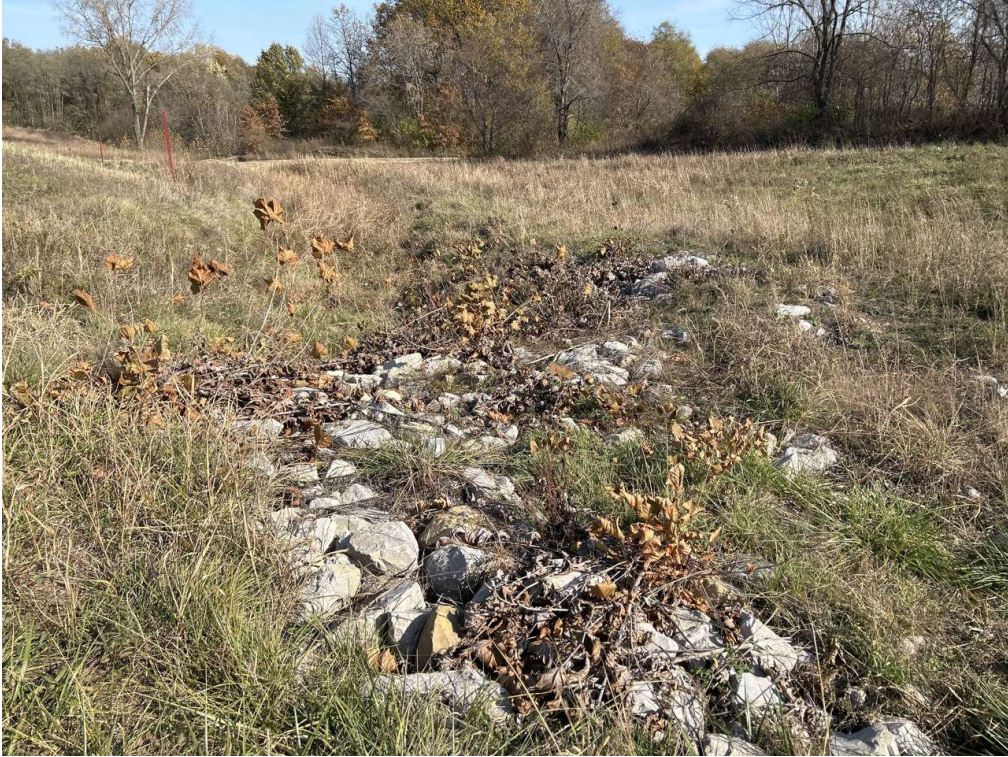
Grid ID Q-15	Photo ID 9

Date November 6, 2023		
Description: Overgrown vegetation within interceptor channel on northeast slope of the landfill. Photo looking north. Removal of vegetation within riprap channel is recommended.		
Grid ID Q-15	Photo ID 10

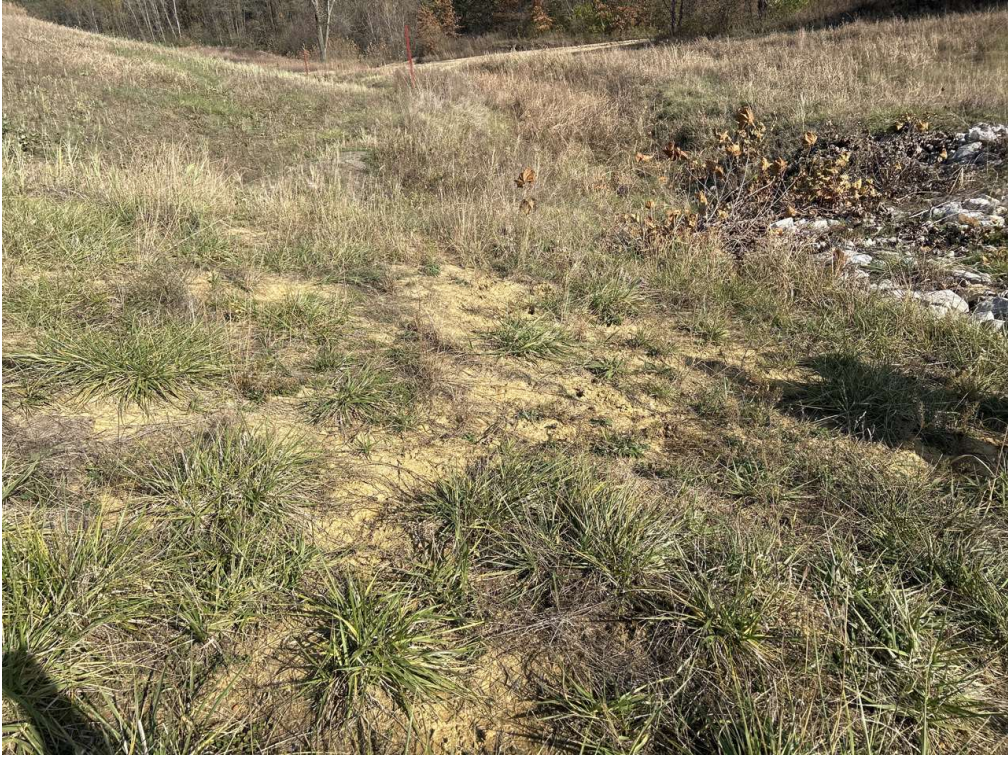
1. Good vegetation exists along much of the south end of the landfill, the top of landfill, and the east slope other than a few bare spots. (Photo ID 10).
 - Recommendation: Repair the soil cover and overseed these areas to establish a protective grass cover.
2. Overgrown vegetation observed on riprap channel section located on the northeast side of the landfill (Photo ID 9).
 - Recommendation: Trim and remove the overgrown vegetation to maintain channel flow capacity.
3. Small rills were observed on the east side of the landfill (Photo ID 7).
 - Recommendation: Repair the soil cover and overseed the area to establish a protective grass cover.

Date November 6, 2023		
Description: Bare spots on the northeast slope of the landfill. Photo looking northeast. Recommend reseeding bare areas to prevent erosion.

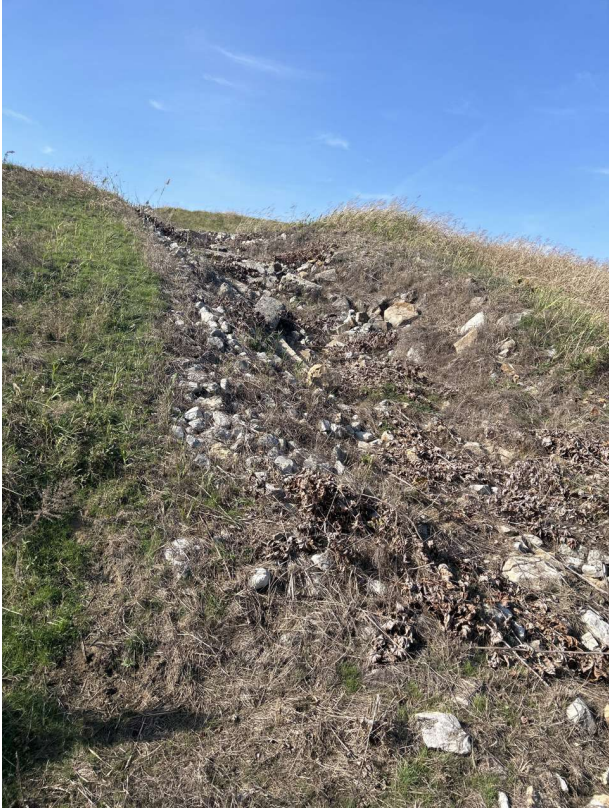
Grid ID Q-14	Photo ID 11

Date November 6, 2023		
Description: The down-drain chute on the northeast slope of the landfill looks good. No issues observed. Photo looking southwest.		
Grid ID N-13	Photo ID 12

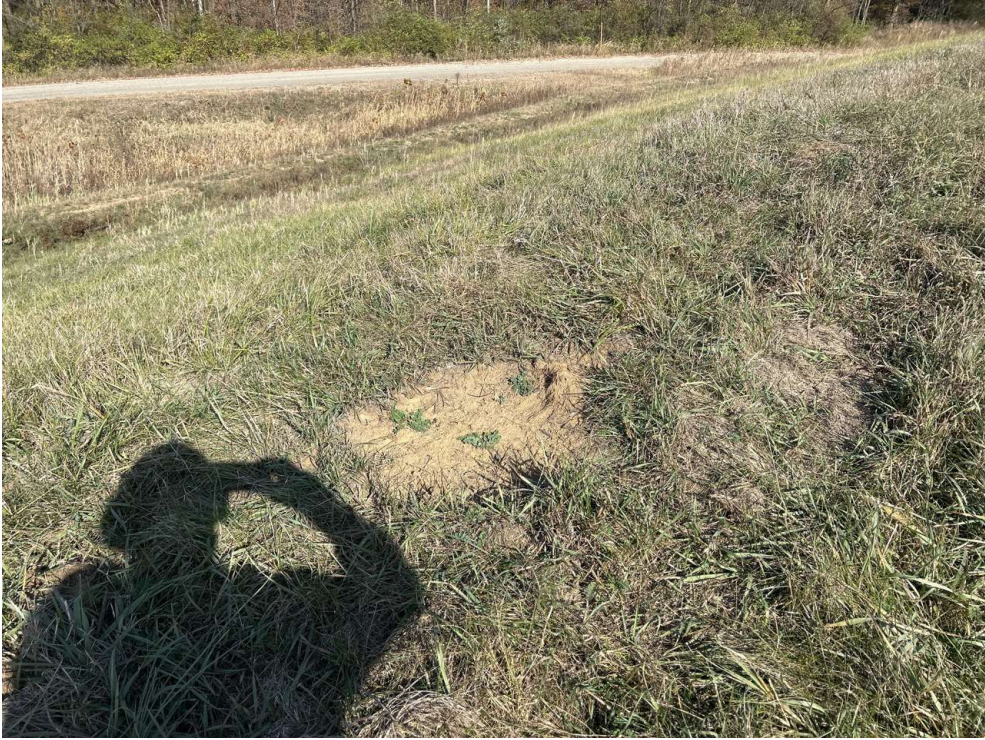
1. Good vegetation exists overall in most of the north and west side partial closure areas other than some bare spots observed. (e.g., Photo ID 12, 13, 15 and 16).
 - o Recommendation: Repair the soil cover and overseed these areas to establish a protective grass cover.
2. Erosion of side slope observed on the southwest side of the landfill (Photo ID 17).
 - o Recommendation: Replace eroded soil cover and overseed the area to establish a protective grass cover.

Date November 6, 2023		
Description: Bare spots on side slope on the north side of the landfill. Photo looking north. Recommend reseeding bare spots.

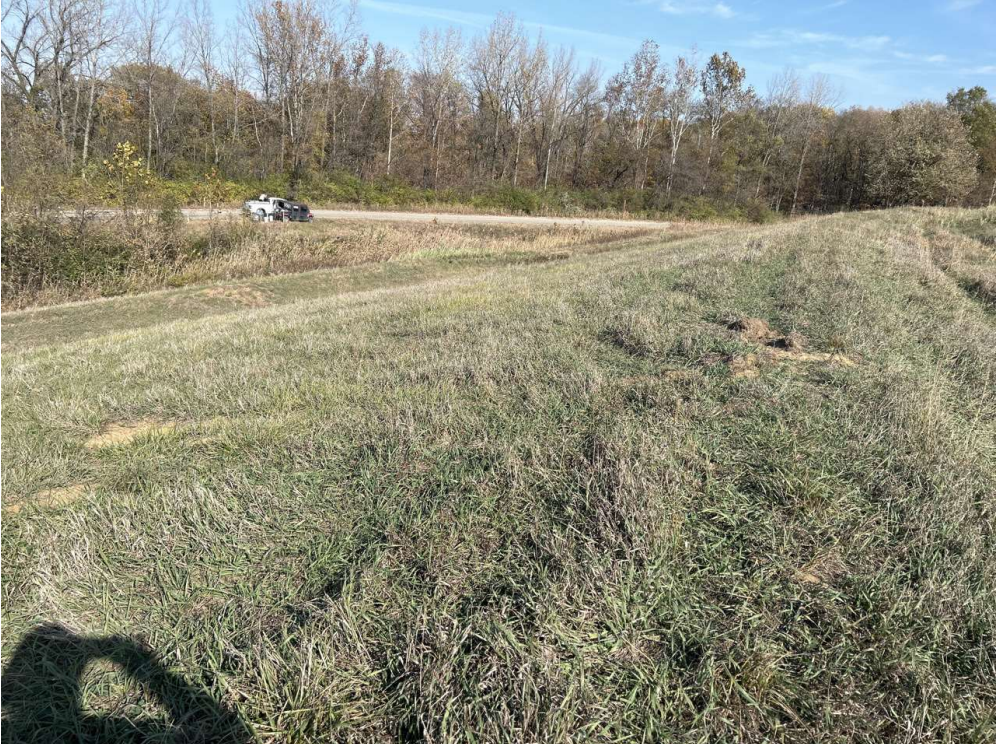
Grid ID N-13	Photo ID 13

Date November 6, 2023		
Description: Bare spots on the north slope of the landfill. Photo looking northeast. Recommend seeding bare areas.		
Grid ID N-13	Photo ID 14

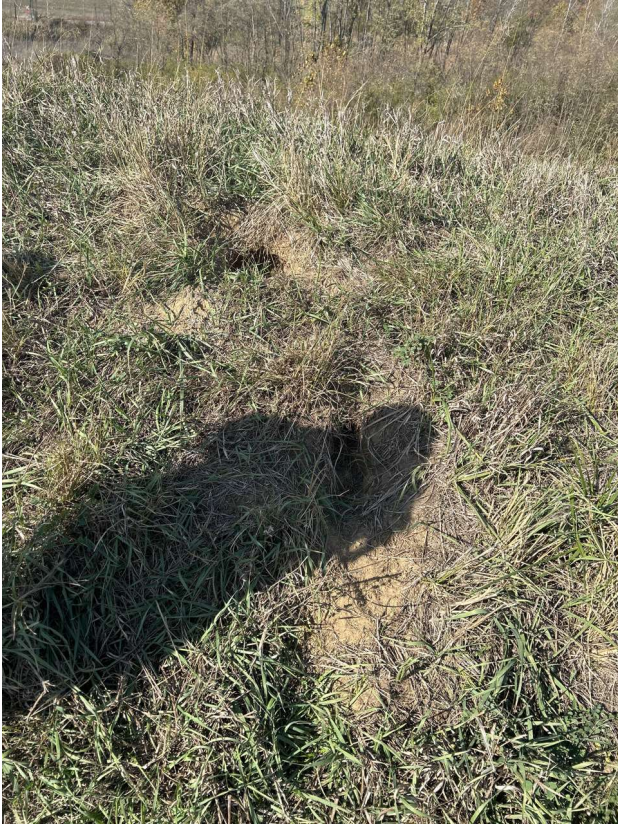
3. Animal burrow observed on the north side slope of the landfill (Photo ID 14).
 - Recommendation: Fill in and repair the soil cover and overseed the area to establish a protective grass cover.

Date November 6, 2023		
Description: Animal burrow on the north side slope of the landfill. Photo looking northwest. Recommend repair and reseeding bare areas to prevent erosion.

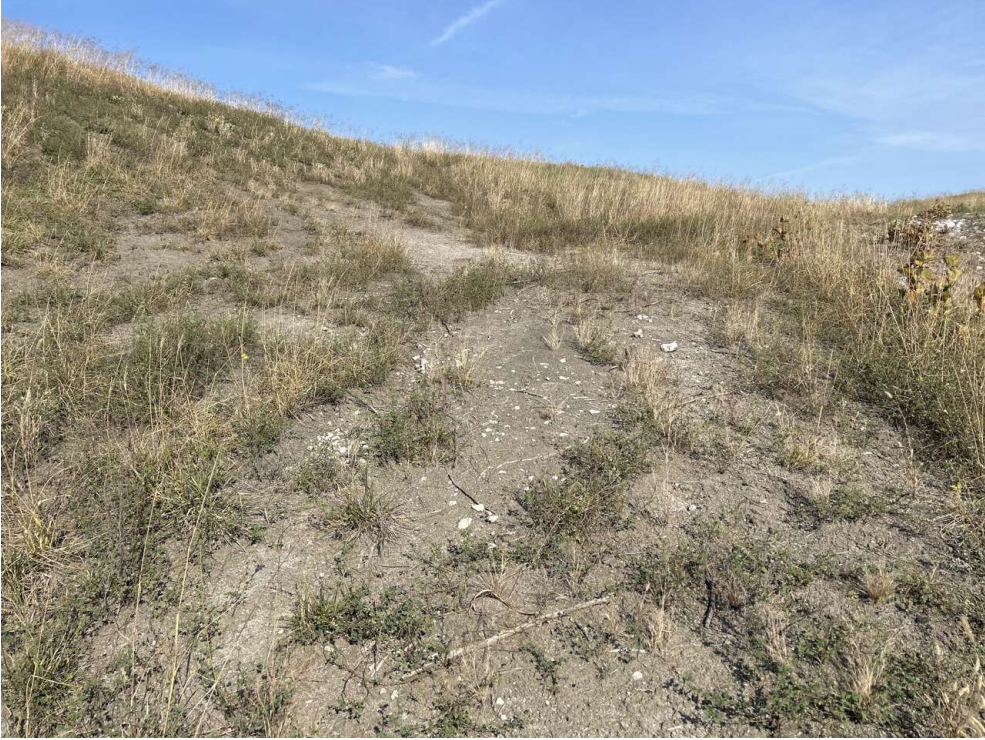
Grid ID M-23	Photo ID 17

Date November 6, 2023		
Description: Erosion occurring along south slope has exposed underlying Poz-o-tec material. Photo looking north. Install topsoil and re-seed bare spots to prevent erosion and maintain proper grass cover.		
Grid ID O-13	Photo ID 18

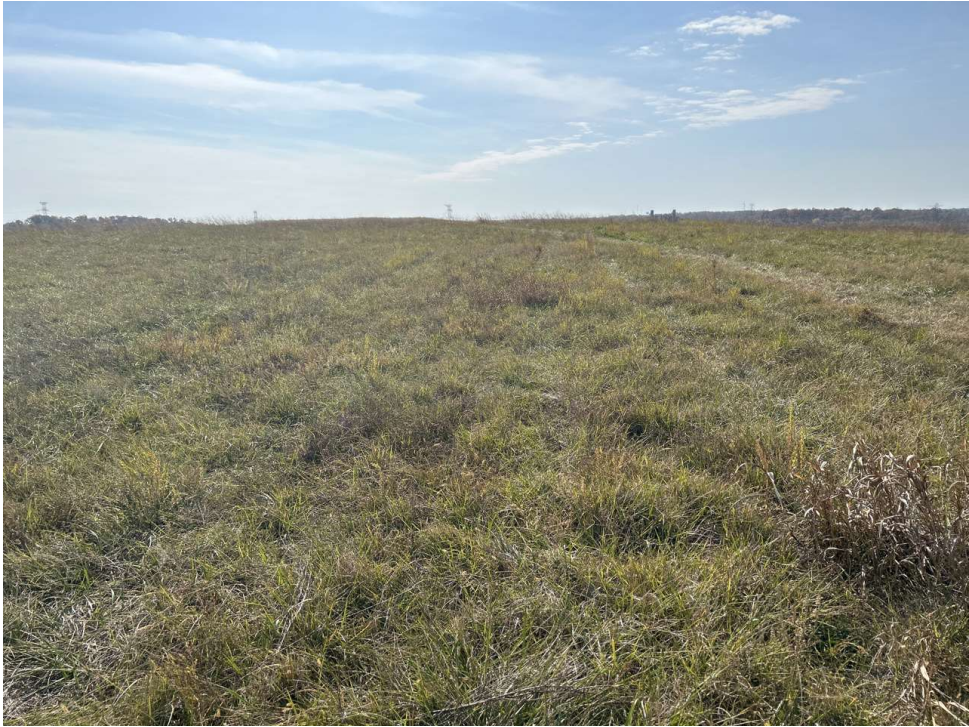
Date November 6, 2023		
Description: Vegetation well established on top of the landfill. No issues observed. Photo looking south.

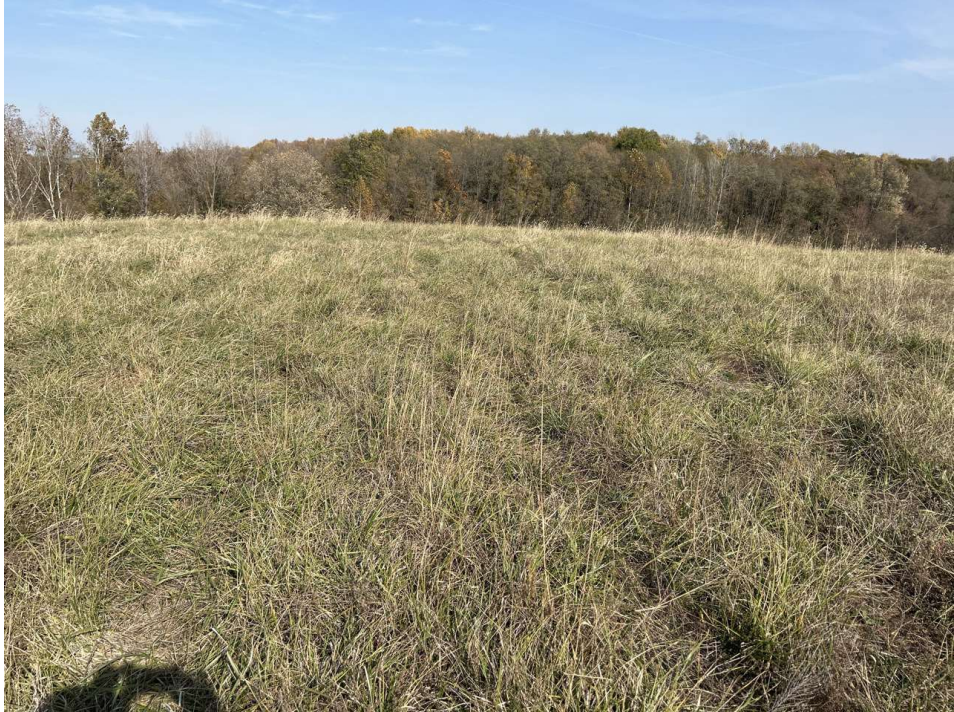
Grid ID O-13	Photo ID 19

Date November 6, 2023		
Description: Vegetation well established on top of the landfill. No issues observed. Photo looking east.		
Grid ID O-18	Photo ID 20

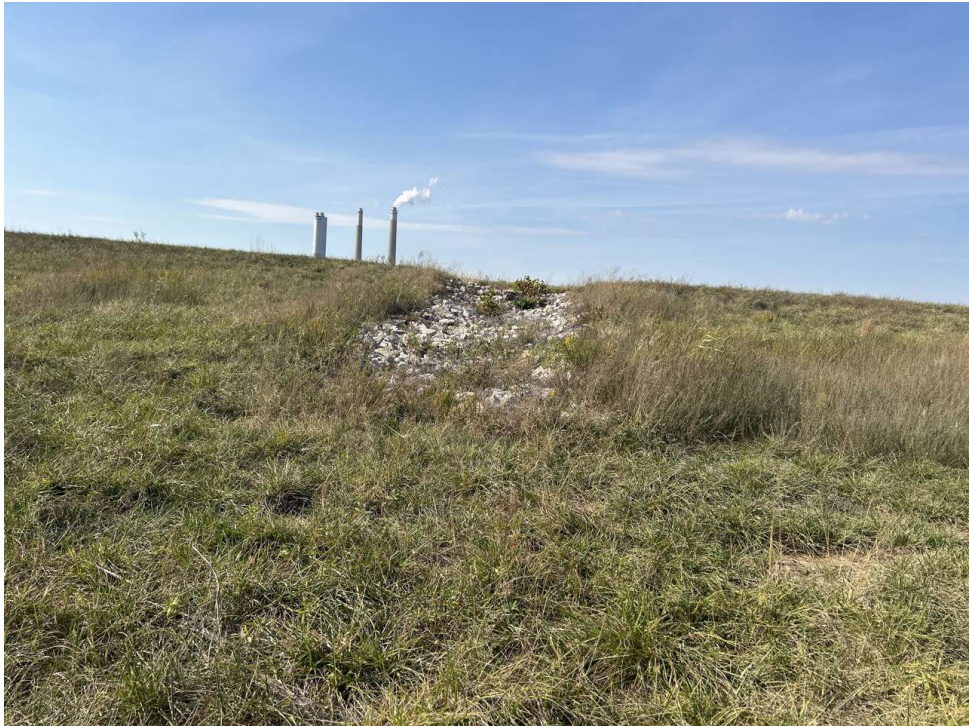
Date November 6, 2023		
Description: Down drain on the east slope of the landfill. No issues observed. Photo looking west.
