**2024 VISUAL INSPECTION OF ASH POND EMBANKMENTS
AES PETERSBURG ASH POND SYSTEM**

AES INDIANA PETERSBURG GENERATING STATION
6925 NORTH STATE ROAD 57
PETERSBURG, INDIANA 47567

ATLAS PROJECT NO. 170AES0005

NOVEMBER 12, 2024

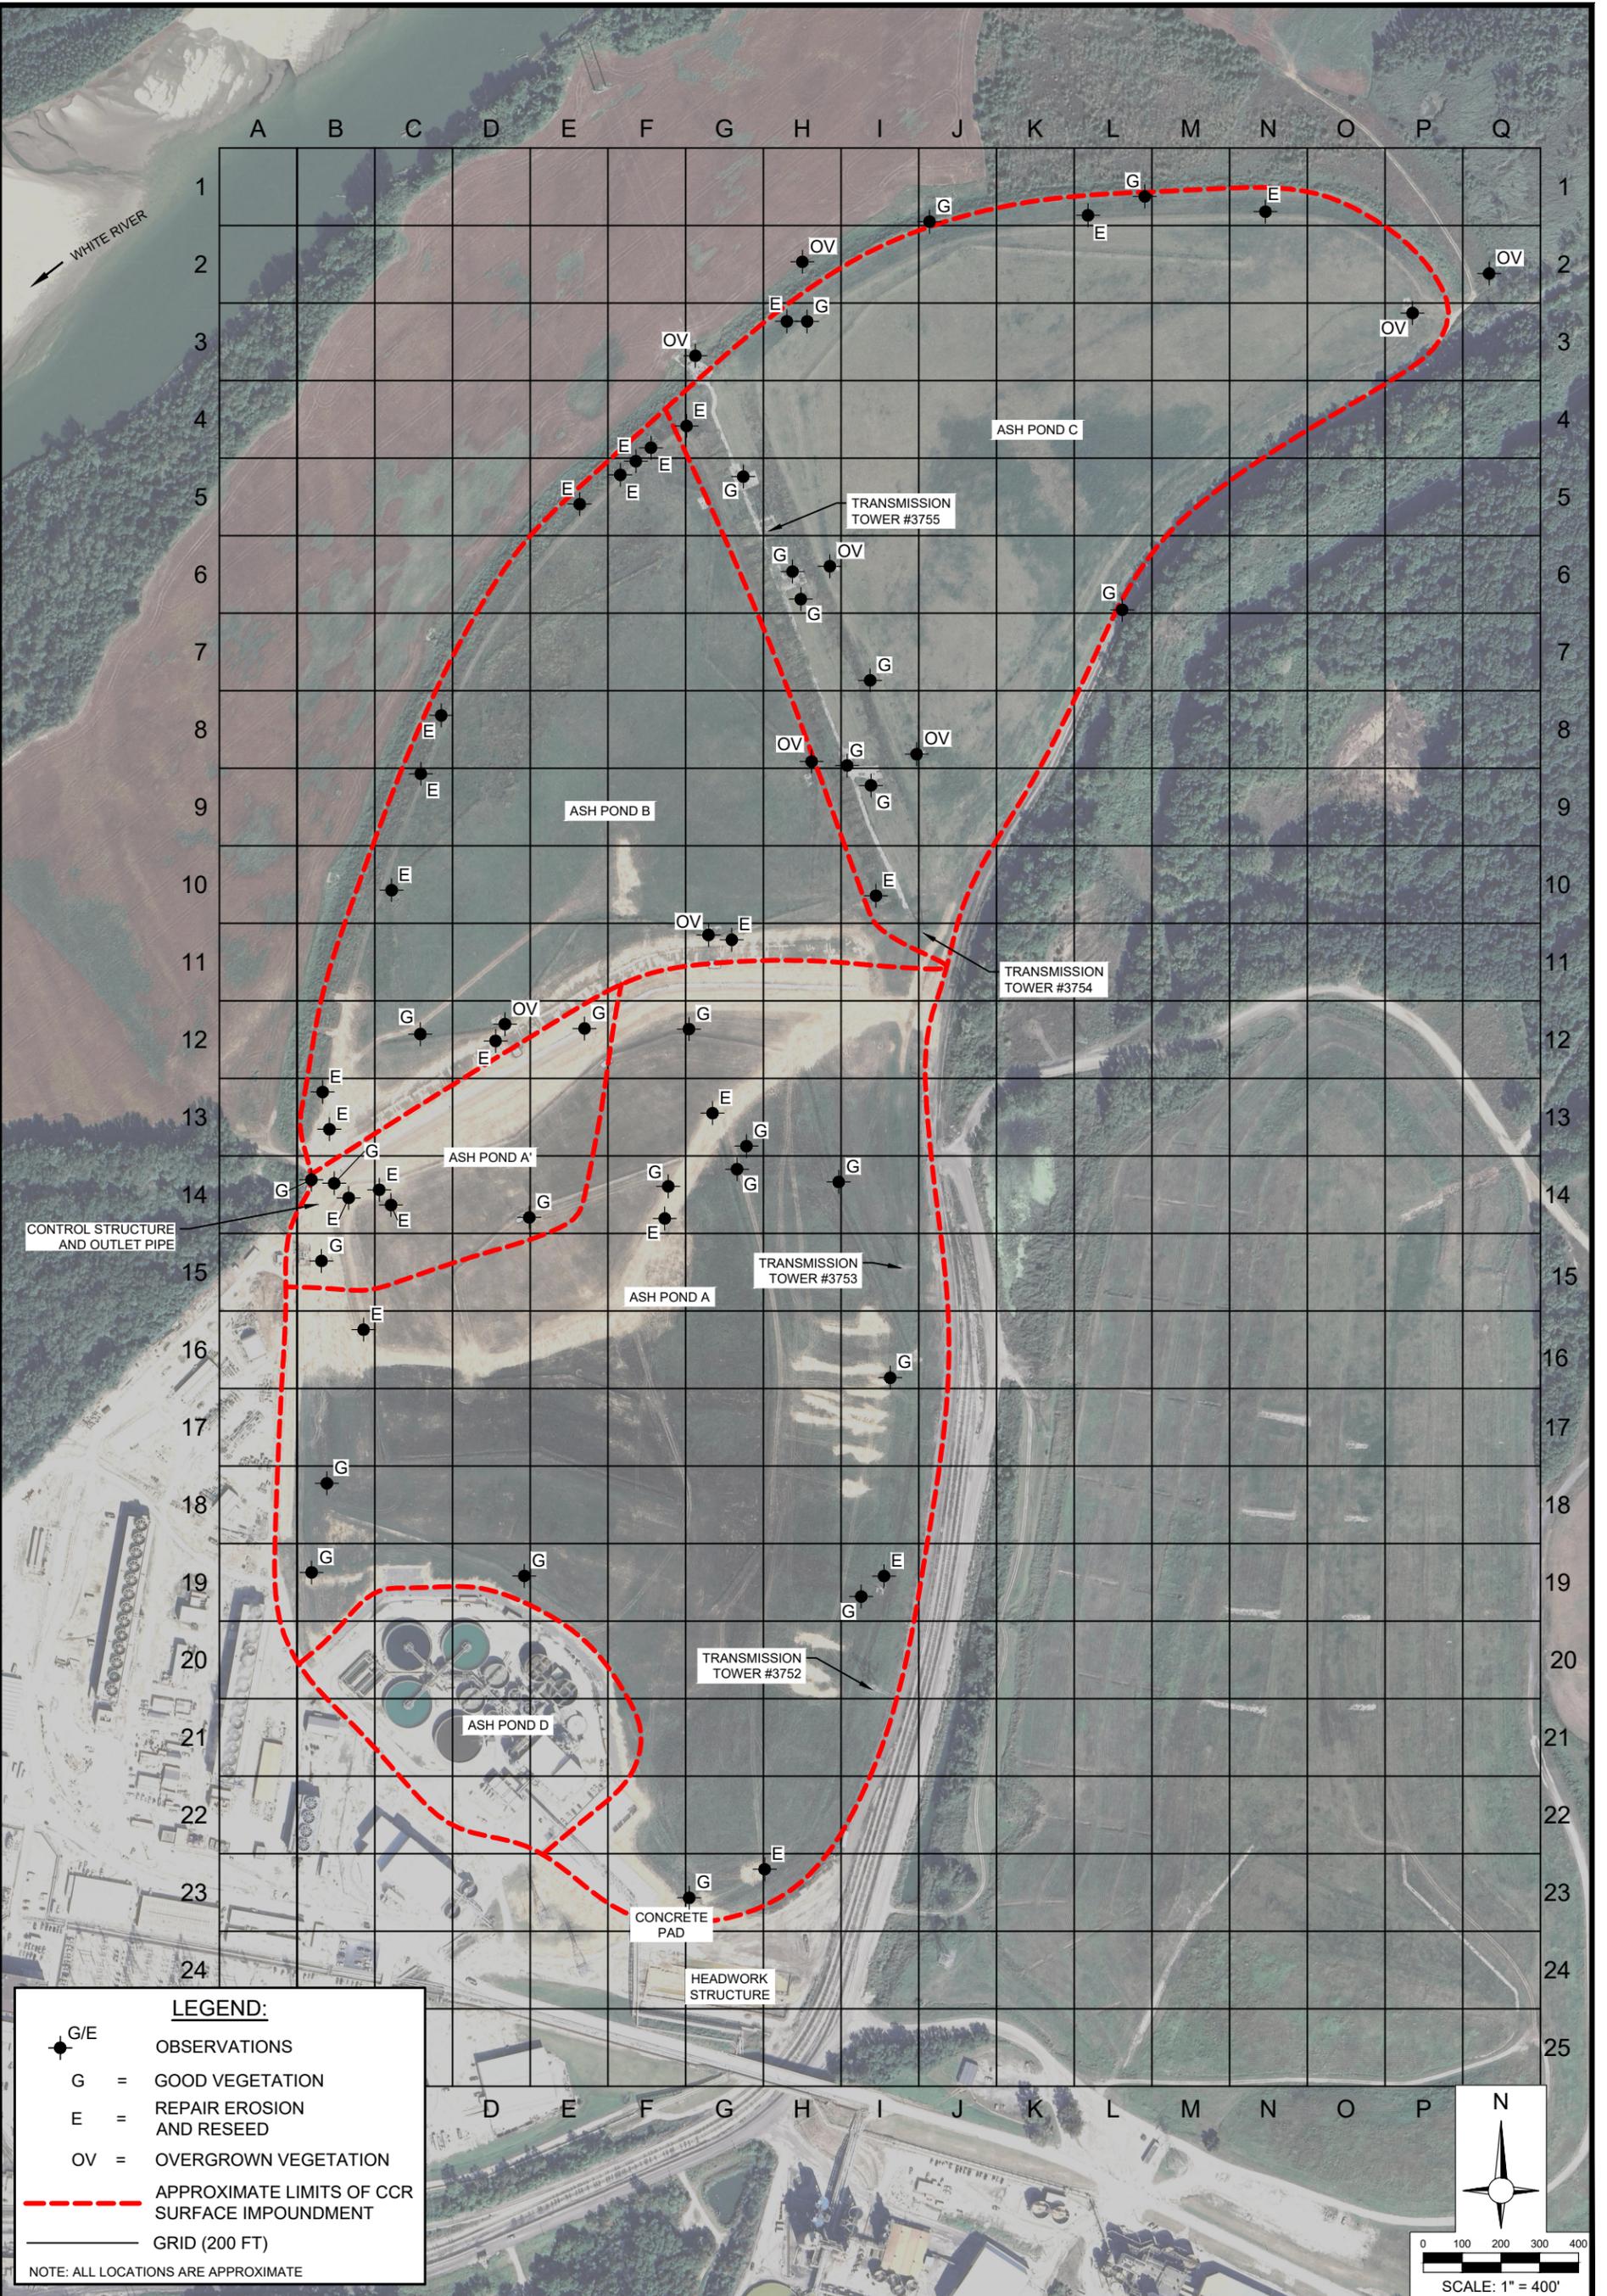
Engineering observations performed on September 26, 2024 are shown in Figure 3, 2024 Visual Site Inspection Grid Map. Atlas visually inspected the embankments for Ash Ponds A, A', B, C, and D and found no areas of instability. However, there were few areas with minor erosion issues on sections of Ash Pond A, B and C (Figure 3).

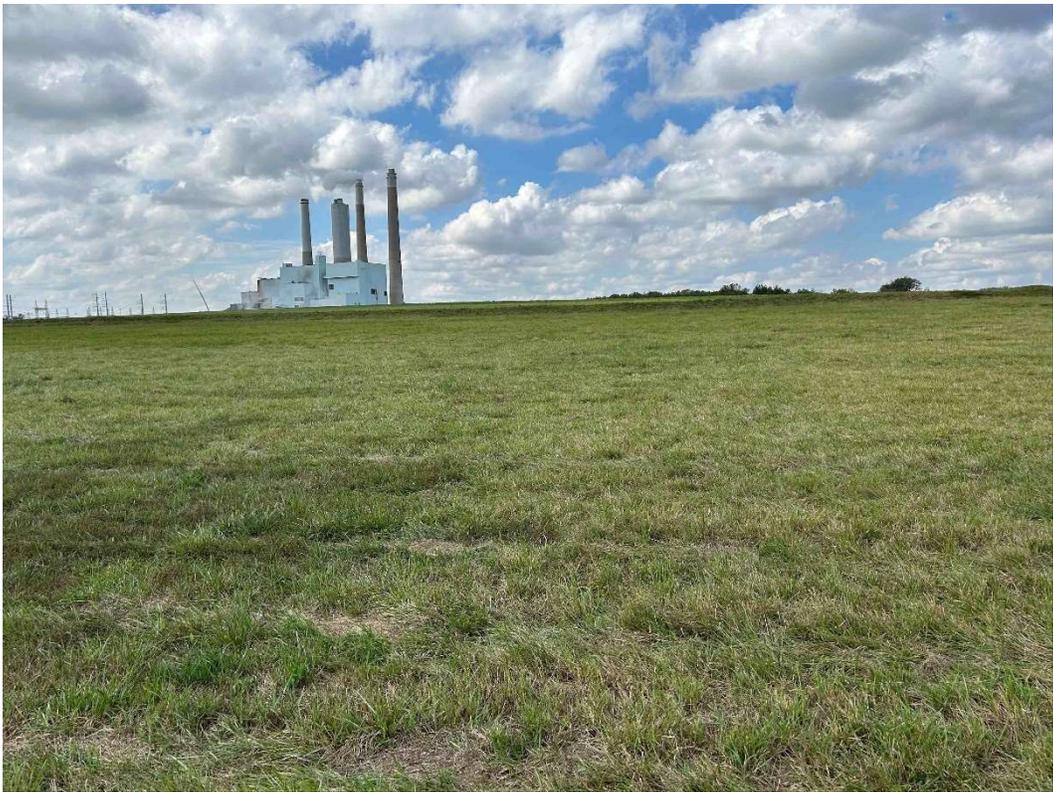
| Grid ID H-14 | Location ID A-1 | |

| Description: Well established vegetation on east side of Ash Pond A. Photo looking west. No issues observed. | | |

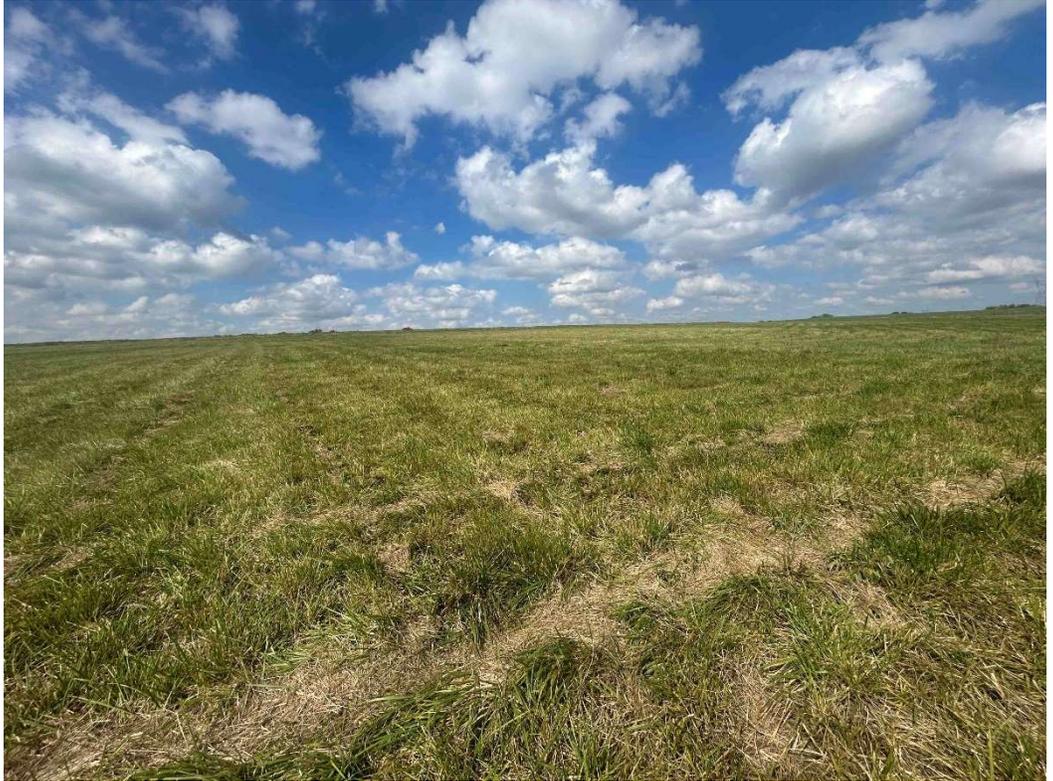
| Grid ID I-16 | Location ID A-2 | |

| Description: Well established vegetation on east side of Ash Pond A. Photo looking east. No issues observed. | | |

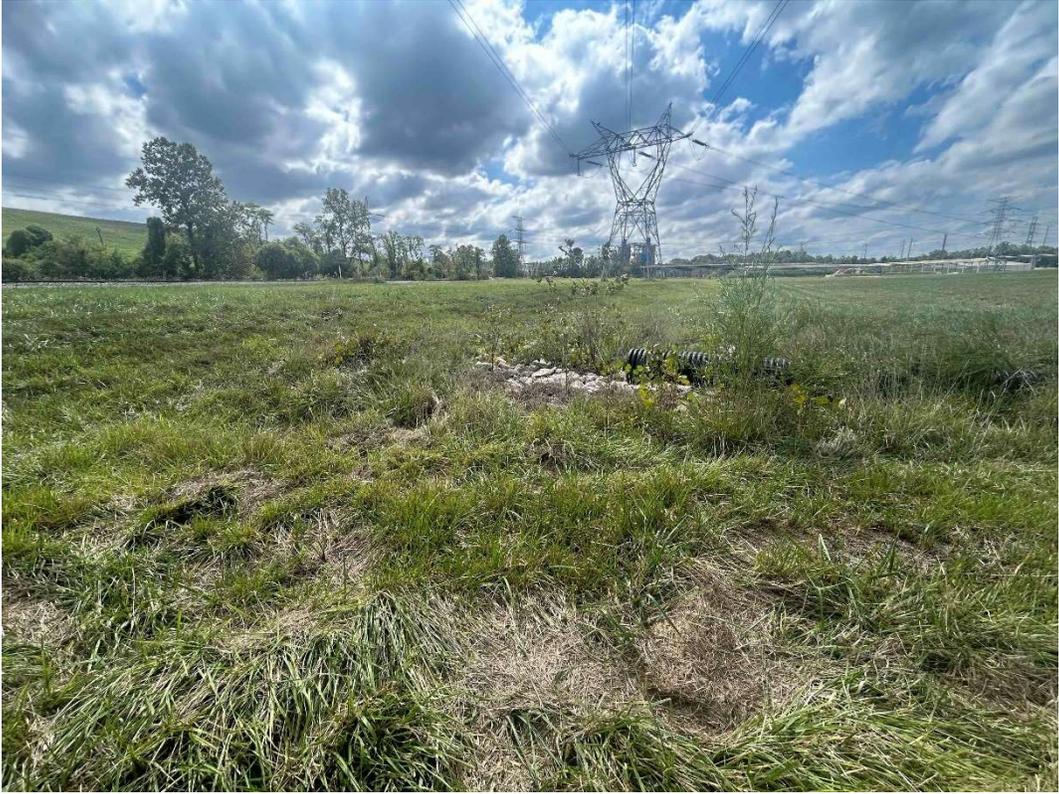
| Grid ID I-19 | Location ID A-3 | |

1. Debris and/or tall vegetation observed around outlet pipe riprap located on south side of the Ash Pond A (location ID A-3).
 - o Recommendation: Cut down tall vegetation at riprap area.

| Description: Overgrown vegetation observed around the riprap area. Recommend cutting down tall vegetation. | | |

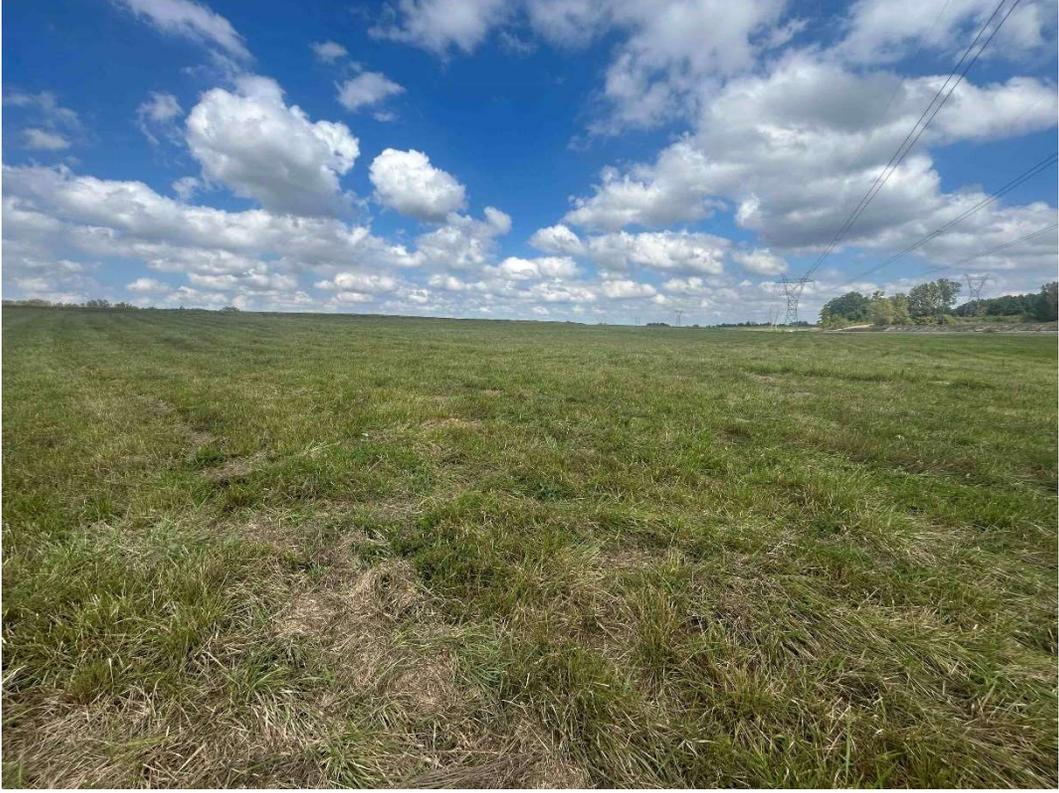
| Grid ID I-19 | Location ID A-4 | |

| Description: Vegetation well established on east section of Ash Pond A. No issues observed. | | |

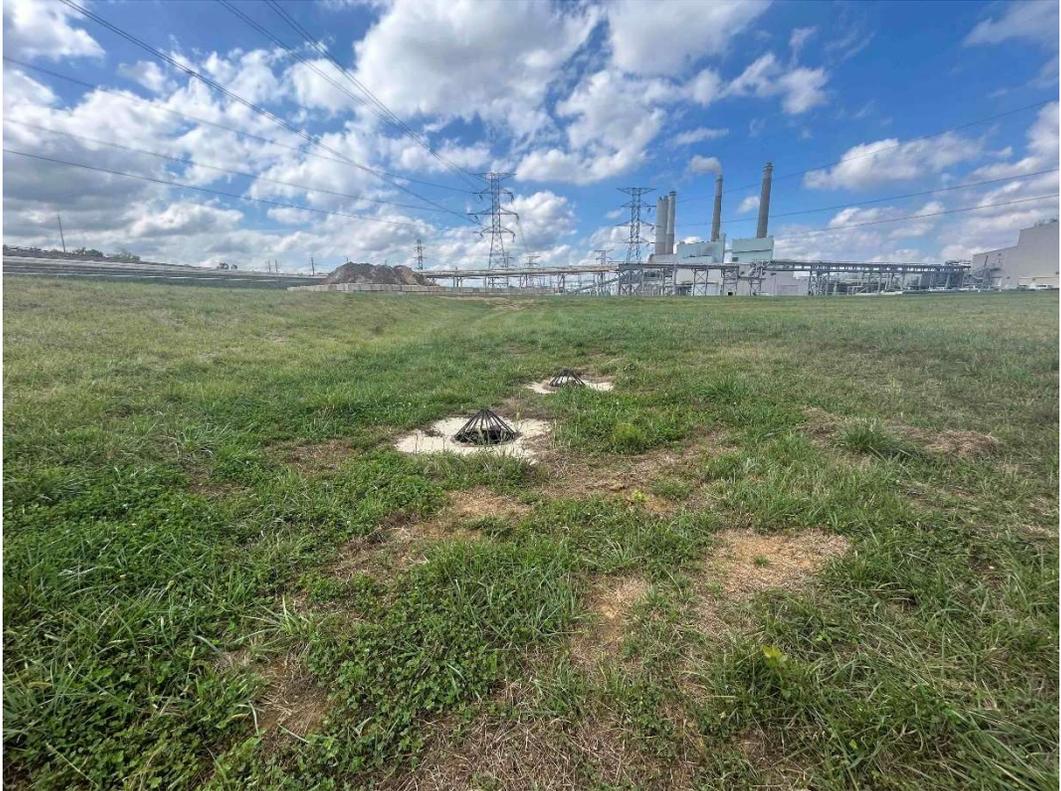
| Grid ID H-23 | Location ID A-5 | |

| Description: Drop inlets in the south side of Ash Pond A are in good conditions. Recommend re-seeding bare spots adjacent to drop inlets. | | |

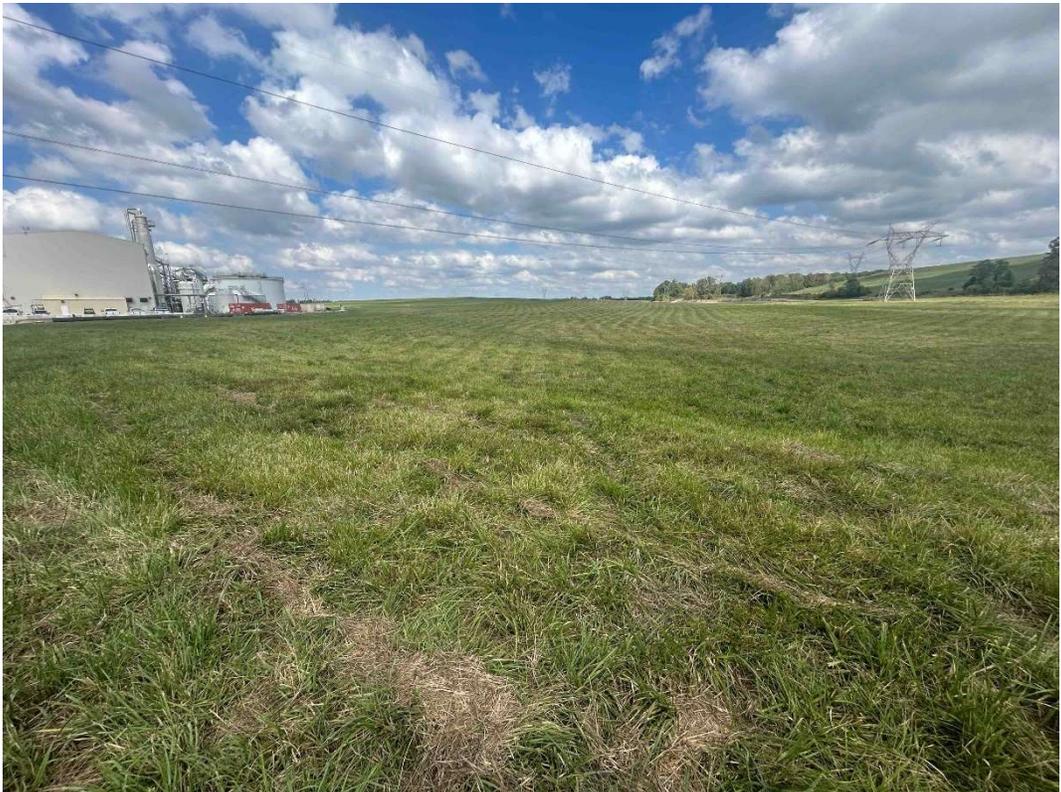
| Grid ID G-23 | Location ID A-6 | |

| Description: Vegetation well established on south section of Ash Pond A. No issues observed. | | |

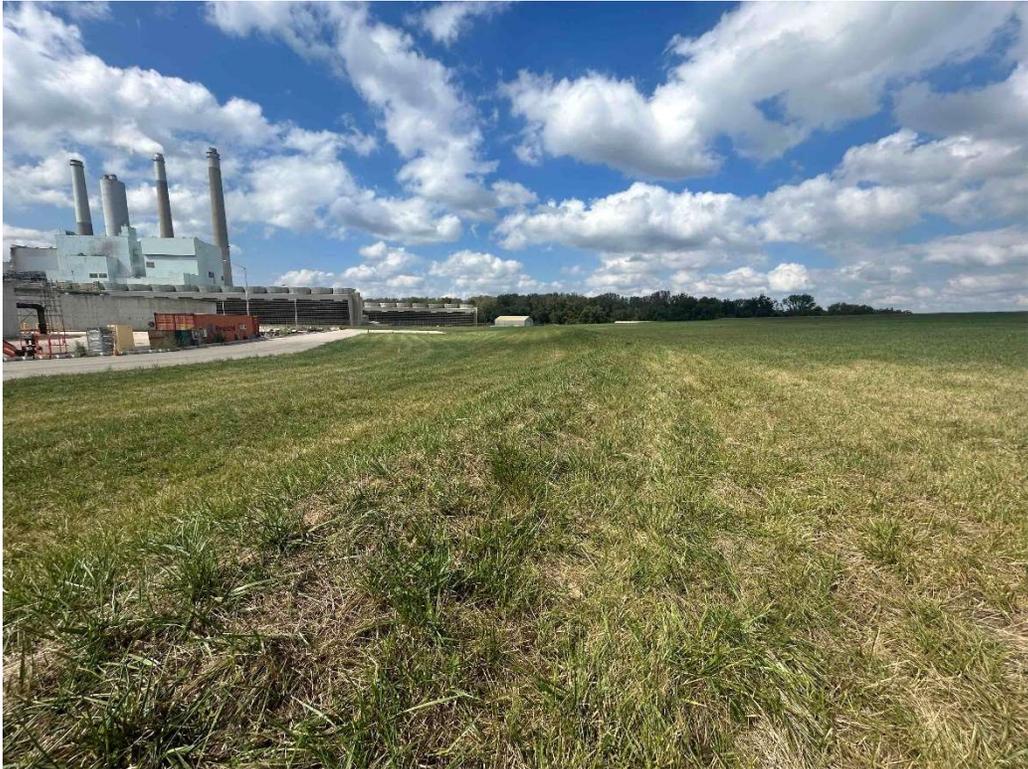
| Grid ID D-19 | Location ID A-7 | A wide-angle photograph showing a large, open field of tall, green and yellowish grass in the foreground. In the background, a large industrial facility with several tall smokestacks is visible under a bright blue sky with scattered white clouds. |

| Description: Well established vegetation observed along south side of Ash Pond A, adjacent to Ash Pond D to the left of the photo. No issues found. | | |

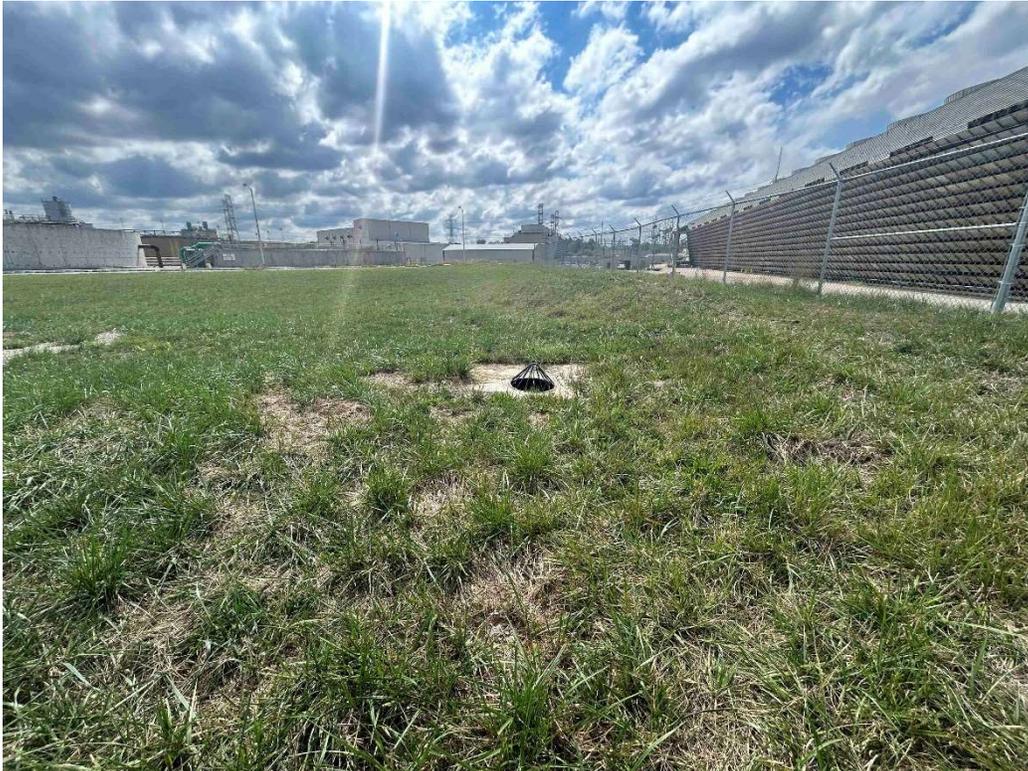
| Description: Drop inlets appear well maintained. No issues observed. | | |

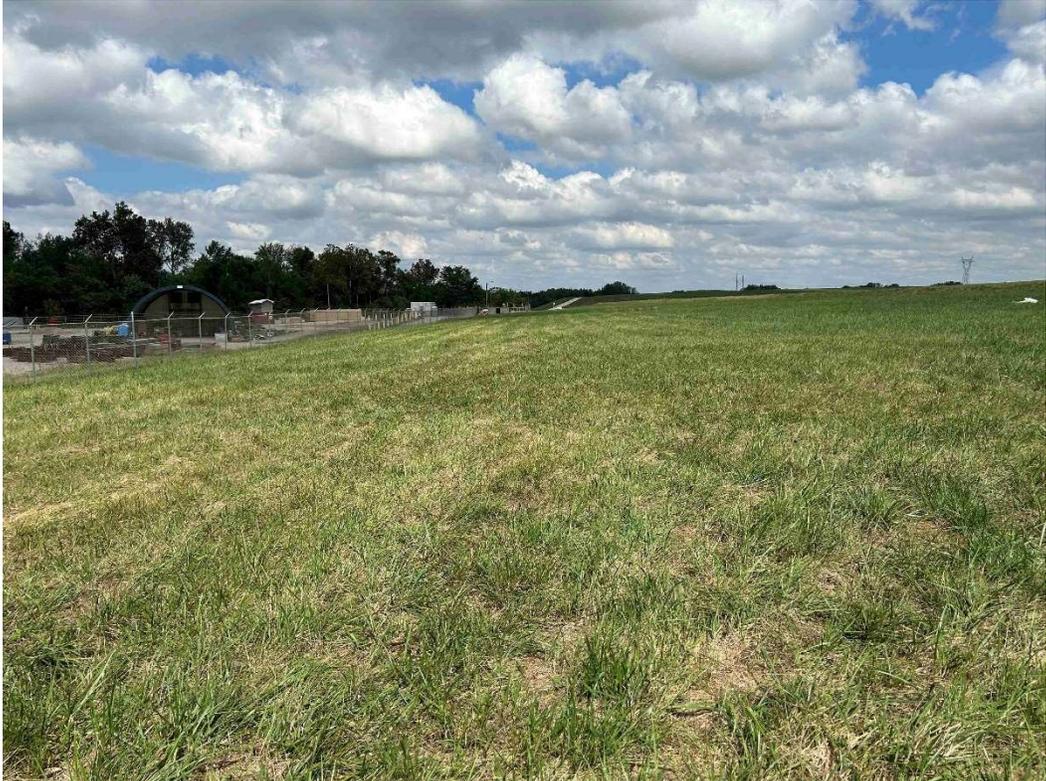
| Grid ID B-18 | Location ID A-9 | |

| Description: Well established vegetation observed along the west side of Ash Pond A. No issues found. | | |

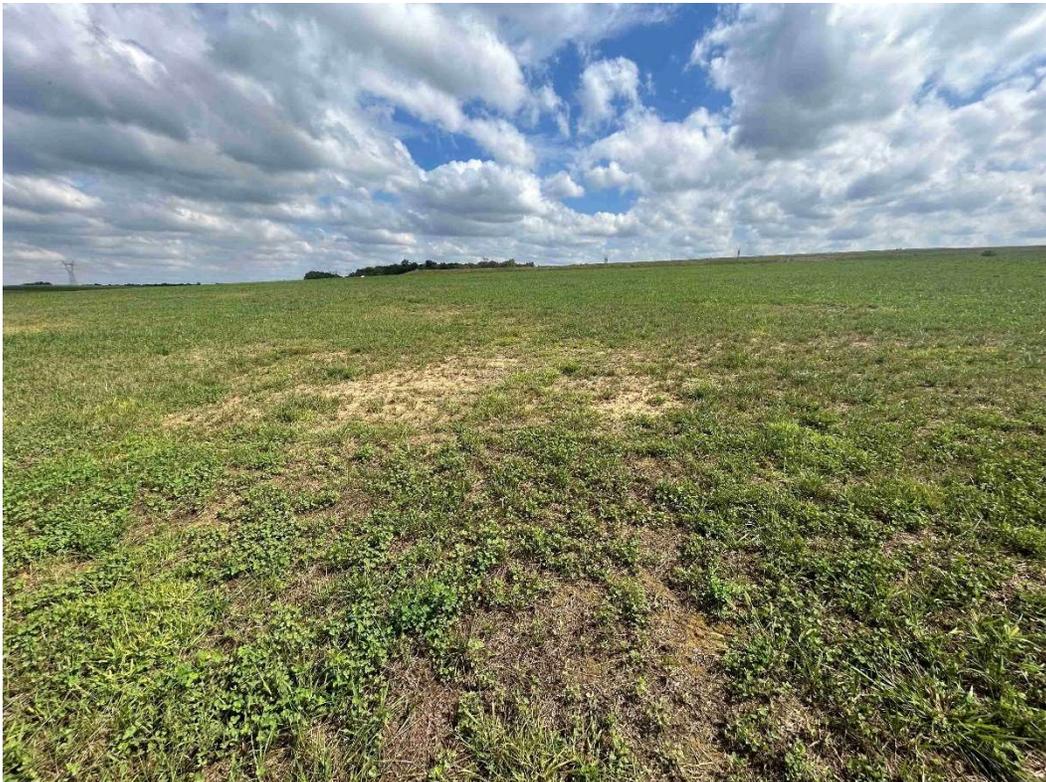
| Grid ID B-16 | Location ID A-10 | |

| Description: Bare spots observed on the northwest side of Ash Pond A. Recommend re-seeding bare spots. | | |

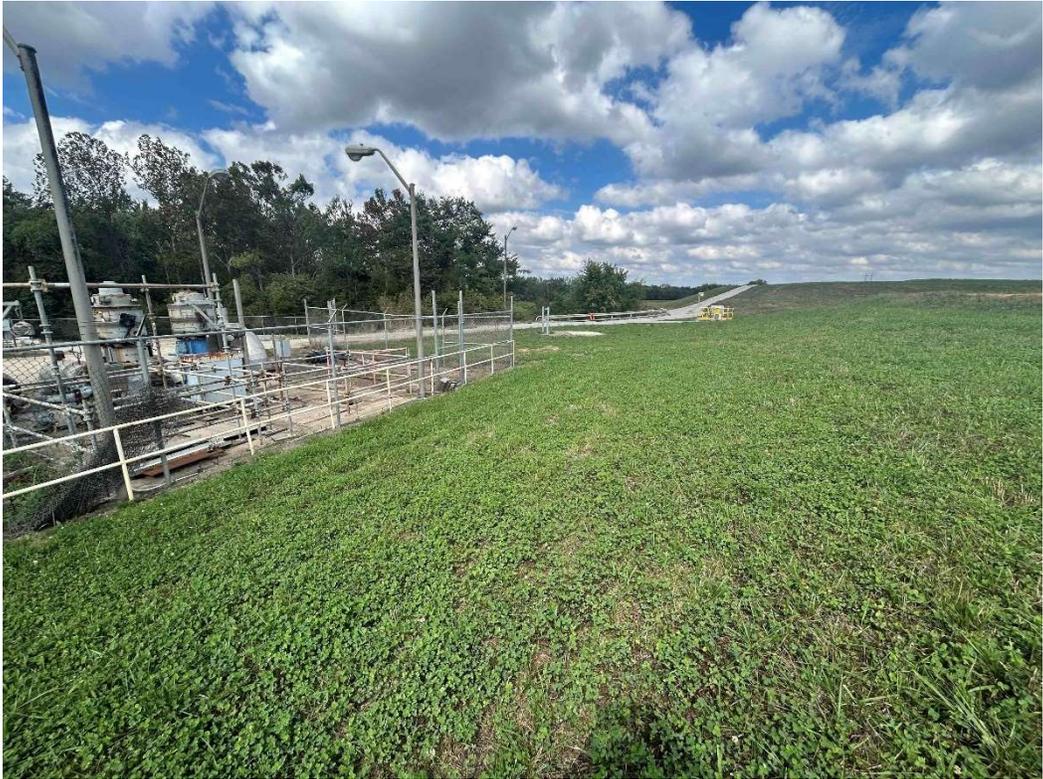
| Grid ID B-15 | Location ID A-11 | |

| Description: Well established vegetation observed on the west side of Ash Pond A'. No issues found. | | |

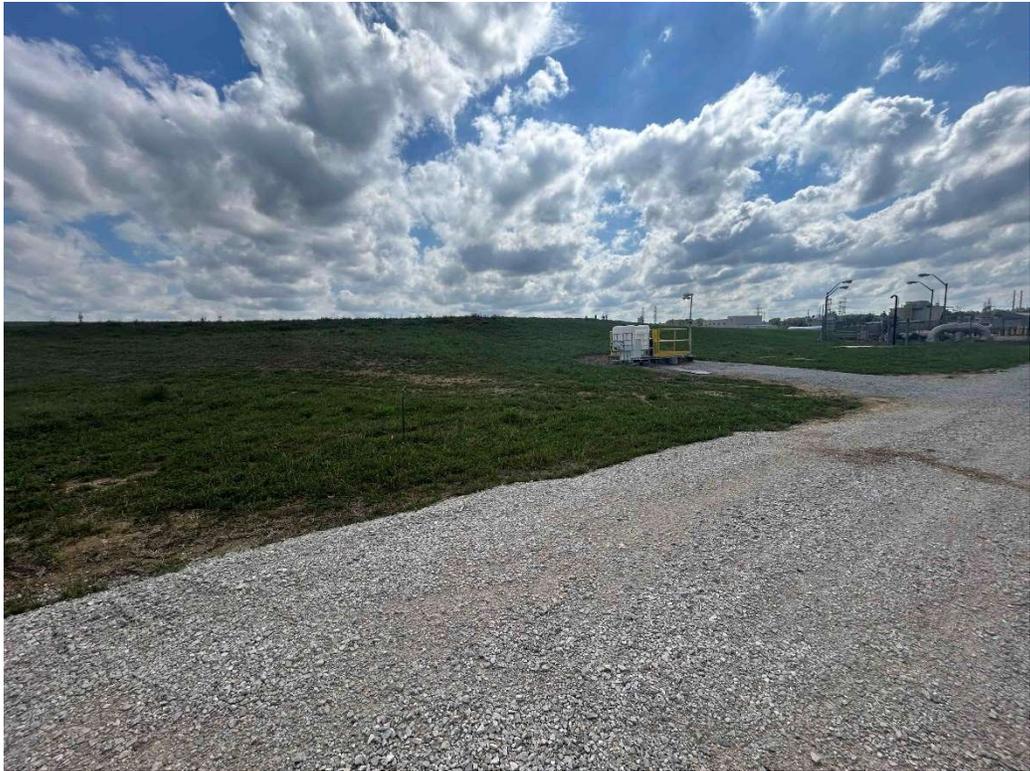
| Grid ID B-14 | Location ID A-12 | |

| Description: Access road along west side of Ash Pond A', with Outfall Control Structure on the background. No issues found. | | |

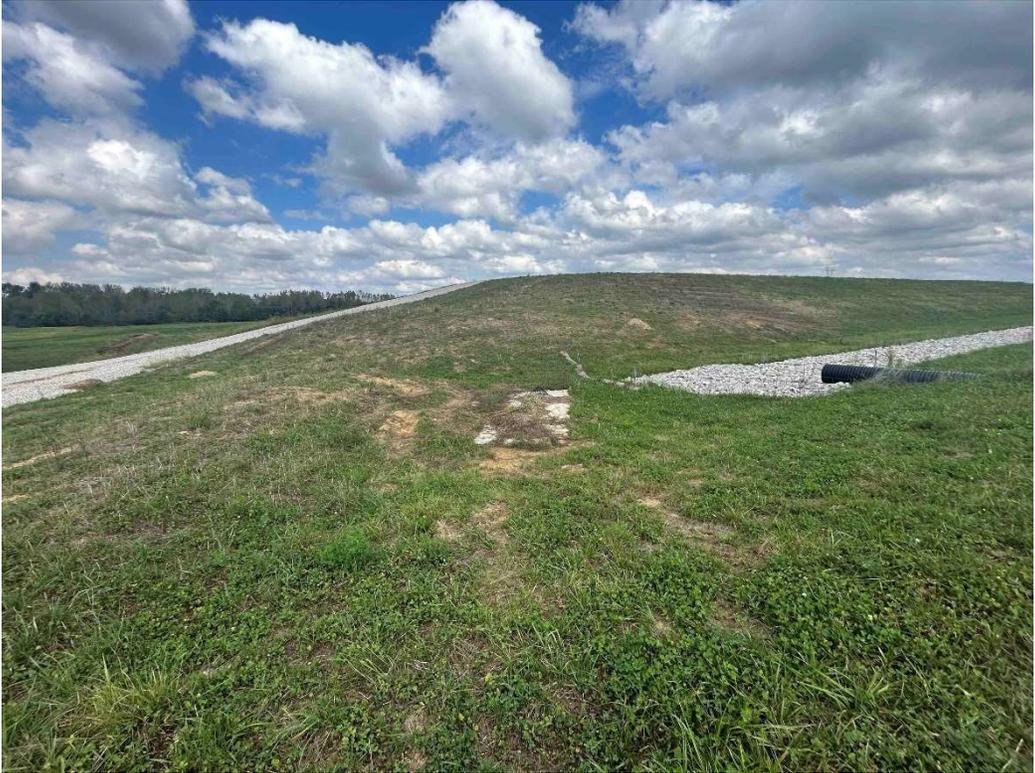
| Grid ID B-14 | Location ID A-13 | |

| Description: Riprap channel between Ash Pond A' and B looked well maintained. No issues found. | | |

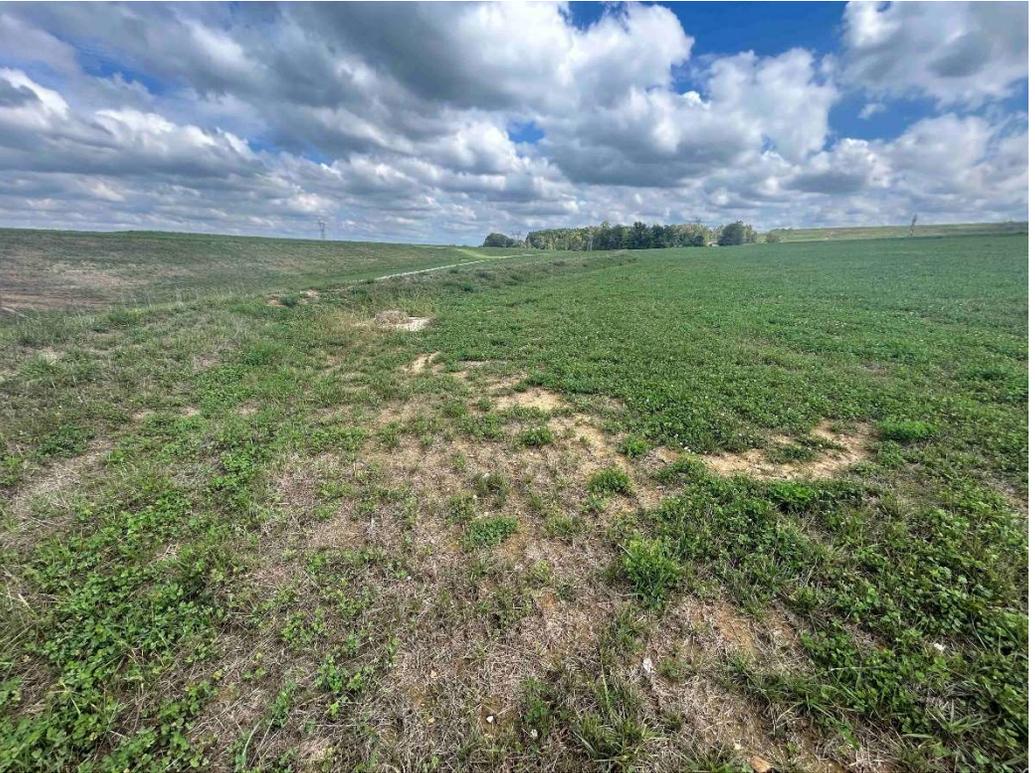
| Grid ID B-14 | Location ID A-14 | |

| Description: Bare spots observed on the northwest side of Ash Pond A'. Recommend re-seeding bare spots. | | |

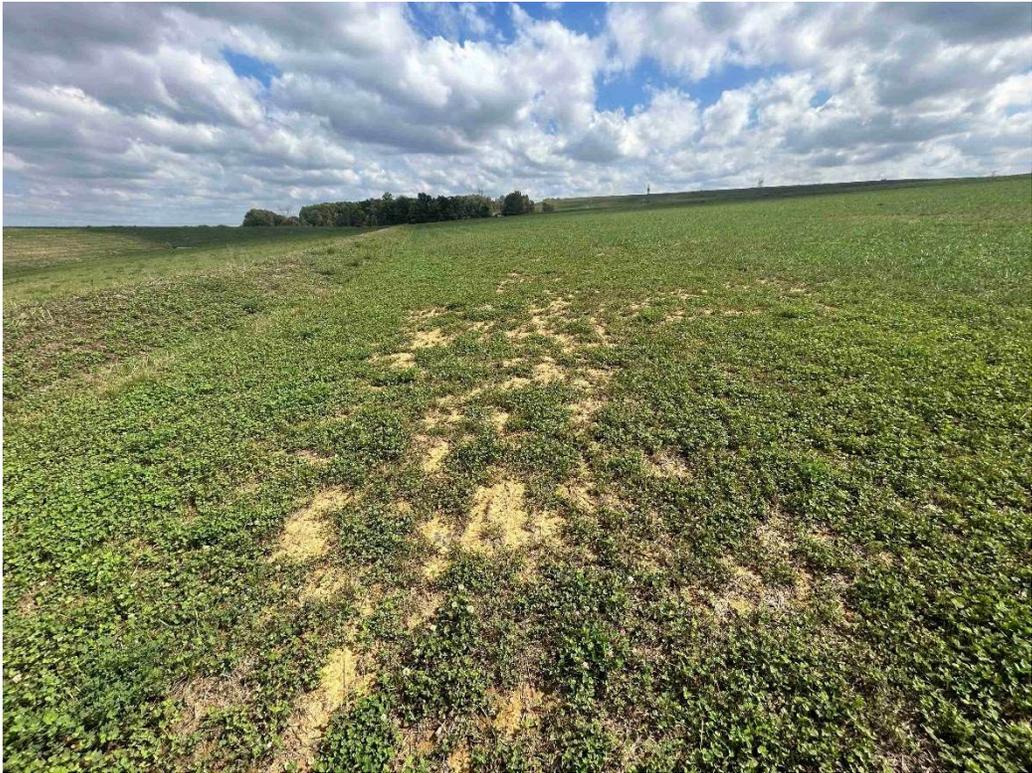
| Grid ID C-14 | Location ID A-15 | |

| Description: Bare spots observed on the northwest side of Ash Pond A'. Recommend re-seeding bare spots. | | |

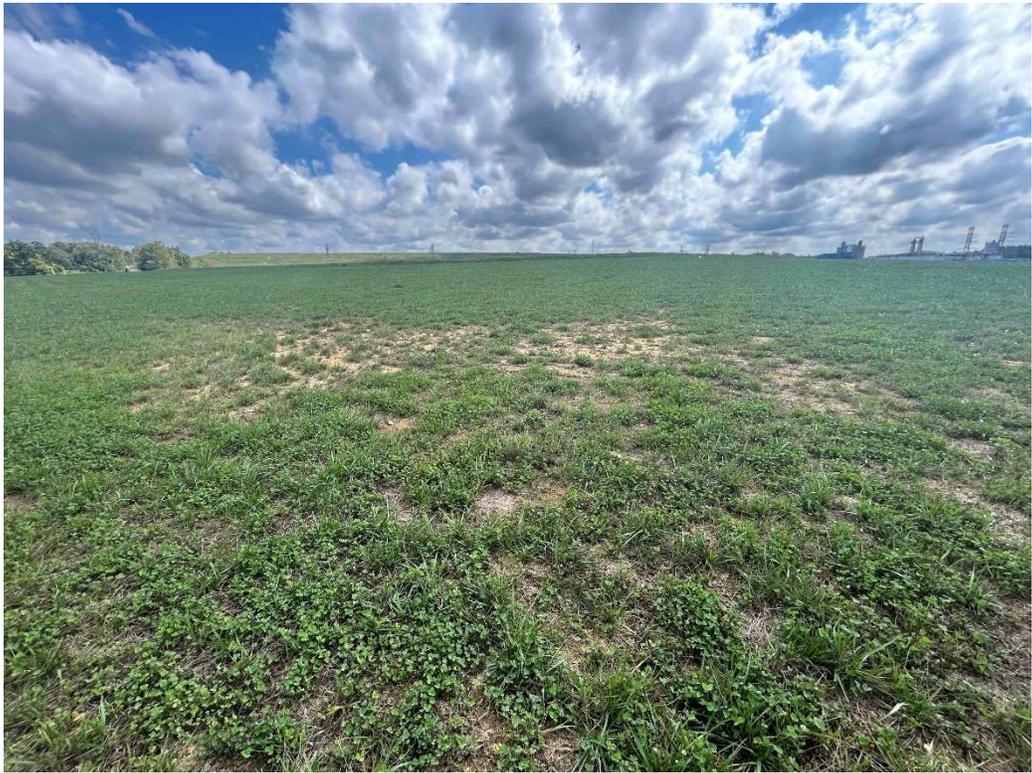
| Grid ID C-14 | Location ID A-16 | |

| Description: Bare spots observed on the north side of Ash Pond A'. Recommend re-seeding bare spots. | | |

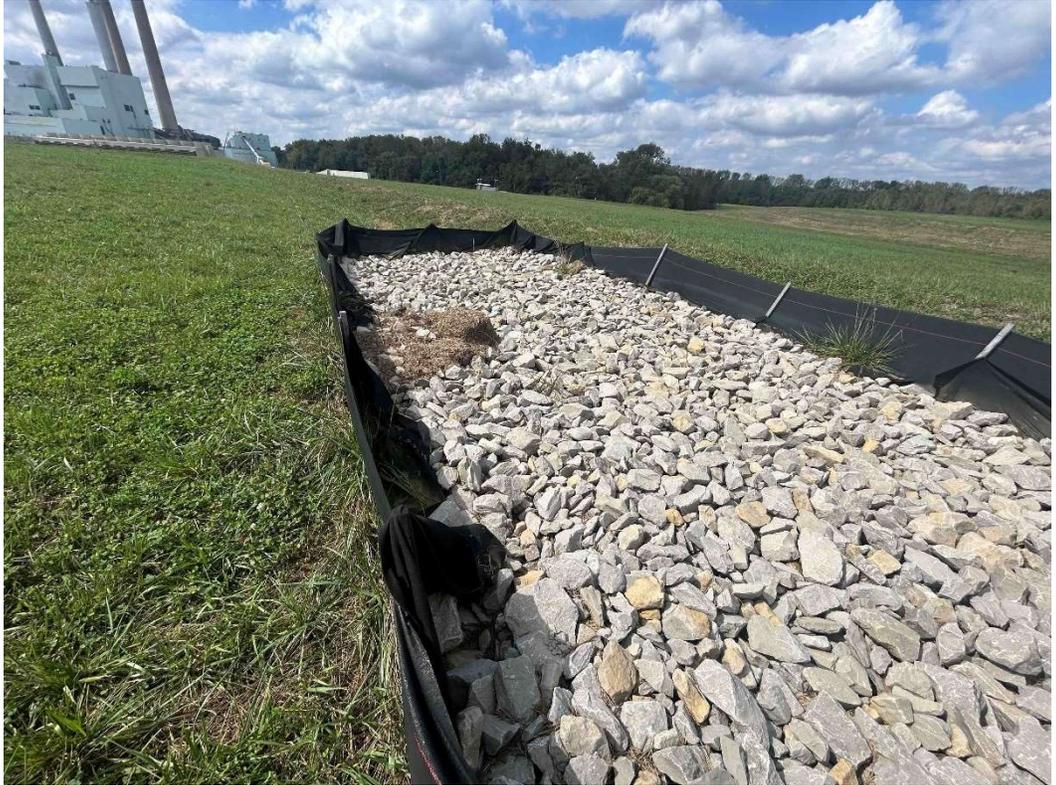
| Grid ID D-14 | Location ID A-17 | |

| Description: Riprap on the north side is in good condition. No issues found. | | |

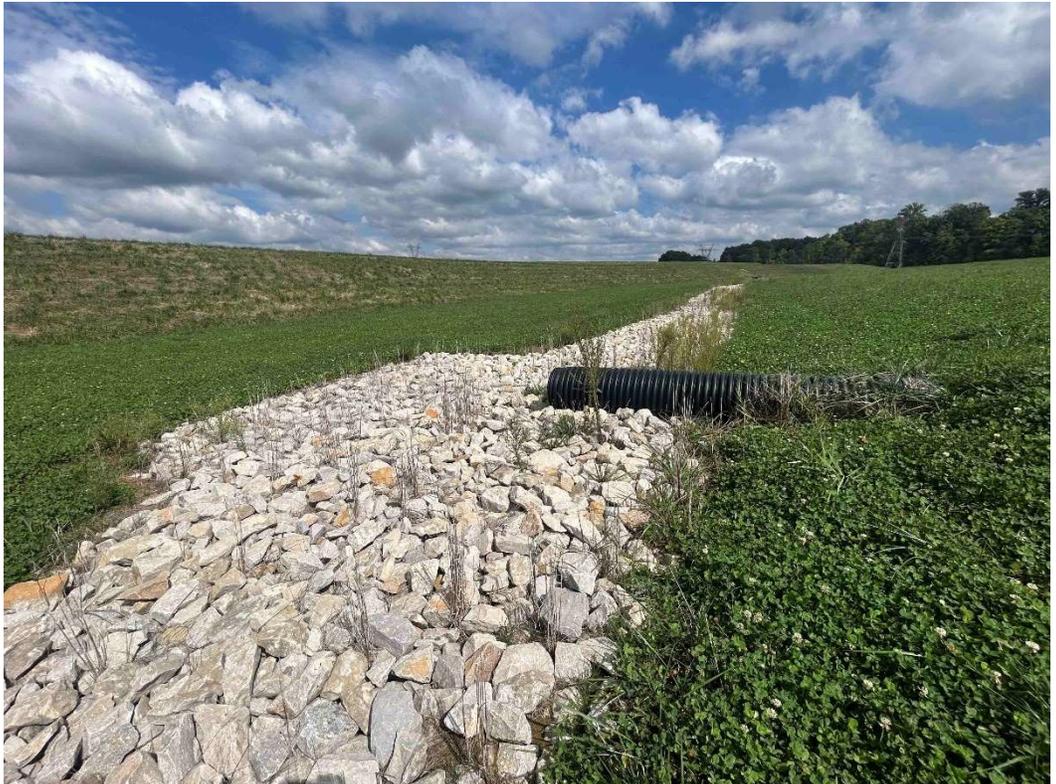
| Grid ID E-12 | Location ID A-18 | |

| Description: Riprap channel between Ash Pond A' and B looked well maintained. No issues found. | | |

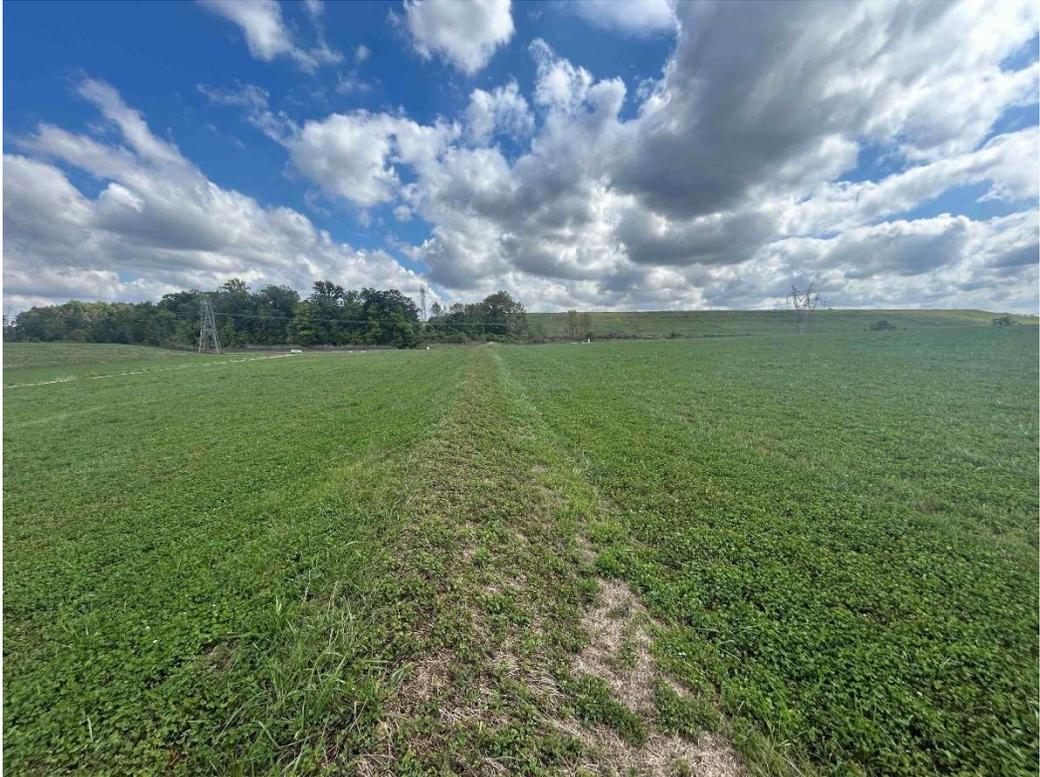
| Grid ID G-12 | Location ID A-19 | |

| Description: Well established vegetation observed near the north berm. No issues found. | | |

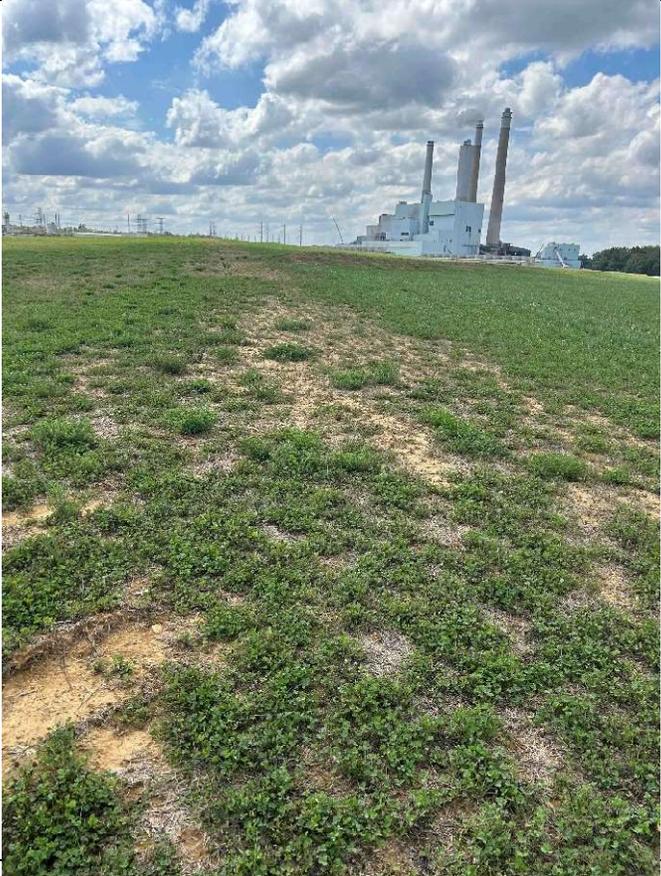
| Grid ID G-13 | Location ID A-20 | |

| Description: Bare spots and soil erosion observed on the north side of Ash Pond A. Recommend re-seeding bare spots. | | |

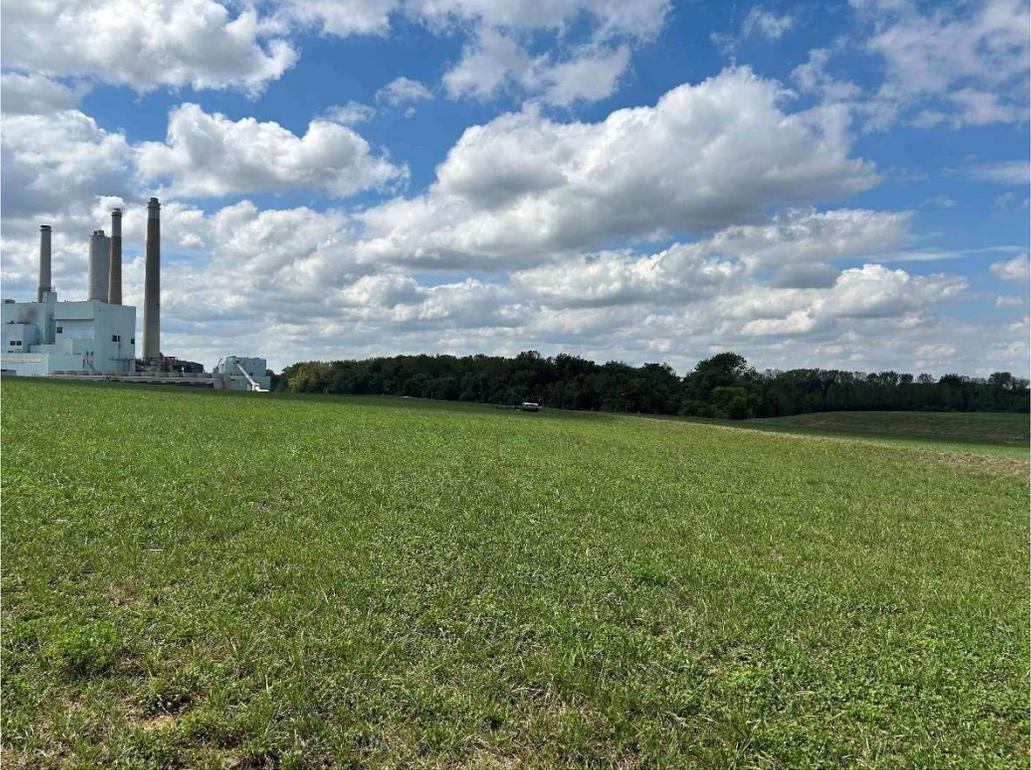
| Grid ID F-14 | Location ID A-21 | |

| Description: Well established vegetation observed. No issues found. | | |

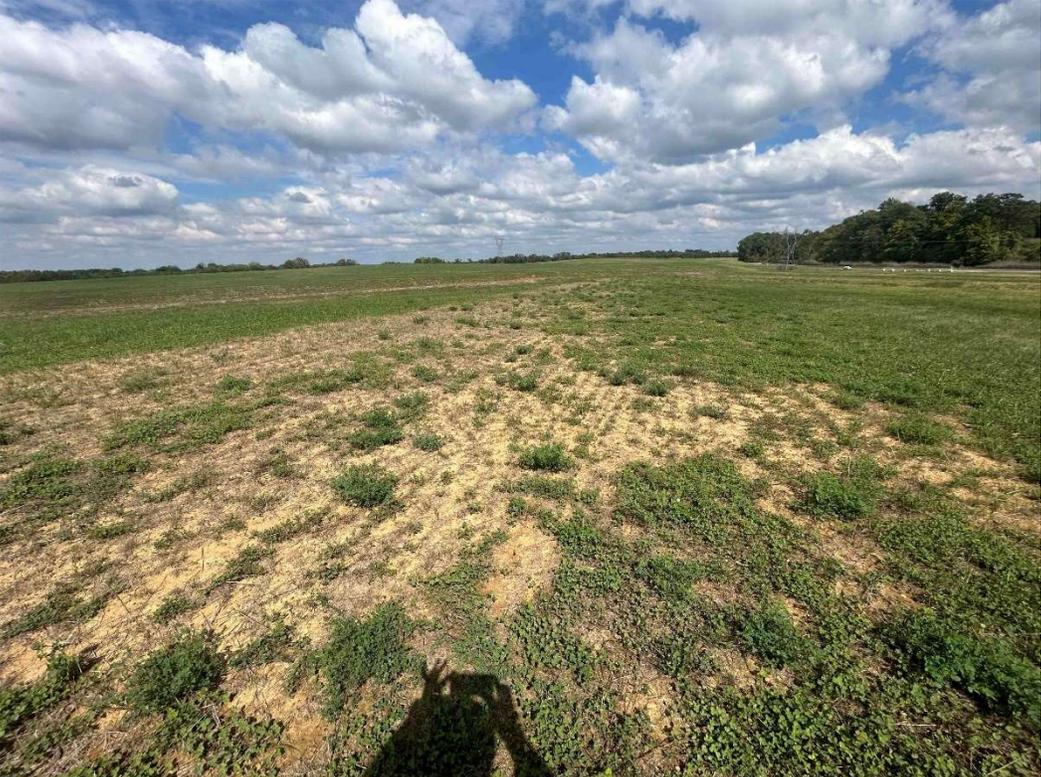
| Grid ID F-14 | Location ID A-22 | |

| Description: Bare spots observed on the north top slope of Ash Pond A. Recommend re-seeding bare spots. | | |
