**2024 VISUAL INSPECTION OF ASH POND EMBANKMENTS
AES PETERSBURG ASH POND SYSTEM**

AES INDIANA PETERSBURG GENERATING STATION
6925 NORTH STATE ROAD 57
PETERSBURG, INDIANA 47567

ATLAS PROJECT NO. 170AES0005

NOVEMBER 12, 2024

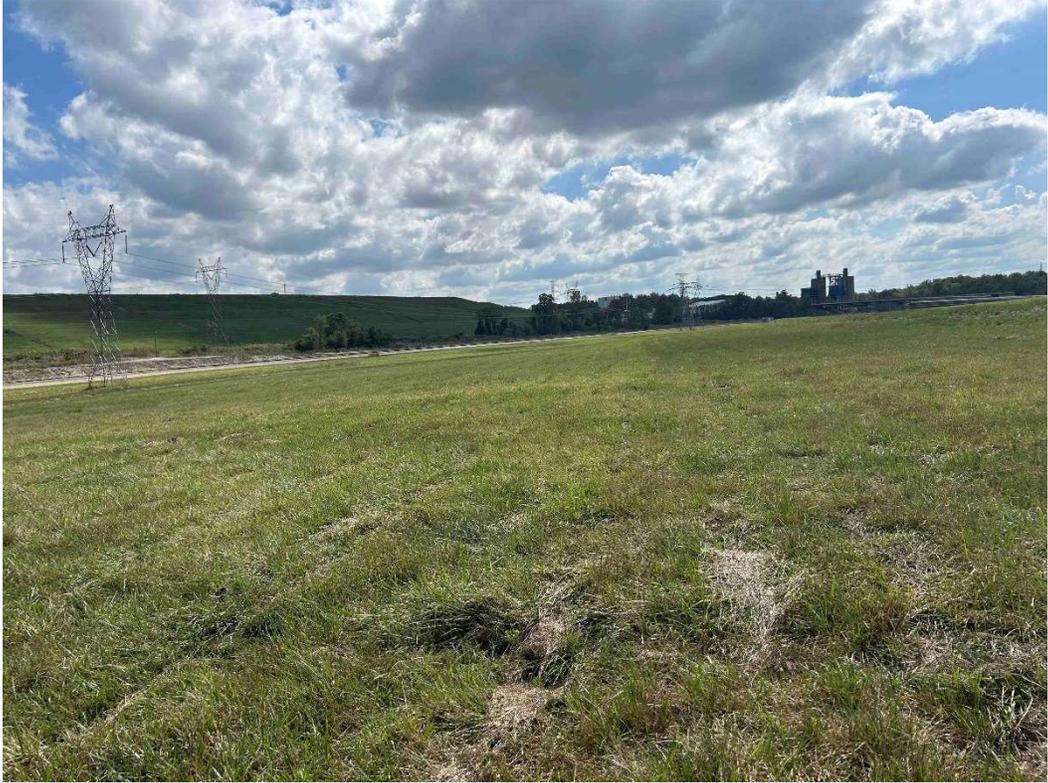
| Grid ID G-14 | Location ID A-23 | |

| Description: Well established vegetation observed. No issues found. | | |

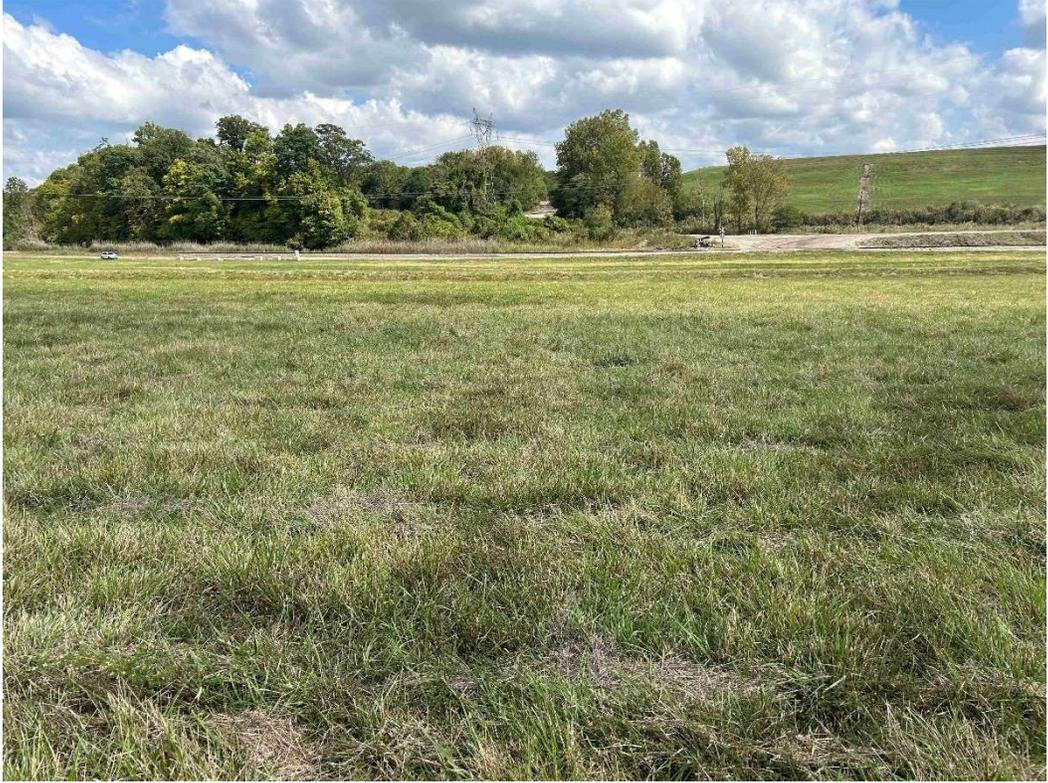
| Grid ID G-13 | Location ID A-24 | |

| Description: Well established vegetation observed. No issues found. | | |

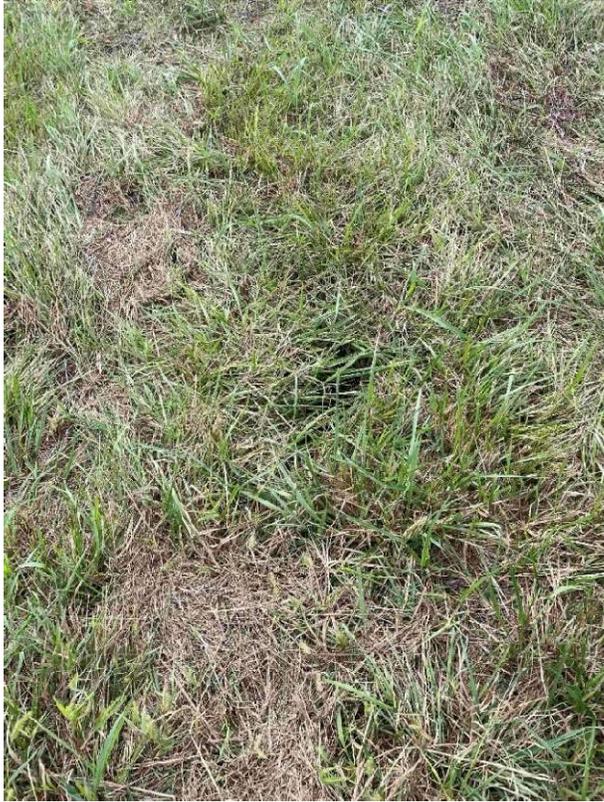
| Grid ID I-10 | Location ID B-1 | |

| Description: Animal burrow observed on the southeast side of Ash Pond B. Recommend repair and reseed. | | |

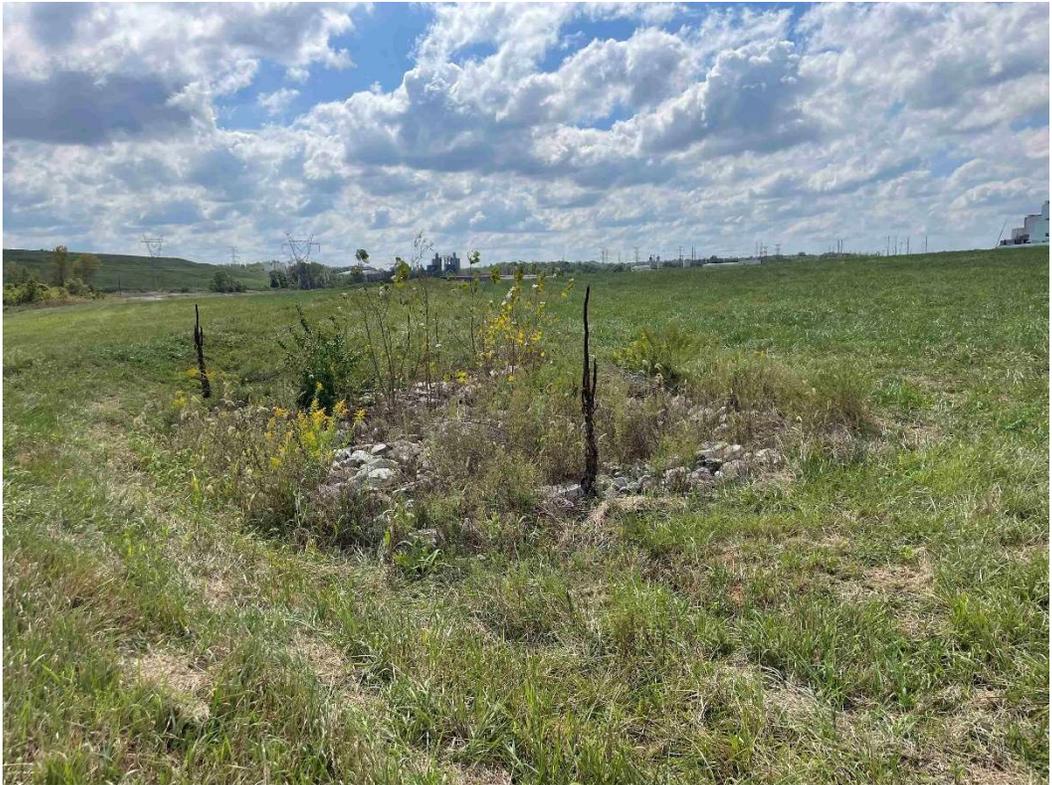
| Grid ID H-8 | Location ID B-2 | |

| Description: Tree saplings and overgrown vegetation observed around the drop inlet. Recommend cutting down tall vegetation and tree saplings. | | |

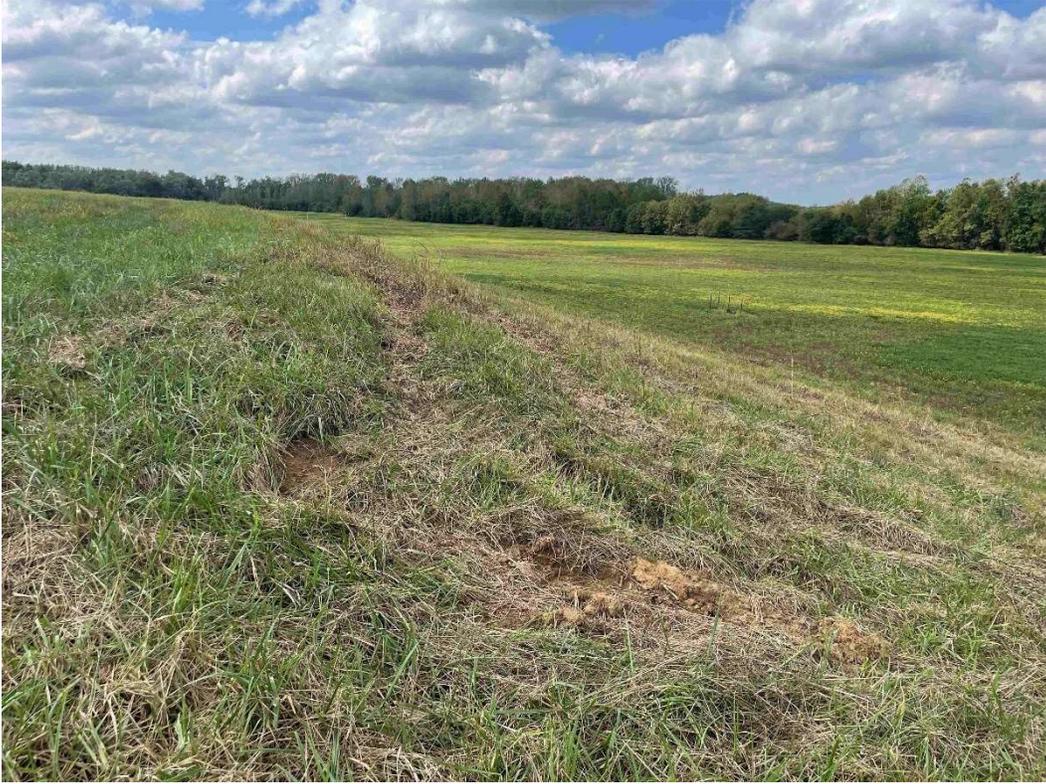
| Grid ID G-4 | Location ID B-3 | |

| Description: Erosion observed on the northwest side of Ash Pond B. Recommend repair the soil cover and re-seed for proper vegetative cover. | | |

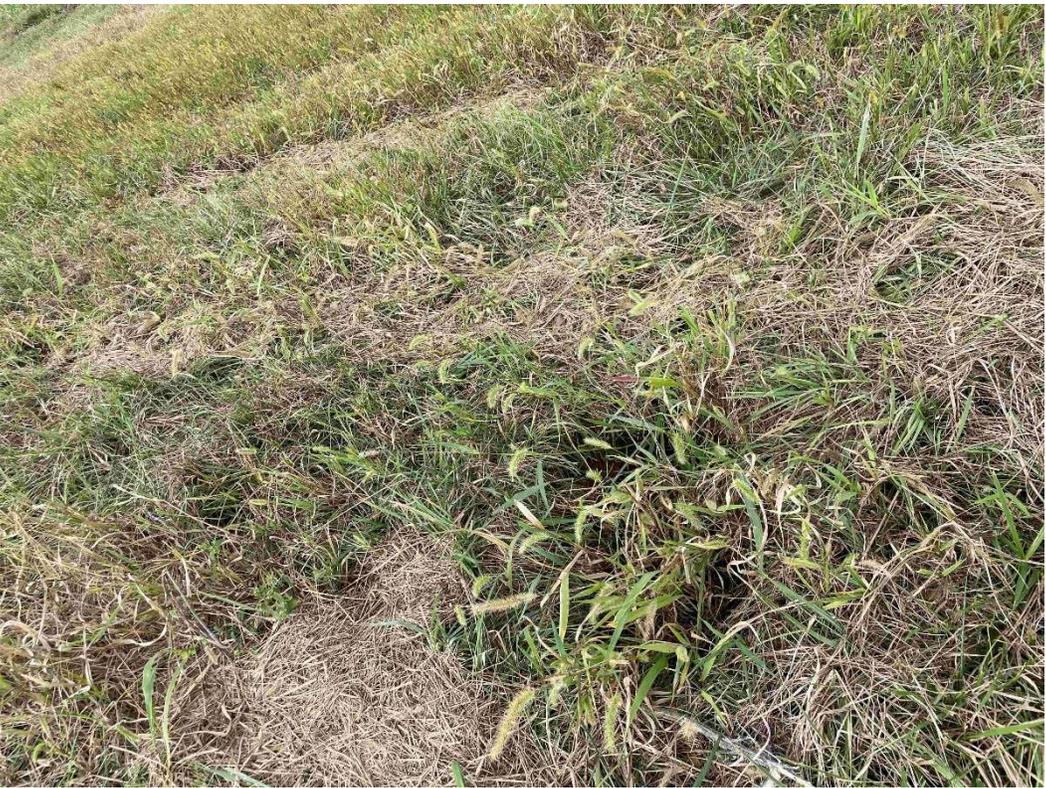
| Grid ID F-4 | Location ID B-4 | |

| Description: Erosion observed on the west side of Ash Pond B. Recommend repair the soil cover and re-seed for proper vegetative cover. | | |

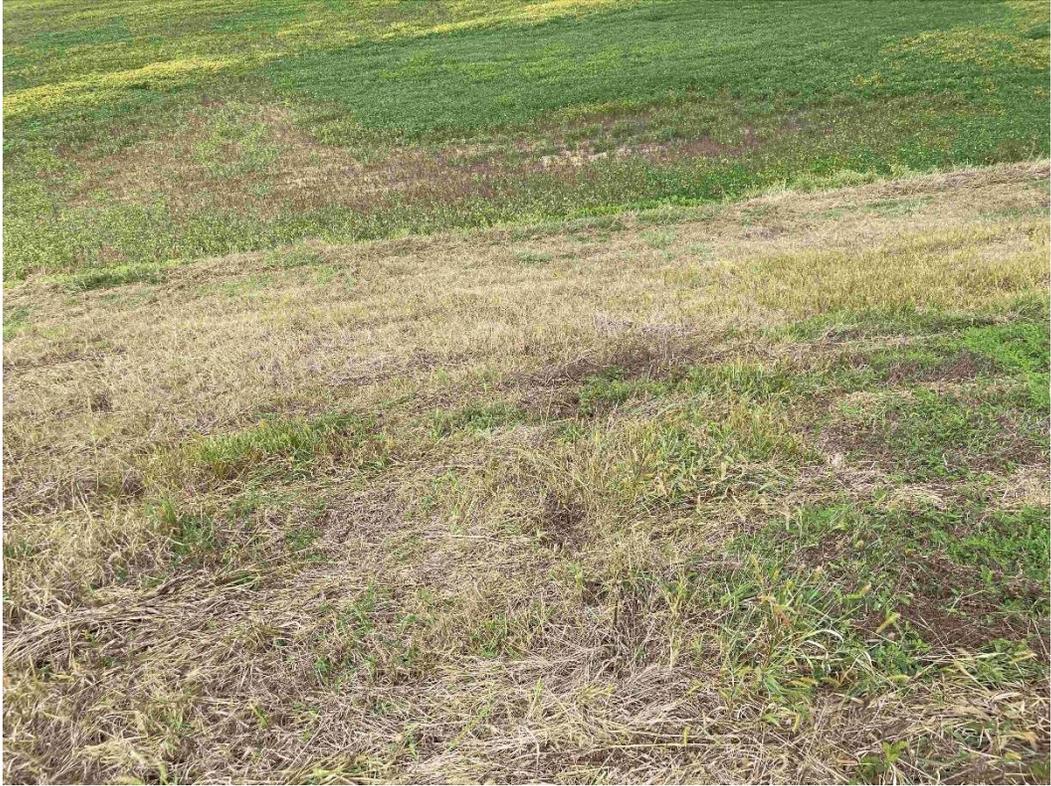
| Grid ID F-5 | Location ID B-5 | |

| Description: Erosion rill observed on the west side. Recommend repair the soil cover and re-seed for proper vegetative cover. | | |

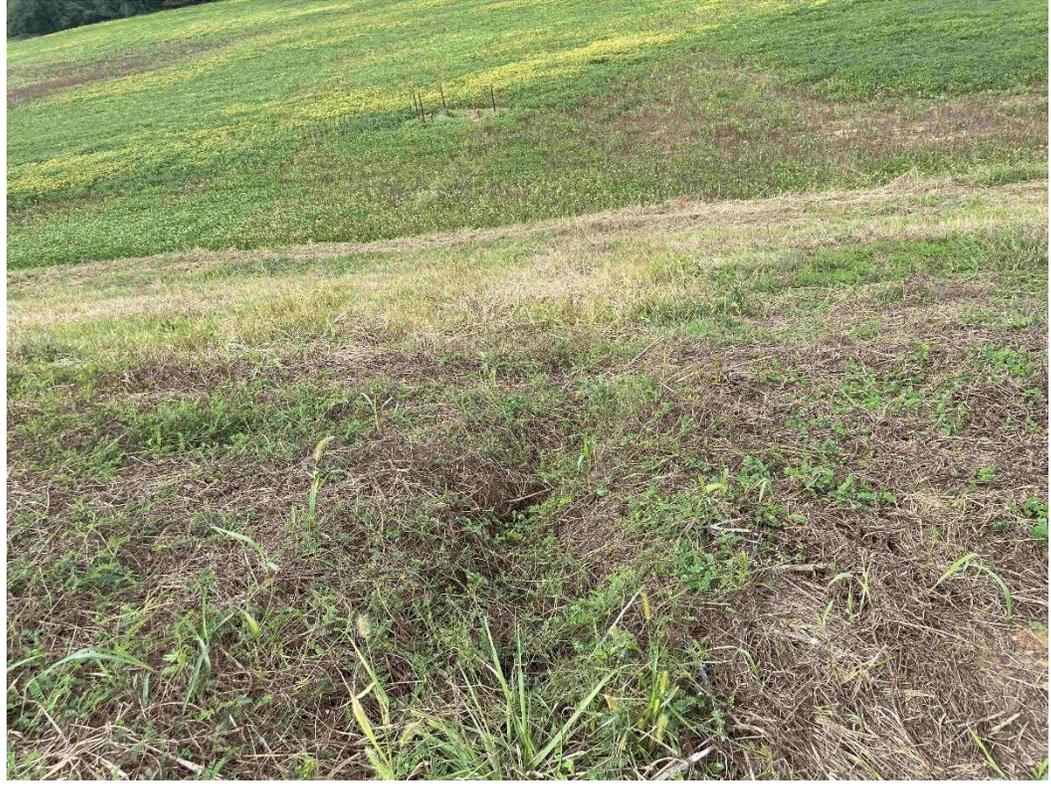
| Grid ID F-5 | Location ID B-6 | |

| Description: Erosion rill observed on the west side. Recommend repair the soil cover and re-seed for proper vegetative cover. | | |

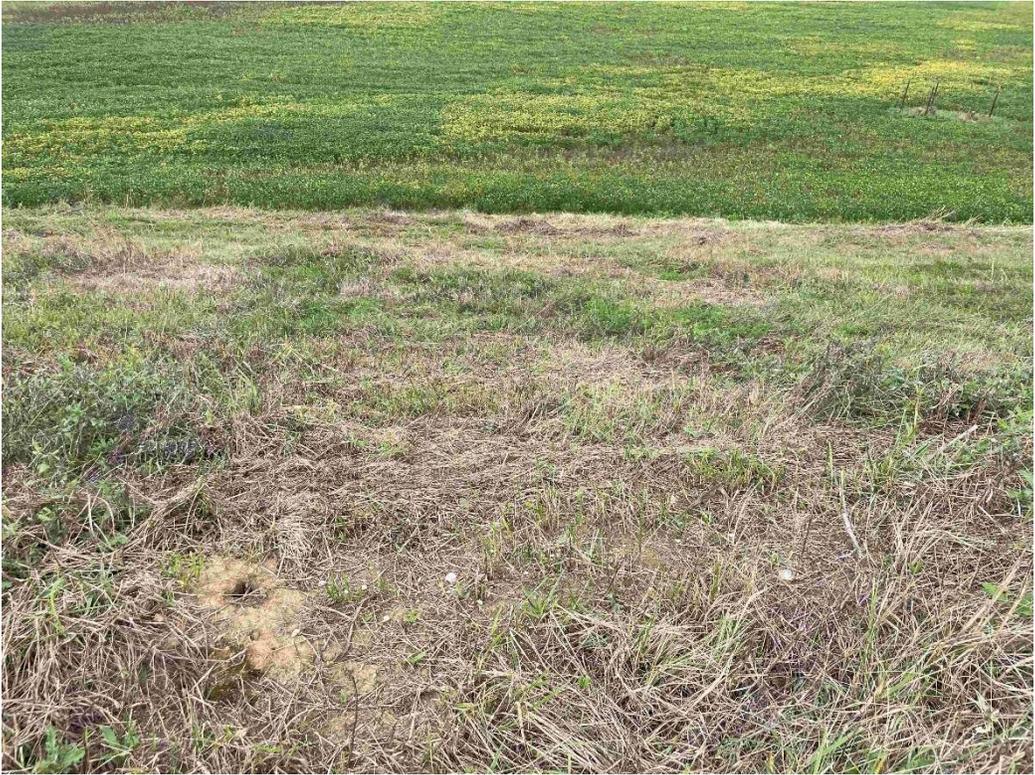
| Grid ID E-5 | Location ID B-7 | |

| Description: Animals borrow and bare spot observed on the west side. Recommend repair the soil cover and re-seed for proper vegetative cover. | | |

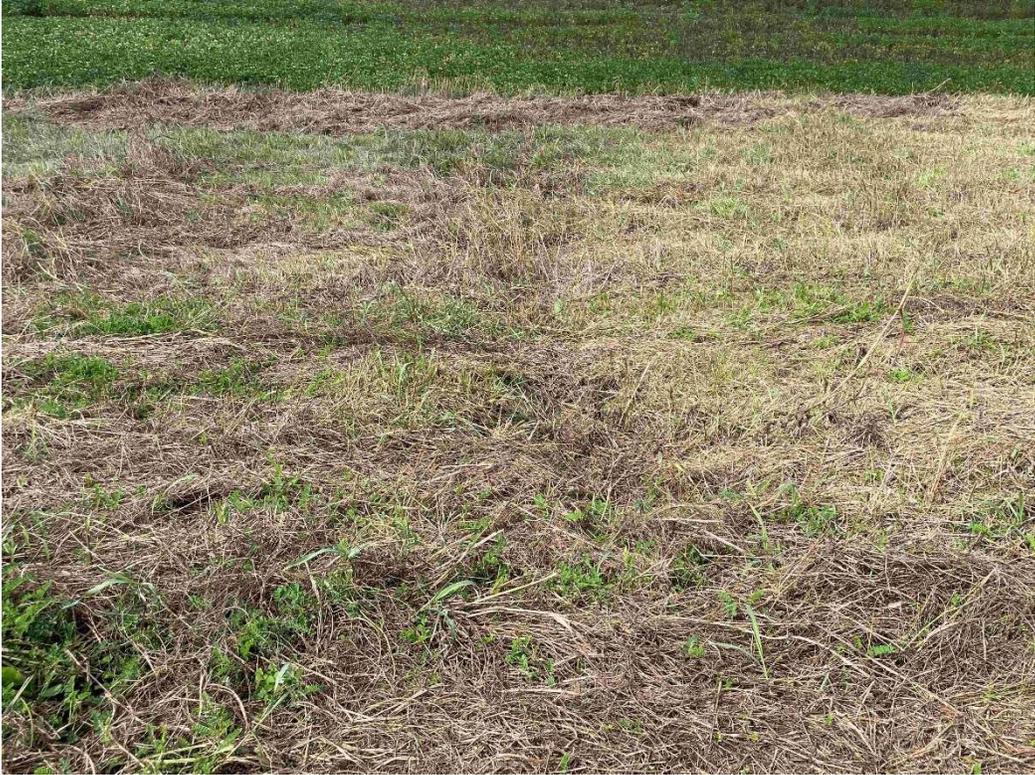
| Grid ID C-8 | Location ID B-8 | |

| Description: Erosion rill observed on the west side. Recommend repair the soil cover and re-seed for proper vegetative cover. | | |

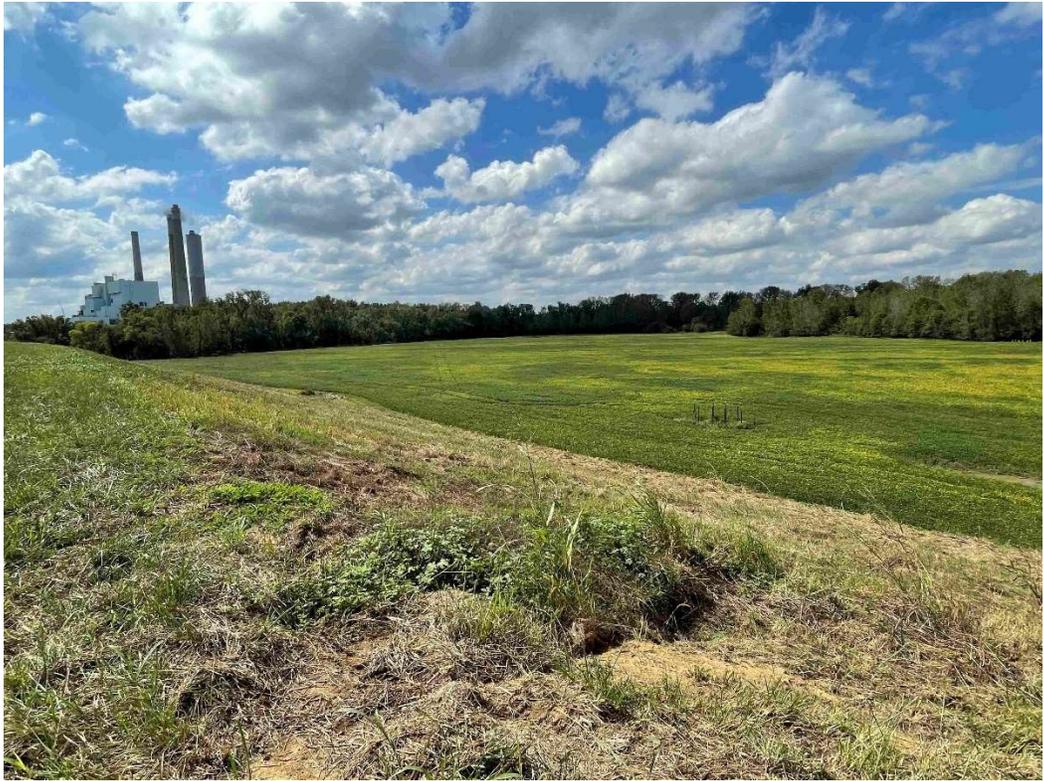
| Grid ID C-9 | Location ID B-9 | |

| Description: Erosion rill observed on the west side. Recommend repair the soil cover and re-seed for proper vegetative cover. | | |

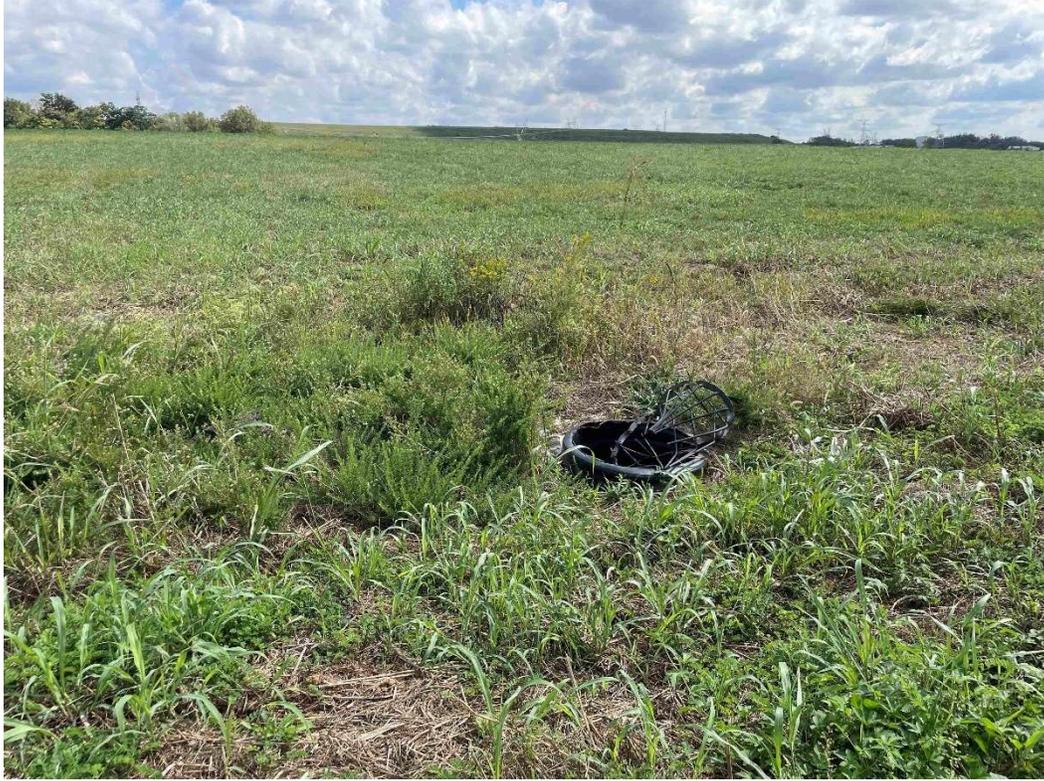
| Point ID C-10 | Location ID B-10 | |

| Description: The drop inlet domed grate cover is damaged. Recommend replacing the drop inlet domed grate cover. | | |

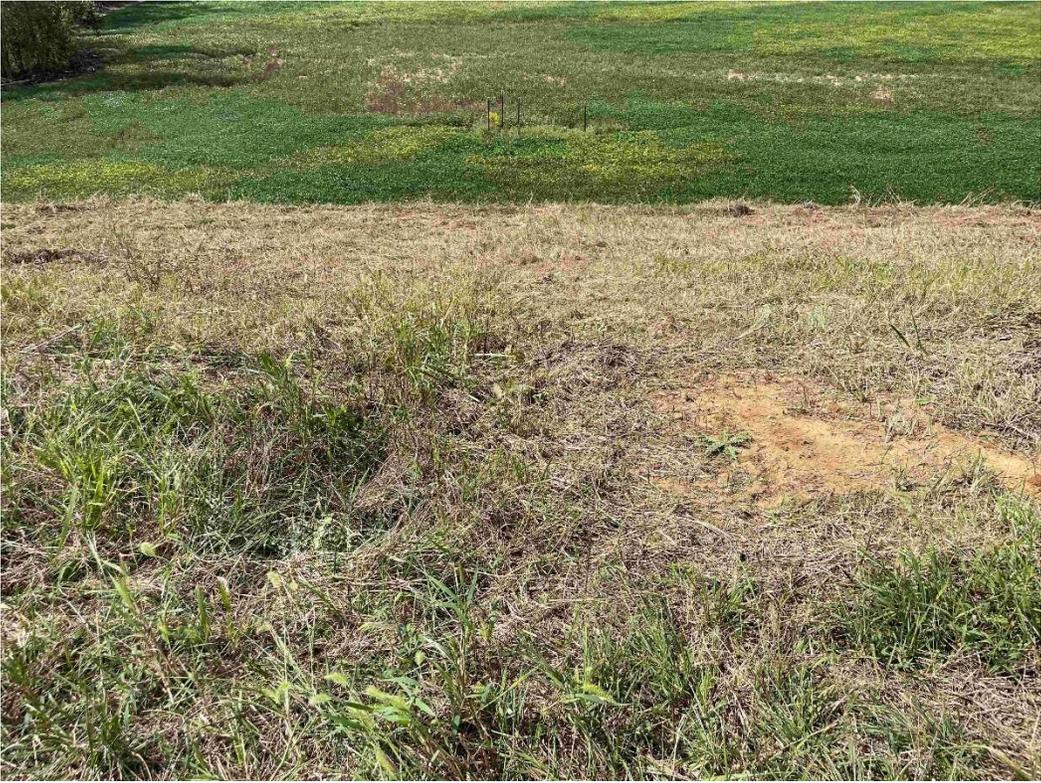
| Point ID B-13 | Location ID B-11 | |

| Description: Erosion observed on the southwest side. Recommend re-seed bare spots for proper vegetative cover. | | |

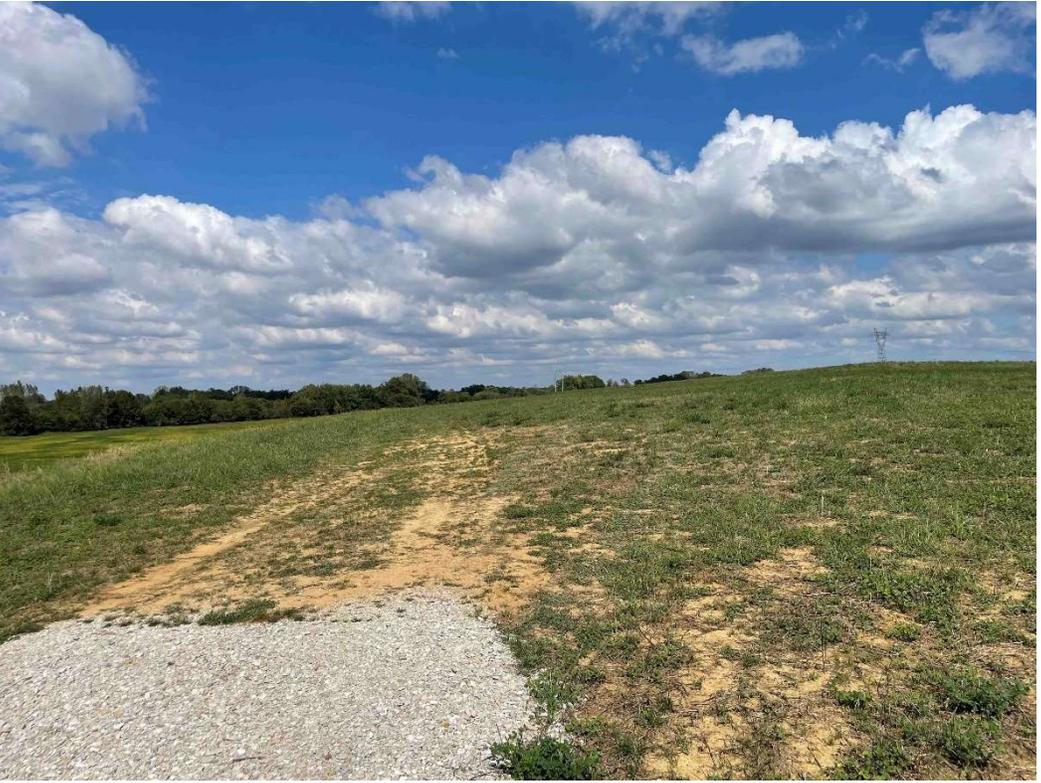
| Point ID B-13 | Location ID B-12 | |

| Description: Bare spots observed on the southwest side of Ash Pond B. Recommend re-seeding bare spots for proper vegetative cover. | | |

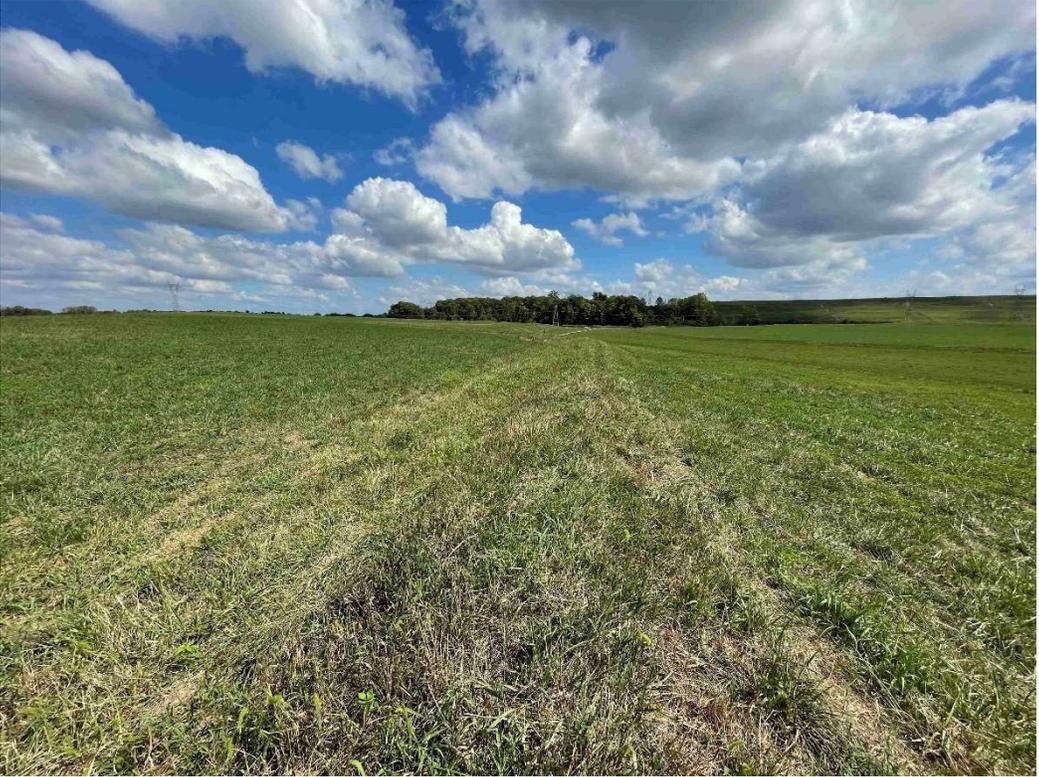
| Point ID C-12 | Location ID B-13 | |

| Description: Well established vegetative cover observed on the south side of Ash Pond B. No issues observed. | | |

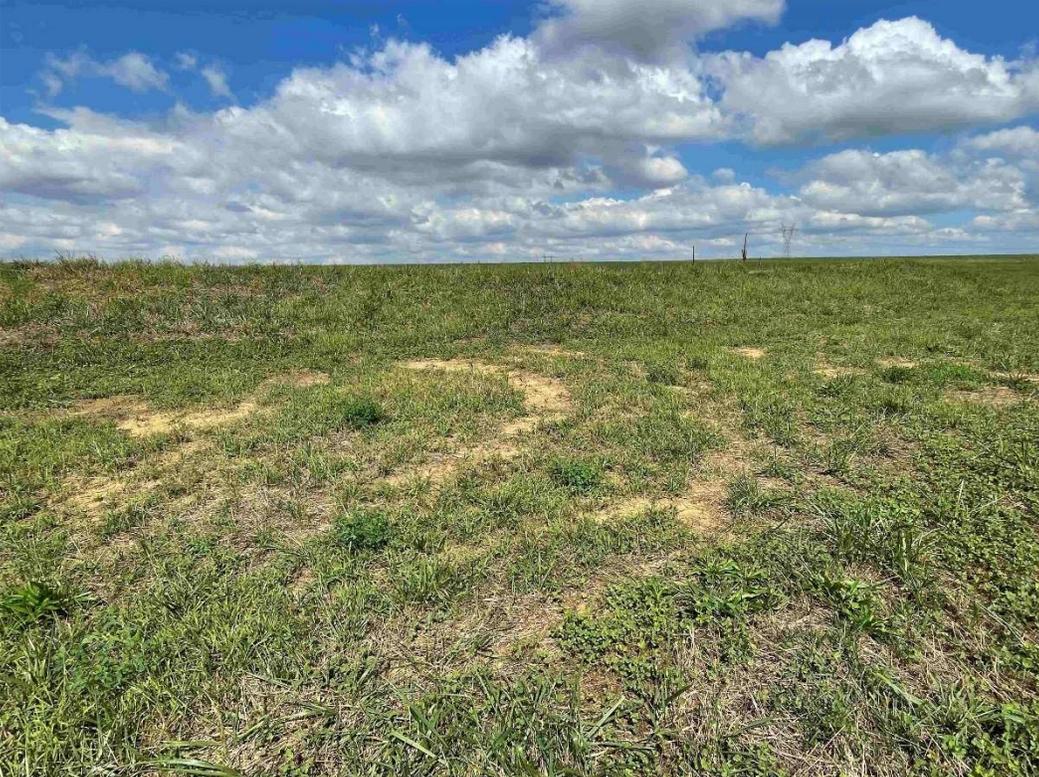
| Point ID D-12 | Location ID B-14 | |

| Description: Bare spots observed on the south side of Ash Pond B. Recommend re-seeding bare spots for proper vegetative cover. | | |

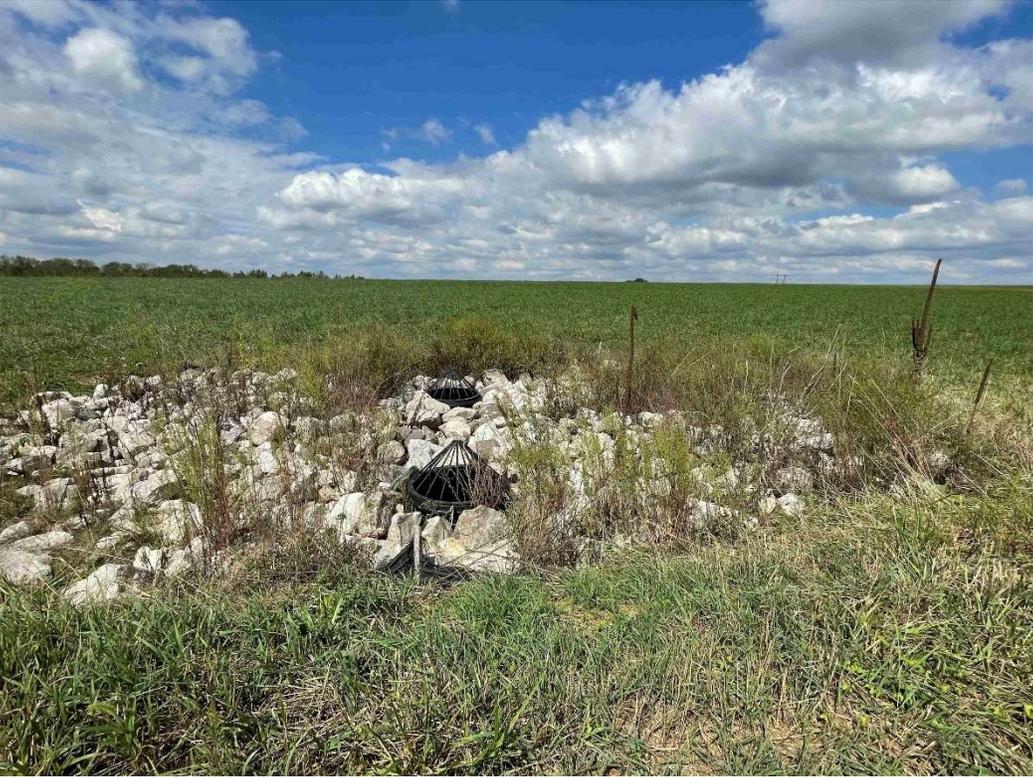
| Point ID D-12 | Location ID B-15 | |

| Description: One of the drop inlet domed grate covers is damaged. Tree saplings and tall vegetation observed around the drop inlets. Recommend replacing the damaged drop inlet domed grate cover and removing excess vegetation growth. | | |

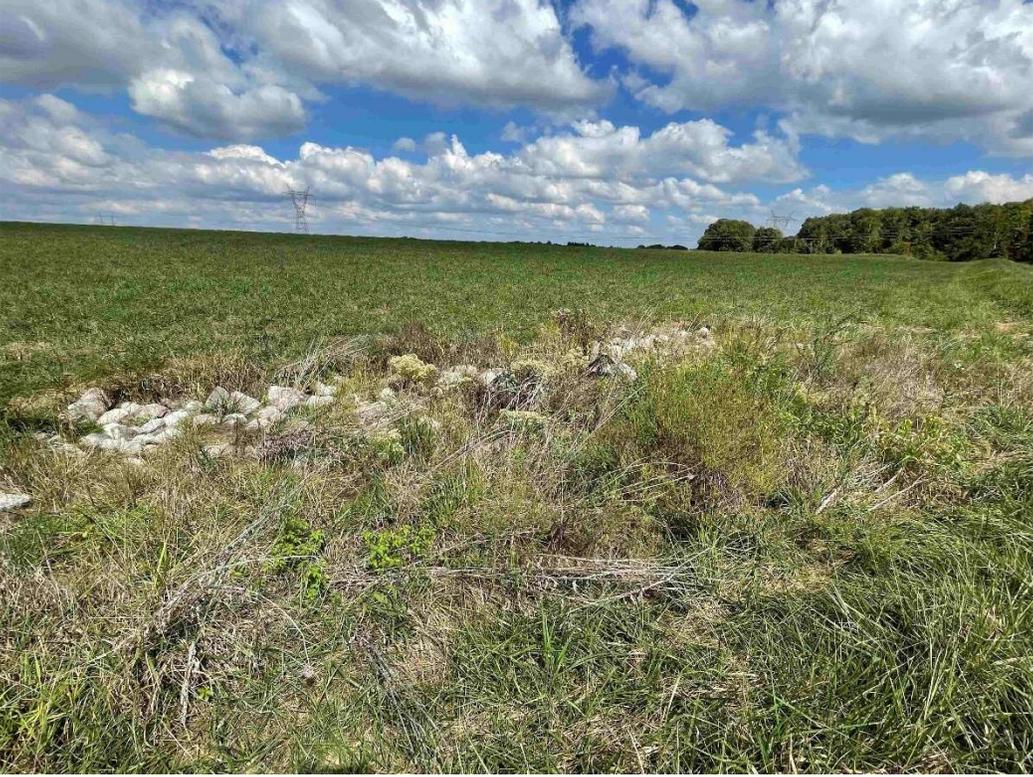
| Point ID G-11 | Location ID B-16 | |

| Description: Tree saplings and tall vegetation observed around the drop inlets. Recommend removing excess vegetation growth. | | |

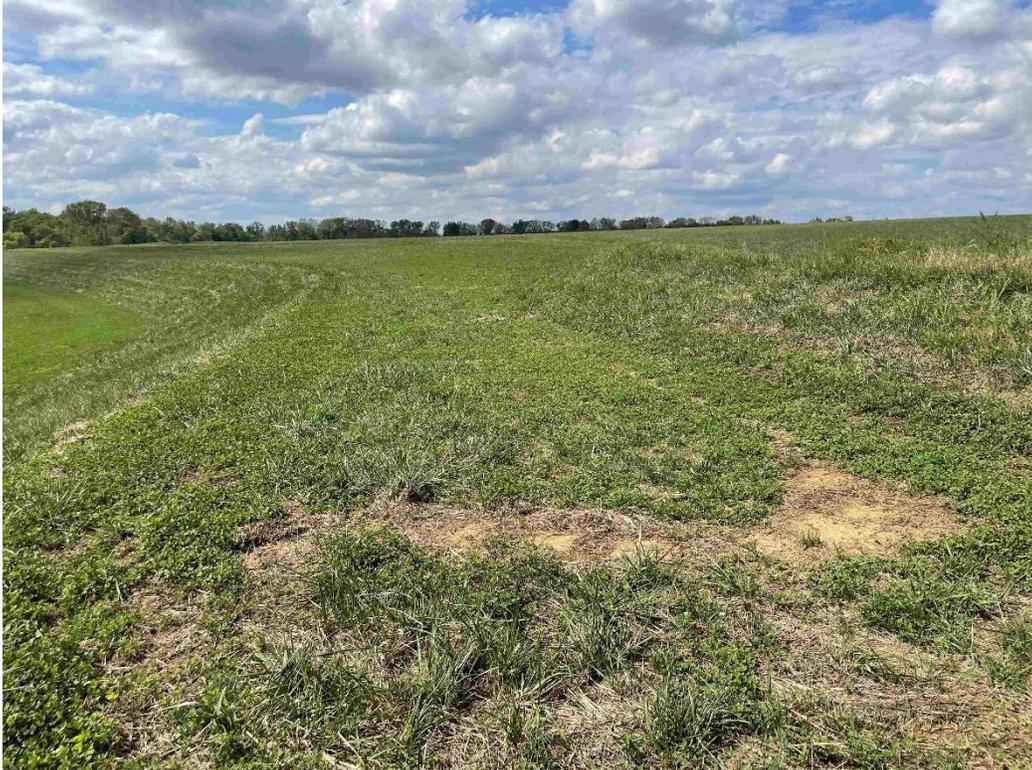
| Point ID G-11 | Location ID B-17 | |

| Description: Bare spots observed on the south side of Ash Pond B. Recommend re-seeding bare spots. | | |

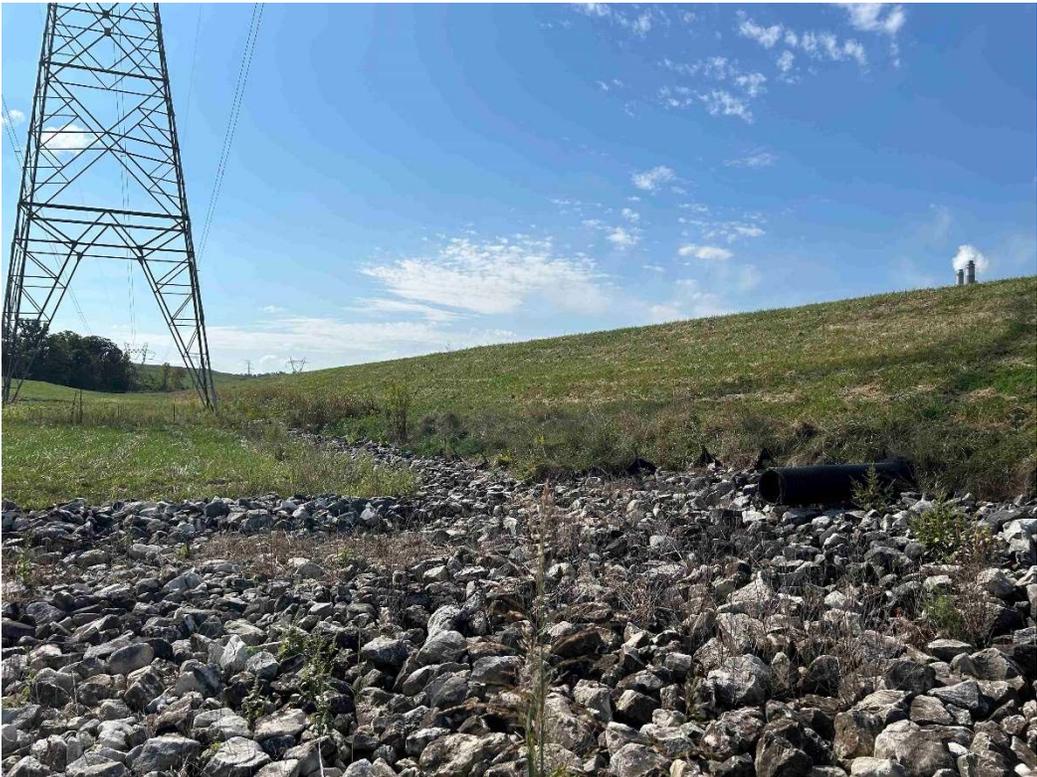
| Point ID G-5 | Location ID B-18 | |

| Description: Rip-rap channel between Ash Pond B and C on the east side looked well maintained, No issues observed. | | |

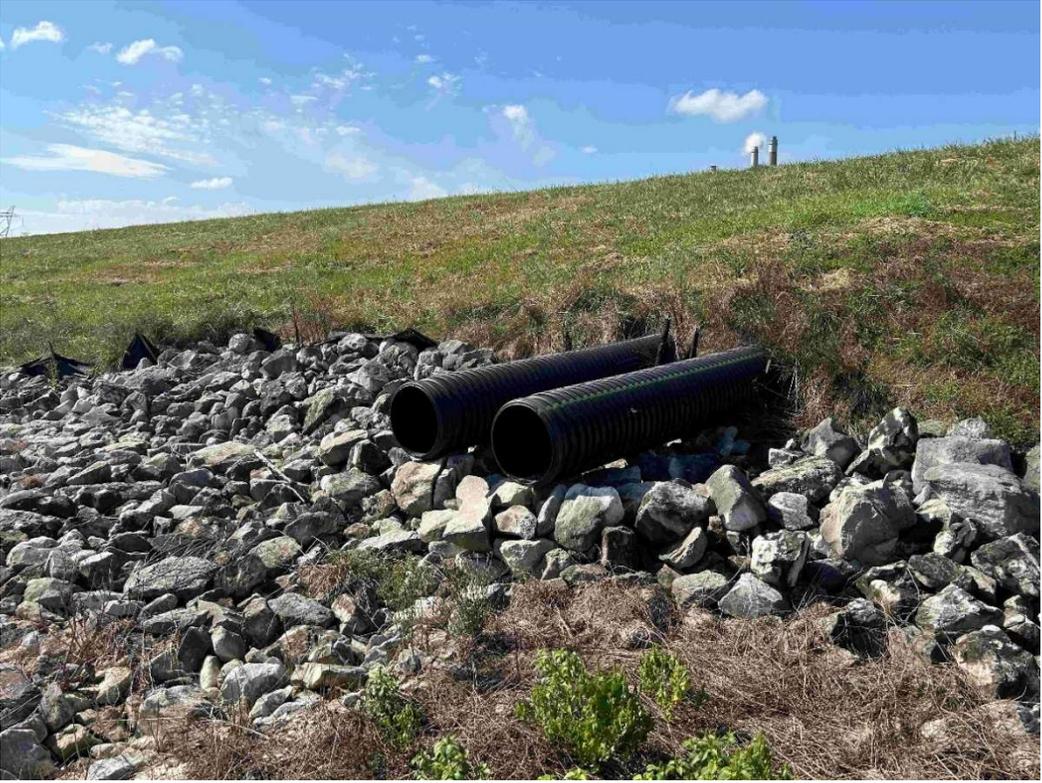
| Point ID I-8 | Location ID B-19 | |

| Description: Rip-rap channel between Ash Pond B and C on the east side looked well maintained, No issues observed. | | |

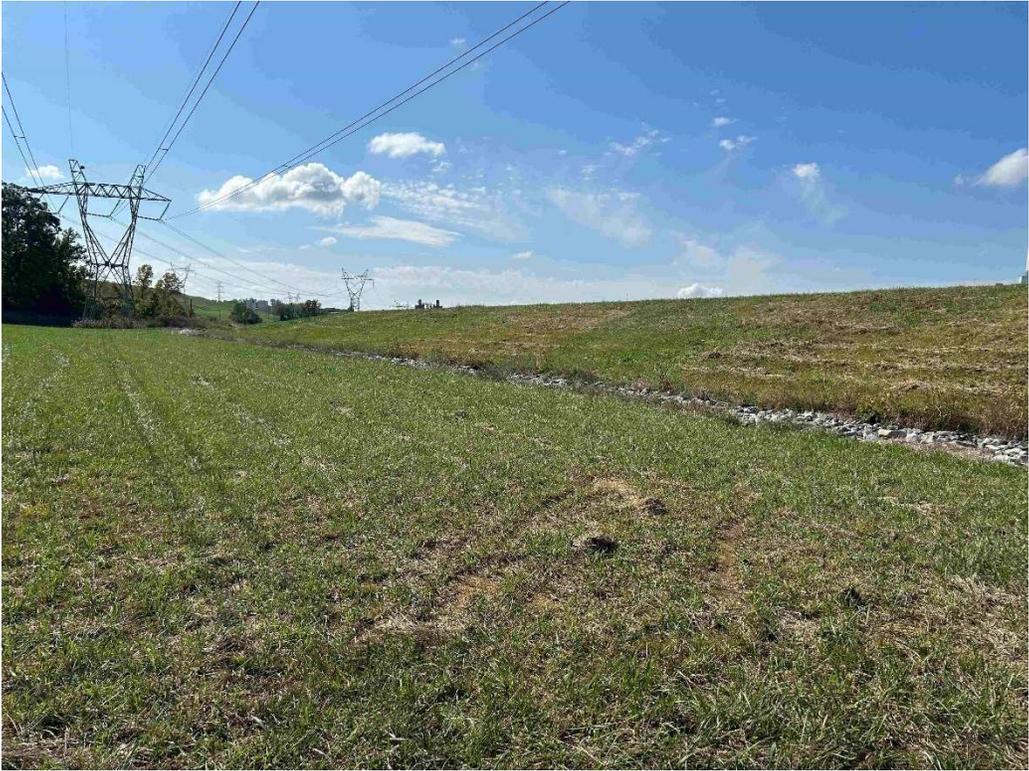
| Point ID I-9 | Location ID B-20 | |

| Description: Vegetative cover looked well established on the east of Ash Pond B. No issues observed. | | |

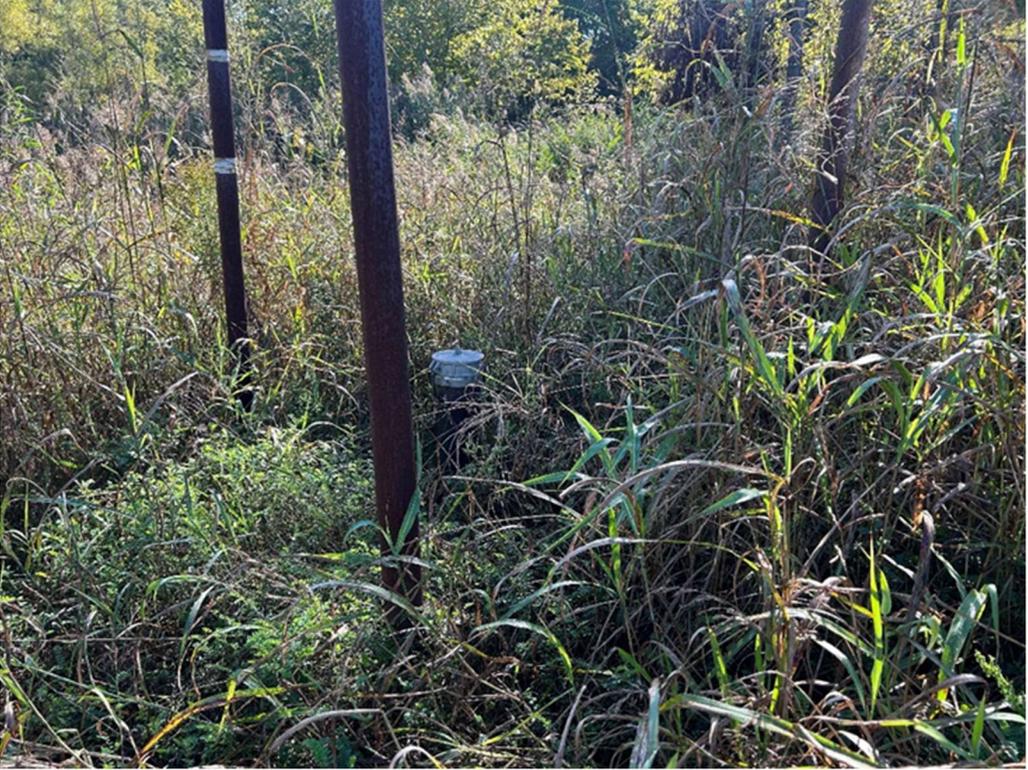
| Point ID Q-2 | Location ID C-1 | |

| Description: Groundwater monitoring well AP-7 found to be capped/locked, labeled. Photo looking northeast. Recommend cut down vegetation. | | |

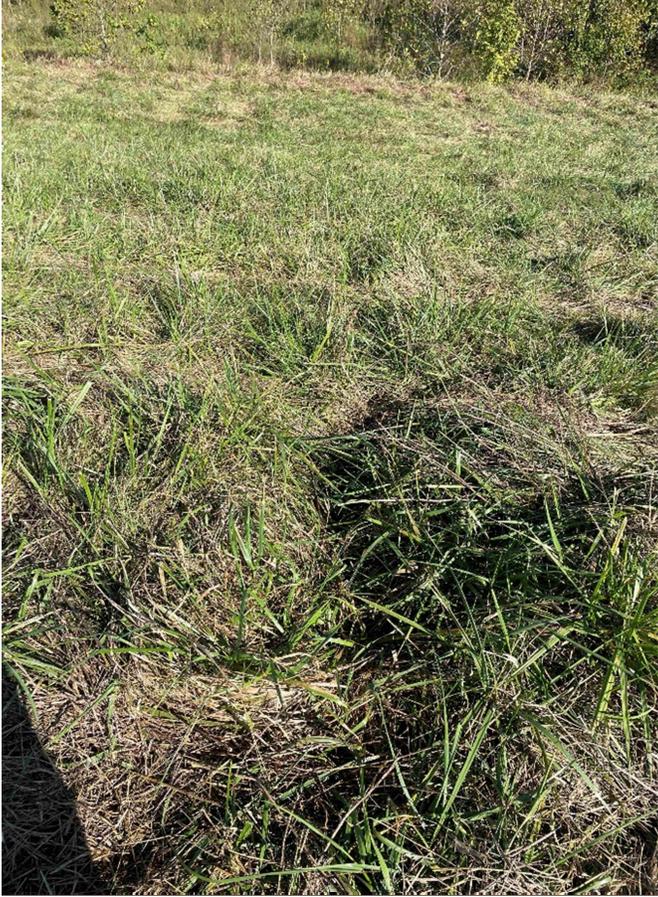
| Point ID N-1 | Location ID C-2 | |

7. Minor erosion rills were observed at two separate locations on the north section of Ash Pond C (locations C-2, and C-8 of Figure 4).
 - o Recommendation: Repair the soil cover and overseed these areas to establish a protective grass cover.

| Description: Erosion gully on side slope, northeast section of Ash Pond C. Photo looking north. Recommend repair the soil cover and re-seed for proper vegetative cover. | | |

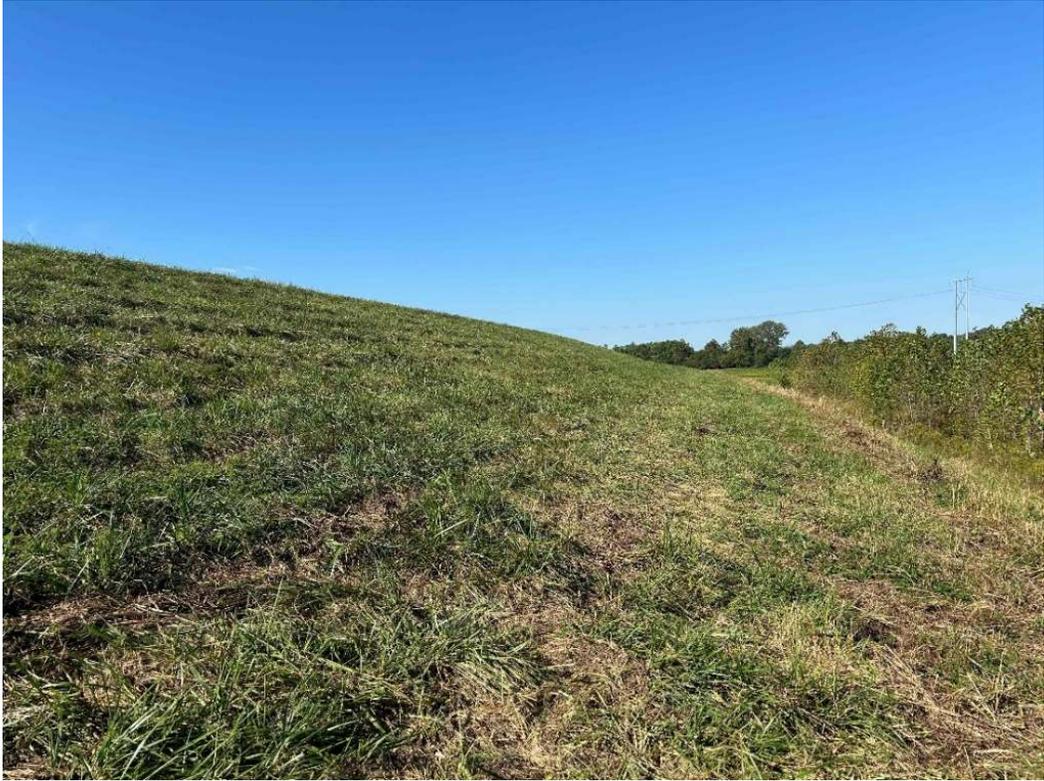
| Point ID L-1 | Location ID C-3 | |

| Description: Vegetation well established on the northeast slope of Ash Pond C. Photo looking north. No issues observed. | | |

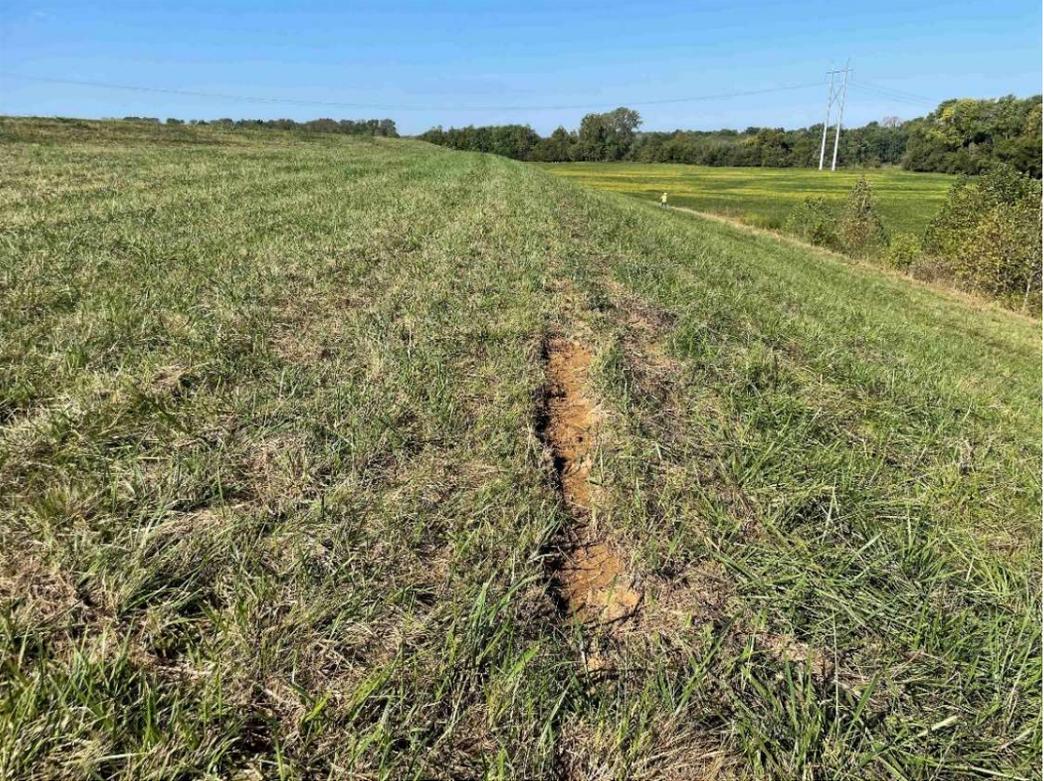
| Point ID L-1 | Location ID C-4 | |

| Description: Minor bare area along the northeast side of Ash Pond C. Photo looking north. Recommend re-seeding bare spots. | | |

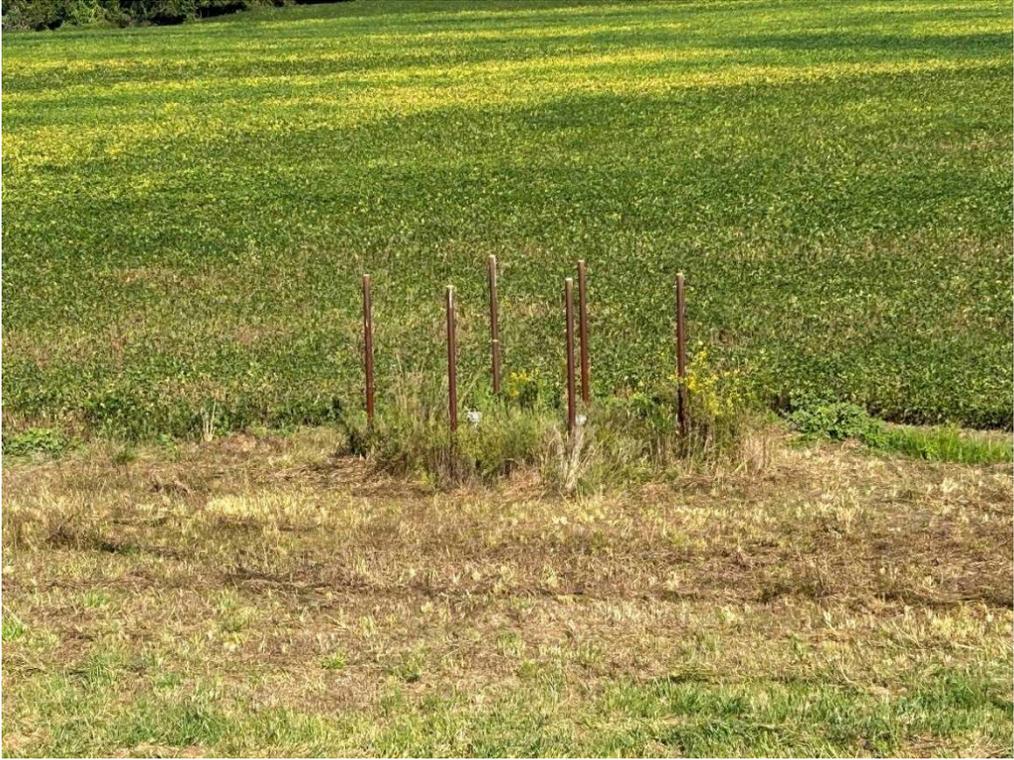
| Point ID J-1 | Location ID C-5 | |

| Description: Groundwater monitoring well AP-6A found to be capped/locked, labeled and maintained properly. Photo looking north. No issues observed. | | |
