**2024 VISUAL INSPECTION OF ASH POND EMBANKMENTS
AES PETERSBURG ASH POND SYSTEM**

AES INDIANA PETERSBURG GENERATING STATION
6925 NORTH STATE ROAD 57
PETERSBURG, INDIANA 47567

ATLAS PROJECT NO. 170AES0005

NOVEMBER 12, 2024

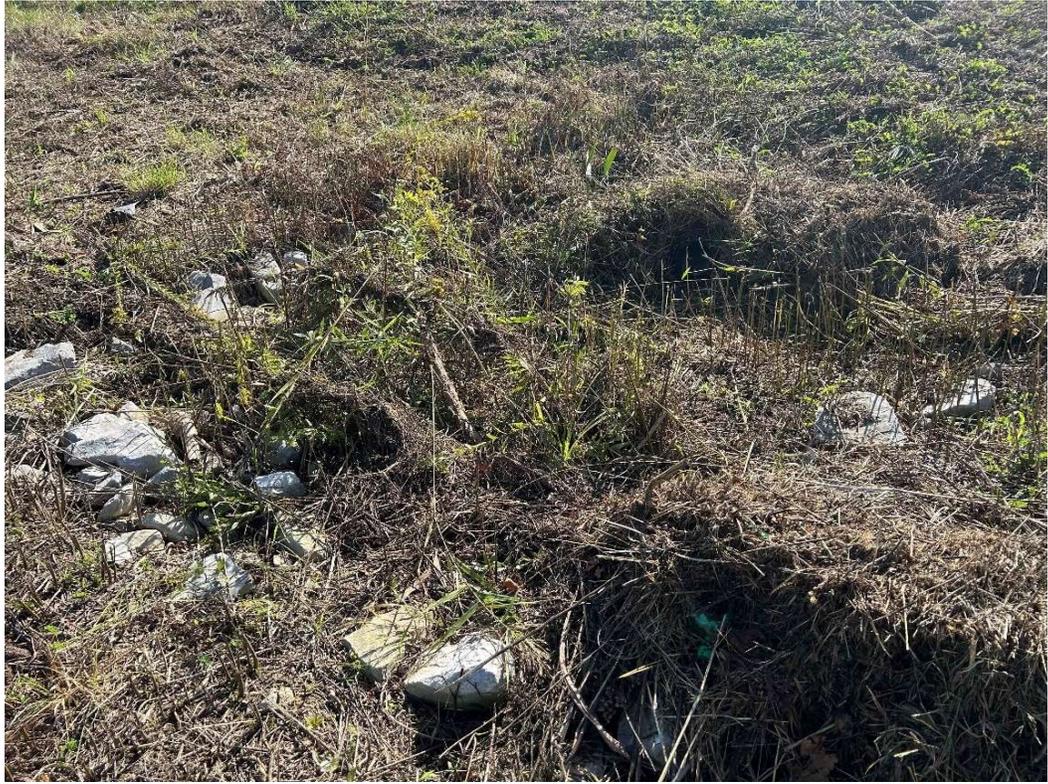
| Point ID H-2 | Location ID C-6 | |

| Description: Plunge pool energy dissipator at downrain outfall pipes located on north side of Ash Ponds C. Photo looking north. Recommend remove debris and cut down tall vegetation. | | |

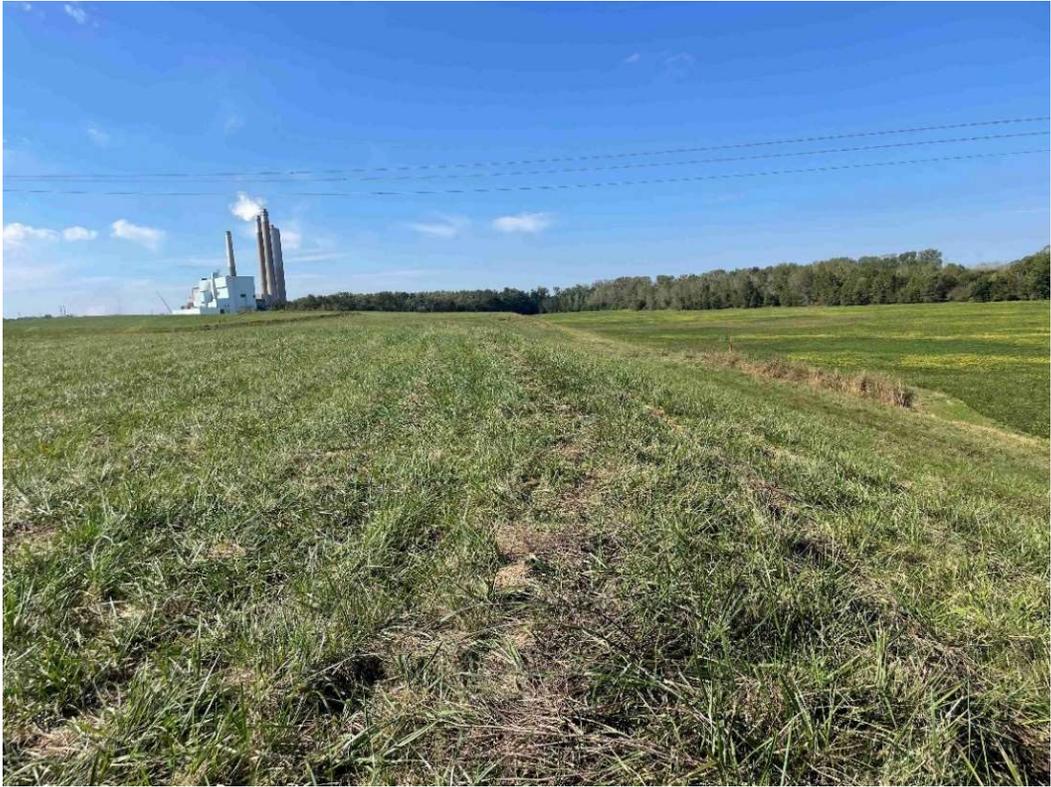
| Point ID H-3 | Location ID C-7 | |

| Description: Vegetation well established along the top and sideslope on the north side of Ash Pond C. Photo looking west. No issues observed. | | |

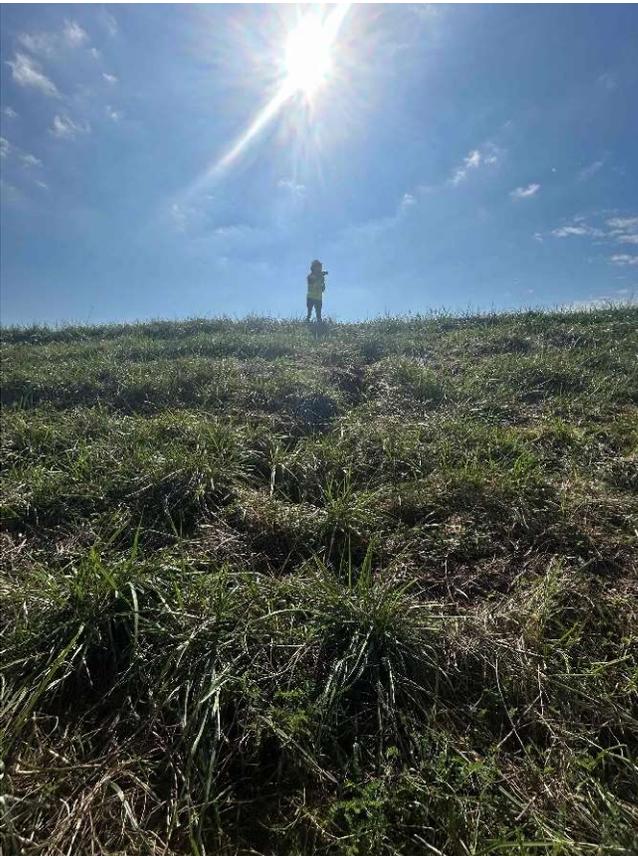
| Point ID H-3 | Location ID C-8 | |

7. Minor erosion rills were observed at two separate locations on the north section of Ash Pond C (locations C-2, and C-8 of Figure 4).
 - o Recommendation: Repair the soil cover and overseed these areas to establish a protective grass cover.

| Description: Erosion gully on side slope, northwest section of Ash Pond C. Photo looking south. Recommend repair the soil cover and re-seed for proper vegetative cover. | | |

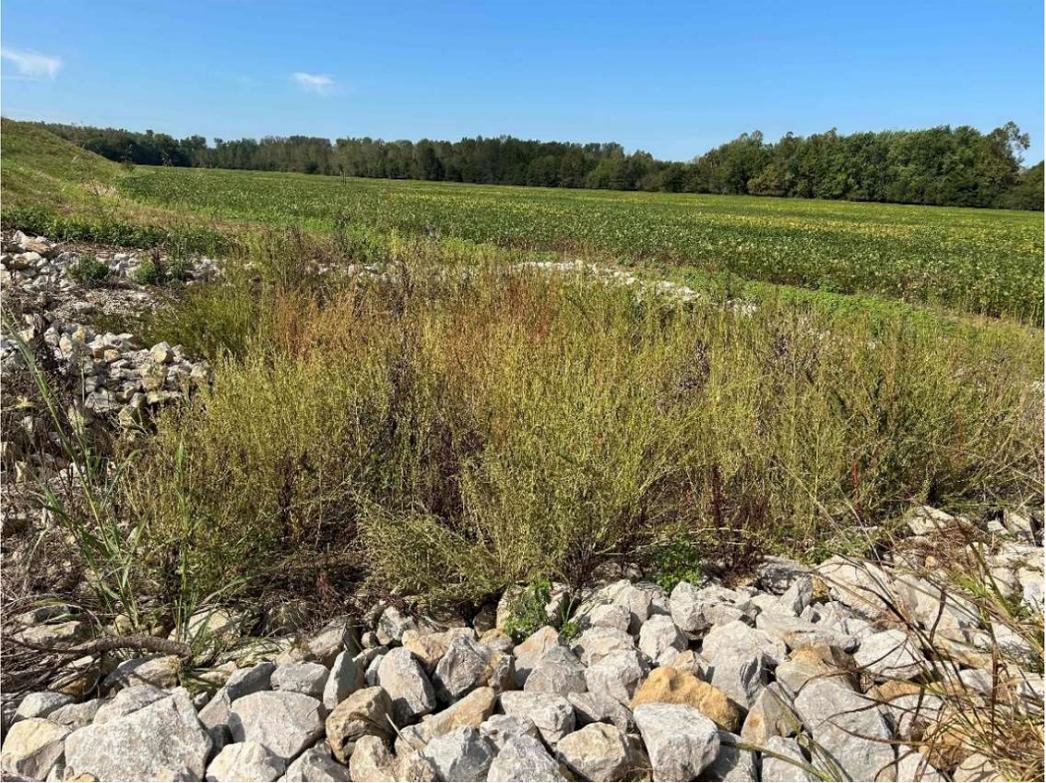
| Description: Observed tall vegetation growth at plunge pool energy dissipator at down drain outfall channel located on northwest side of Ash Ponds C. Photo looking west. Recommend remove debris and cut down vegetation. | | |

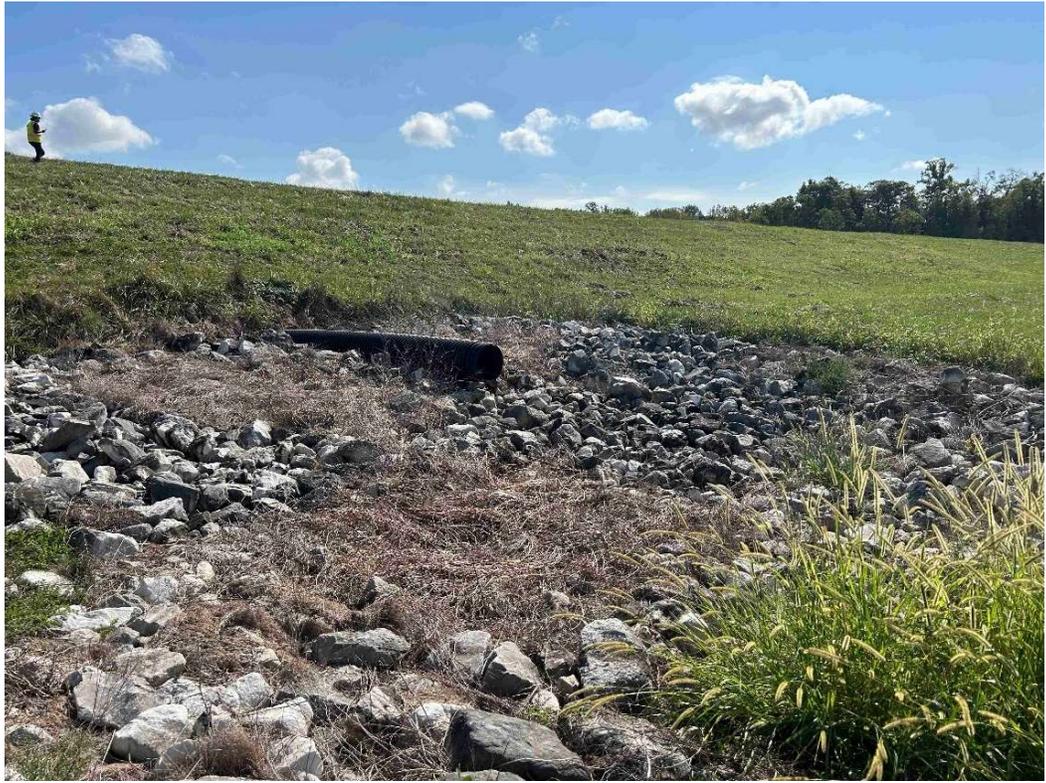
| Description: Plunge pool energy dissipator at down drain outfall channel located on west side of Ash Ponds C looks in good conditions. No issues observed. | | |

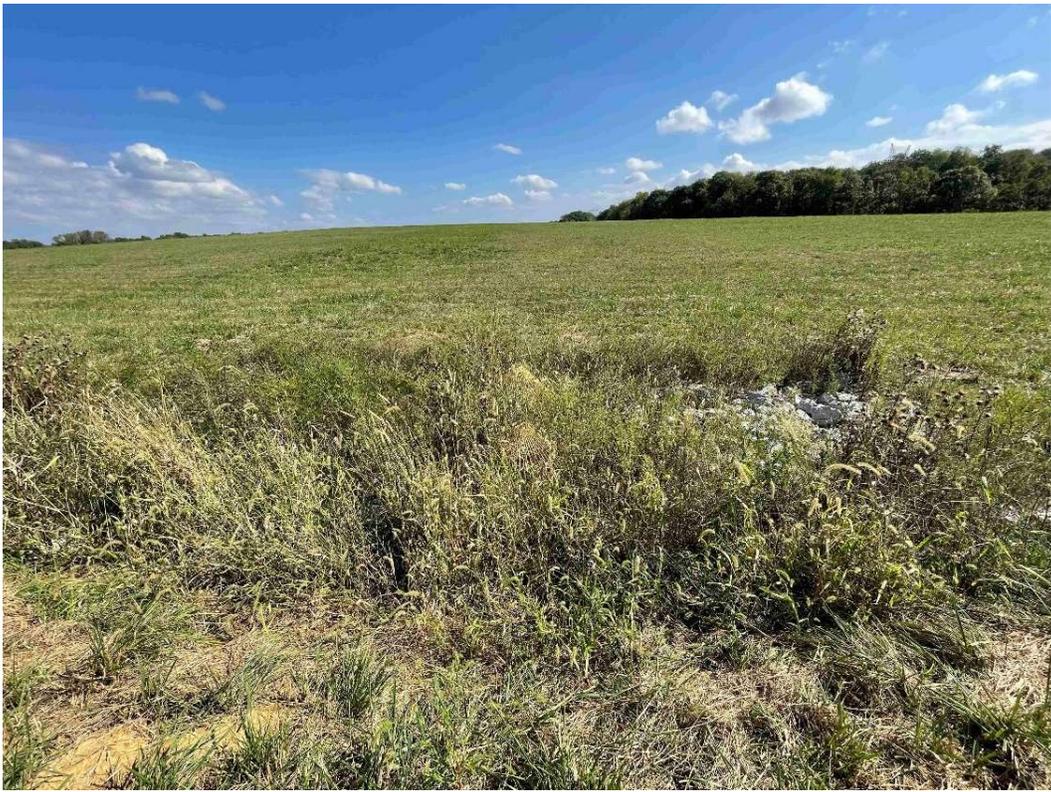
| Point ID H-6 | Location ID C-11 | |

6. Accumulated sediments/debris and/or tall vegetation observed at five separate locations on the Ash Pond C (locations C-1, C-5, C-11, C-14, and C-15, of Figure 4).
 - Recommendation: Cut down tall vegetation and remove debris from the drop inlets.

| Description: Accumulated debris and tall vegetation at drop inlets on the southwest section of Ash Pond C. Photo looking east. Recommend remove debris and cut down vegetation. | | |

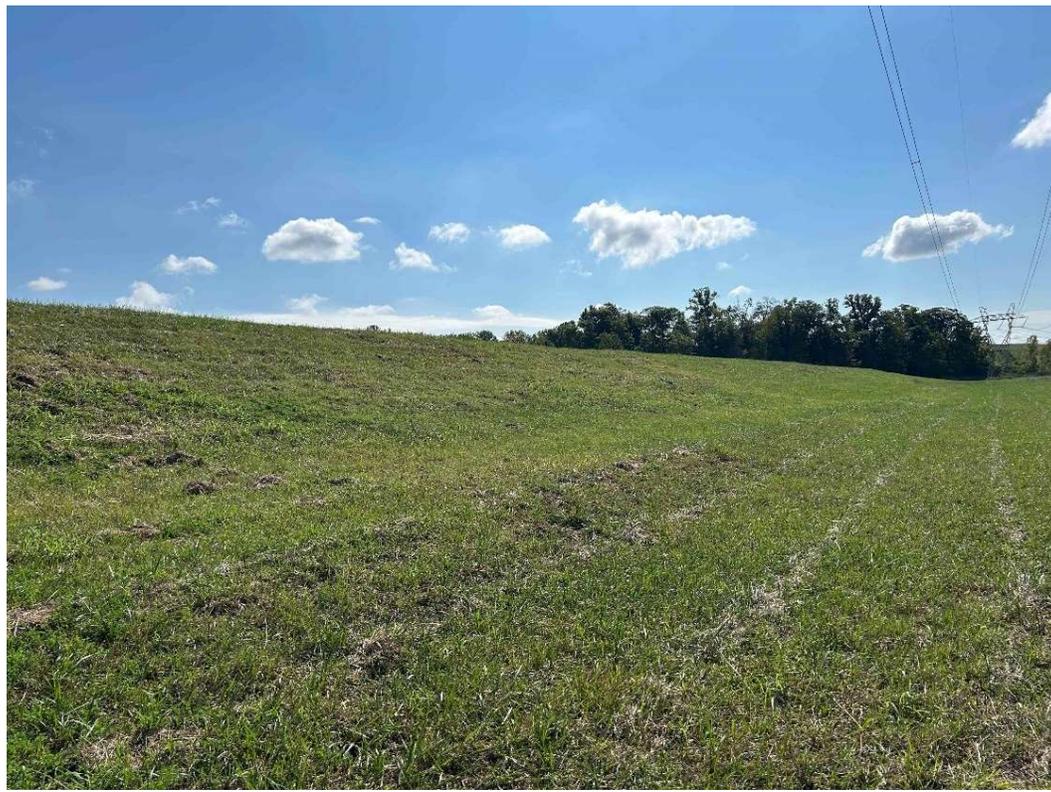
| Point ID H-6 | Location ID C-12 | |

| Description: Vegetation well established along the west side slope of Ash Pond C. Photo looking south. No issues observed. | | |

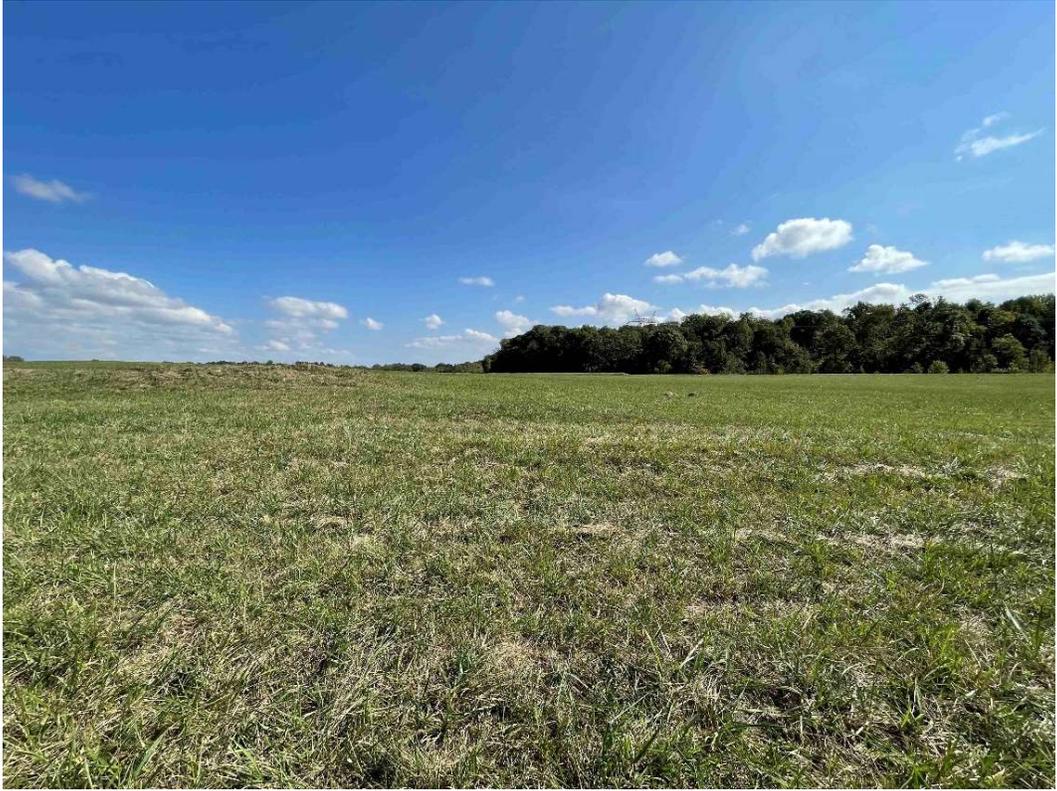
| Point ID I-7 | Location ID C-13 | |

| Description: Vegetation well established along the top of Ash Pond C. Photo looking northeast. No issues observed. | | |

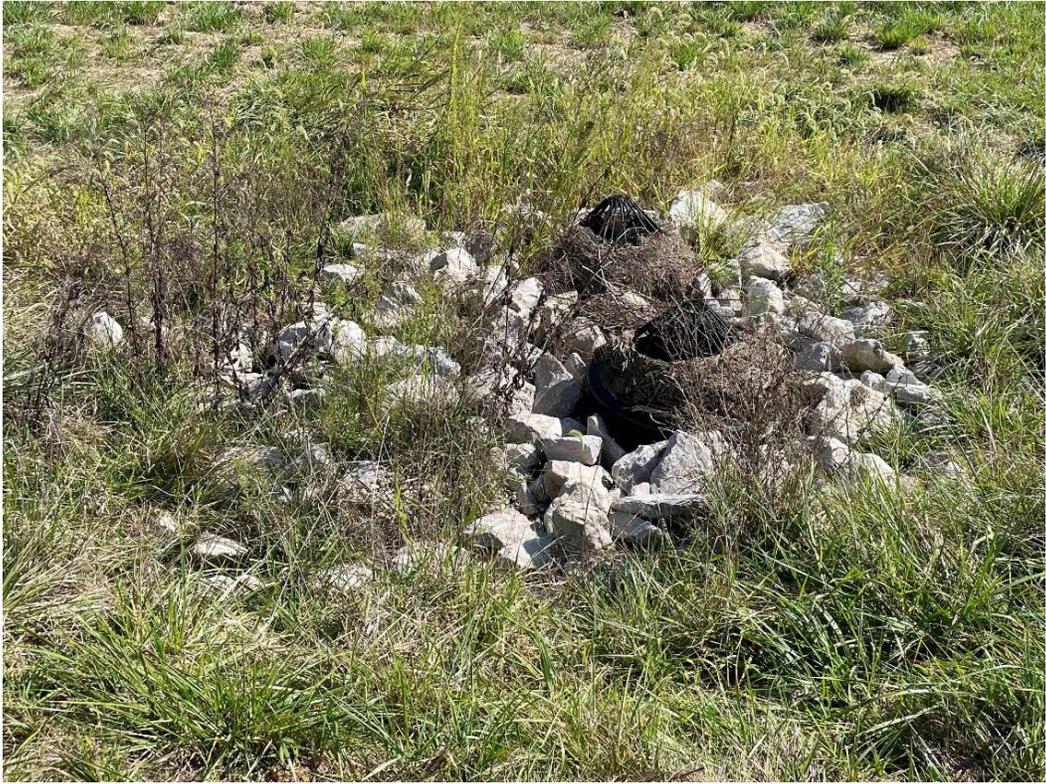
| Point ID I-8 | Location ID C-14 | |

| Description: Accumulated debris and tall vegetation at drop inlet on the southwest section of Ash Pond C. Photo looking east. Recommend remove debris and cut down vegetation. | | |

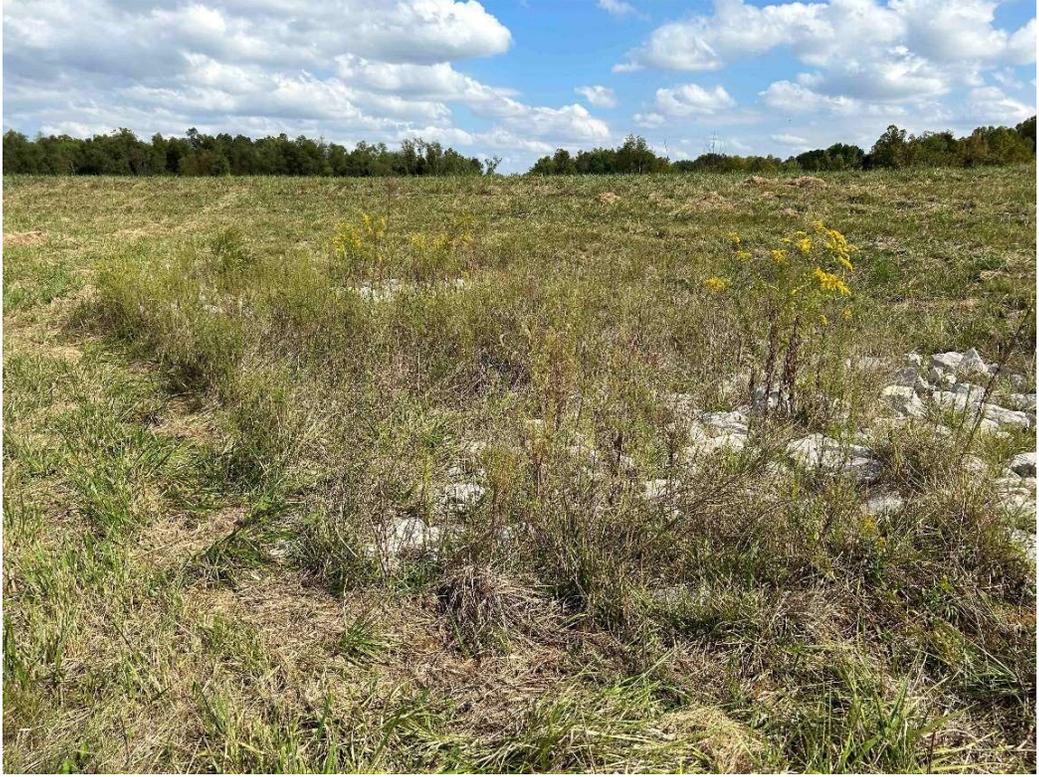
| Point ID P-3 | Location ID C-15 | |

| Description: Accumulated debris and high vegetation at drop inlets on the northeast section of Ash Pond C. Photo looking north. Recommend remove debris and cut down vegetation. | | |

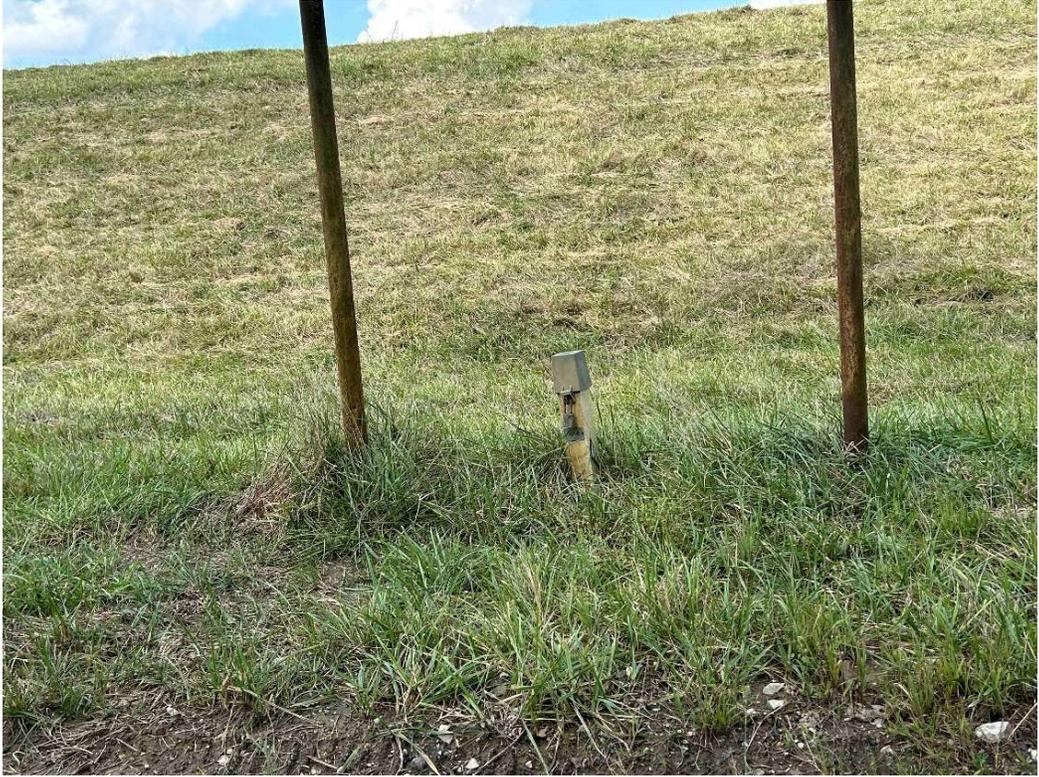
| Point ID L-6 | Location ID C-16 | |

| Description: Groundwater monitoring well AP-8 found to be capped/locked, labeled and maintained properly. Photo looking north. No issues observed. | | |
