Submitted to  
AES Indiana  
Petersburg Generating Station  
6925 North State Road 57  
Petersburg, IN 47567

Submitted by  
AECOM  
1300 E 9<sup>th</sup> Street  
Suite 500  
Cleveland, OH 44114

November 12, 2025

CCR Annual Inspection  
§257.83 (b)  
for the  
Ash Ponds A, A', B, C, and D  
at the  
Petersburg Generating Station  
Revision 0

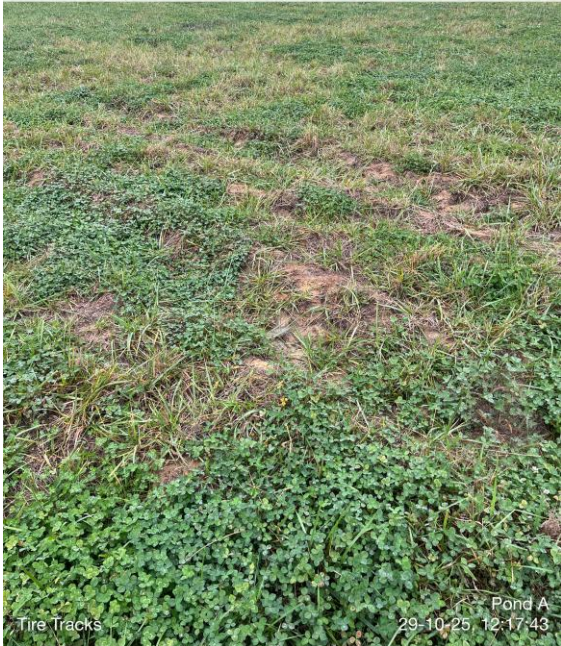
Photo A-3	Date: 10/29/2025	<div><div>North East</div><div>☉ 57°NE (T) ● 38°31'49"N, 87°14'42"W ±13ft ▲ 442ft</div>

</div>
Location: Indiana Petersburg, Ash Pond A		
Description: Facing Northeast, tire tracks.  Recommend repair and reseed.		
Photo A-4	Date: 10/29/2025	<div><div>North</div><div>☉ 346°N (T) ● 38°31'51"N, 87°14'38"W ±9ft ▲ 435ft</div>

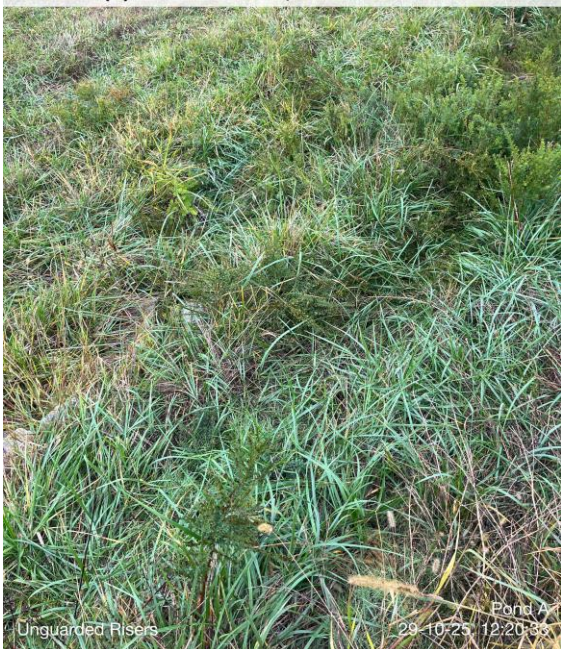
</div>
Location: Indiana Petersburg, Ash Pond A		
Description: Facing North, stormwater risers without guards.  Recommend replacement of stormwater riser guards and trim back vegetation.

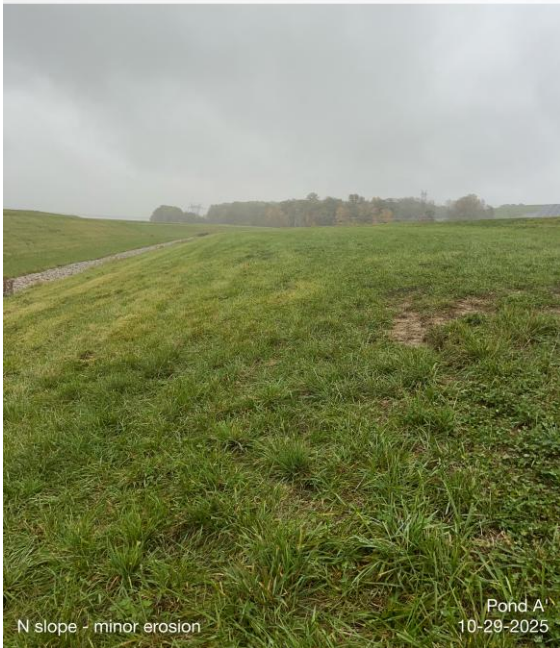
Photo A-5	Date: 10/29/2025	<div><div><div>NNEE</div><div>0306090120</div><div>BRG: 66°NE (T) LAT: 38.533637 LON: -87.247635 ±19ft ALT: 447ft</div></div><div>

<div><div>N slope - minor erosion</div><div>Pond A' 10-29-2025</div></div></div></div>
Photo A-6	Date: 10/29/2025	<div><div><div>South West</div><div>222°SW (T) 38°32'5"N, 87°14'39"W ±16ft ▲ 436ft</div></div><div>

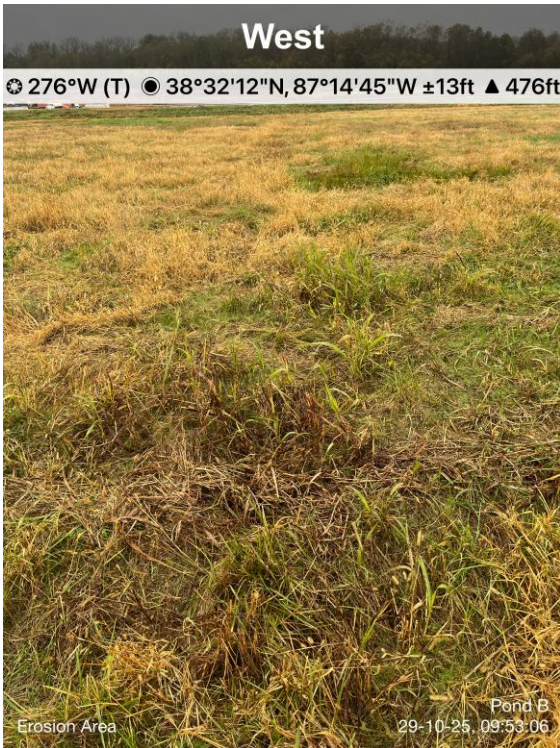
</div></div></div>
Location: Indiana Petersburg, Ash Pond B		
Description: Facing West, erosion and bare spots.  Recommend repair and reseed.

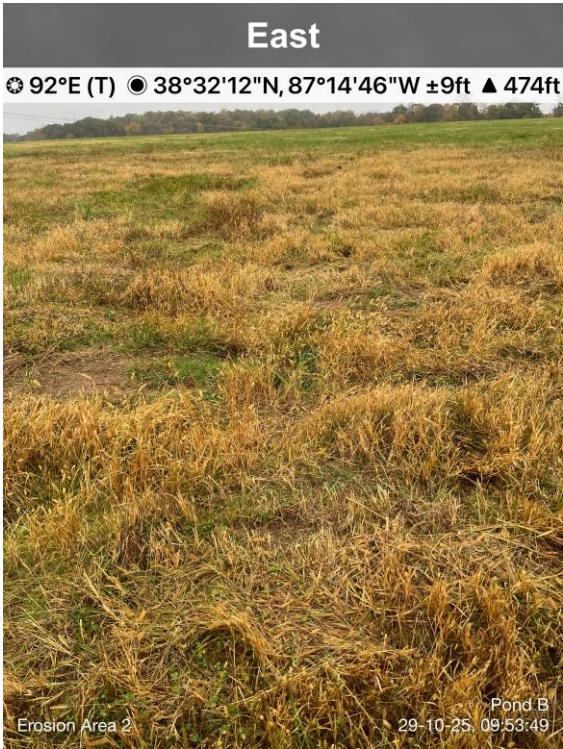
Photo B-2	Date: 10/29/2025

Location: Indiana Petersburg, Ash Pond B	Description: Facing East, erosion and bare spots.  Recommend repair and reseed.	
Photo B-3	Date: 10/29/2025

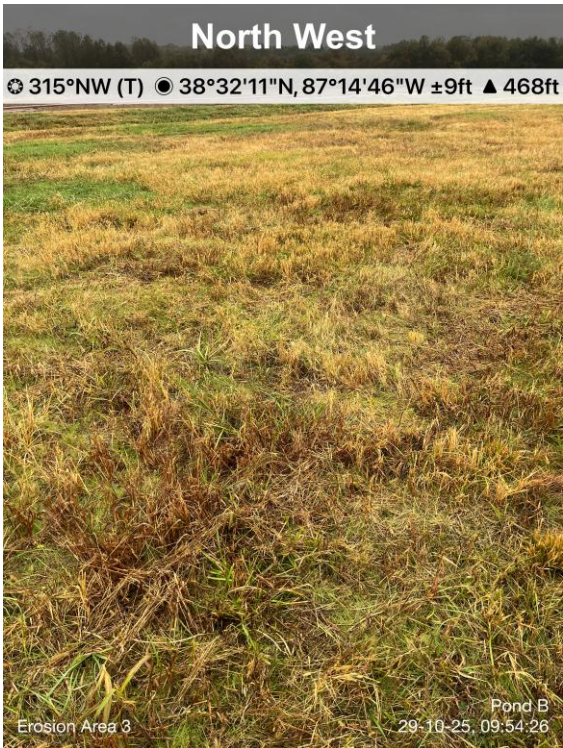
Location: Indiana Petersburg, Ash Pond B	Description: Facing Northwest, erosion and bare spots.  Recommend repair and reseed.

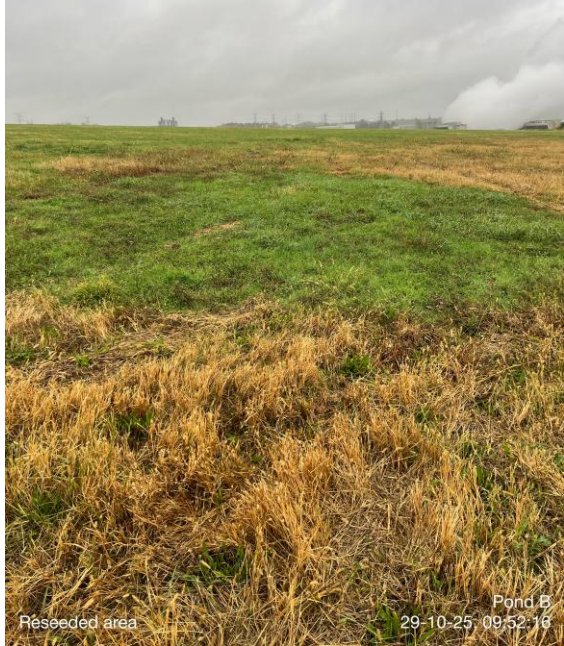
<p>Reseeded area Pond B 29-10-25 09:52:16</p> </div>
<p>Location: Indiana Petersburg, Ash Pond B</p>		
<p>Description: Facing South, reseeded area.</p> <p>Recommend monitoring area and reseeding as necessary.</p>		
<p>Photo B-5</p>	<p>Date: 10/29/2025</p>	<div data-bbox="792 1054 1352 1797"> <p><b>North West</b></p> <p>☉ 321°NW (T) ● 38°32'8"N, 87°14'49"W ±9ft ▲ 518ft</p>

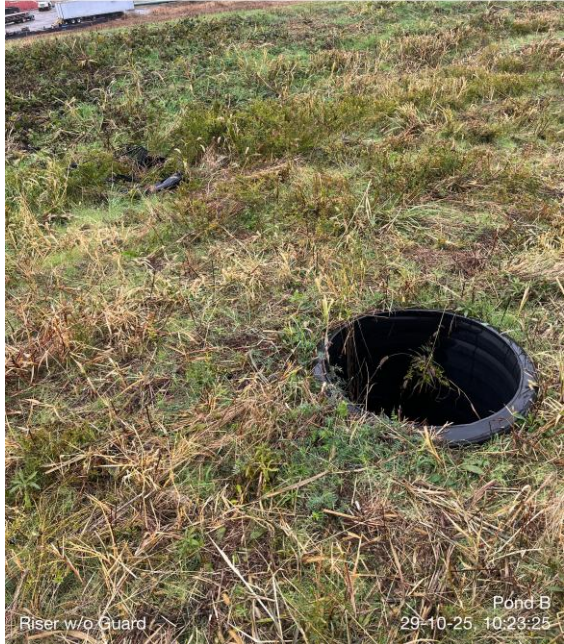
<p>Riser w/o Guard Pond B 29-10-25 10:23:25</p> </div>
<p>Location: Indiana Petersburg, Ash Pond B</p>		
<p>Description: Facing North, stormwater risers without guards.</p> <p>Recommend replacement of stormwater riser guards and trim back vegetation</p>

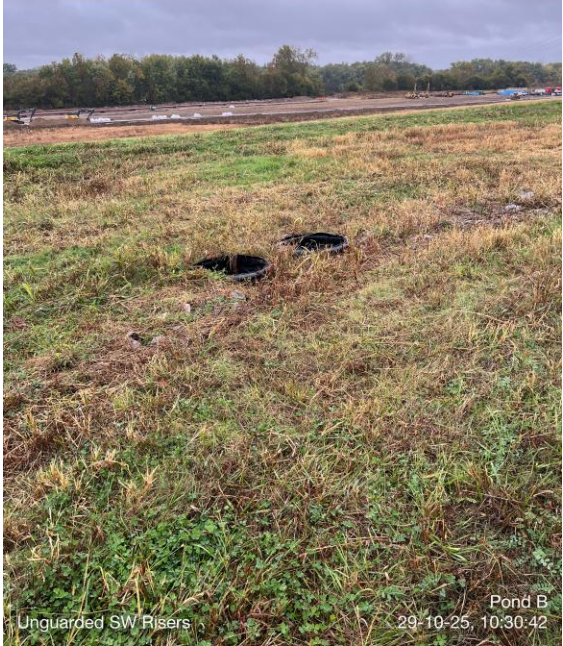
<p>Unguarded SW Risers Pond B 29-10-25, 10:30:42</p> </div>
<p>Location: Indiana Petersburg, Ash Pond B</p>		
<p>Description: Facing North, stormwater risers without guards.</p> <p>Recommend replacement of stormwater riser guards and trim back vegetation</p>		
<p>Photo B-7</p>	<p>Date: 10/29/2025</p>	<div data-bbox="784 1056 1343 1799"> <p>S SW W NW 30 210 240 270 300</p> <p>BRG: 251°W (T) LAT: 38.534888 LON: -87.245313 ±13ft ALT: 450ft</p>

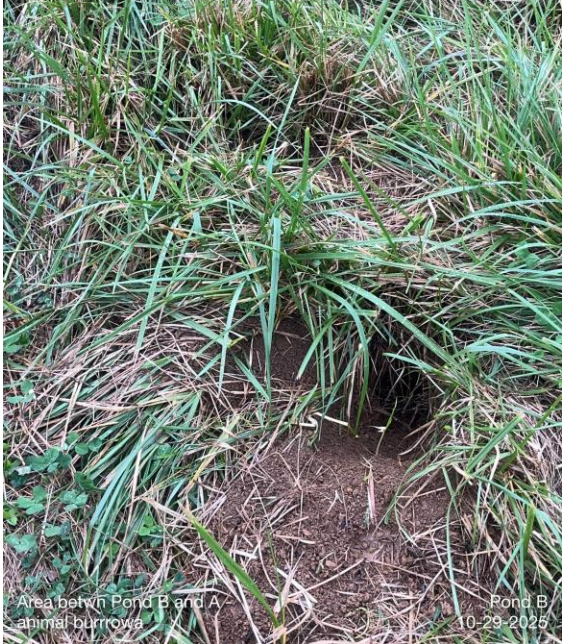
<p>Area between Pond B and A animal burrows Pond B 10-29-2025</p> </div>
<p>Location: Indiana Petersburg, Ash Pond B</p>		
<p>Description: Facing Southwest, animal burrows.</p> <p>Recommend repair and reseed.</p>

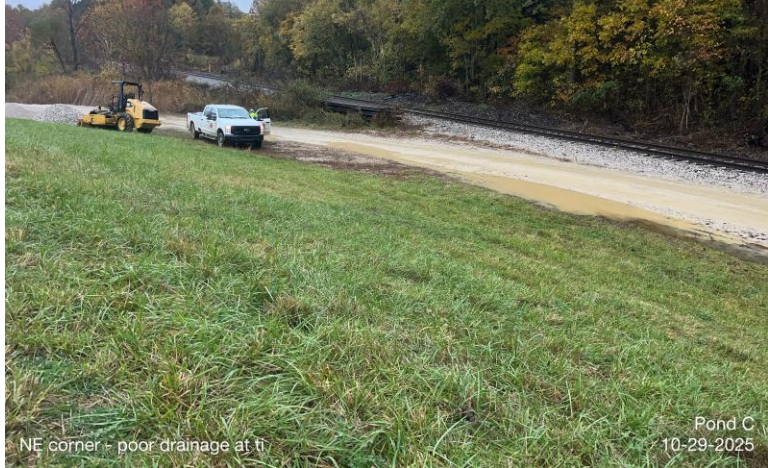
<p>NE corner - poor drainage at ti Pond C 10-29-2025</p> </div>
<p>Location: Indiana Petersburg, Ash Pond C</p>		
<p>Description: Facing East, poor drainage at toe.</p> <p>Recommend drainage repair at toe.</p>

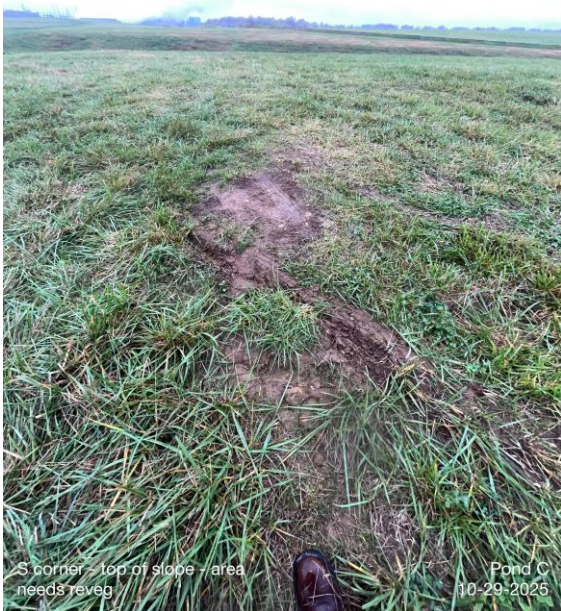
</div><div>S corner - top of slope - area needs reveg</div><div>Pond C 10-29-2025</div></div>
Location: Indiana Petersburg, Ash Pond C		
Description: Facing Southwest, bare spots and erosion.  Recommend repair and reseed.

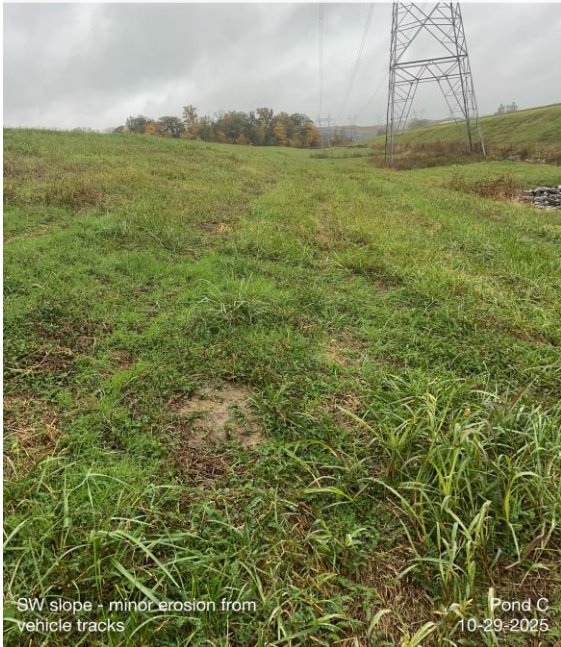
</div><div>SW slope - minor erosion from vehicle tracks</div><div>Pond C 10-29-2025</div></div>
Location: Indiana Petersburg, Ash Pond C		
Description: Facing Southeast, erosion and vehicle tracks along slope.  Recommended repair and reseed.

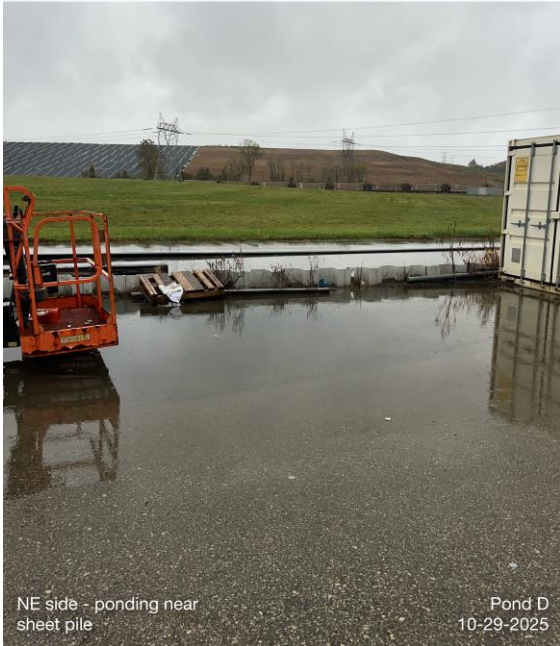
</div><div>NE side - ponding near sheet pilePond D10-29-2025</div></div>
Location: Indiana Petersburg, Ash Pond D		
Description: Facing East, ponding near sheet pile.		
Recommend monitoring and repairing as necessary.

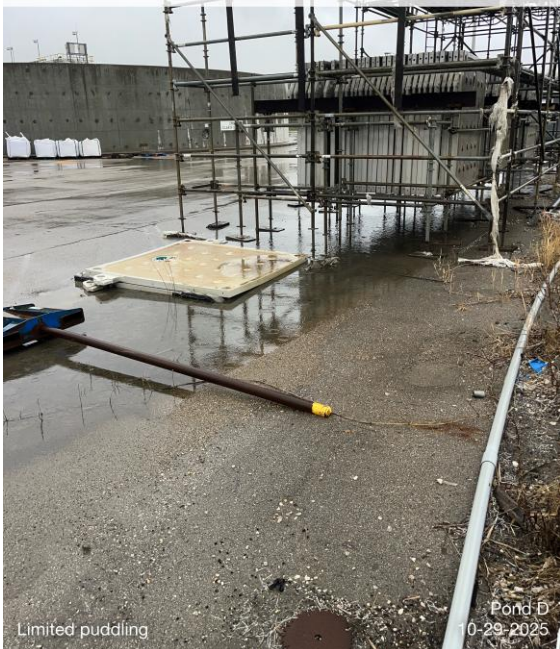
</div><div>Limited puddlingPond D10-29-2025</div></div>
Location: Indiana Petersburg, Ash Pond D		
Description: Facing West, limited puddling on asphalt.		
Recommend monitoring and repairing as necessary.

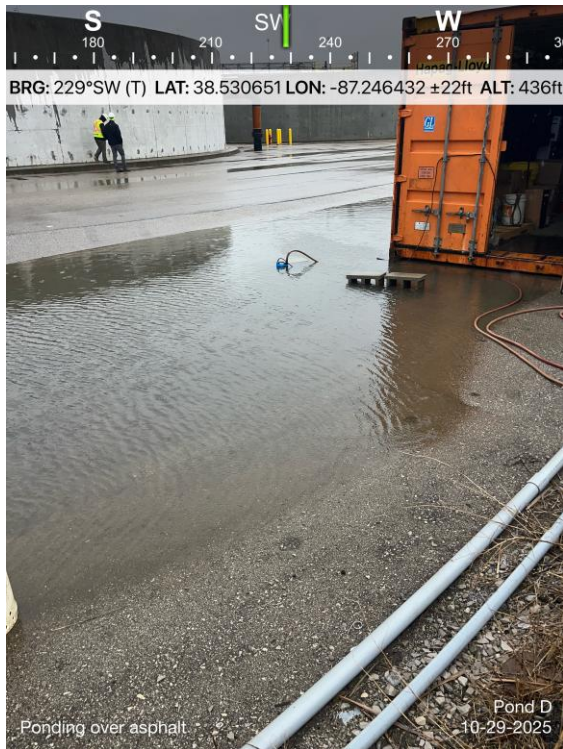
Photo D-3	Date: 10/29/2025

Location: Indiana Petersburg, Ash Pond D		
<p>Description: Facing Southwest, ponding over asphalt.</p> <p>Recommend monitoring and repairing as necessary.</p>		
Photo D-4	Date: 10/29/2025

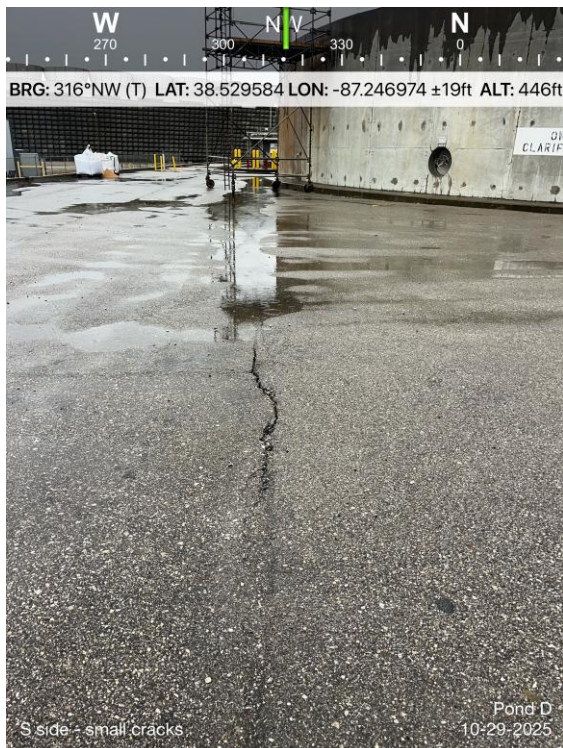
Location: Indiana Petersburg, Ash Pond D		
<p>Description: Facing Northwest, asphalt with cracks and minimal ponding.</p> <p>Recommend sealing cracks and monitoring stormwater ponding.</p>
