Submitted to
AES Indiana
Petersburg Generating Station
6925 North State Road 57
Petersburg, IN 47567

Annual CCR Inspection
§257.84 (b)

Restricted Waste Landfill

Petersburg Generating Station

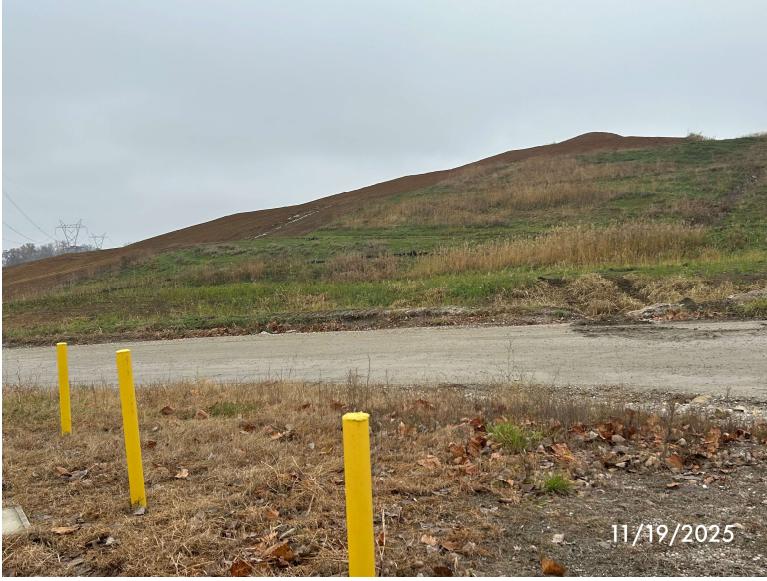
Photo 1	Date: 11/19/2025

Location: Indiana, Petersburg Generating Station		
Description: Facing North, southeast portion of the landfill that is not under closure construction.		
Photo 2	Date: 11/19/2025

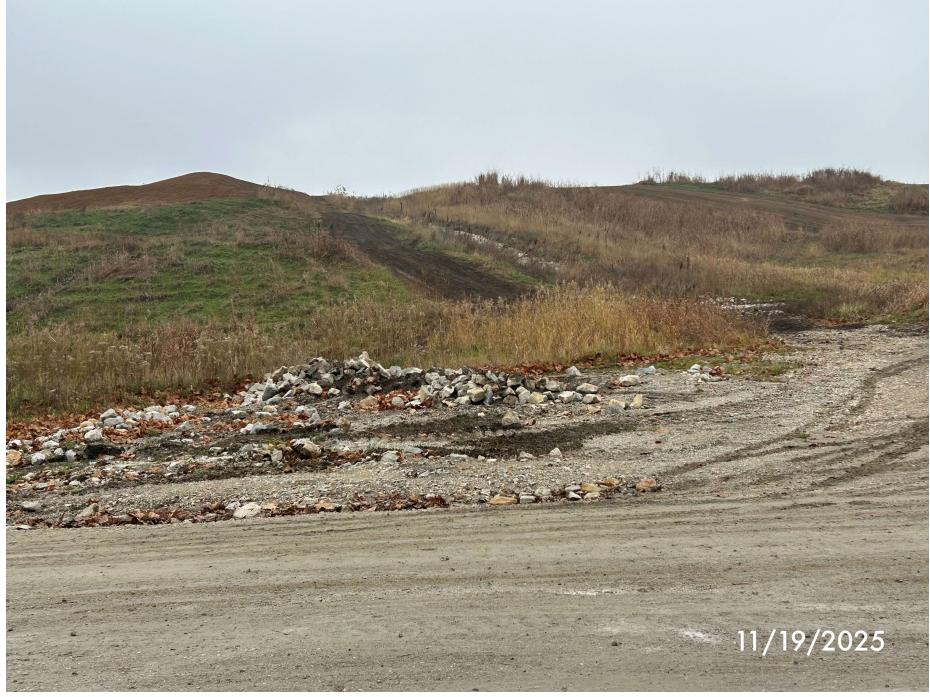
Location: Indiana, Petersburg Generating Station		
Description: Facing North, southeast to south central portion of the landfill that is not under closure construction.

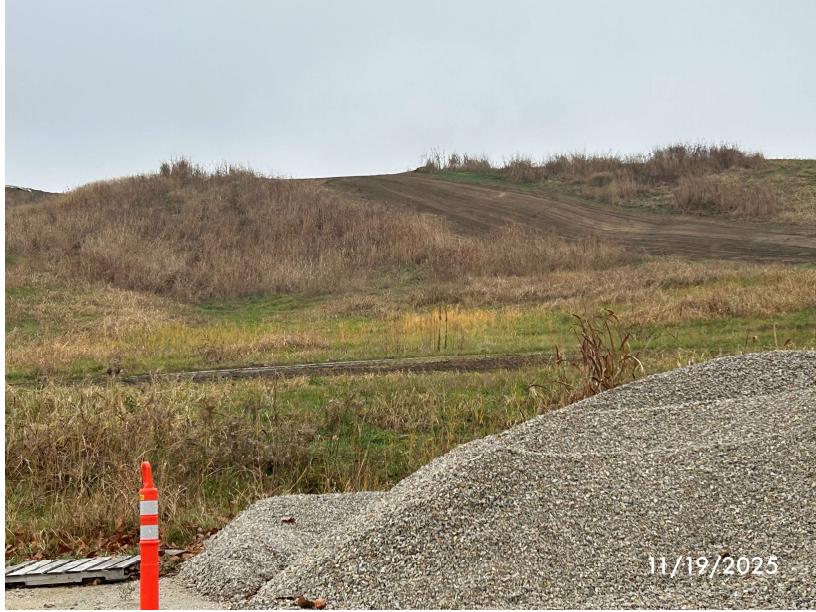
Photo 3	Date: 11/19/2025

Location: Indiana, Petersburg Generating Station		
Description: Facing North, south central portion of the landfill that is not under closure construction.		
Photo 4	Date: 11/19/2025

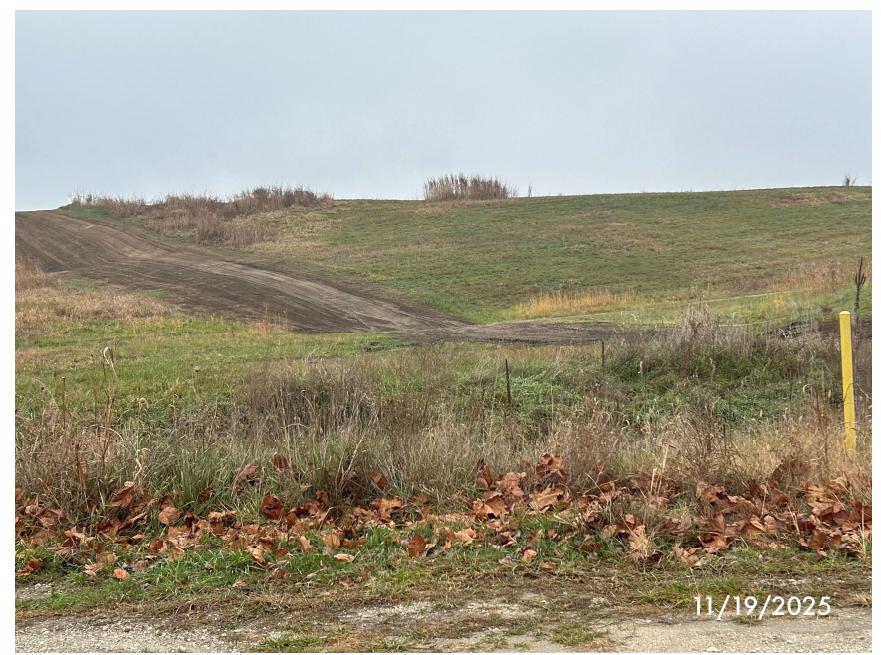
Location: Indiana, Petersburg Generating Station		
Description: Facing North, south central portion of the landfill that is not under closure construction.

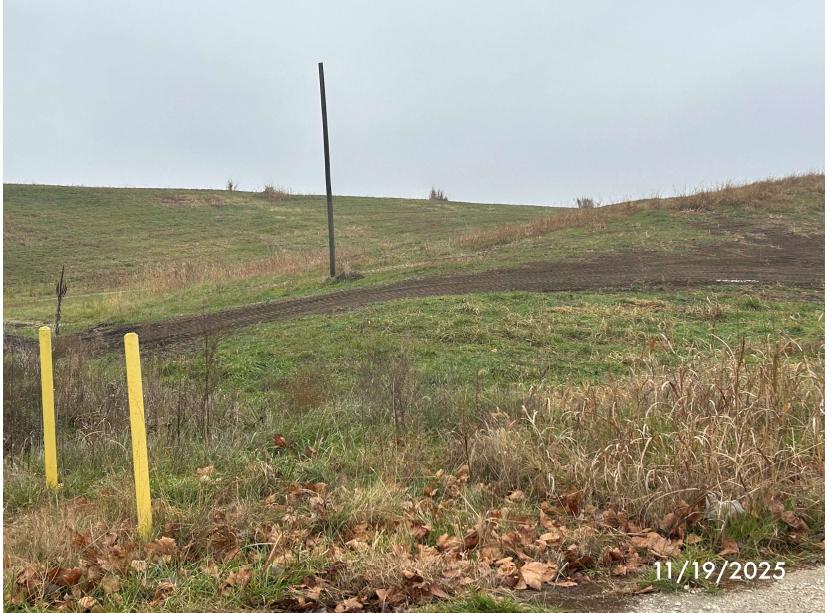
Photo 5	Date: 11/19/2025

11/19/2025
Location: Indiana, Petersburg Generating Station		
Description: Facing North, south central portion of the landfill that is not under closure construction.		
Photo 6	Date: 11/19/2025

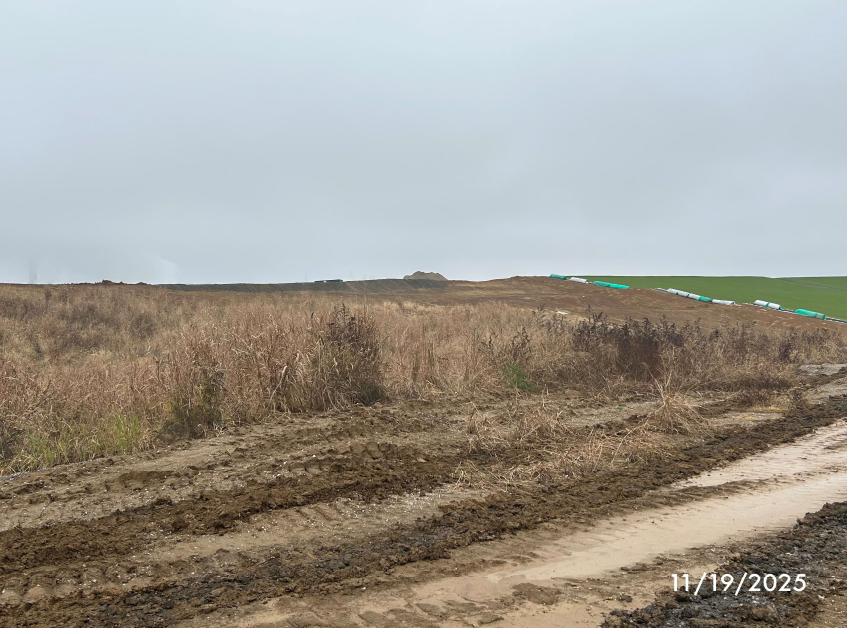
11/19/2025
Location: Indiana, Petersburg Generating Station		
Description: Facing East, western portion of the landfill that is not under closure construction.

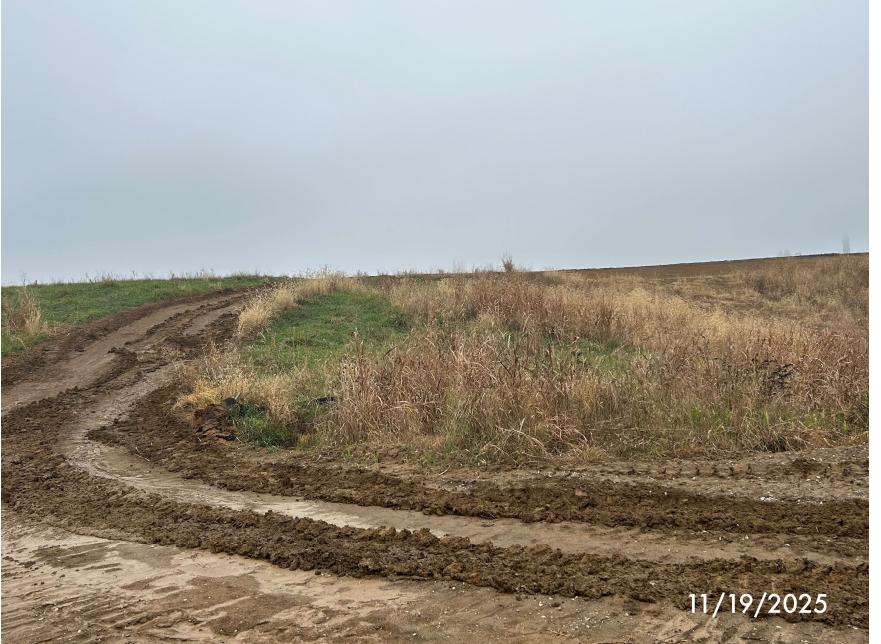
Photo 7	Date: 11/19/2025

11/19/2025
Location: Indiana, Petersburg Generating Station		
Description: Facing East, western portion of the landfill that is not under closure construction.		
Photo 8	Date: 11/19/2025

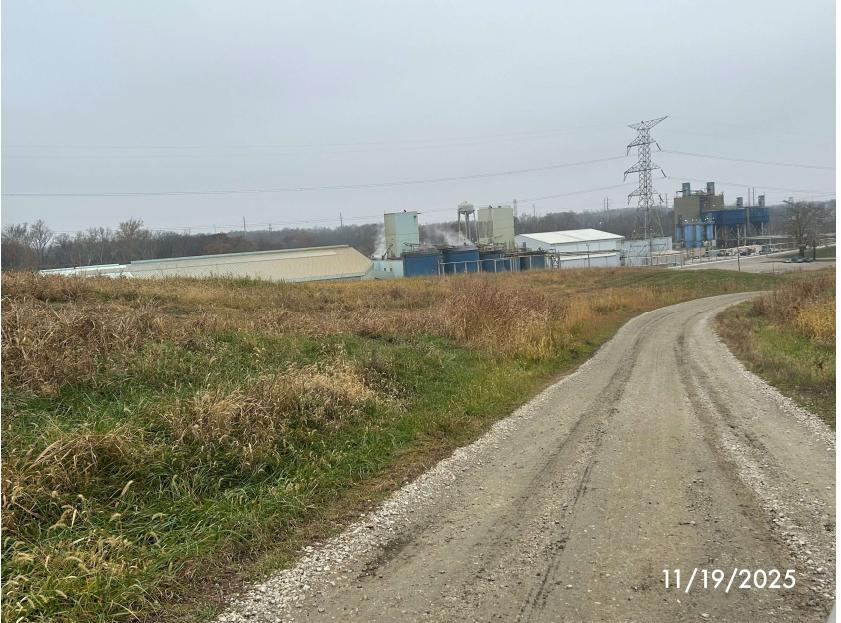
11/19/2025
Location: Indiana, Petersburg Generating Station		
Description: Facing Southeast, down access road in southern portion of landfill.

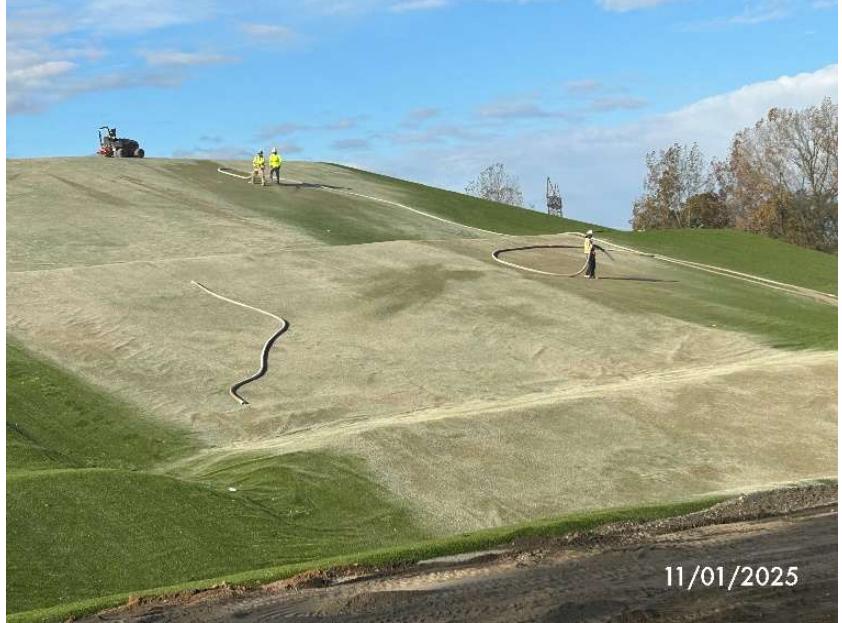
Photo 9	Date: 11/01/2025

11/01/2025
Location: Indiana, Petersburg Generating Station Indiana Petersburg, Ash Pond B		
Description: East slope facing northwest, view of sand blowing in progress.		
Photo 10	Date: 10/29/2025

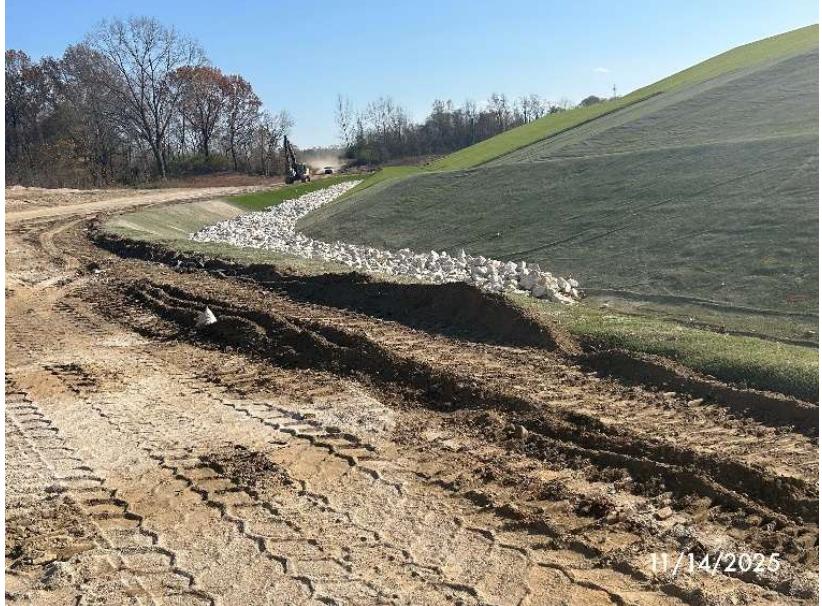
11/14/2025
Location: Indiana Petersburg, Ash Pond B		
Description: Northeast slope facing east, View of rip rap installation progress.

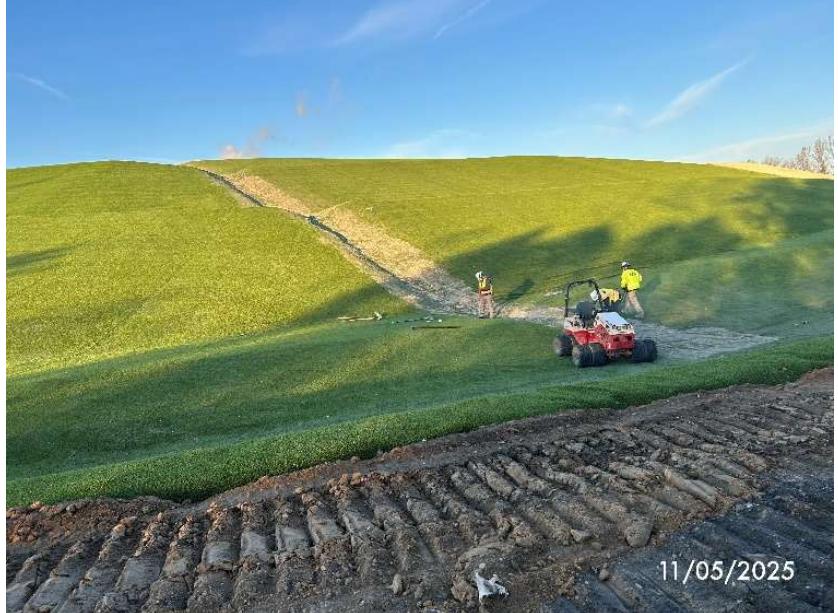
Photo 11	Date: 11/05/2025

A photograph showing the northeast slope of a landfill hill. The hill is covered in green grass. Several construction workers in yellow vests and hard hats are working on the slope. A red utility vehicle is parked on the hill. The sky is blue with some wispy clouds. A timestamp '11/05/2025' is visible in the bottom right corner of the image.
Location: Indiana, Petersburg Generating Station		
Description: Northeast slope of landfill facing west, view of hydro-binder being installed.		
Photo 12	Date: 10/01/2025

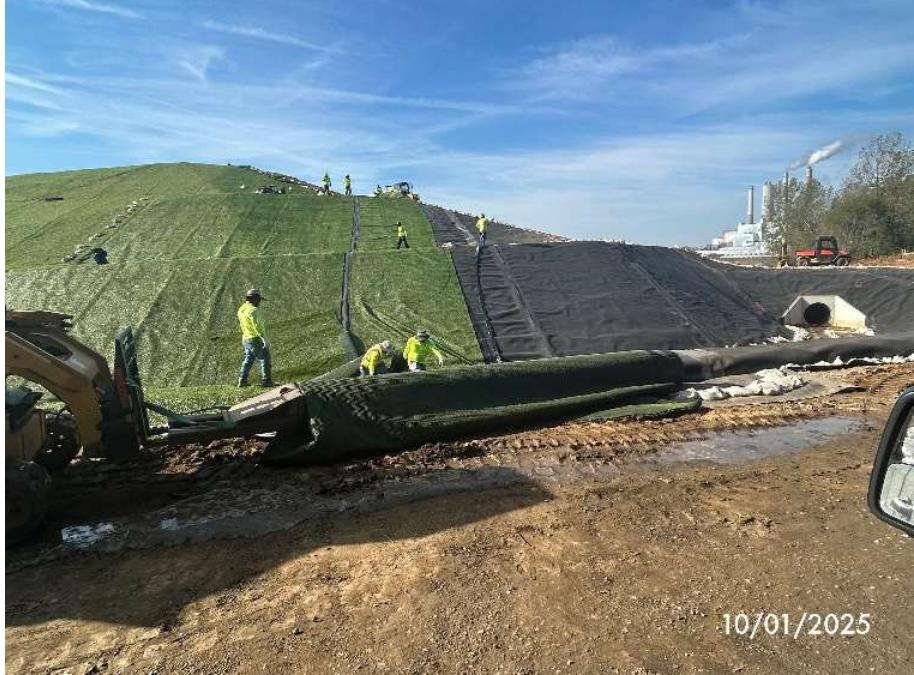
Location: Indiana, Petersburg Generating Station		
Description: North slope facing west. View of turf installation in progress.

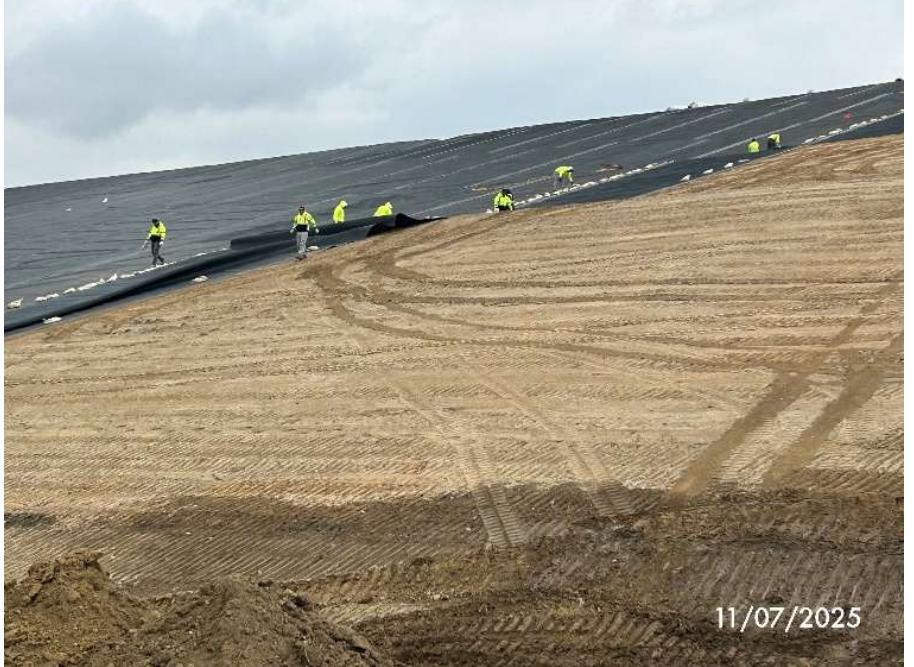
Photo 13	Date: 11/07/2025

A photograph showing a steep, brown, textured slope of earth. Several construction workers in high-visibility yellow vests and hard hats are scattered across the slope, some walking and some standing. The top of the slope is covered with a dark, textured material, likely a geomembrane. The sky is overcast. A timestamp '11/07/2025' is in the bottom right corner of the image.
Location: Indiana, Petersburg Generating Station		
Description: West slope facing northeast, view of geomembrane installation in progress.		
Photo 14	Date: 11/14/2025

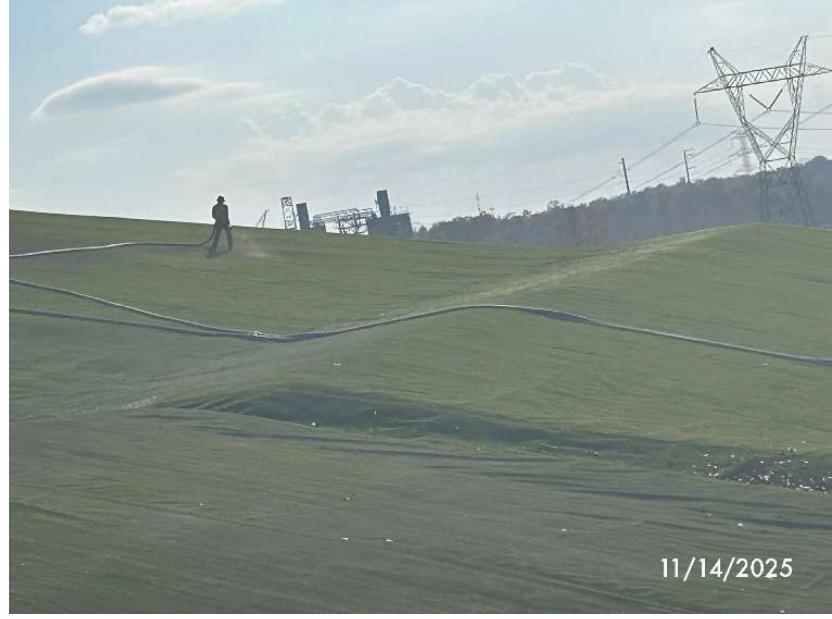
Location: Indiana, Petersburg Generating Station		
Description: West slope facing south, View of air blowing of sand in progress.
