SCS ENGINEERS

January 27, 2017
File No. 25211357.31

Subject: 2016-1 Dike Inspection-Eagle Valley Generating Station
Ponds A, B, and C Ash Ponds

IPL Eagle Valley Station – Ponds A-C – 16-1 Inspection
Martinsville, Indiana
SCS Engineers Project #25211357.31

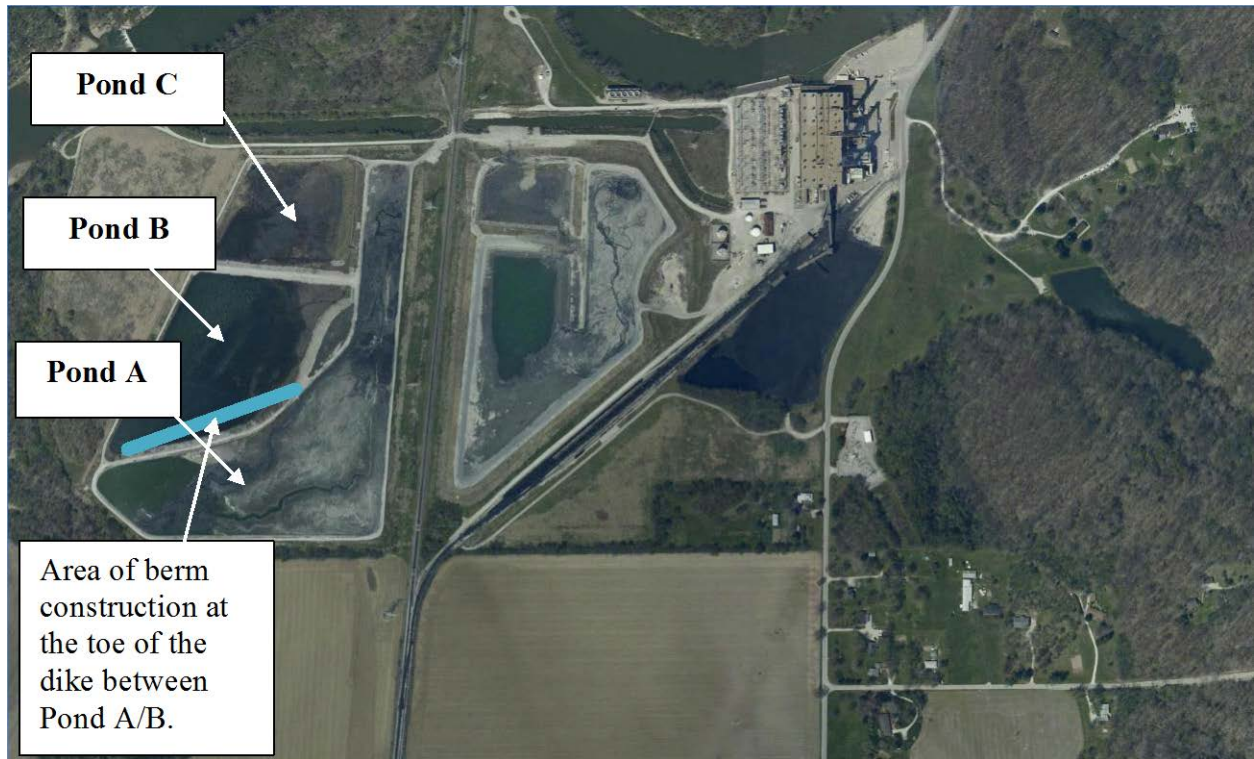
Figure 1 – Location Plan of Basin and Ponds

The layouts of the Ponds A, B, and C facility are shown on **Figure 1**. At the time of the inspection, IPL was not operating the Eagle Valley Plant. Photographs taken during the inspection of Ponds A, B, and C are presented in **Attachment B** to this letter.

8. IPL previously placed the material excavated from the interior of Pond A along the downstream slope of the intermediate dike between Pond A and Pond B as shown on **Figure 1**. No instabilities of the berm material were observed during placement, and the completed berm appeared stable during the inspection.

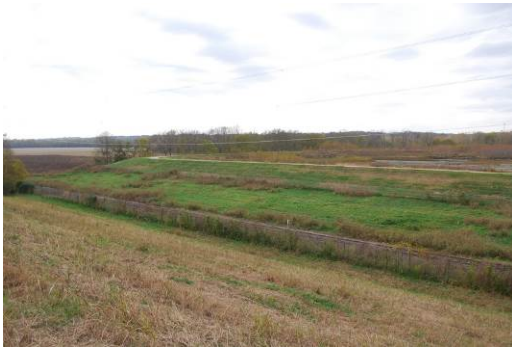
Photo 1: East Perimeter Dike of Pond A, looking south.

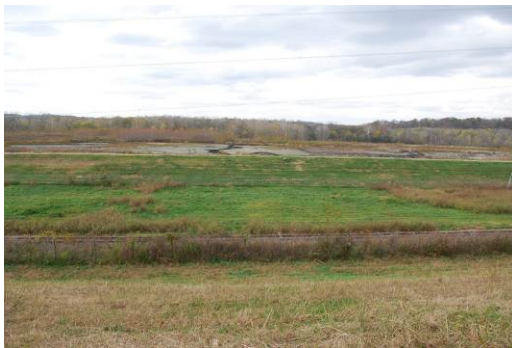
Photo 2: Same as Photo 1, looking west.

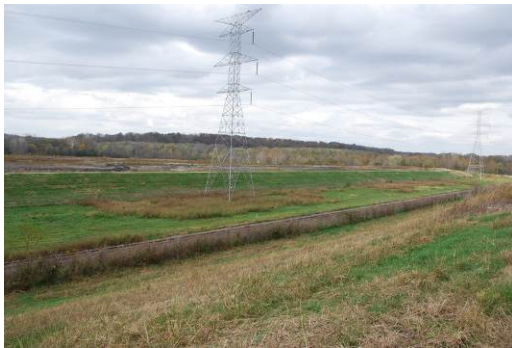
Photo 3: Same as Photo 1, looking northwest.

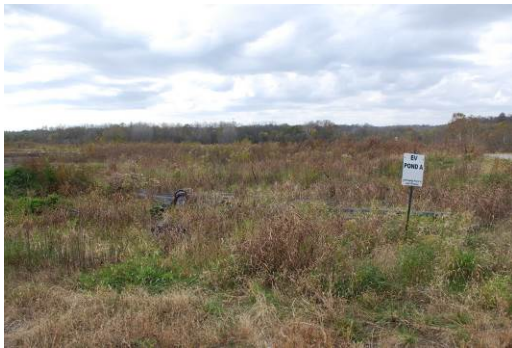
Photo 4: Condition of the top of Pond A. Looking west from the northeast corner of Pond A.

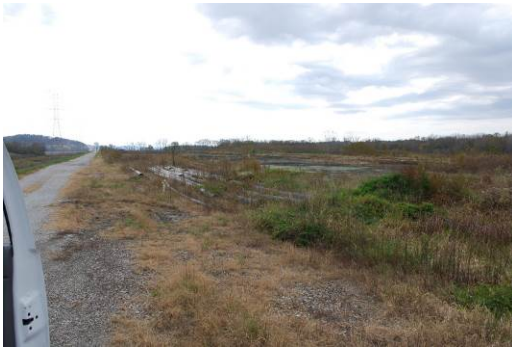
Photo 5: Same as Photo 4, looking south.

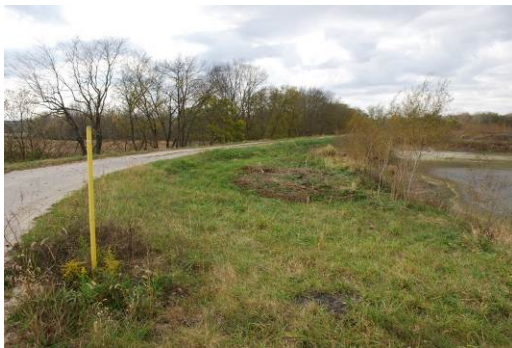
Photo 6: Pond A, looking west from the top of the southeast corner of Pond A. Pond A was dry at the time of the inspection.

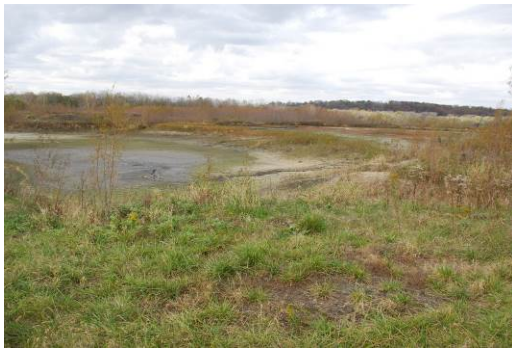
Photo 7: Same, looking northwest from the southeast corner of Pond A.

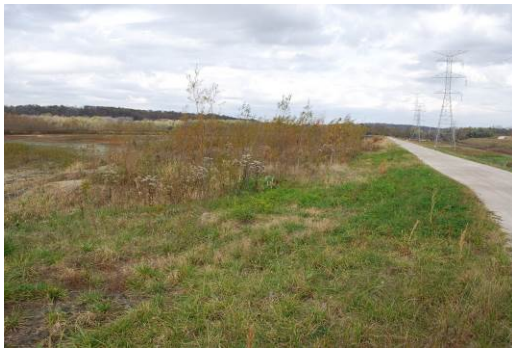
Photo 8: Same, looking north.

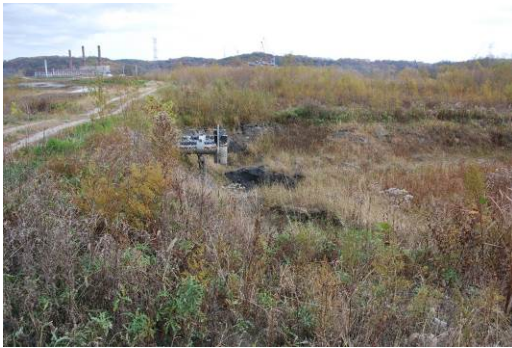
Photo 9: Discharge pipes from Pond A to Pond B, looking east. Pond A was dry at the time of the inspection.

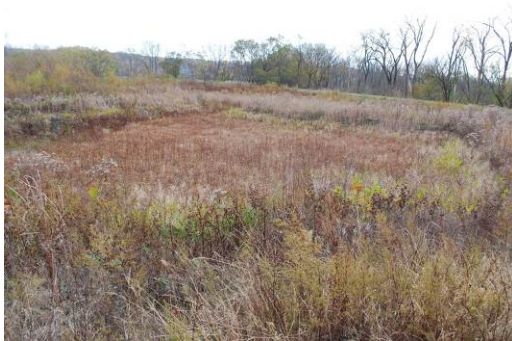
Photo 10: Same as Photo 9, looking southeast.

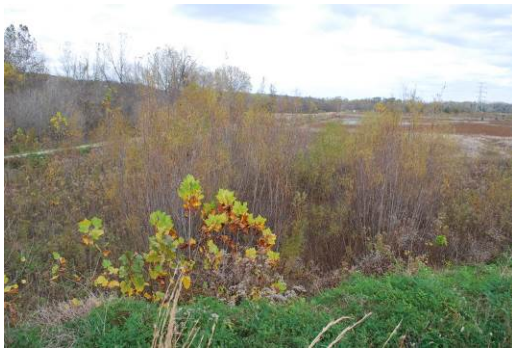
Photo 11: Pond B, looking north from the southwest corner of Pond B.

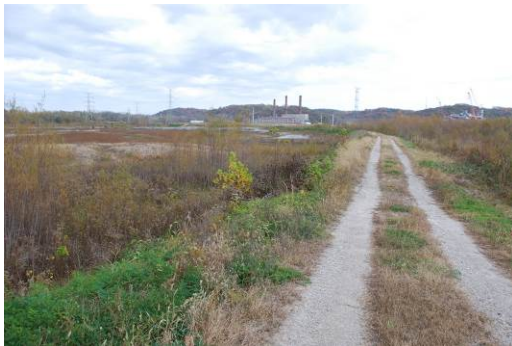
Photo 12: Same, looking east along the intermediate dike between Pond A and Pond B.

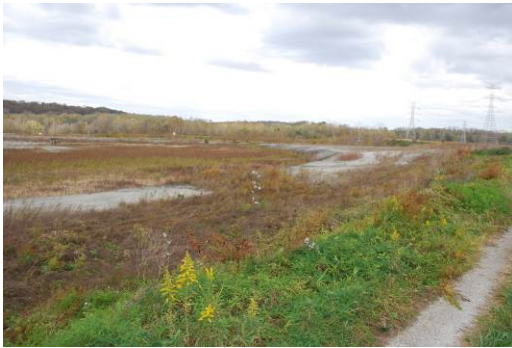
Photo 13: Pond B, looking northeast from the southwest corner of Pond B.

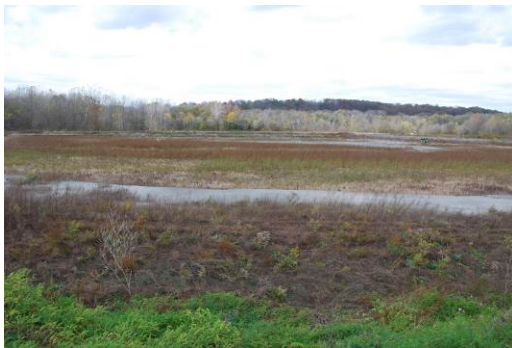
Photo 14: Same, looking north. Some residual ponded water in Pond B at the time of the inspection.

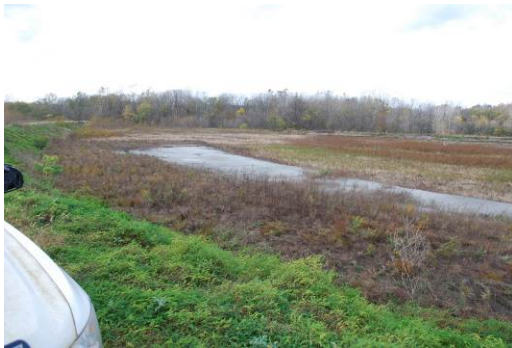
Photo 15: Same, looking west.

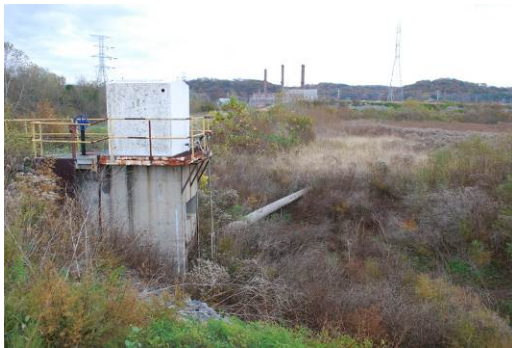
Photo 16: Discharge structure at the northwest corner of Pond C. Pond C was dry at the time of the inspection.

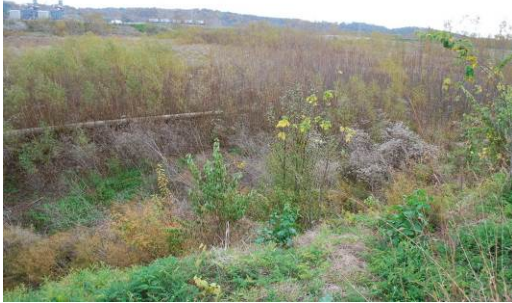
Photo 17: Pond C, looking southeast from the northwest corner of Pond C.

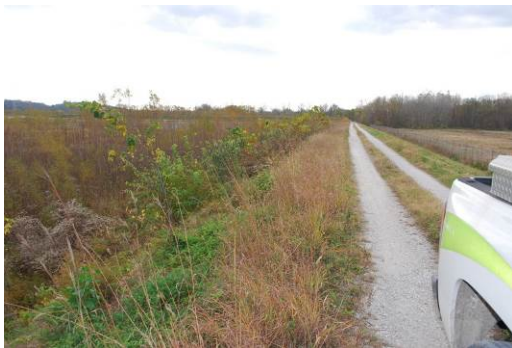
Photo 18: Typical condition of the crest of the West Perimeter Dike of Pond C.
