SCS ENGINEERS

Subject: 2015-2 Dike Inspection - Eagle Valley Generating Station
Ponds A, B, and C

**IPL Eagle Valley Station – Ponds A-C – 15-2 Inspection
Martinsville, Indiana
SCS Engineers Project #25211357.31**

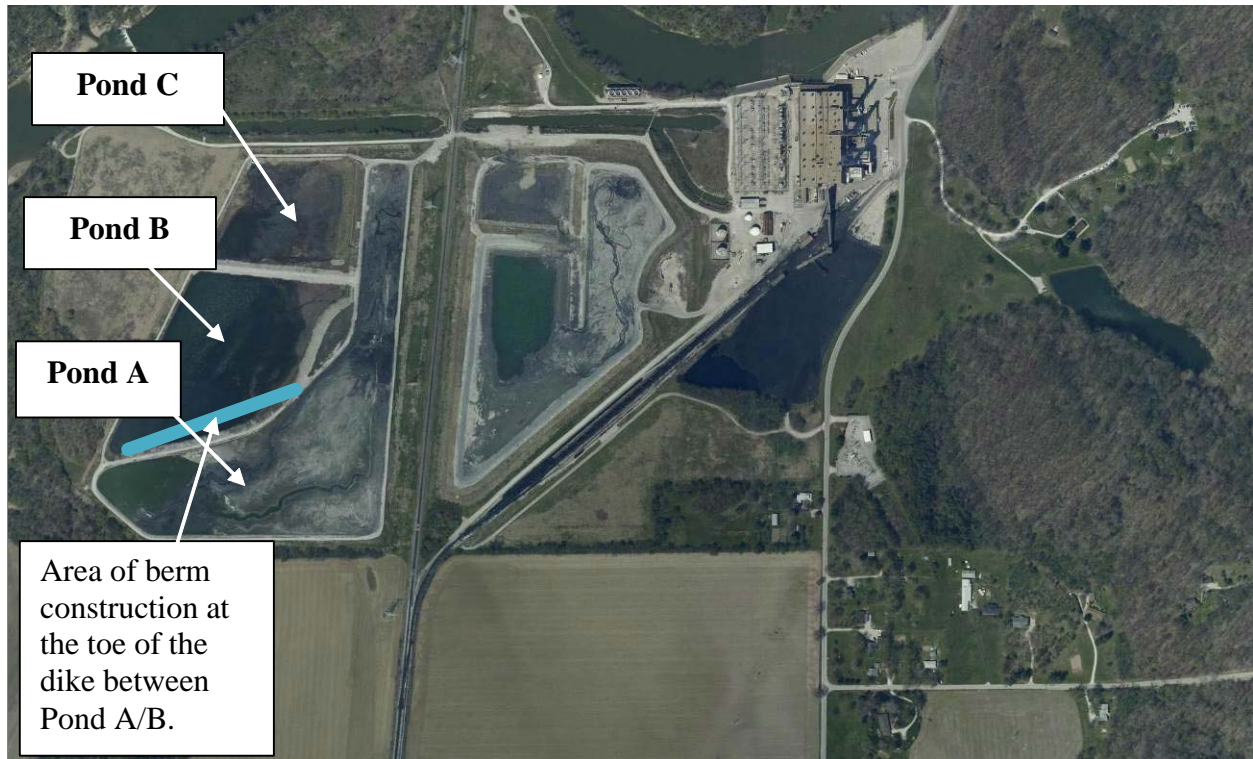
Figure 1 – Location Plan of Basin and Ponds

- IPL previously placed the material excavated from the interior of Pond A along the downstream slope of the intermediate dike between Pond A and Pond B as shown on **Figure 1**. No instabilities of the berm material were observed during placement, and the completed berm appeared stable during the inspection.

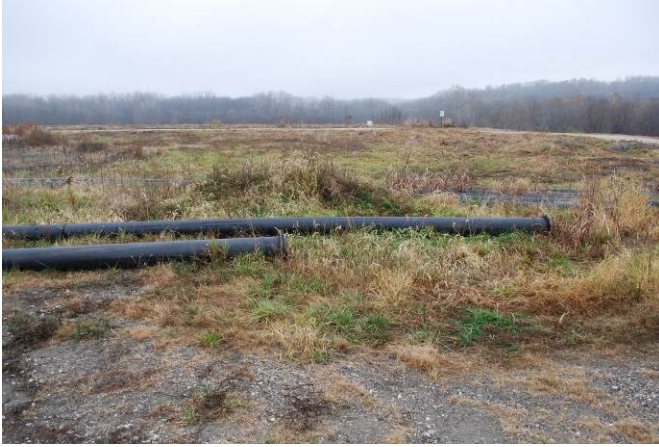
Photo 1: Pond A, looking west from the Northeast corner of Pond A.

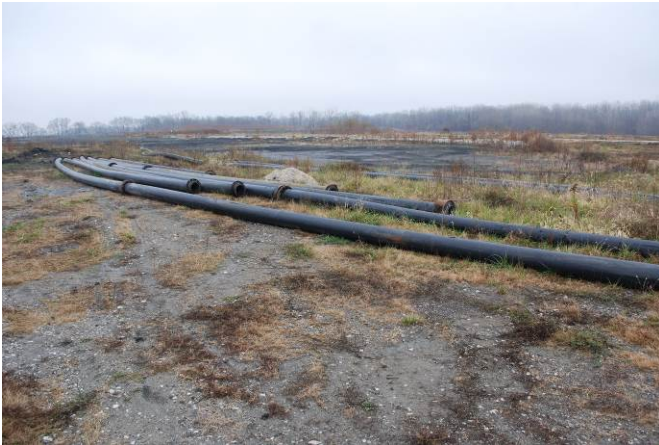
Photo 2: Same, looking southwest.

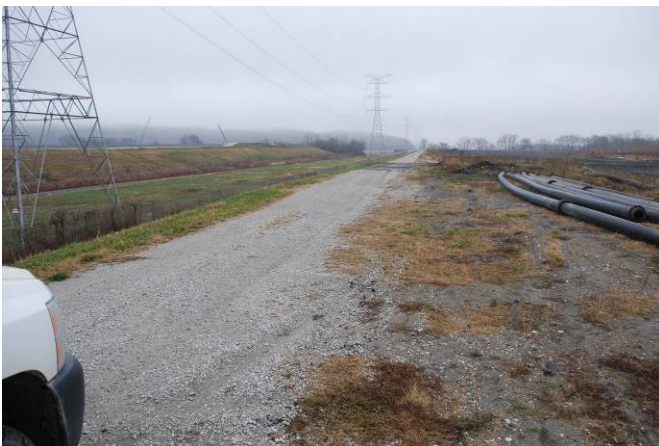
Photo 3: Same, looking south.

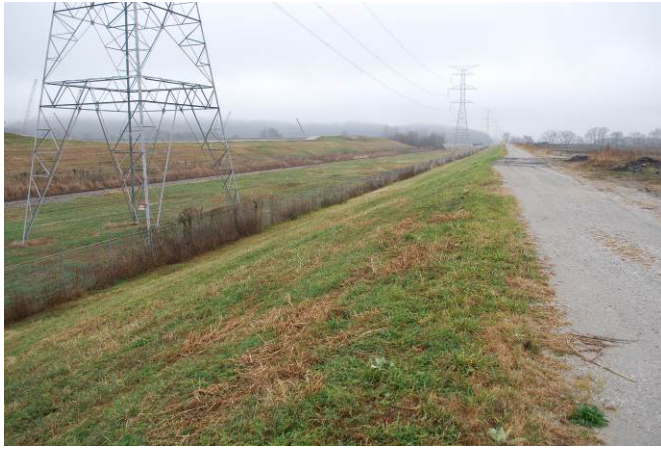
Photo 4: Typical condition of the downstream slope of the East perimeter dike of Pond A.

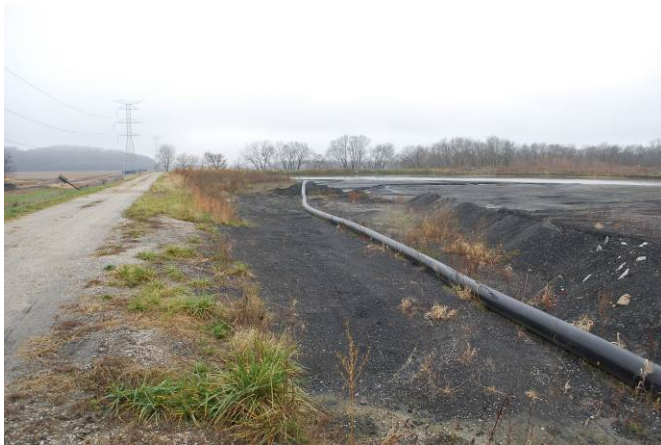
X ☐ Other: Limited freeboard on the Eastern perimeter slope of Pond A has been corrected by excavation of an area of Pond A. Area appears to conform to previous recommendations. Pond A is not being used for ash processing at the time of inspection.

Photo 5: Freeboard in the Northeast corner of Pond A.

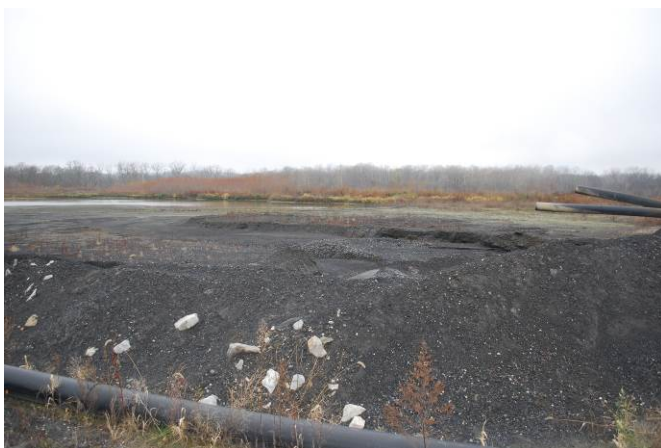
Photo 6: Surface of Pond A, looking southeast from the center of the East perimeter dike of Pond A.

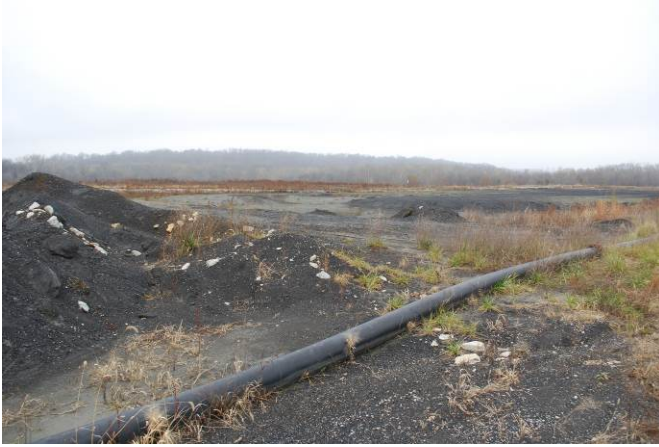
Photo 7: Same, looking south.

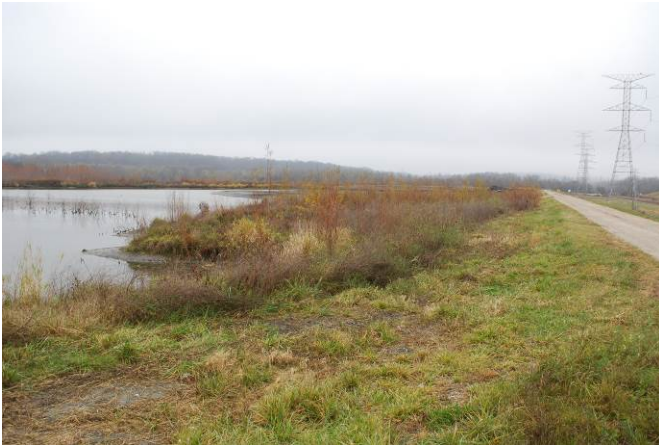
Photo 8: Pond A, looking north from the Southeast corner of Pond A.

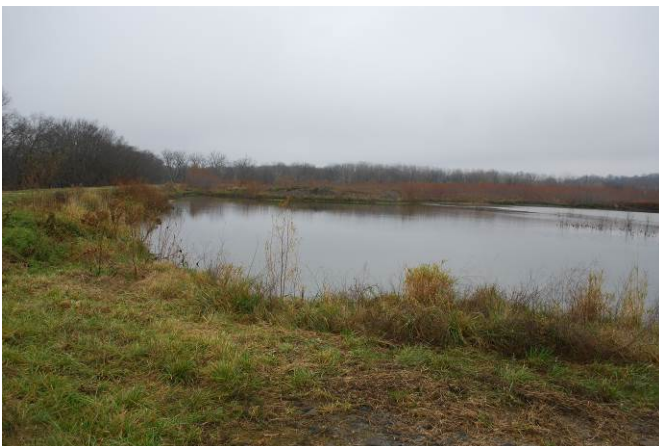
Photo 9: Same, looking west.

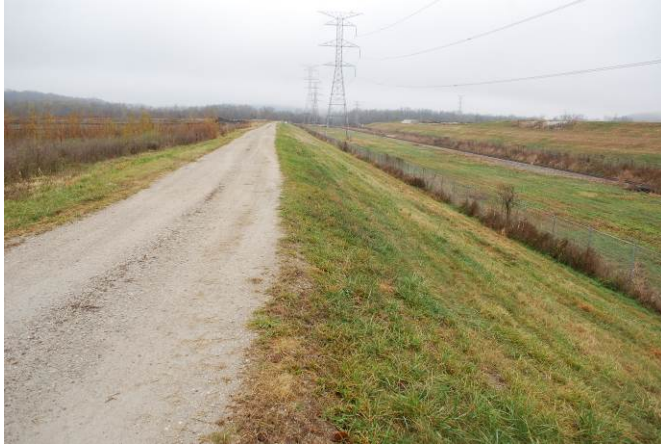
Photo 10: Typical condition of the downstream slope of the East perimeter dike of Pond A, looking north from the Southeast corner of Pond A.

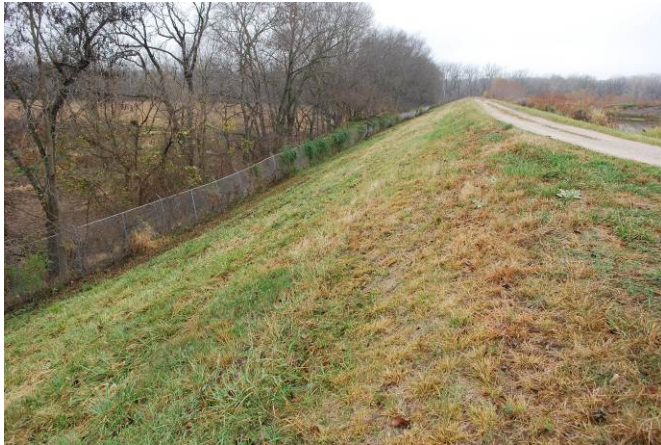
Photo 11: Typical conditions of the downstream slope of the South perimeter dike of Pond A, looking west.

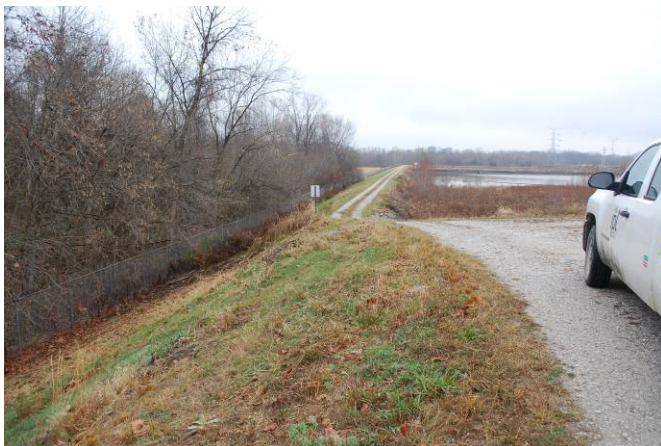
Photo 12: Typical condition of the crest and downstream slope of the West perimeter dike of Pond A and Pond B, looking north from the Southwest corner of Pond B.

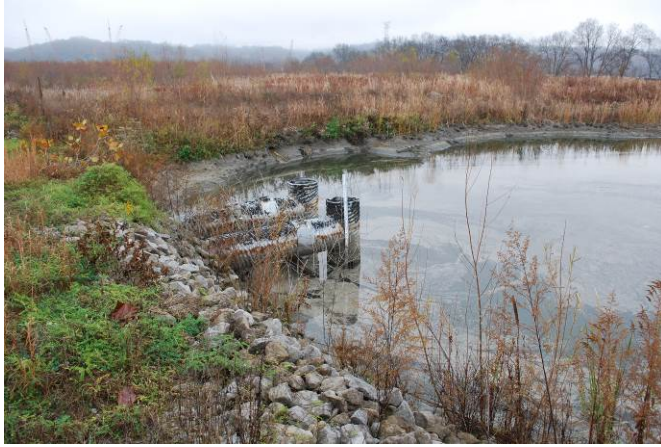
Photo 13: Outlet from Pond A to Pond B.

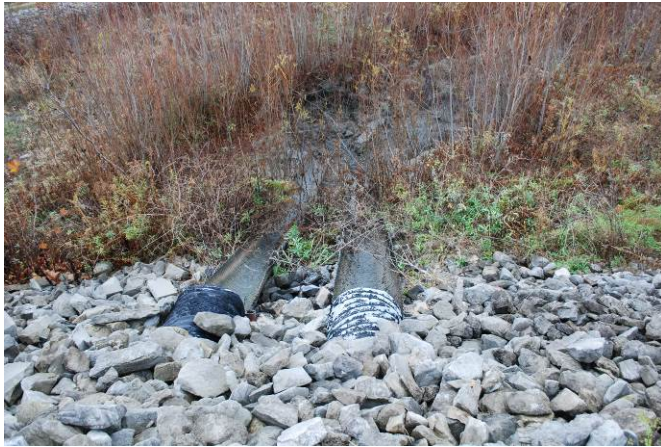
Photo 14: Discharge pipes from Pond A into Pond B. No discharge at the time of the inspection.

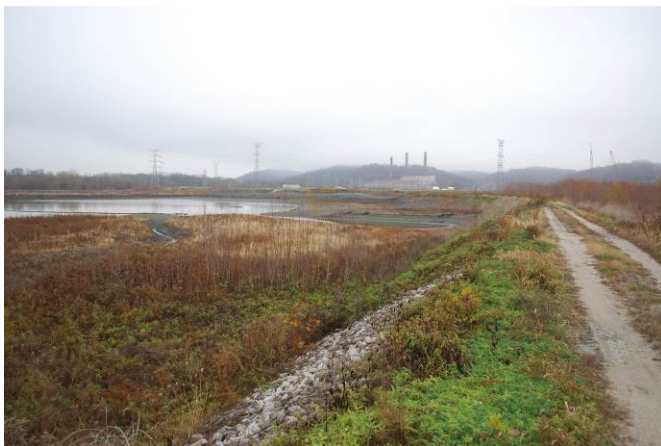
Photo 15: Downstream slope of intermediate dike between Pond A and Pond B, looking northeast from West end of intermediate dike.

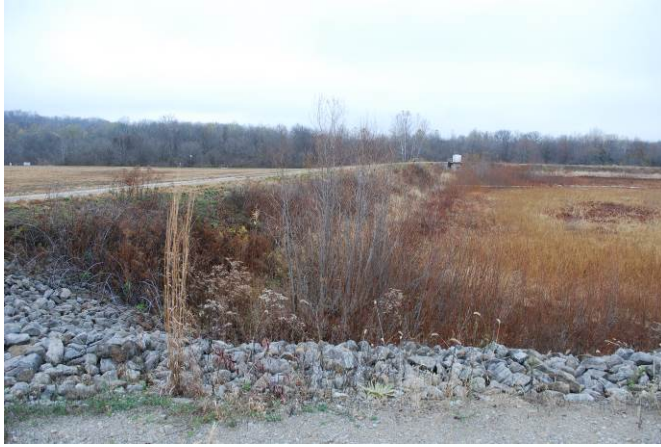
Photo 16: Typical condition of the interior slope of the West perimeter dike of Pond B, looking north from the West end of the intermediate dike.

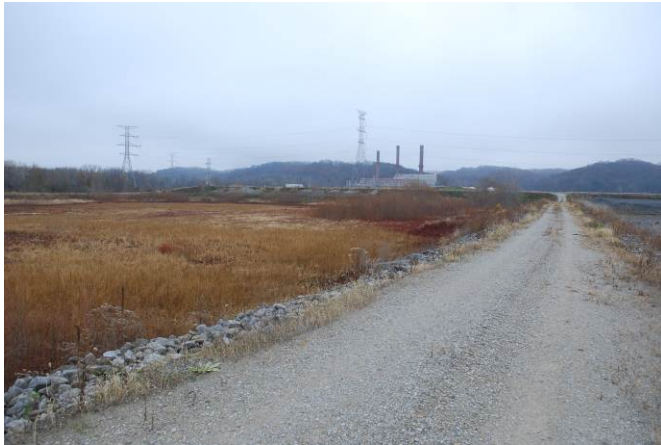
Photo 17: Same as Photo 16, looking northeast from the center of the intermediate dike.

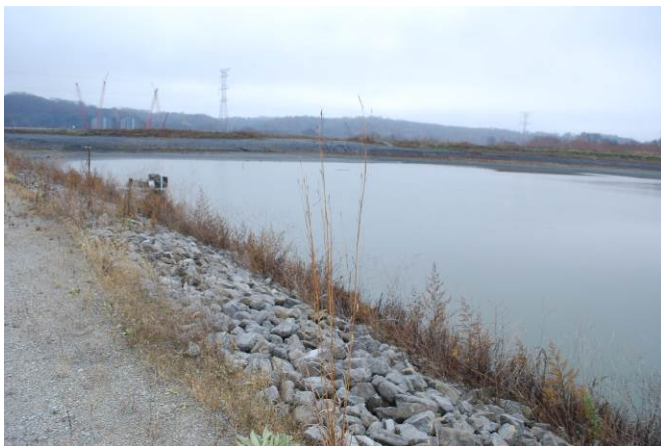
Photo 18: Pond B, looking east from the Northwest corner of Pond B.

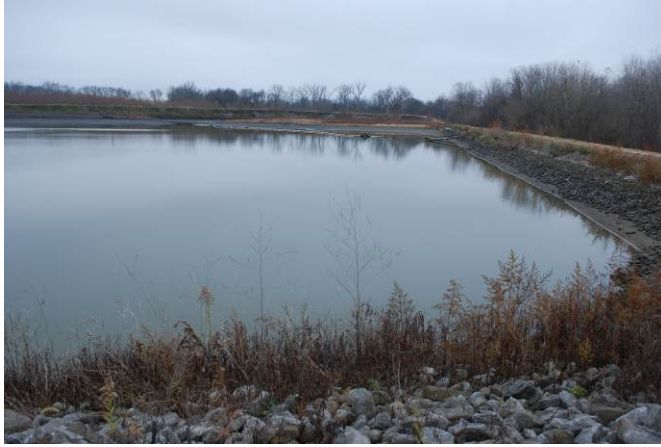
Photo 19: Same, looking south.

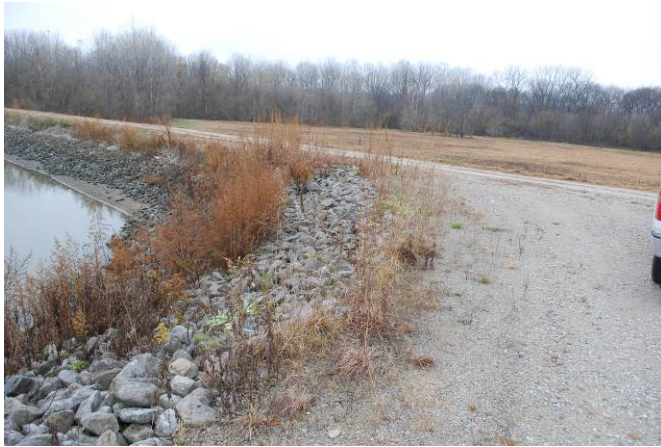
Photo 20: Same, looking at the condition of the rip-rap placed in the Northwest corner of Pond B.

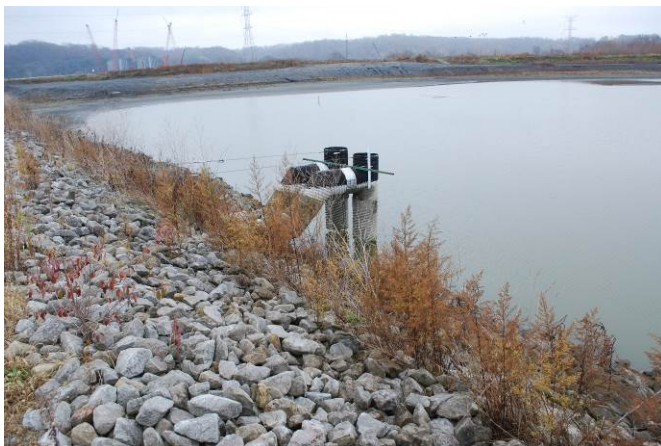
Photo 21: Outlet from Pond B into Pond C.

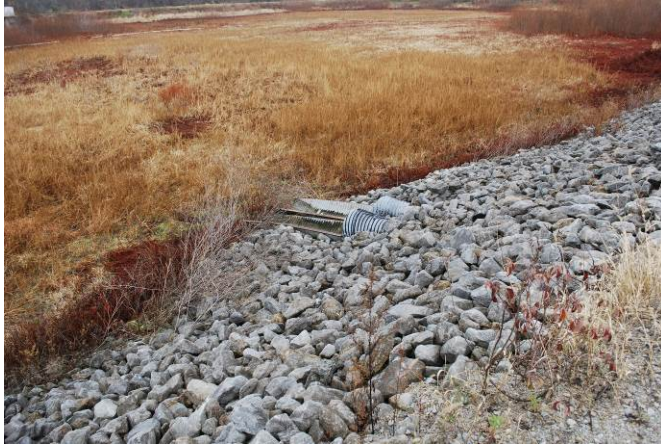
Photo 22: Outlet from Pond B into Pond C. No discharge occurring at the time of the inspection.

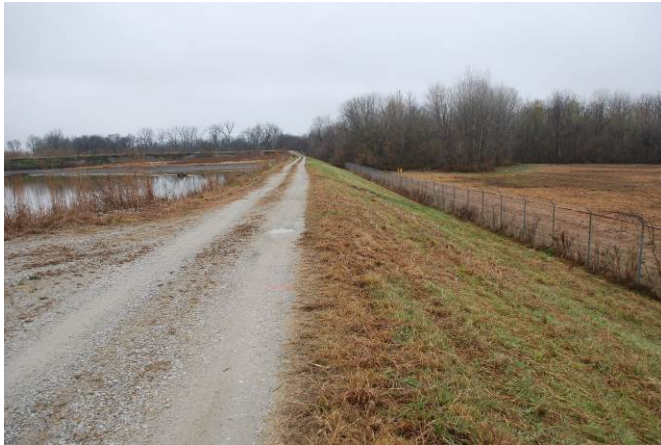
Photo 23: Typical condition of the downstream slope of Pond B, looking south from the Northwest corner of Pond B.

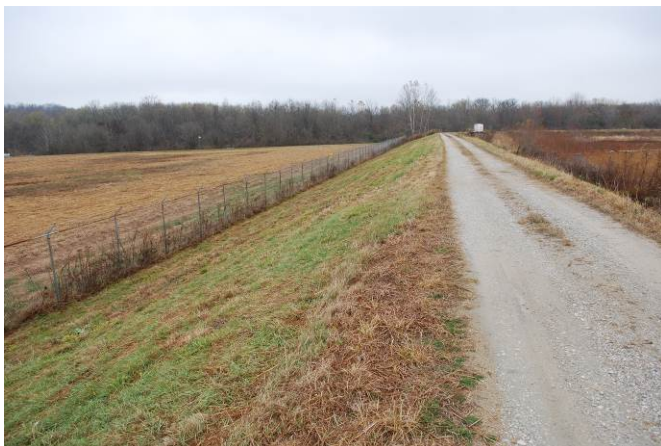
Photo 24: Same, looking north.

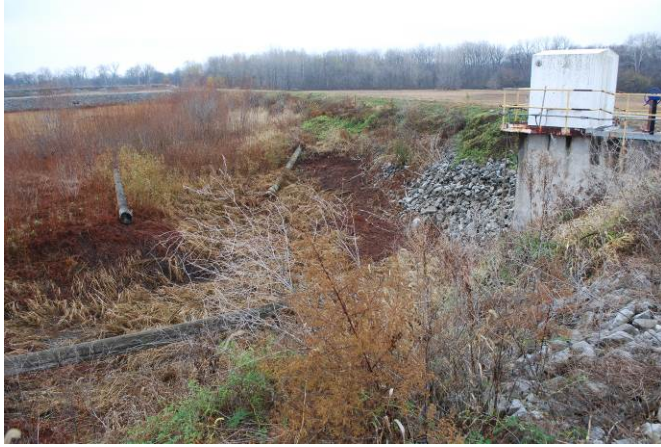
Location: Minor erosion noted on west and north interior slopes of Pond C.

Photo 25: Outlet structure and interior slope of the West perimeter dike of Pond C, looking south from the Northwest corner of Pond C.

Notes: Recommend to place rip-rap in these areas if erosion continues or if the water level in the basin impinges on exterior slope and erosion is observed.
