SCS ENGINEERS

February 17, 2016
File No. 25211357.32

Subject: 2015-2 Dike Inspection-Harding Street Generating Station Ash Pond Facilities

**IPL Harding Street Station – Photos from 15-2 Inspection
3700 South Harding Street-Indianapolis, IN
SCS Engineers Project #25211357.32**

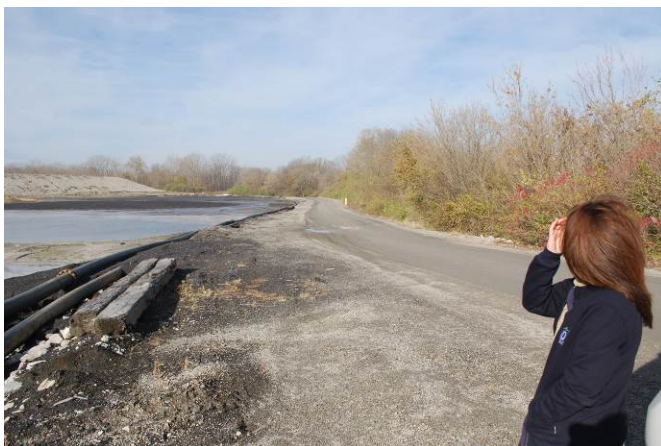
that has been regarded to provide freeboard for Pond 1 appears satisfactory. Continue to monitor.

Notes: **Roadway appeared to be stable at the time of the inspection.**

Photo 3: Crest Road condition on North side of Pond 1.

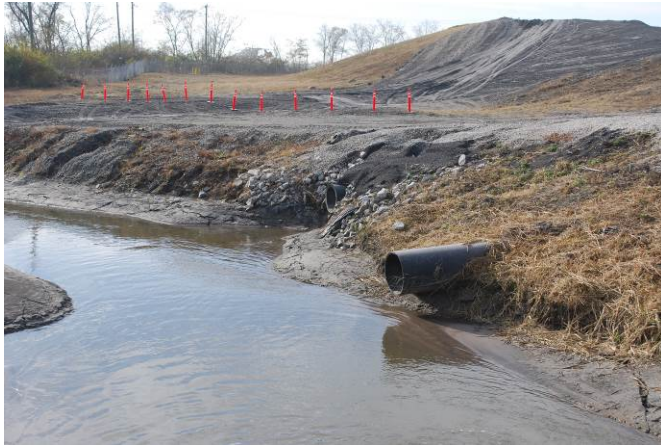
Photo 7: Discharge conditions occurring from Pond 2 into Pond 2A.

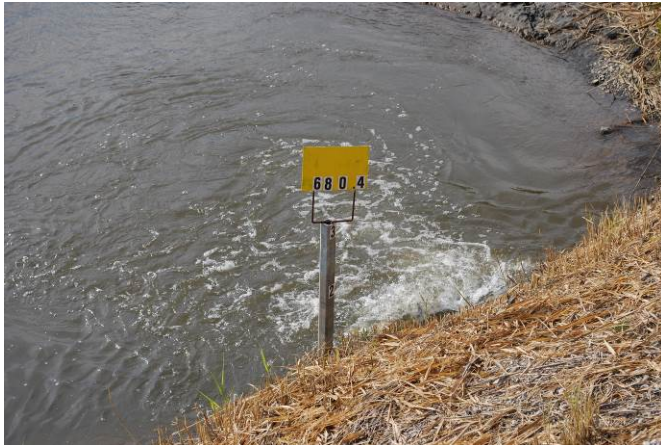
Photo 8: Discharge conditions occurring from Pond 1 into Pond 2A.

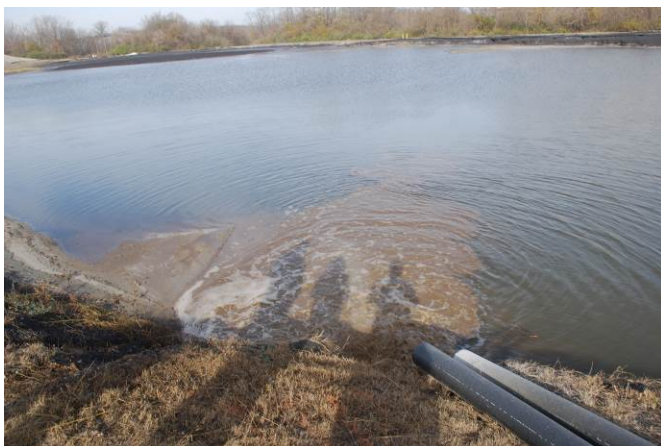
Photo 9: FGD slurry discharge into Pond 1.

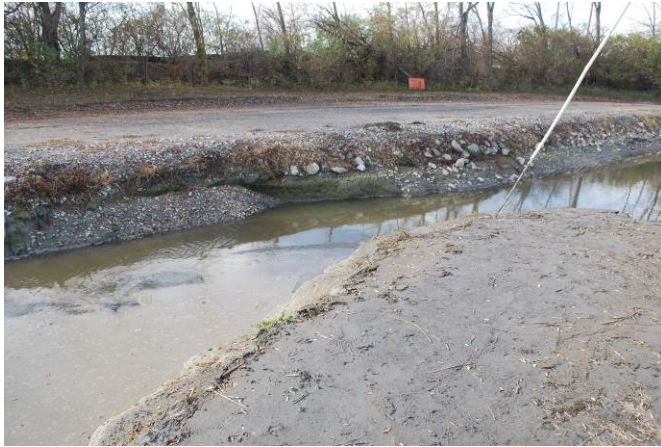
4. There appears to be some erosion of the South perimeter dike of Pond 2A/B where the breach was excavated. This erosion should be repaired by placement of suitably designed rip-rap as soon as practical. An alternate may be to excavate a breach somewhere internal on the dike separating Ponds 2A and 2B and filling the breach created at the westernmost point of this dike.

Photo 10: Breach excavated in the South abutment of the intermediate dike between former Pond 2A and Pond 2B. Some erosion of the interior slope in the abutment.

1. There appears to be some erosion of the south perimeter dike of Ponds 2A/B where the breach was excavated. This erosion should be repaired by placement of suitably designed rip-rap as soon as practical. An alternate may be to excavate a breach somewhere internal on the dike separating Ponds 2A and 2B and filling the breach created at the westernmost point of this dike.

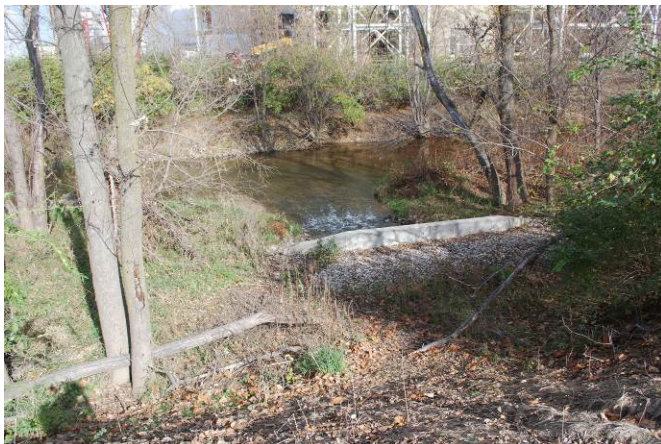
1. The downstream slope of Pond 3 appeared stable at the time of the inspection.
2. The recommended repair of the discharge pipe from Pond 3 into Lick Creek contained in the 12-1 Inspection Report continued to appear to be in satisfactory condition.

Photo 21: Outfall of Pond 3 to Lick Creek.

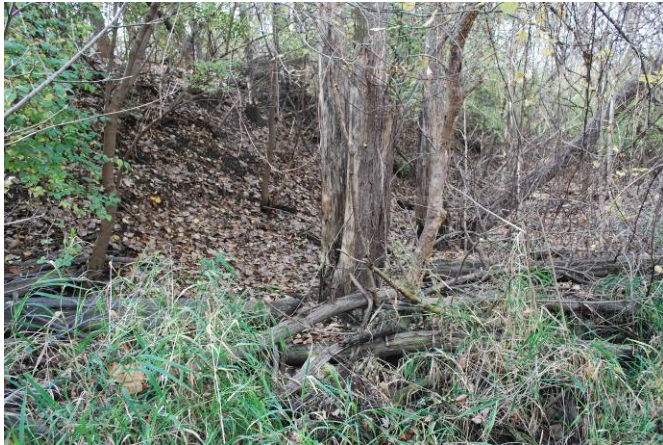
5. It was possible to observe seepage conditions on the downstream slope of the Northern perimeter dike of Pond 3. There were no observations of seepage or instability of the area during this inspection.

Notes/Causes: **Area of downstream slope of Pond 3 was inspected. No**

seepage observed. Continue to monitor this area for seepage.

Photo 22: Conditions of the exterior slope of the North perimeter dike of Pond 3, looking west from the outfall structure. No seepage observed.
