**2018 VISUAL INSPECTION OF ASH POND EMBANKMENTS  
IPL PETERSBURG ASH POND SYSTEM**

IPL PETERSBURG GENERATING STATION  
6925 NORTH STATE ROAD 57  
PETERSBURG, INDIANA 47567

ATC PROJECT NO. 170LF00626

JANUARY 16, 2019

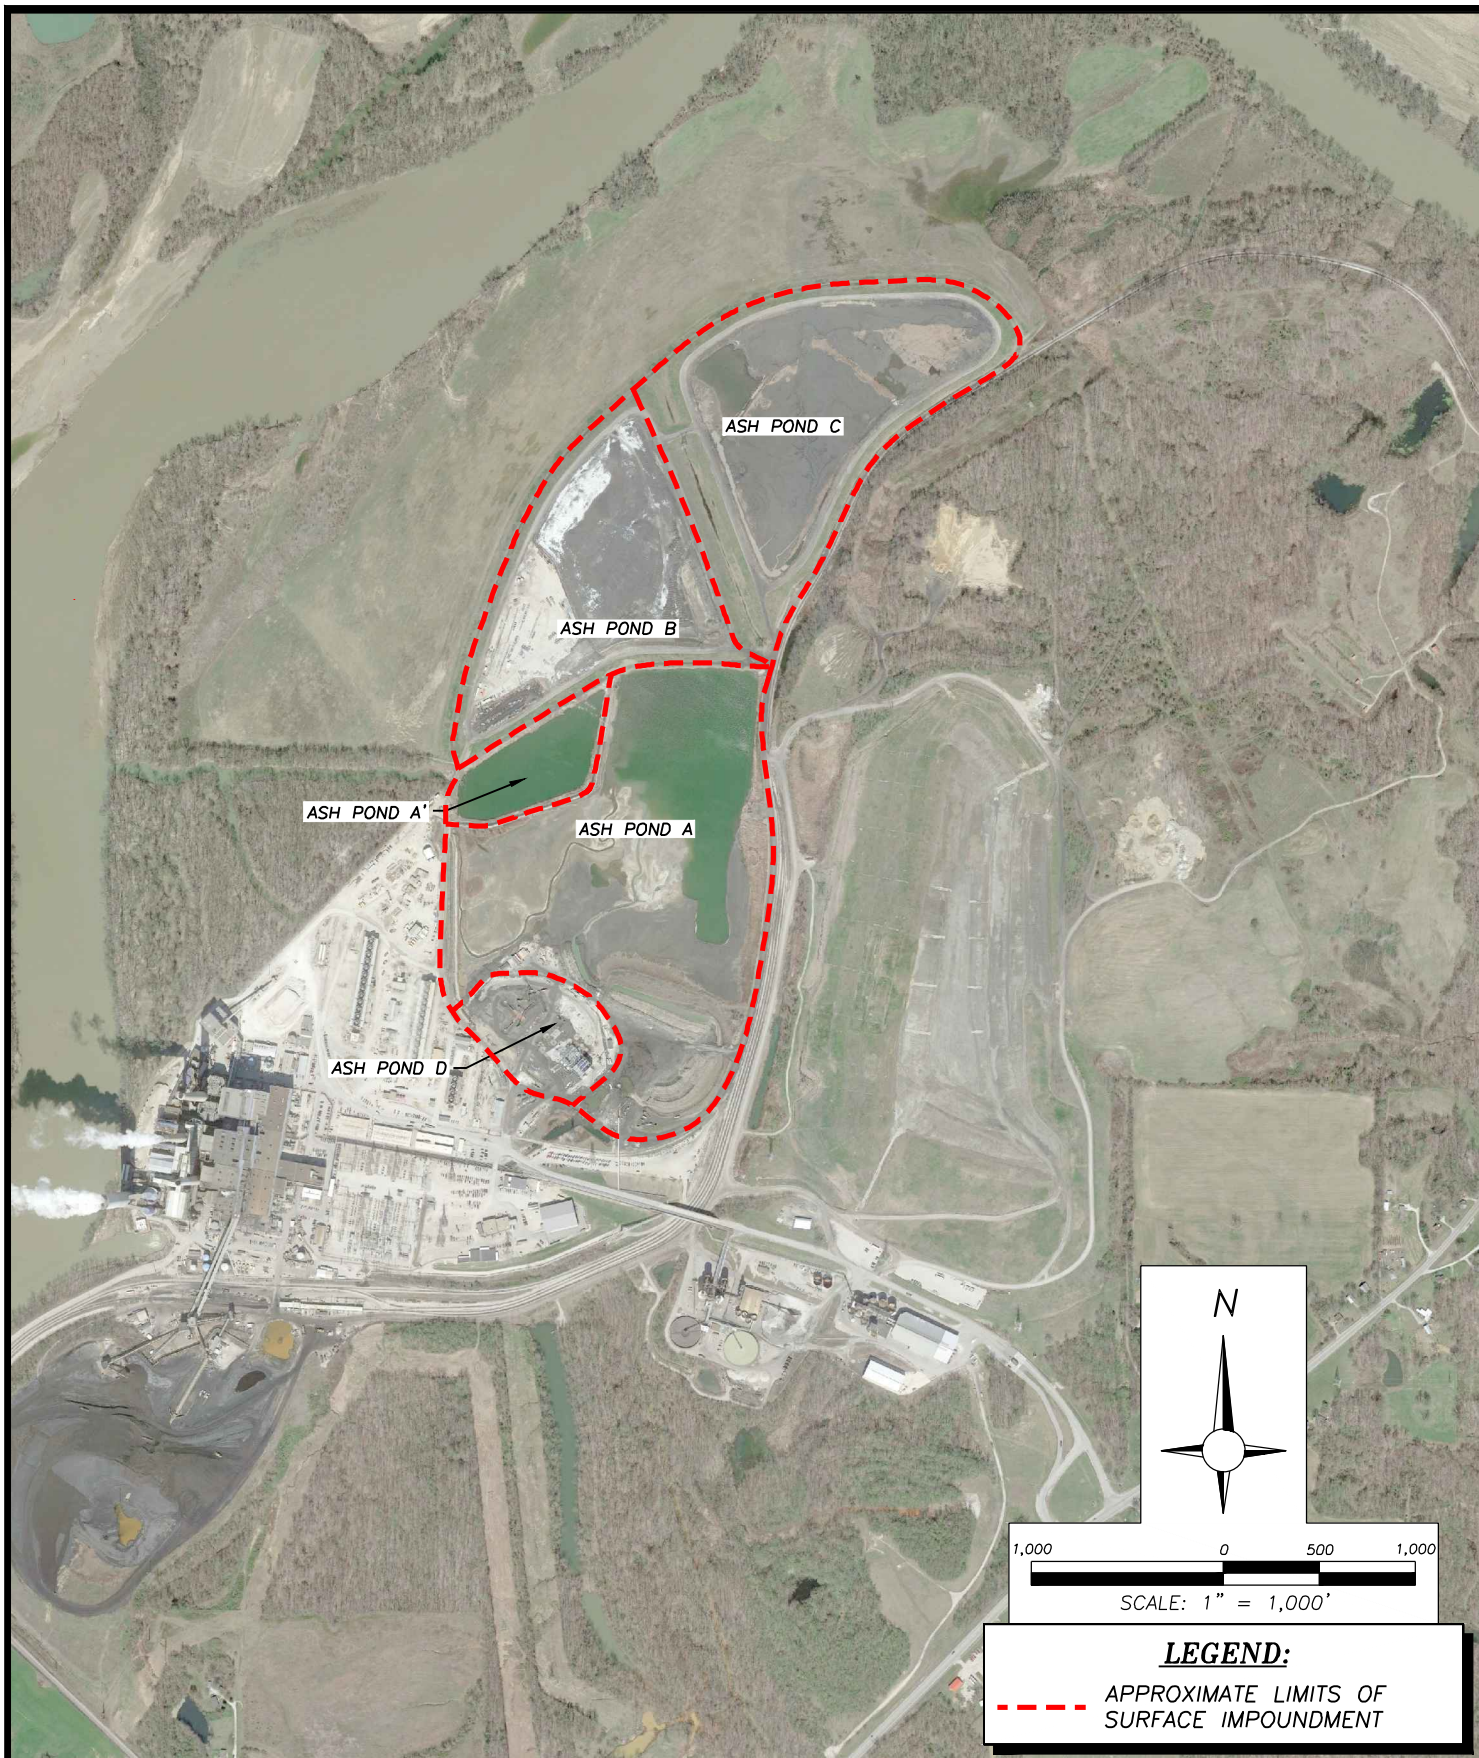
## CCR ASH POND SYSTEM CCR ASH POND EMBANKMENT ANNUAL INSPECTION REPORT

A layout of the ash pond system for the IPL Petersburg station is presented in Figure 2. Ash Ponds A and A' are the only ponds with water in them, the area occupied by Ash Pond D has been repurposed with the construction of a wastewater treatment plant, and Ash Ponds B and C are in the closure process as in-place closure.

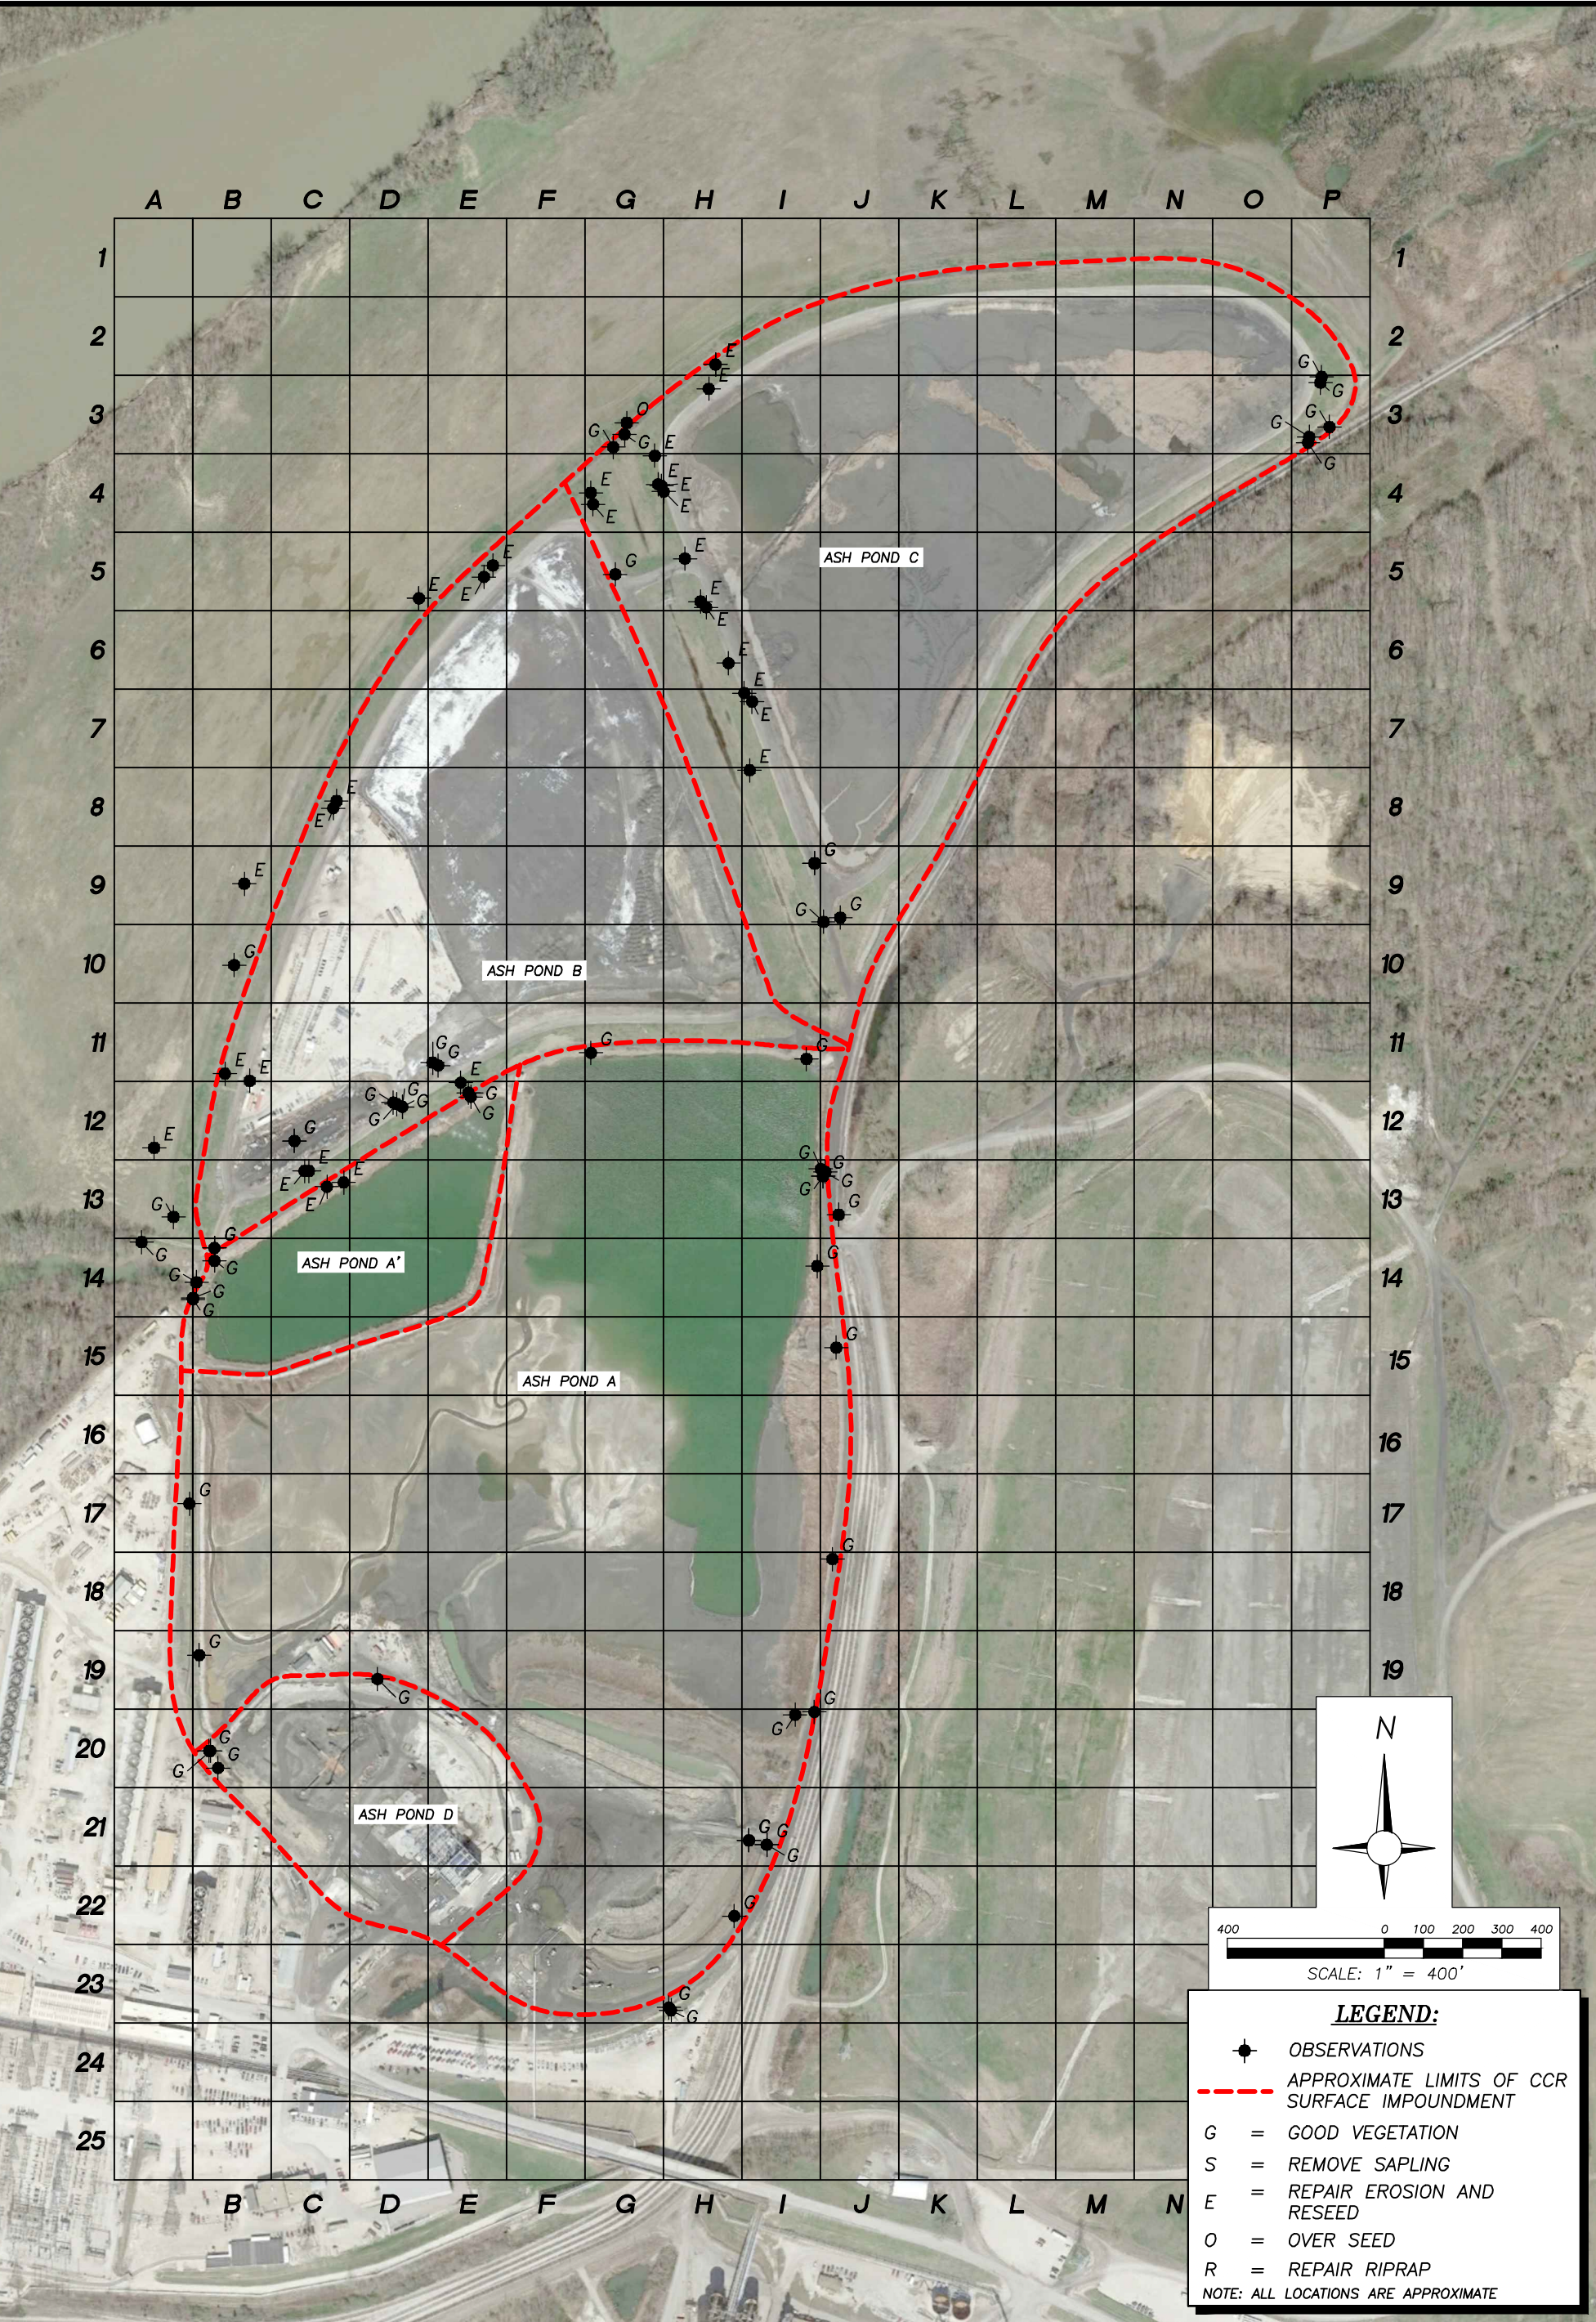
Engineering observations performed on December 6, 2018 are shown in Figure 3, 2018 Visual Site Inspection Grid Map. ATC visually inspected the embankments for Ash Ponds A, A', B, C, and D, and found no areas of instability or of concerns to the proper functioning of the ash basin system.

1. Good vegetation exists along the majority of the west and north slopes of the partial closure area as shown in Figure 3, grid locations H23, H22, I21, I20, I18, I15, J14, J13, J12, I11, G11, E11, E12, A13, B13, A14, B14, A17, B19, B20, L23, L22, K19, M15, and M14.

1. Good vegetation exists along the majority of the basin, including the top of basin, and side slopes as shown in Figure 3, grid locations B14, A13, B10, C12, D12, E11, and G5.
2. At the side slopes along the western, south-eastern, and north there were erosion rills and gullies observed at certain locations as shown in grid A12, E12, C8, C13, B11, B9, D5, and E5.
  - Recommendation: Repair the soil cover and install erosion control mats in areas affected by erosion rills and gullies. Overseed these areas to establish a protective grass cover.

1. Good vegetation exists along the side slopes of the basin as shown in Figure 3, grid locations I9, J9, P2, P3, G4, and G3.
2. At the side slopes along the western, and north there were erosion rills and gullies observed at certain locations as shown in grid G3, G4, G5, I7, I8, H4, H5, H6, H3, and H2.
  - Recommendation: Repair the soil cover and install erosion control mats in areas affected by erosion rills and gullies. Overseed these areas to establish a protective grass cover.
