**2018 VISUAL SITE INSPECTION
IPL PETERSBURG RESTRICTED WASTE TYPE III LANDFILL
SOLID WASTE FACILITY PERMIT NO. FP63-02**

IPL PETERSBURG GENERATING STATION
6925 NORTH STATE ROAD 57
PETERSBURG, INDIANA 47567

ATC PROJECT NO. 170LF00626

JANUARY 16, 2019

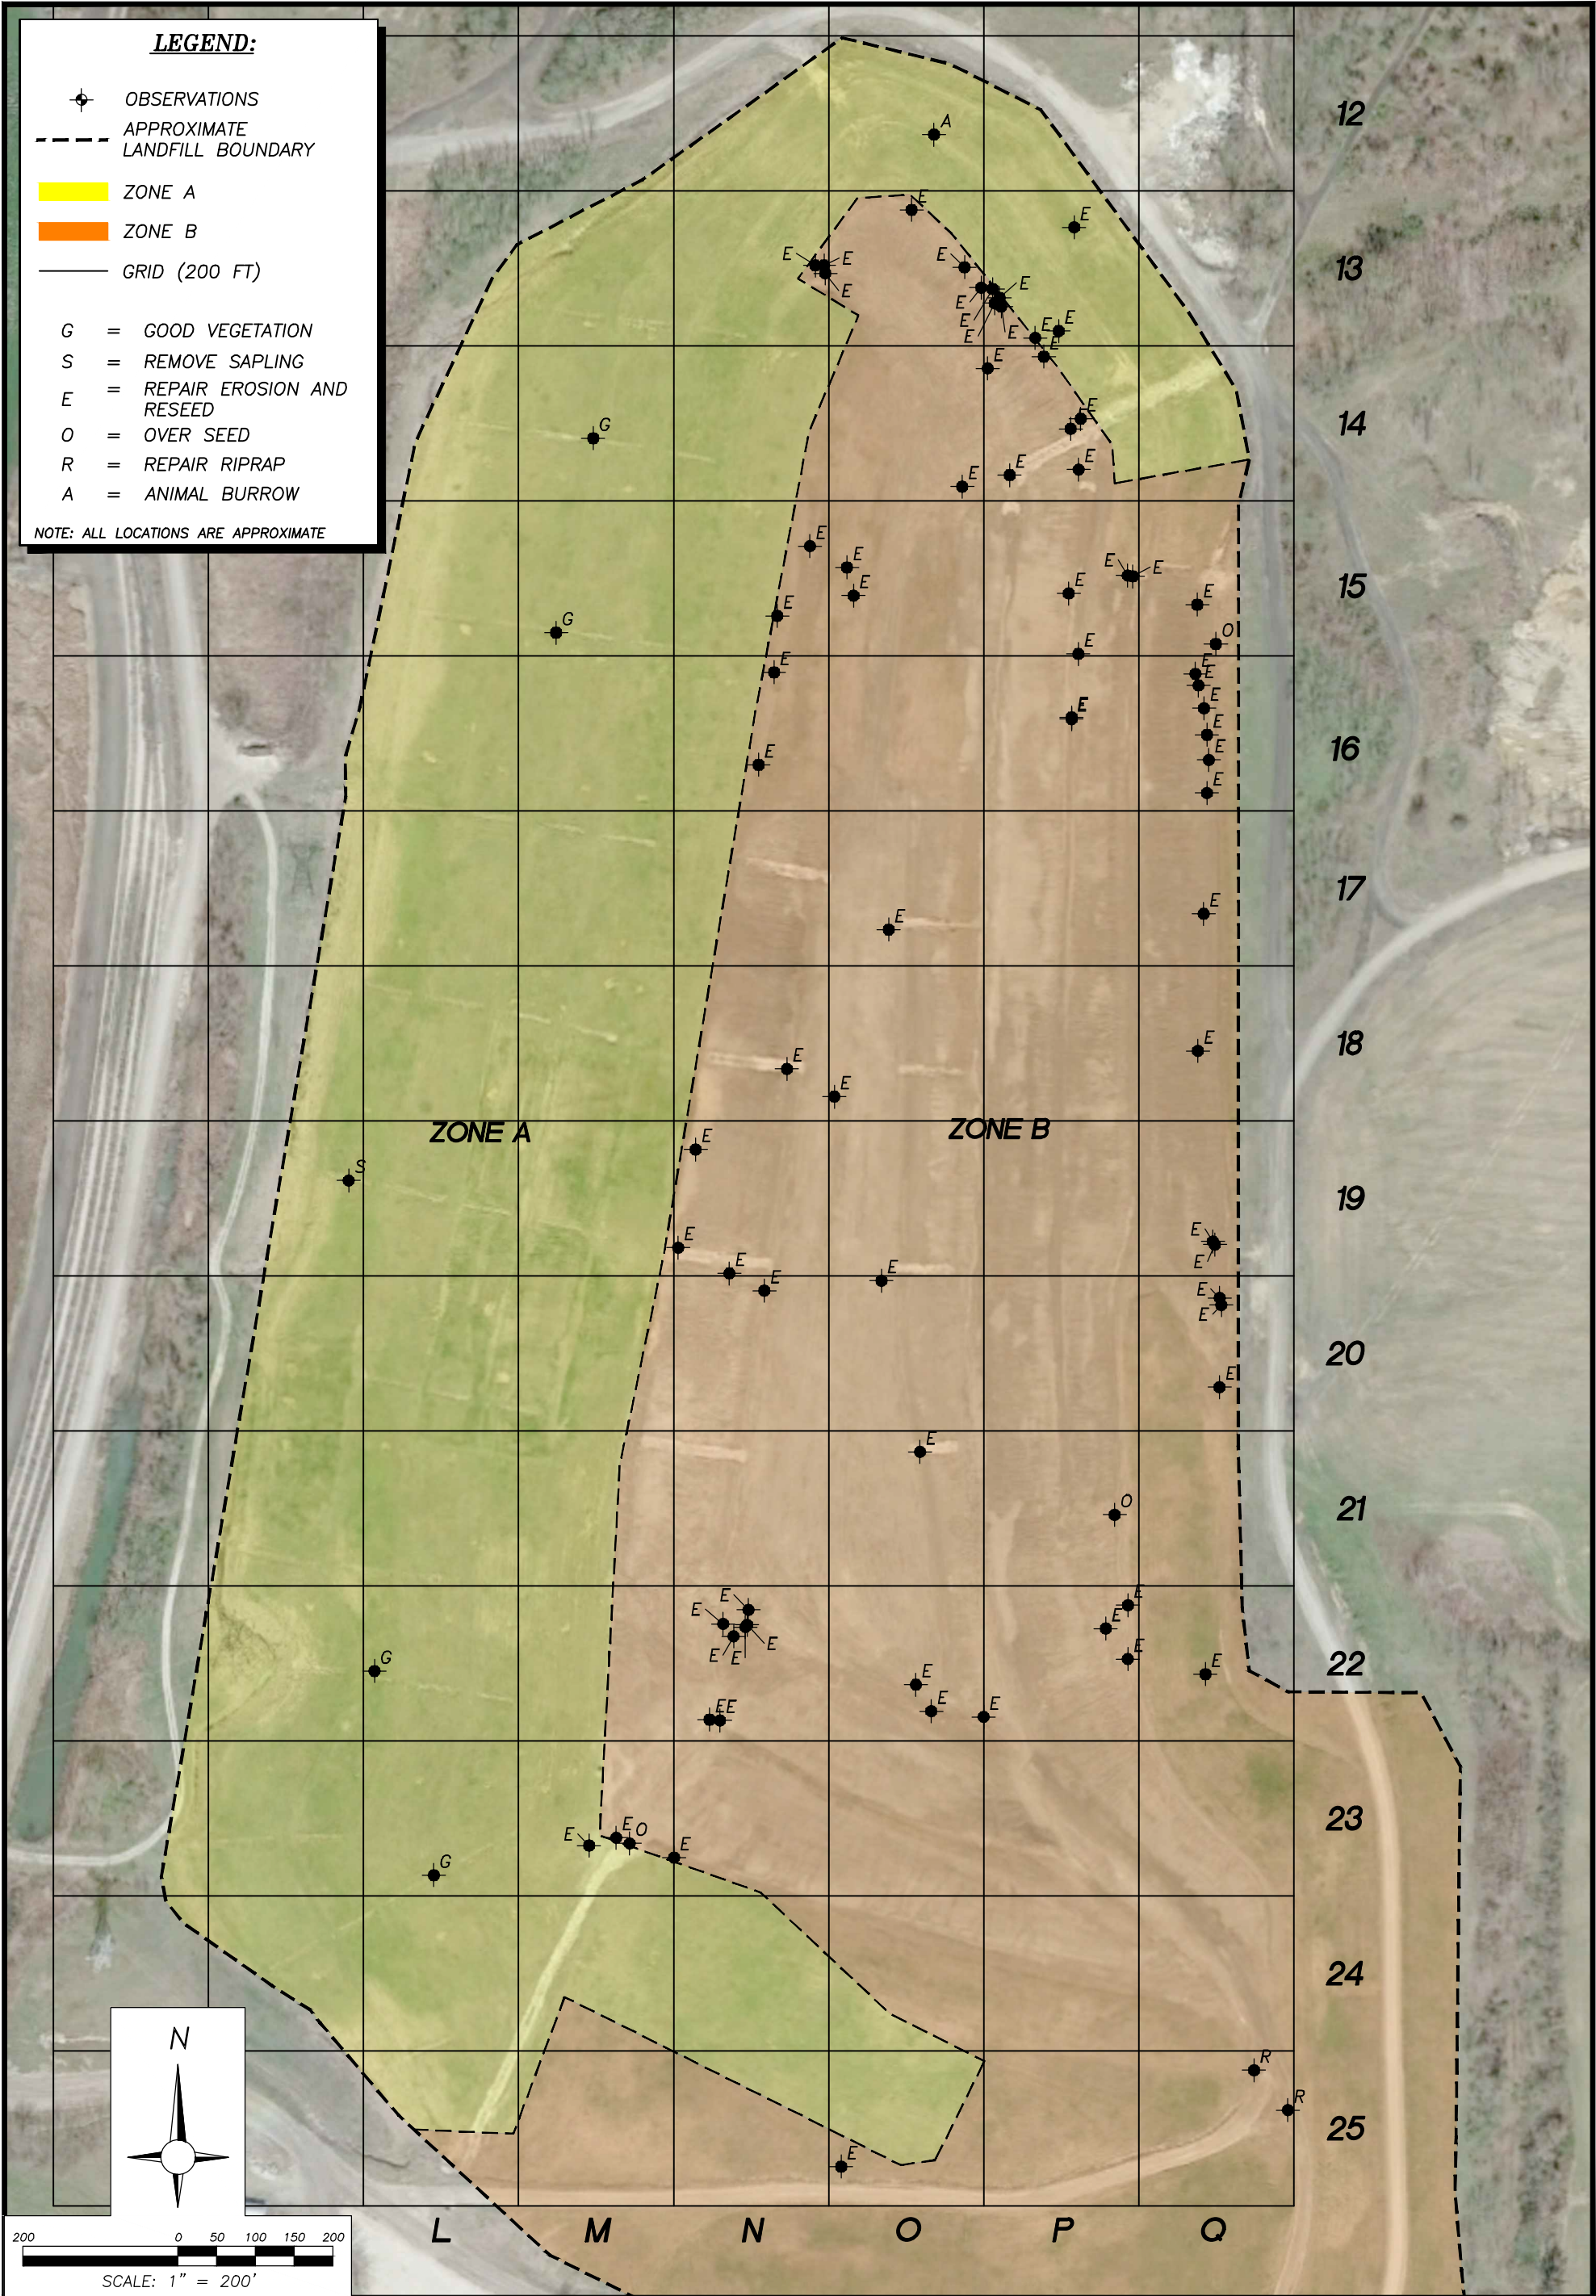
| Figure: 3 | AS SHOWN | Date: 12/18 | 2018 VISUAL SITE INSPECTION GRID MAP IPL PETERSBURG RESTRICTED WASTE TYPE III LANDFILL INDIANAPOLIS POWER AND LIGHT COMPANY 6925 NORTH STATE ROAD 57 PETERSBURG, INDIANA | Project Number: | Drn. By: |

Observed geometry changes during the 2018 Petersburg visual landfill inspection consisted mainly of small grading measures and vegetation improvements. Engineering observations were grouped into two inspection zones shown in Figure 3, 2018 Visual Site Inspection Grid Map.

1. Good vegetation exists along the majority of the west and north slopes of the partial closure area as shown in Figure 3, grid locations L23, L22, K19, M15, and M14.
2. A sapling has grown at the base of one of the riprap down chute channels along the west slope of the landfill, see grid location K19.
 - Recommendation: Remove the sapling to prevent root undermining of the soil cover. Continue an ongoing maintenance program to remove trees and shrubs from the cover system.

3. The northeast corner of the landfill, at the base of a riprap down chute channel, a washout erosion area has formed, see grid location Q13.
 - Recommendation: Install erosion control protection for this area such as erosion control mat to protect the integrity of the soil liner. Overseed the bare soil cover area.
4. At the southwest corner of the landfill, erosion has occurred along the face of the slope, exposing underlying poz-o-tec material, see grid location M23.
 - Recommendation: Repair the soil cover and regrade areas of the slope where erosion has occurred. Install erosion control mat in exposed areas and overseed areas of sparse vegetation once soil cover has been repaired.

2. Exposed and bare spot areas were observed on soil cover section next to the haul road, see grid location Q25.
 - Recommendation: Repair the soil cover in exposed bare area and regrade it to improve drainage flow to haul road swale.

3. Downcutting has occurred along the ditch adjacent to the haul road along the south side of the landfill, see grid locations O25, and Q25.
 - Recommendation: Repair the soil cover in the affected areas and install erosion control mat and where downcutting has occurred in the channel. Install erosion control mat and additional riprap armouring with non-woven geotextile on exposed reaches of the channel.

4. At the top of landfill erosion rills and gullies were observed at certain locations as shown in grid N23, M23, N22, O22, O21, N20, O20, N19, N18, O18, O17, N16, N15, O15, and O14.

5. Along the eastern and northern side slope of the landfill, erosion rills and gullies were observed at locations as shown in grid P22, Q22, P21, Q20, Q19, Q18, Q17, P16, Q16, P15, Q15, P14, P13, O13 and N13.
 - Recommendation: Repair the soil cover and install erosion control mats in areas affected by erosion rills and erosion cavities. Overseed these areas to establish a protective grass cover.
6. Along the eastern and northern side slopes of the landfill there are areas of minor sparse vegetation cover as show in grid locations O13, P13, and Q15.
 - Recommendation: Overseed these areas to establish a fuller grass cover.

- Recommendation: Repair the soil cover and install erosion control mats in areas affected by erosion rills and gullies. Overseed these areas to establish a protective grass cover.
