**2019 VISUAL INSPECTION OF ASH POND EMBANKMENTS
IPL PETERSBURG ASH POND SYSTEM**

IPL PETERSBURG GENERATING STATION
6925 NORTH STATE ROAD 57
PETERSBURG, INDIANA 47567

ATC PROJECT NO. 170LF00780

DECEMBER 11, 2019

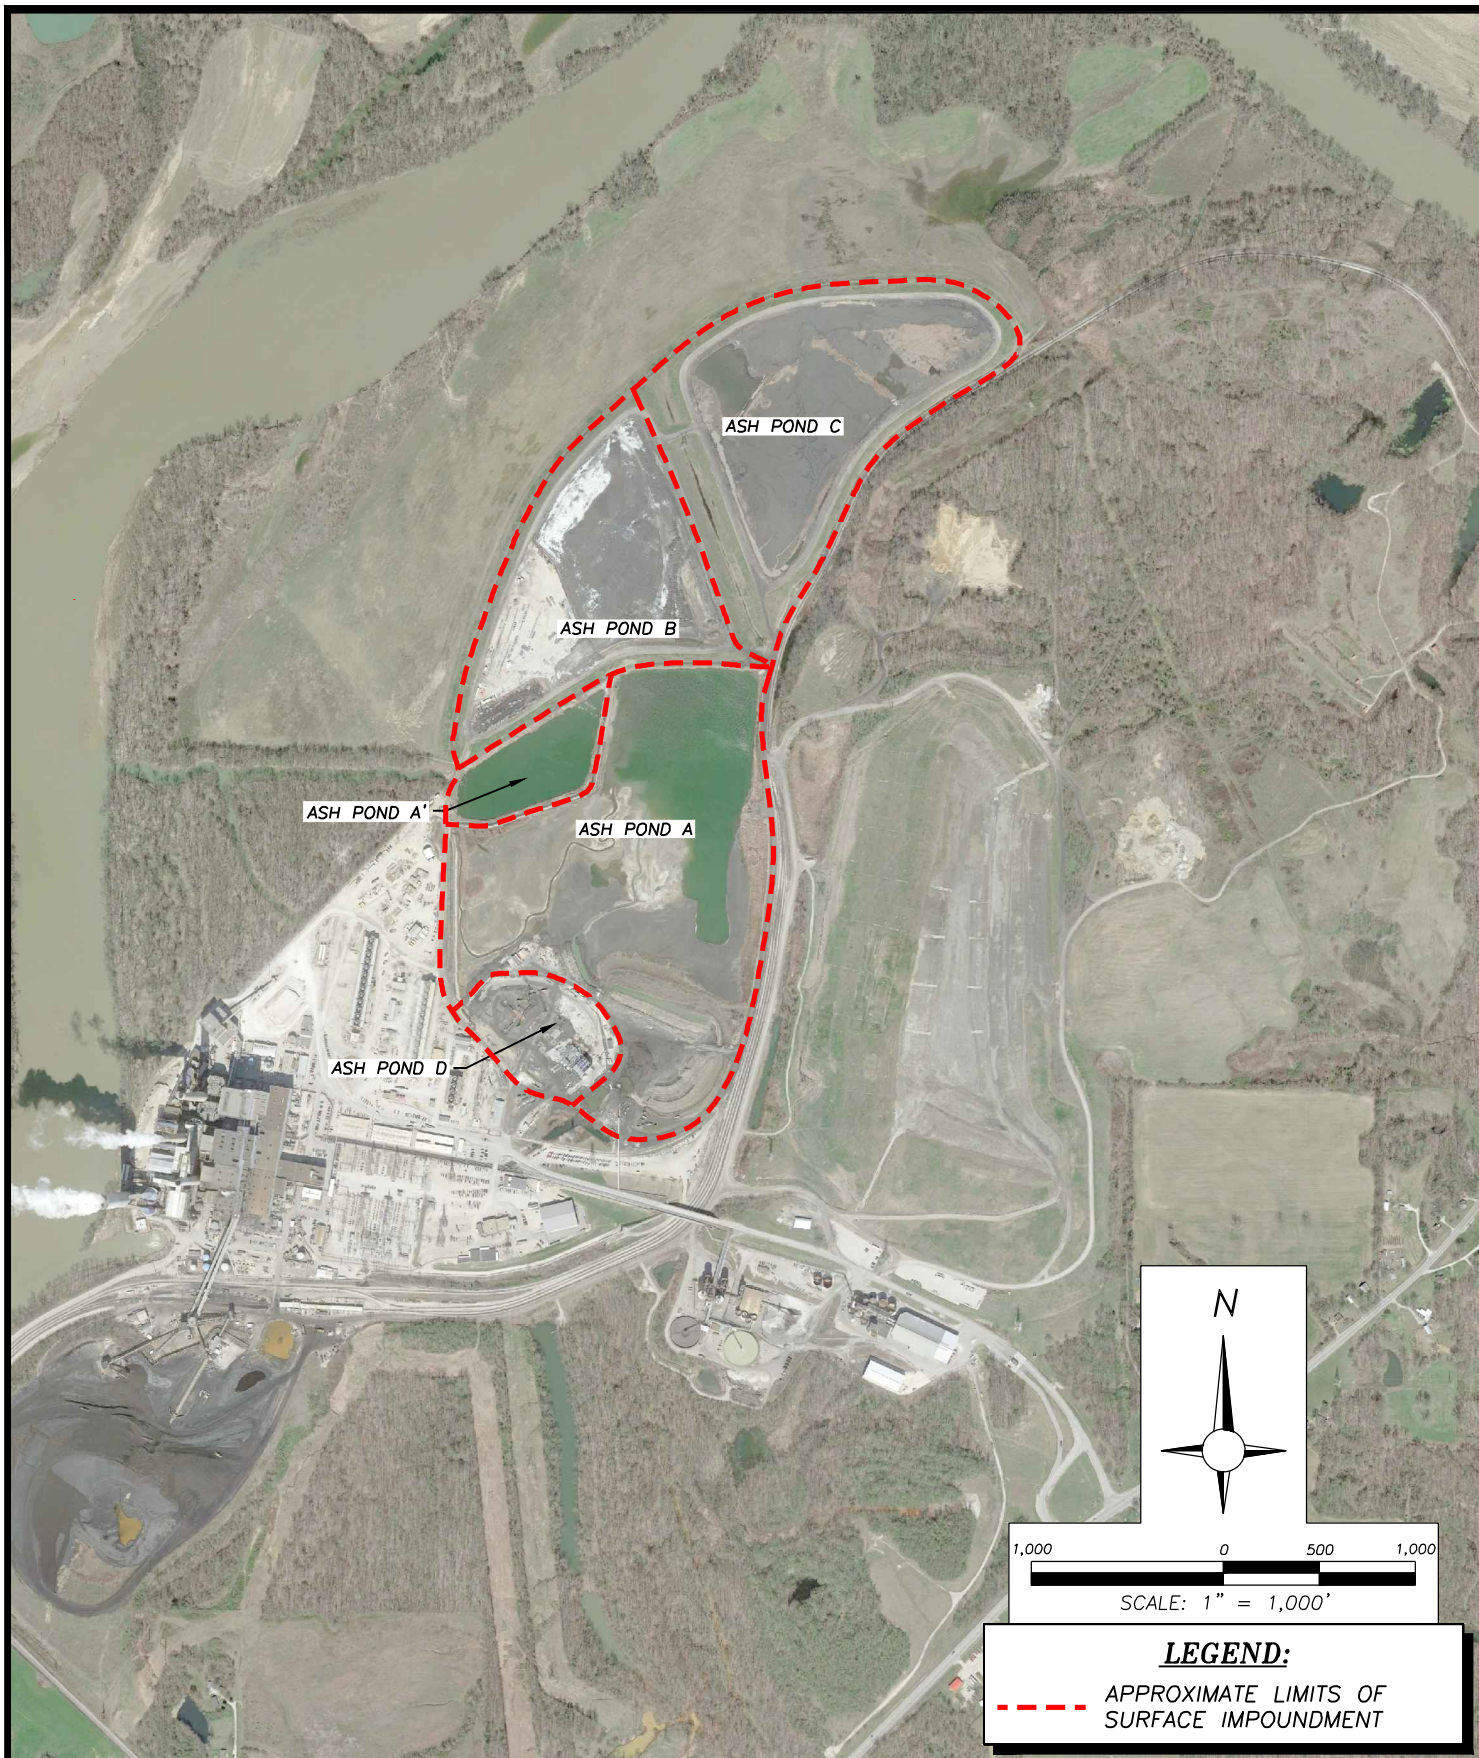
CCR ASH POND SYSTEM CCR ASH POND EMBANKMENT ANNUAL INSPECTION REPORT

Engineering observations performed on November 6, 2019 are shown in Figure 3, 2019 Visual Site Inspection Grid Map. ATC visually inspected the embankments for Ash Ponds A, A', C, and D, and found no areas of instability or of concerns to the proper functioning of the ash basin system.

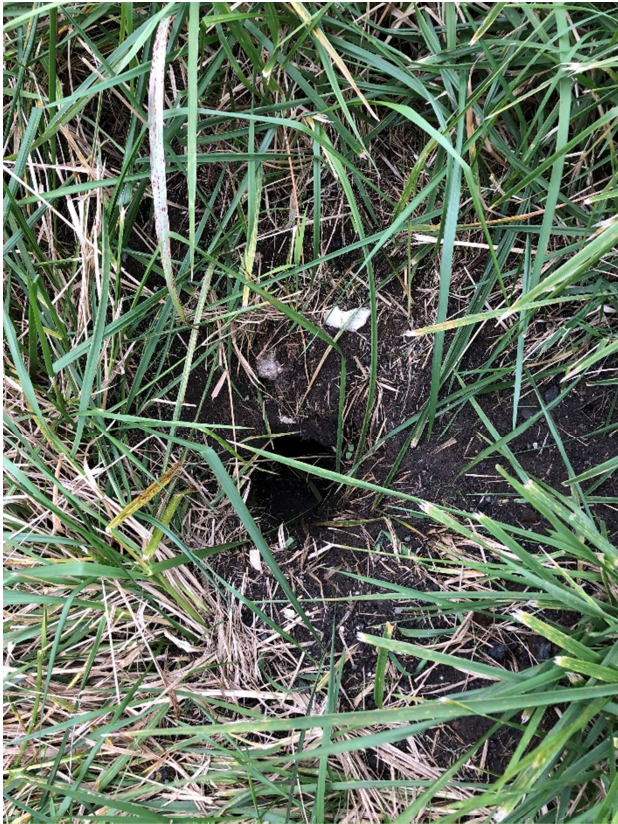
Point ID L-1	Photo ID IMG_8426

Date November 6, 2019		
Description: Animal burrow, north slope of Ash Pond C, photo looking south.

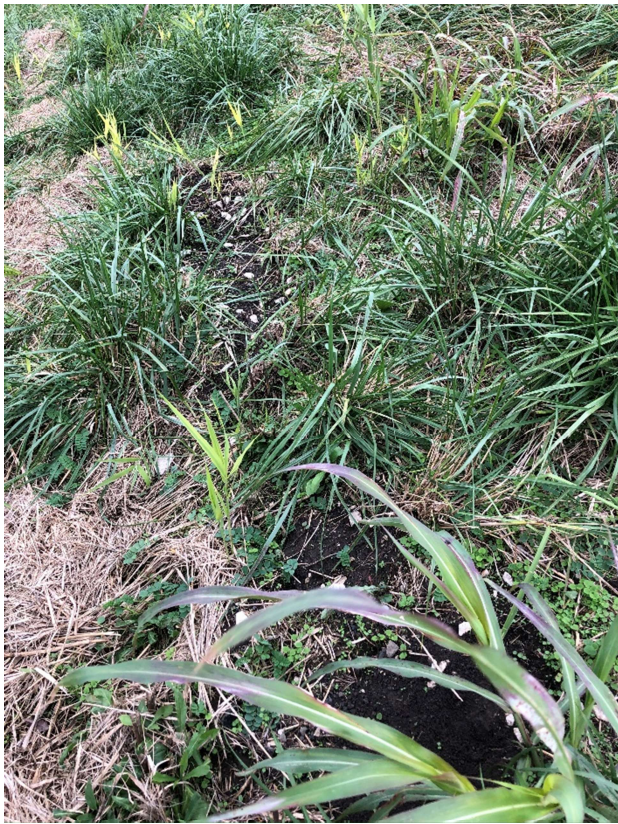
Point ID K-1	Photo ID IMG_8427

Date November 6, 2019		
Description: Spots with sparse vegetation, north slope of Ash Pond C, photo looking south.

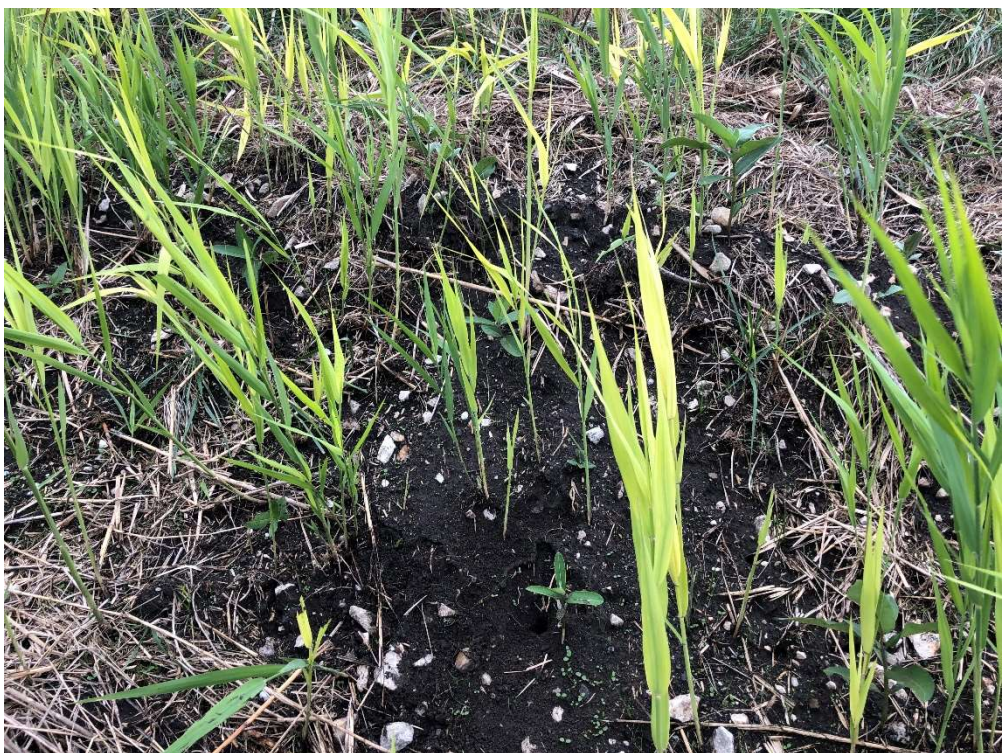
Point ID K-1	Photo ID IMG_8431

Date November 6, 2019		
Description: Spots with sparse vegetation, north slope of Ash Pond C, photo looking south.

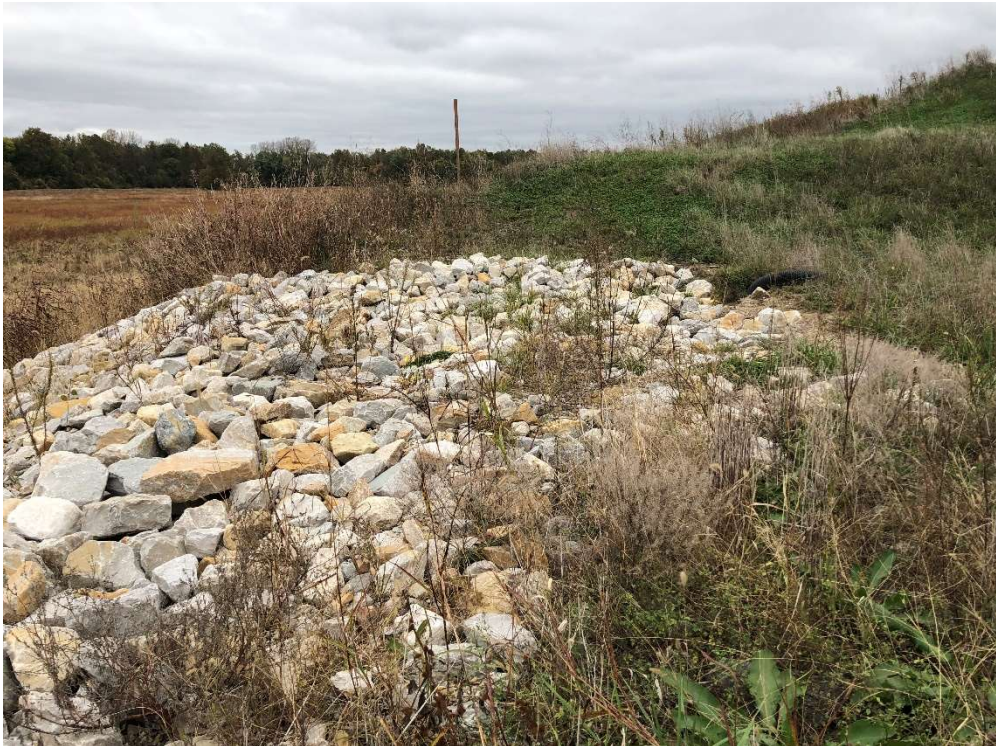
Point ID G-4	Photo ID IMG_8438

Date November 6, 2019		
Description: View of riprap channel at north end of power line corridor, in good condition, photo looking north.

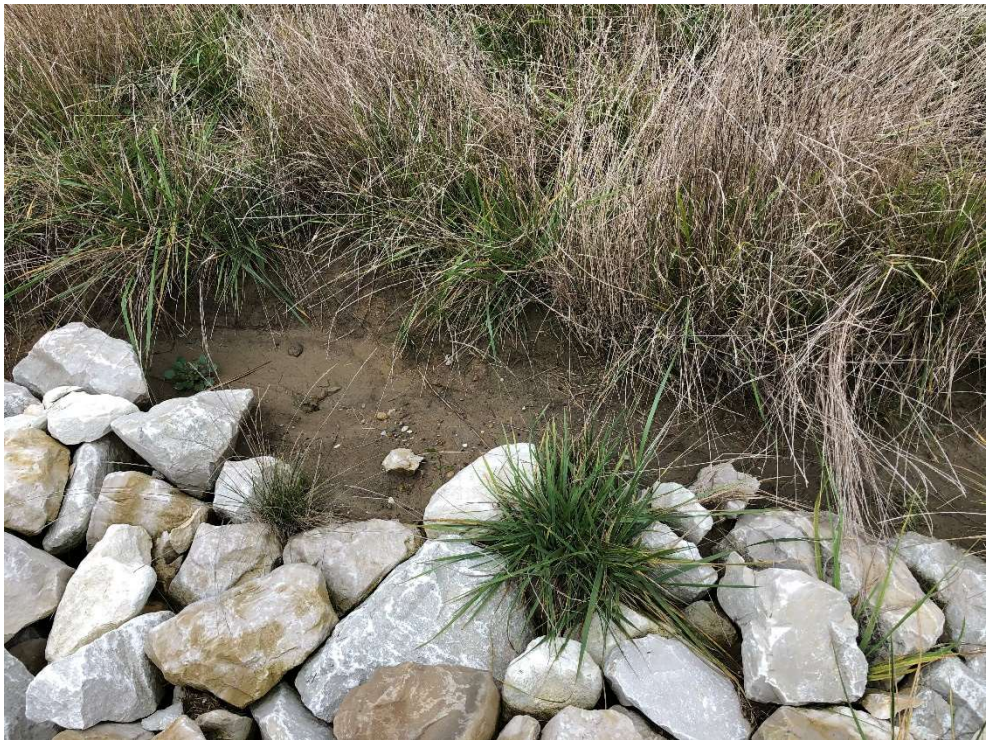
Point ID G-4	Photo ID IMG_8439

Date November 6, 2019		
Description: Erosion occurring adjacent to north end of riprap channel along at power line corridor, photo looking north.

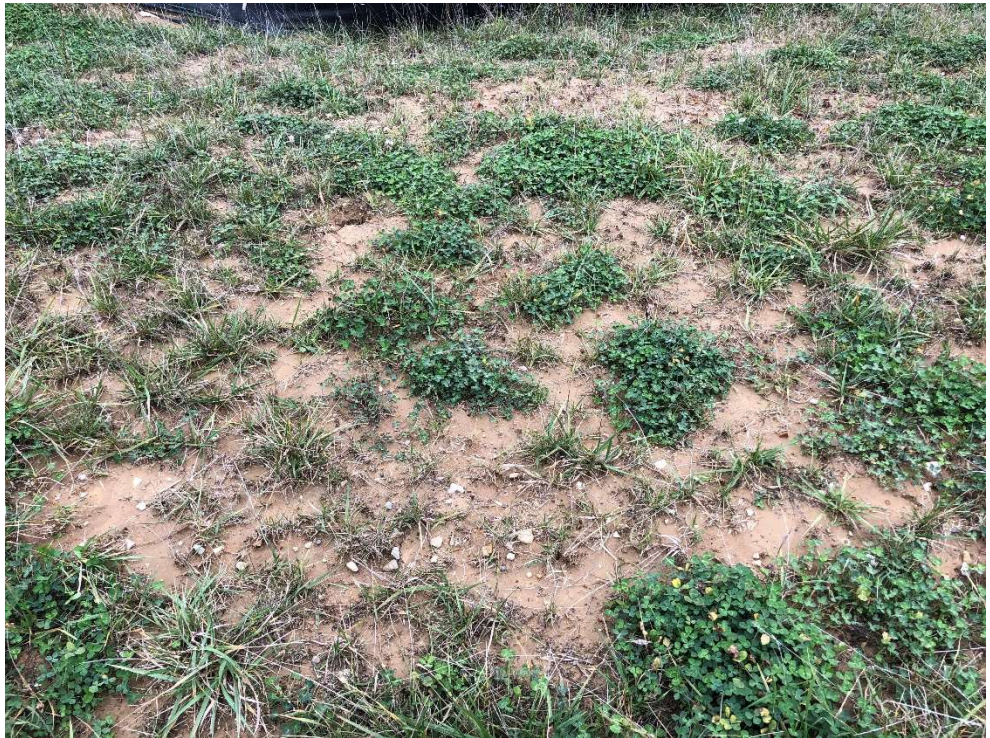
Point ID G-4	Photo ID IMG_8443

Date November 6, 2019		
Description: Sparse vegetation at north side of drainage swale along power line corridor between Ash Pond B and C, photo looking north.

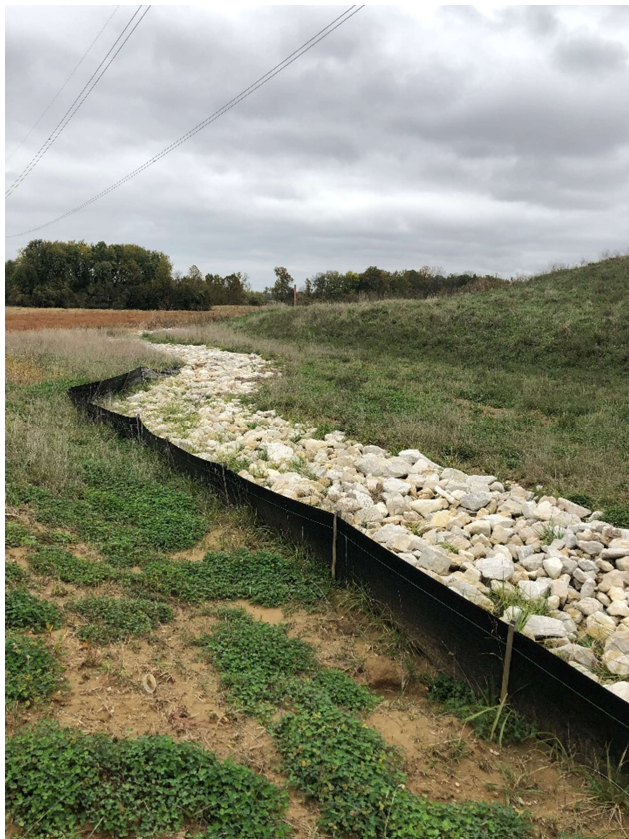
Point ID G-4	Photo ID IMG_8447

Date November 6, 2019		
Description: Sparse vegetation along riprap channel within power line corridor, north side-slope of Ash Pond B, photo looking northwest.

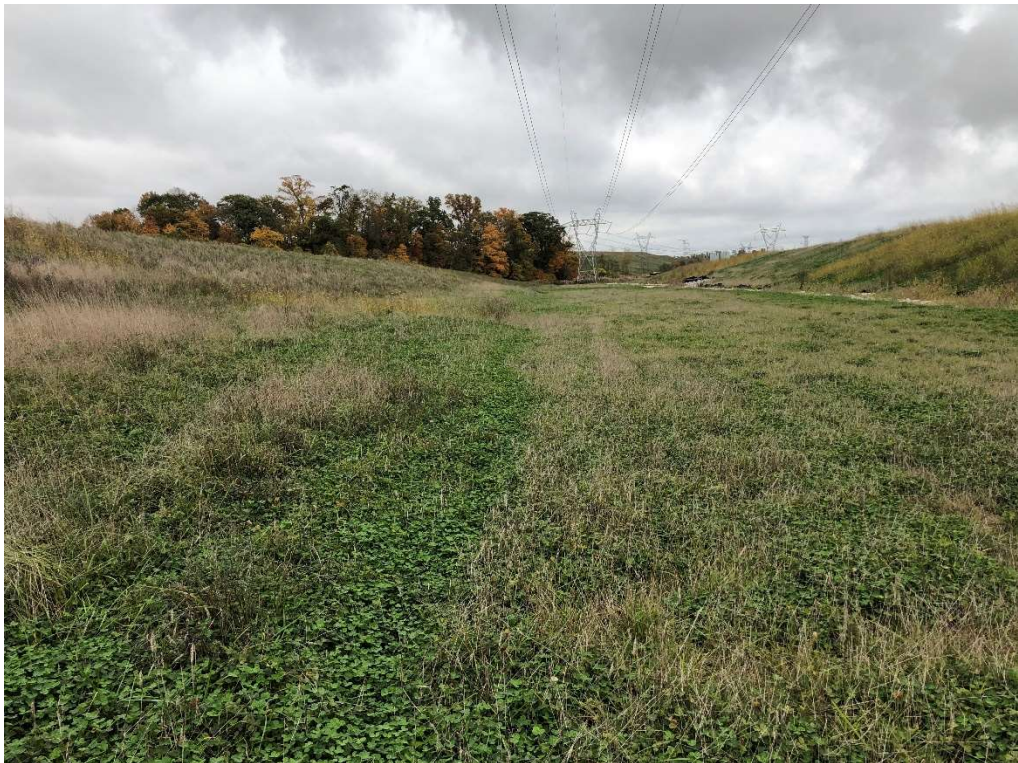
Point ID H-7	Photo ID IMG_8450

Date November 6, 2019		
Description: Well established vegetation along power line corridor between Ash Pond B and C, photo looking north.

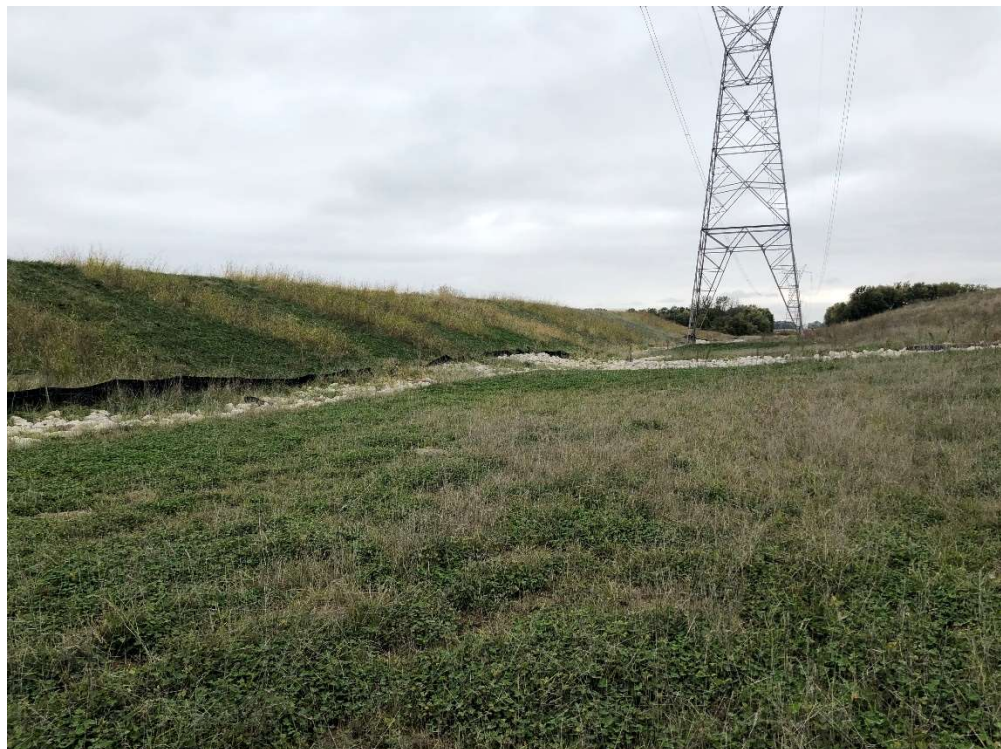
Point ID H-7	Photo ID IMG_8453

Date November 6, 2019		
Description: Well established vegetation on northern side slope of Ash Pond B along drainage swale at power line corridor, photo looking northwest.

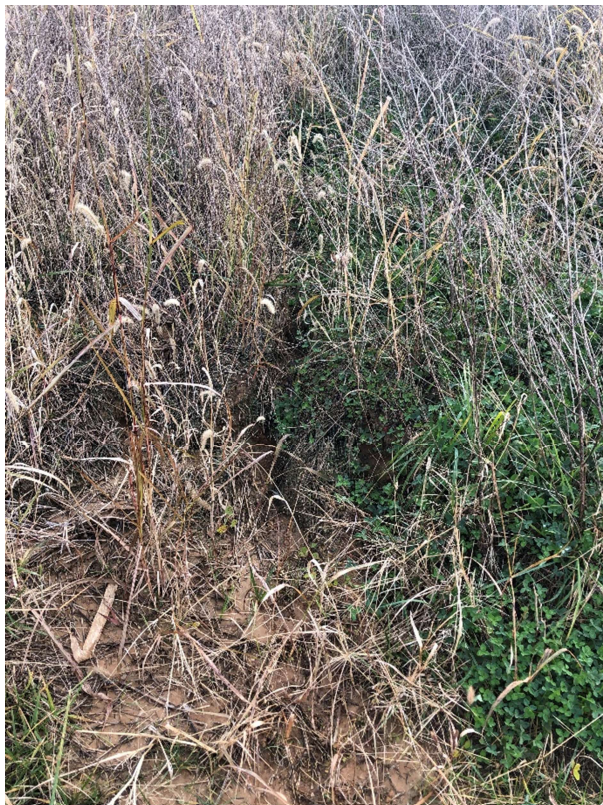
Point ID P3	Photo ID IMG_8556

Date November 6, 2019		
Description: Erosion gullies formed at side slope of western section of Ash Pond B, photo looking west.

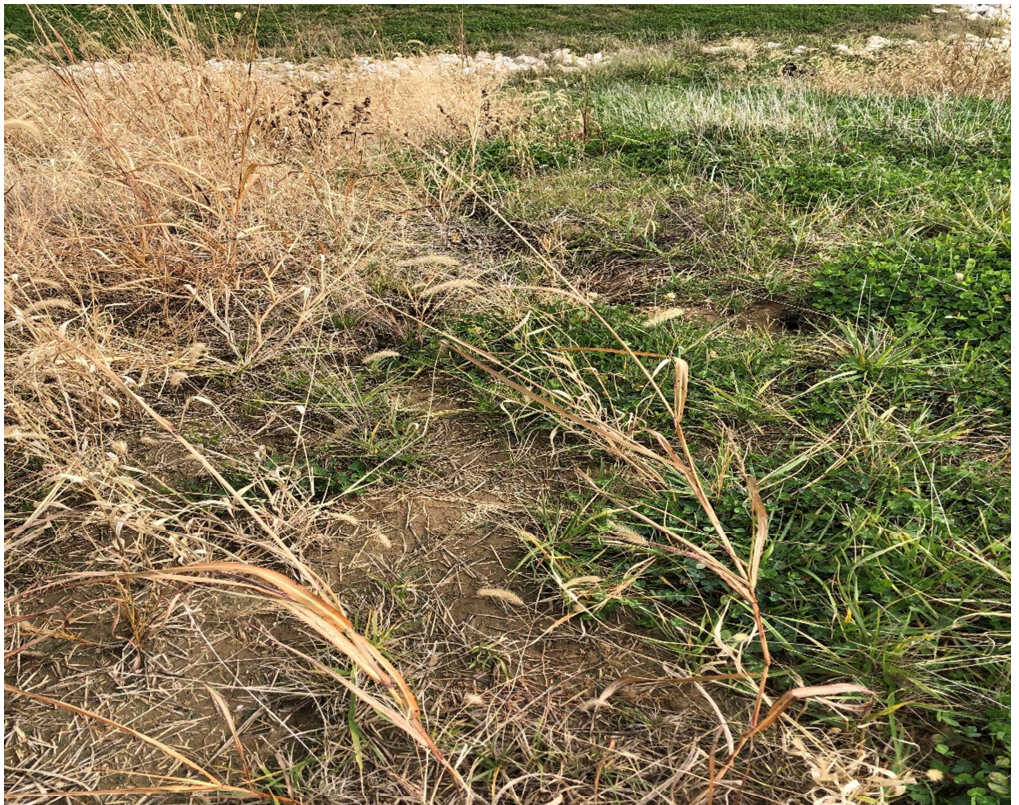
Point ID G-6	Photo ID IMG_8611

Date November 6, 2019		
Description: Erosion rills formed along eastern slope of Ash Pond B, photo looking northeast.		
Point ID G-6	Photo ID IMG_8612	 
Date November 6, 2019		
Description: Erosion rills formed along eastern slope of Ash Pond B, photo looking northeast.

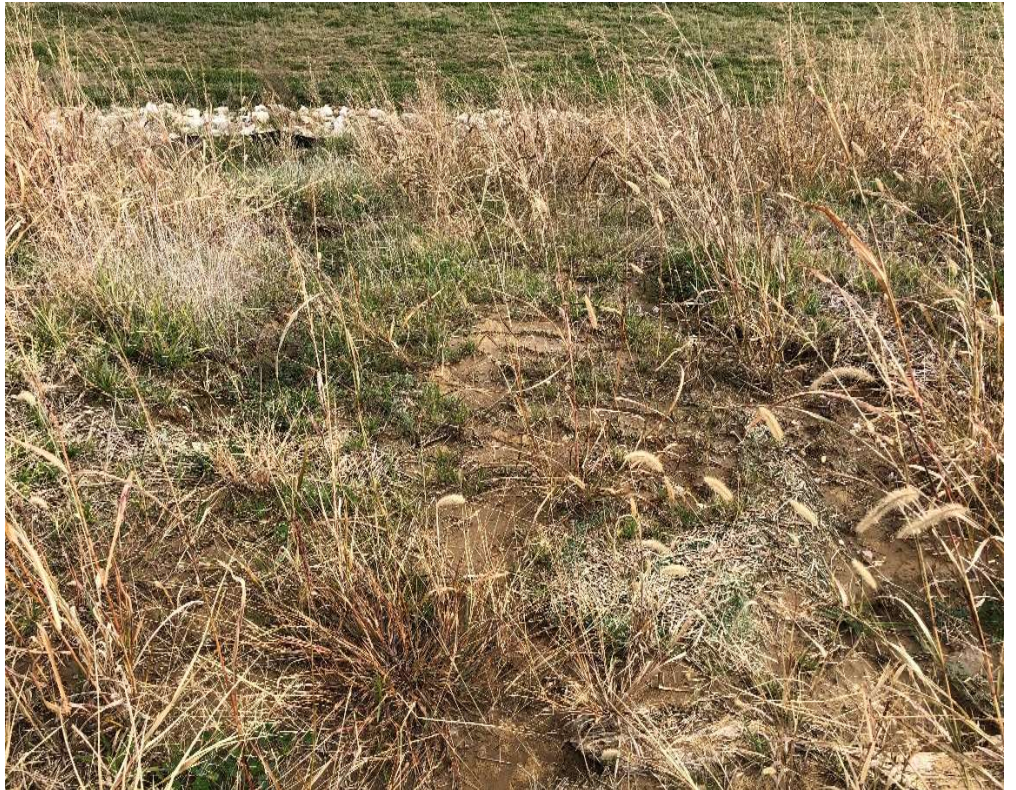
Point ID H-7	Photo ID IMG_8615

Date November 6, 2019		
Description: Erosion rills formed along eastern slope of Ash Pond B, photo looking northeast.

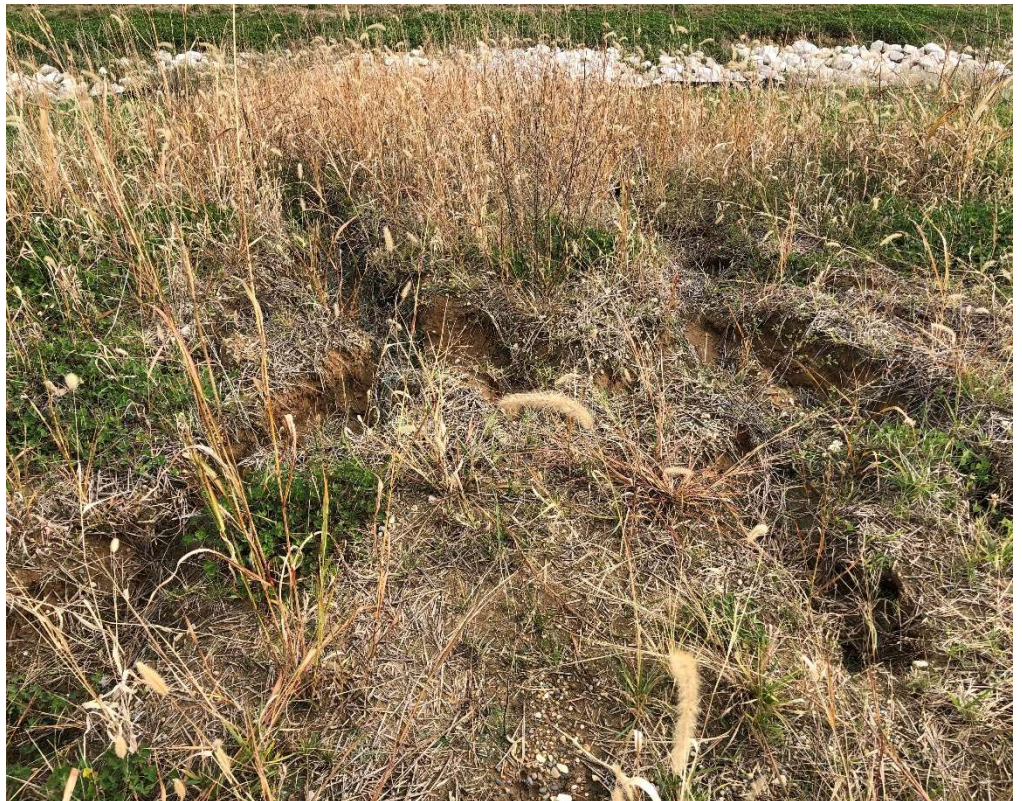
Point ID H-8	Photo ID IMG_8617

Date November 6, 2019		
Description: Erosion gully formed along eastern slope of Ash Pond B, photo looking south.

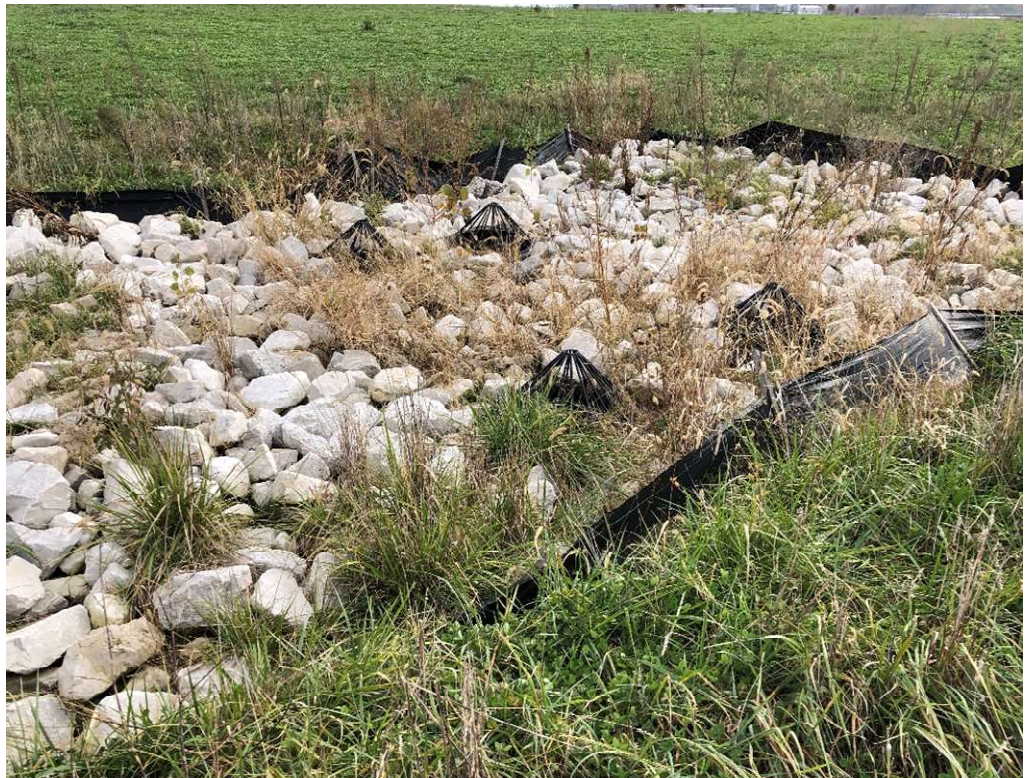
Point ID H-9	Photo ID IMG_8620

Date November 6, 2019		
Description: Downdrain inlets at middle section of Ash Pond B, good condition, photo looking west.

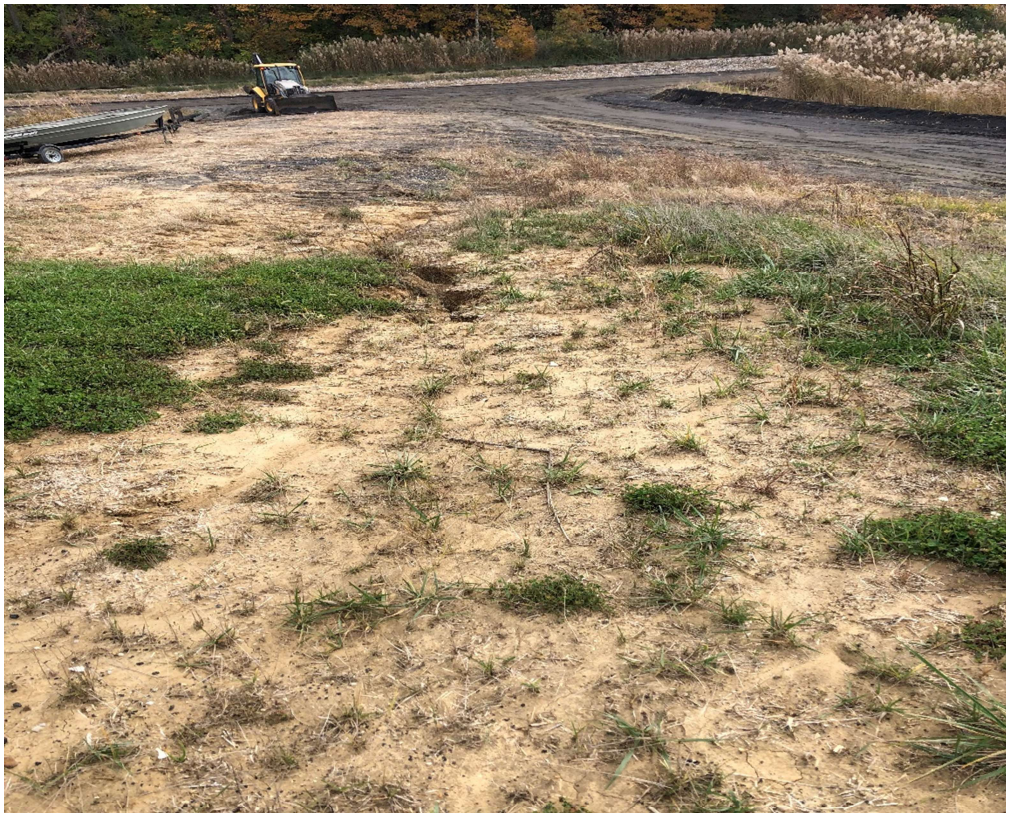
Point ID I-11	Photo ID IMG_8621

Date November 6, 2019		
Description: Erosion rills, sparse vegetation at southeast corner of Ash Pond B, photo looking southeast.

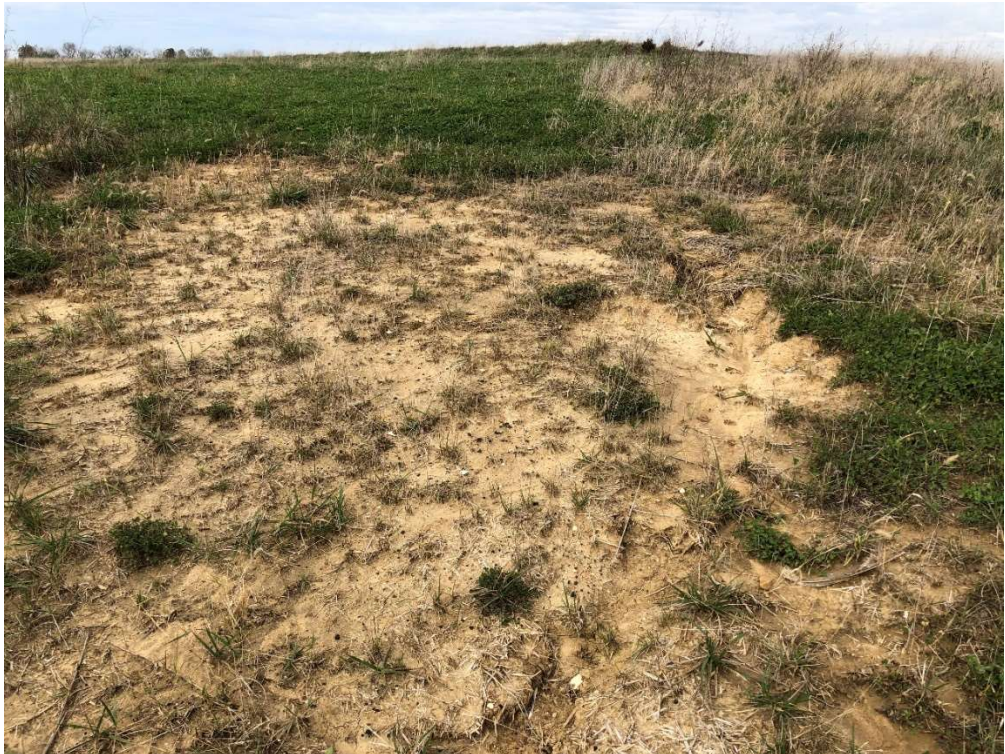
Point ID I-11	Photo ID IMG_8622

Date November 6, 2019		
Description: Erosion rills, sparse vegetation at southeast corner of Ash Pond B, photo looking north.		
Point ID I-11	Photo ID IMG_8623

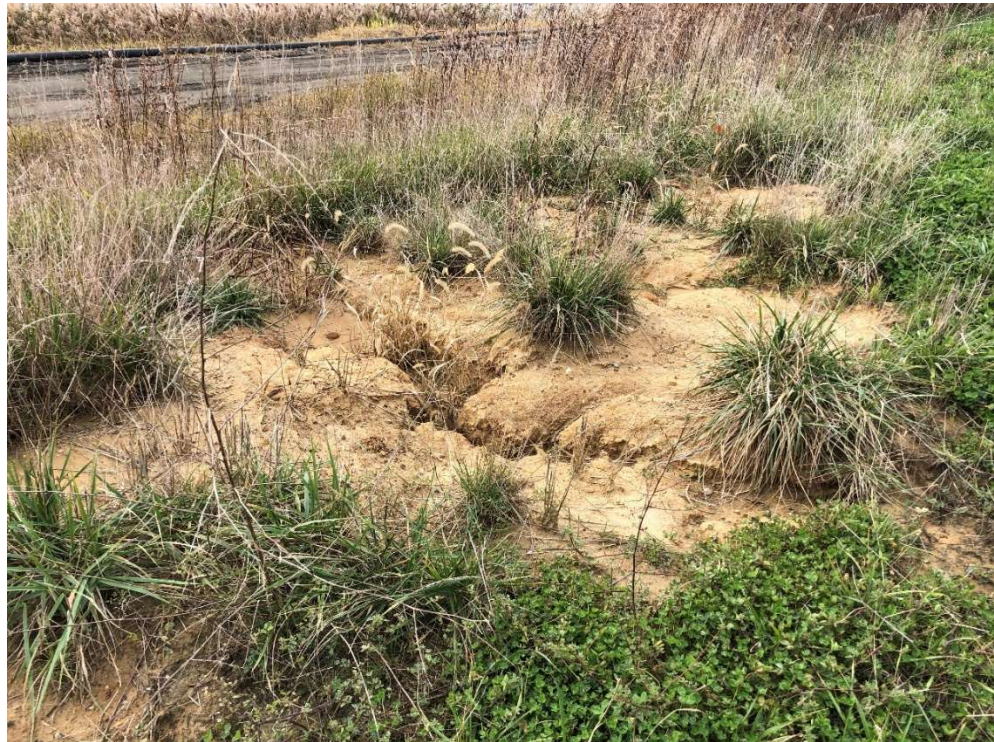
Date November 6, 2019		
Description: Erosion gullies formed along southern slope of Ash Pond B, sparse vegetation, photo looking south.

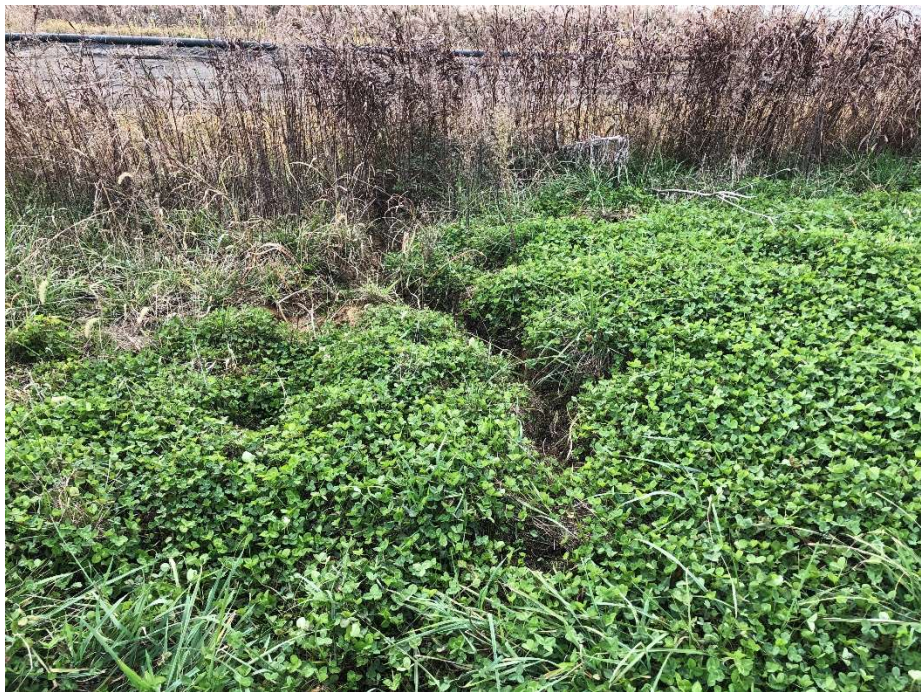
Point ID I-11	Photo ID IMG_8625

Date November 6, 2019		
Description: Erosion gullies formed along southern slope of Ash Pond B, photo looking south.

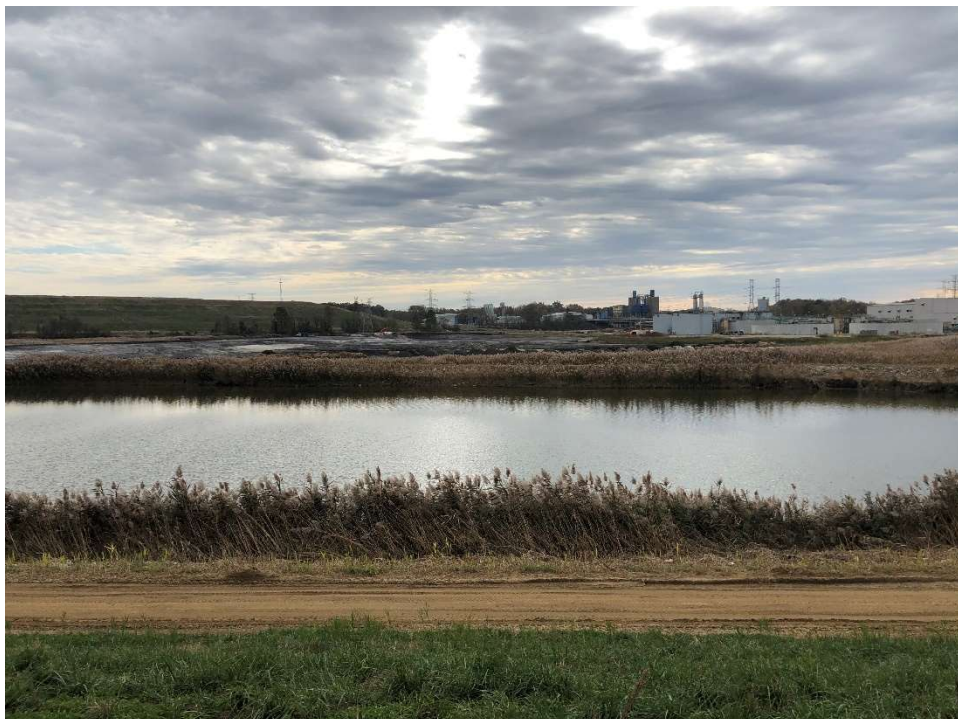
Point ID B-13	Photo ID IMG_8643

Date November 6, 2019		
Description: Middle section of Ash Pond A', vegetation is well established along north and south sides, photo looking south.		
Point ID B-13	Photo ID IMG_8644

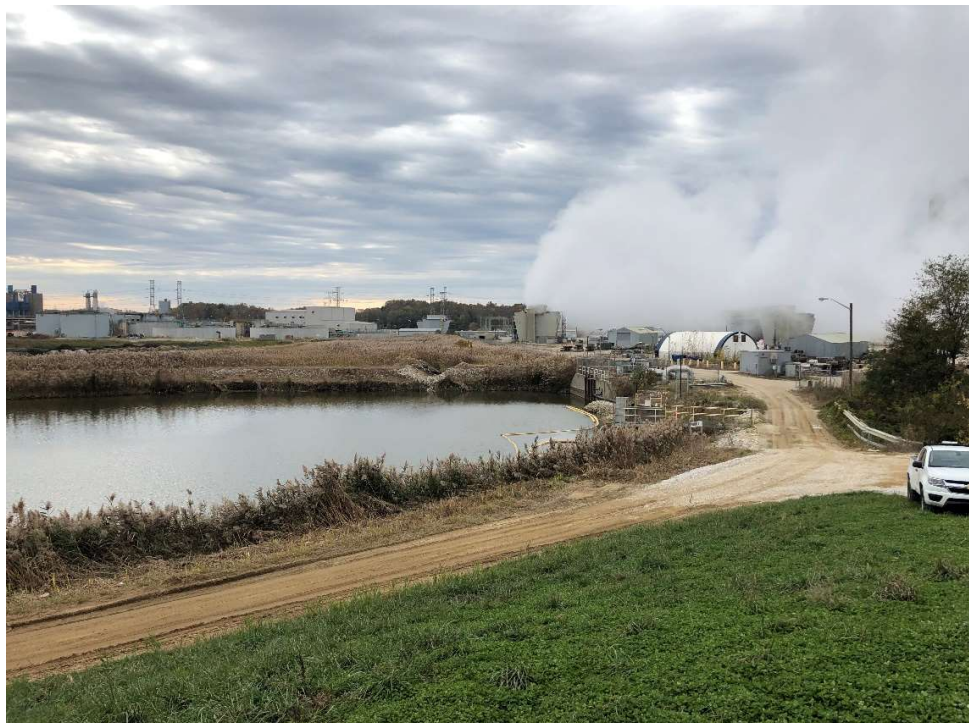
Date November 6, 2019		
Description: Well established vegetation along southern side of Ash Pond B, and view of north section of Ash Pond A, photo looking northeast.

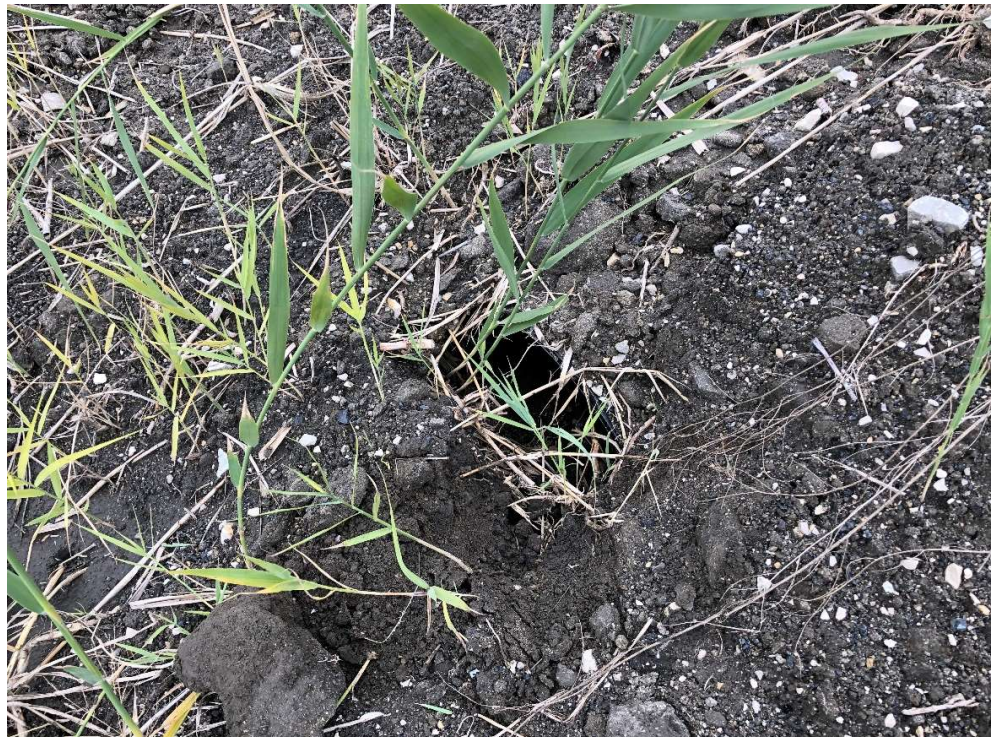
Point ID I-9	Photo ID IMG_8647

Date November 6, 2019		
Description: Existing 18-nch downdrain pipe missing plastic cap, southern section of Ash Pond C, photo looking south.

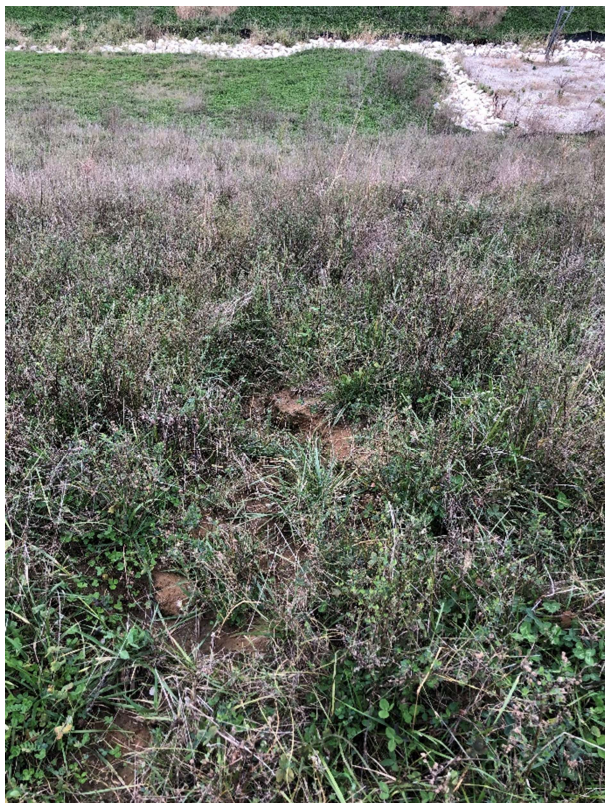
Point ID H-5	Photo ID IMG_8656

Date November 6, 2019		
Description: Erosion gully formed along southwestern slope of Ash Pond C, photo looking south.		
Point ID	Photo ID	
Date		
Description:
