**2020 VISUAL INSPECTION OF ASH POND EMBANKMENTS
IPL PETERSBURG ASH POND SYSTEM**

IPL PETERSBURG GENERATING STATION
6925 NORTH STATE ROAD 57
PETERSBURG, INDIANA 47567

ATC PROJECT NO. 170LF00973

DECEMBER 18, 2020

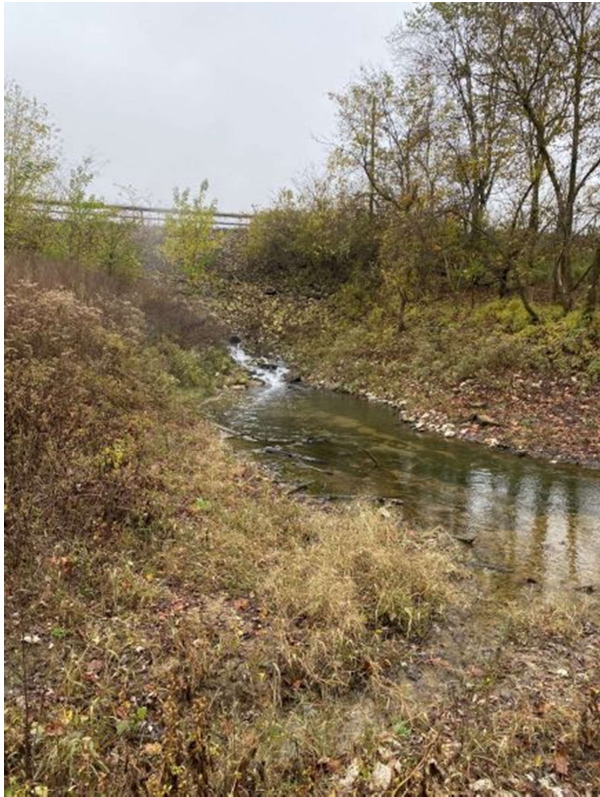
| Grid ID A-4 | Photo ID 3 | |

| Description: Downstream view of outfall structure at Ash Pond A', west slope of Ash Pond A', no issues observed, photo looking east. | | |

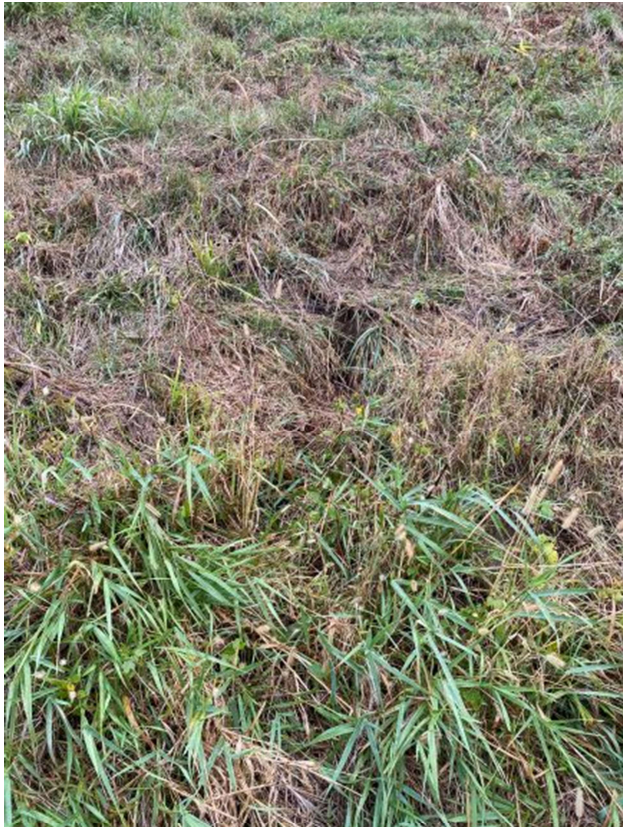
| Point ID B-12 | Photo ID 4 | |

| Description: Erosion gully formed at east side of western slope of Ash Pond B, photo looking east. | | |

1. Good vegetation exists along the majority of the basin, including the top of basin, and side slopes.
2. At the side slopes along the western, south-eastern, and north sections there were erosion rills and gullies observed at certain locations as shown in grid B-12, E-5, H-7, H-8, H-11, D-12, I-12, and C-13.
 - Recommendation: Repair the soil cover and install erosion control mats as needed in areas affected by erosion rills and gullies. Overseed these areas to establish a protective grass cover.
3. At the side slopes along the western side of Ash Pond B two animal burrows were observed at locations shown in grid B-12, and B-11.
 - Recommendation: Repair the soil cover and overseed these areas to establish a protective grass cover.

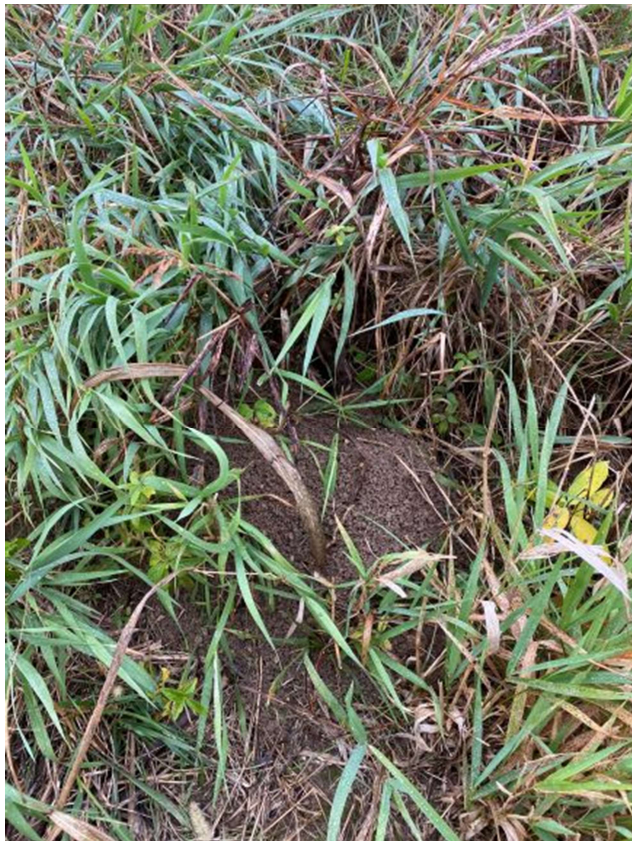
| Point ID B-12 | Photo ID 5 | |

| Description: Animal burrow, west slope of Ash Pond B, photo looking east. | | |

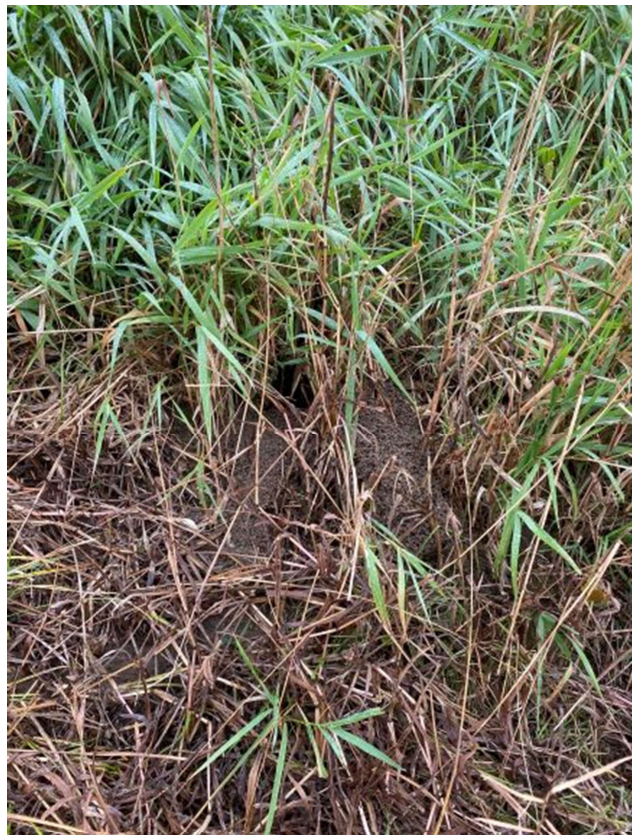
| Point ID B-11 | Photo ID 6 | |

| Description: Animal burrow, west slope of Ash Pond B, photo looking east. | | |

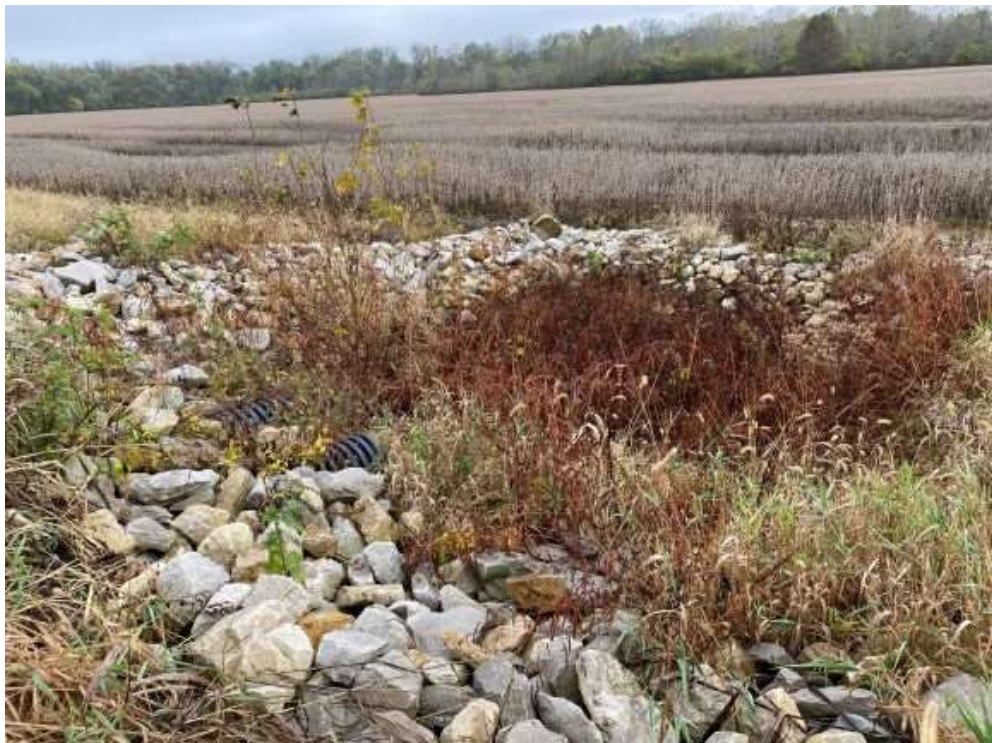
| Point ID C-7 | Photo ID 9 | |

| Description: Recommend removal of vegetation from riprap area at down drain splash pad, north slope of Ash Pond B, photo looking south. | | |

- Recommendation: Repair the soil cover and install erosion control mats as needed in areas affected by erosion rills and gullies. Overseed these areas to establish a protective grass cover.
3. Overgrown weedy vegetation was observed at down drain riprap chutes and inlet located in the east and south sections of Ash Pond B, see grid locations C-7, G-3, and G-11.
- Recommendation: Remove vegetation.

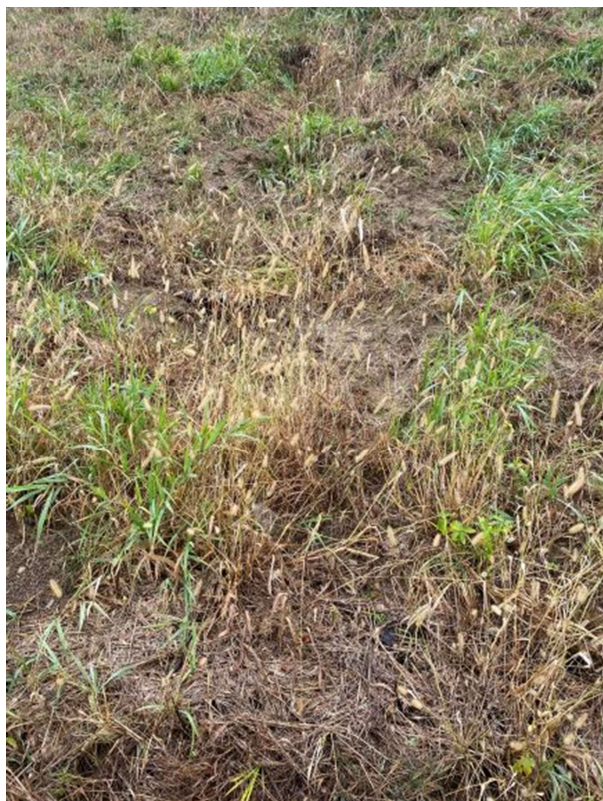
| Point ID E-5 | Photo ID 10 | |

| Description: Erosion gully formed along western slope of Ash Pond B, photo looking southeast. | | |

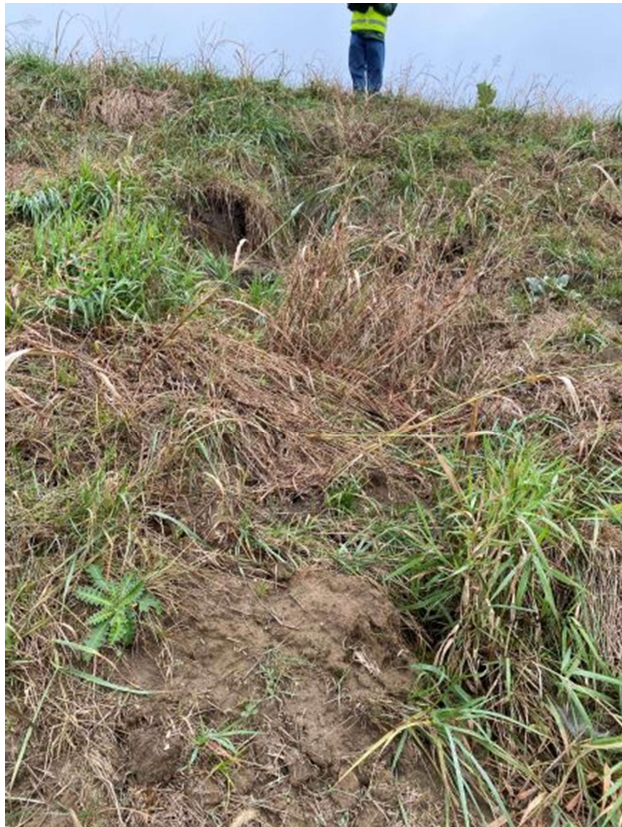
| Point ID E-5 | Photo ID 11 | |

| Description: Erosion gully formed along western slope of Ash Pond B, photo looking southeast. | | |

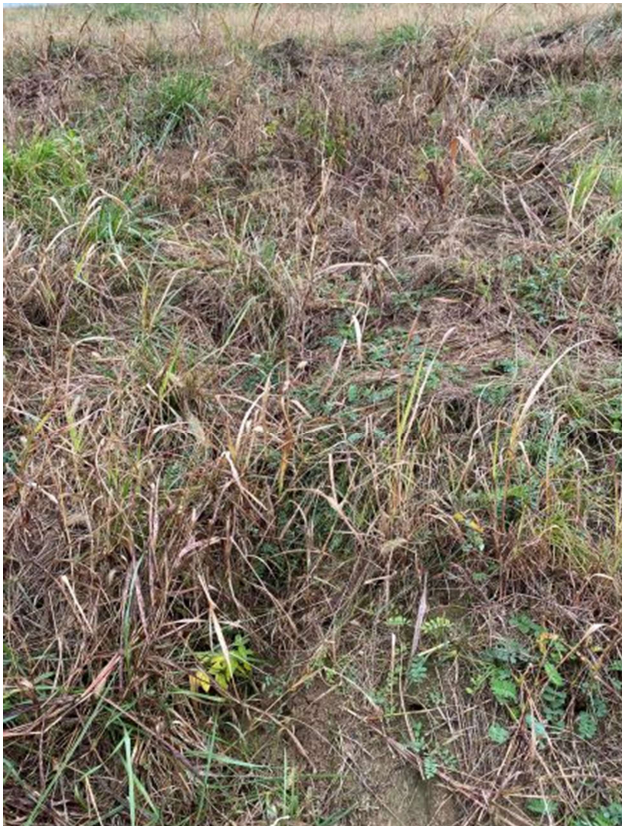
| Point ID E-5 | Photo ID 12 | |

| Description: Erosion gully formed along western slope of Ash Pond B, photo looking southeast. | | |

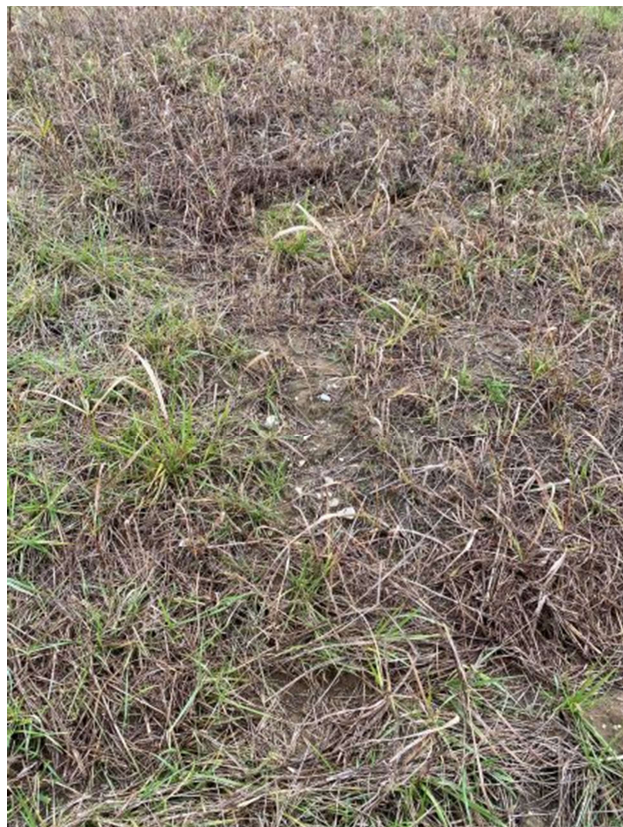
| Point ID H-7 | Photo ID 17 | |

| Description: Erosion gully formed at south side of drainage swale along power line corridor between Ash Pond B and C, photo looking west. | | |

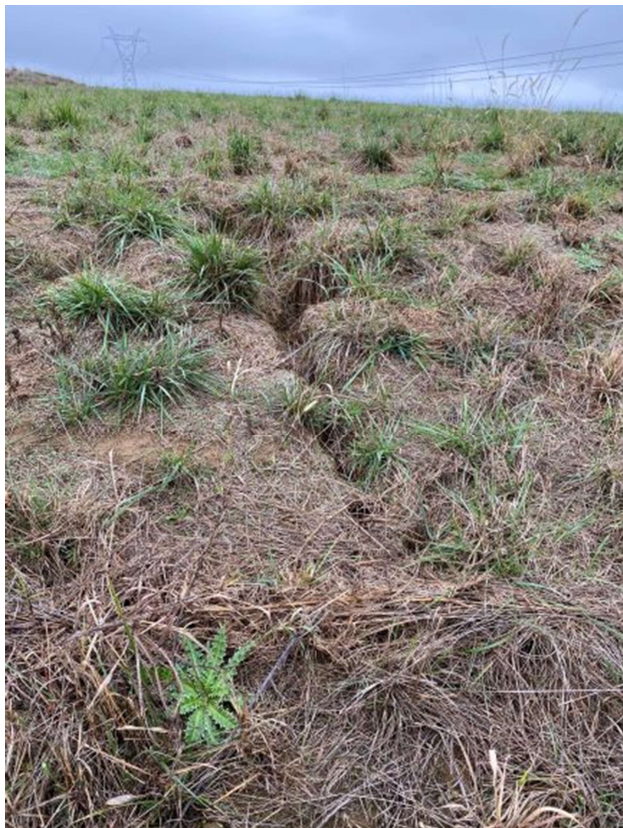
| Point ID I-11 | Photo ID 18 | |

| Description: Erosion gully formed along southern slope of Ash Pond B, photo looking north. | | |

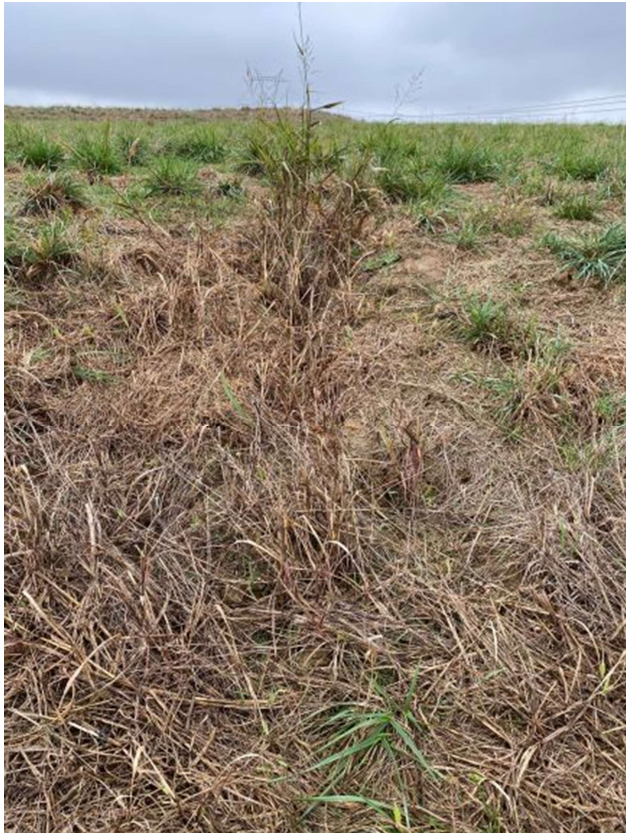
| Point ID H-11 | Photo ID 19 | |

| Description: Erosion gully formed along southern slope of Ash Pond B, photo looking north. | | |

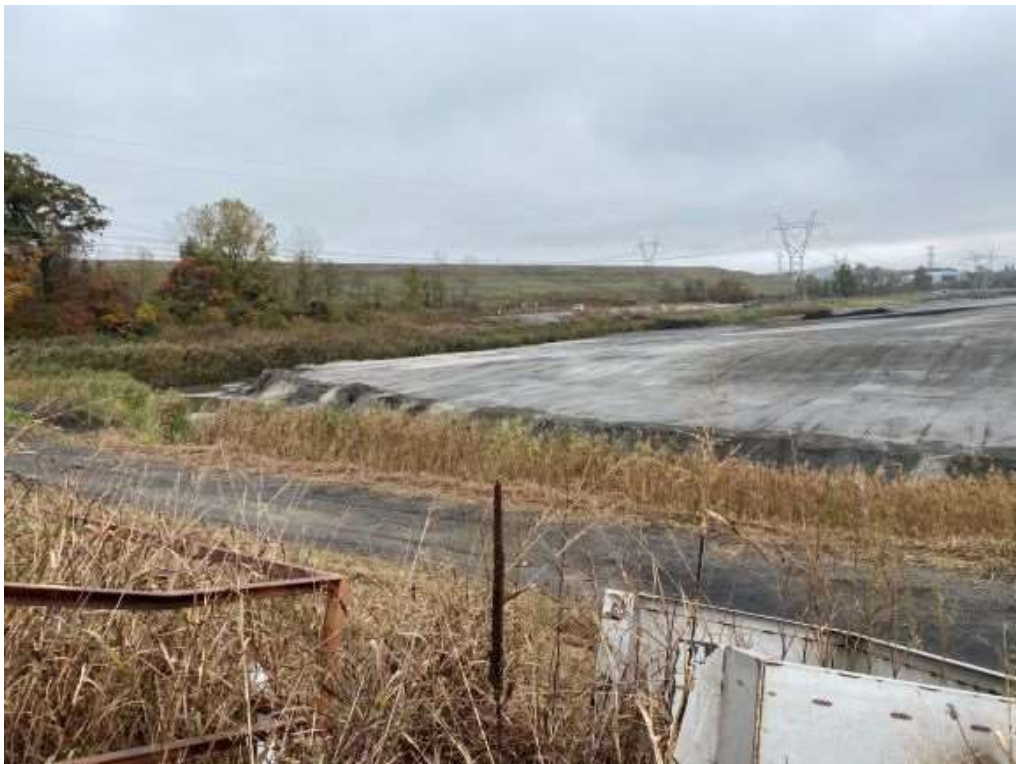
| Point ID H-11 | Photo ID 20 | |

| Description: View of ash filled area at northeast corner of Ash Pond A, fill grading work is part of Ash Pond A Basin Closure, photo looking southeast. | | |

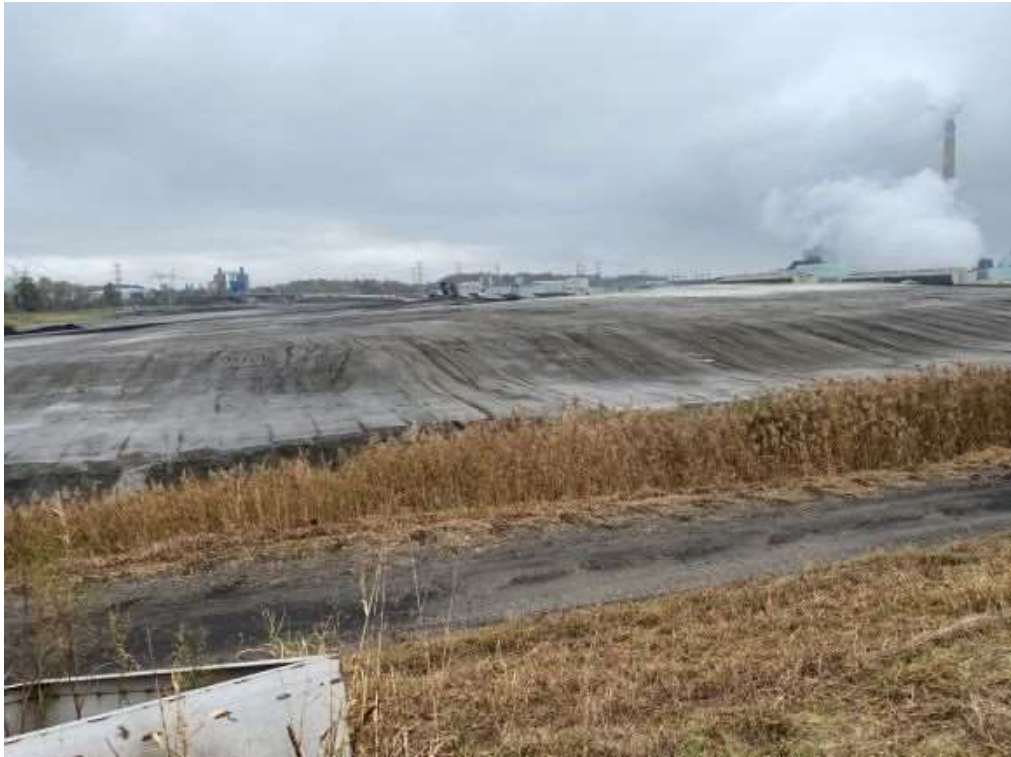
| Point ID H-11 | Photo ID 21 | |

| Description: View of ash filled area at north side of Ash Pond A, fill grading work is part of Ash Pond A Basin Closure, photo looking south. | | |

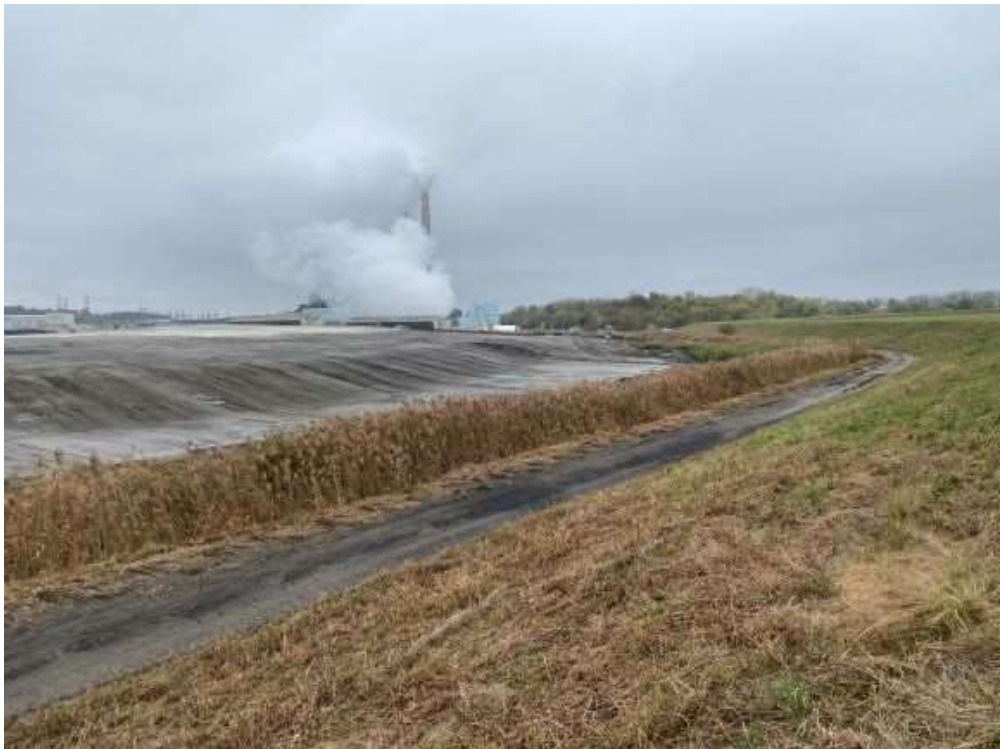
| Point ID H-11 | Photo ID 22 | |

| Description: View of northeast side of ash filled area at Ash Pond A, fill grading work is part of Ash Pond A Basin Closure, photo looking southwest. | | |

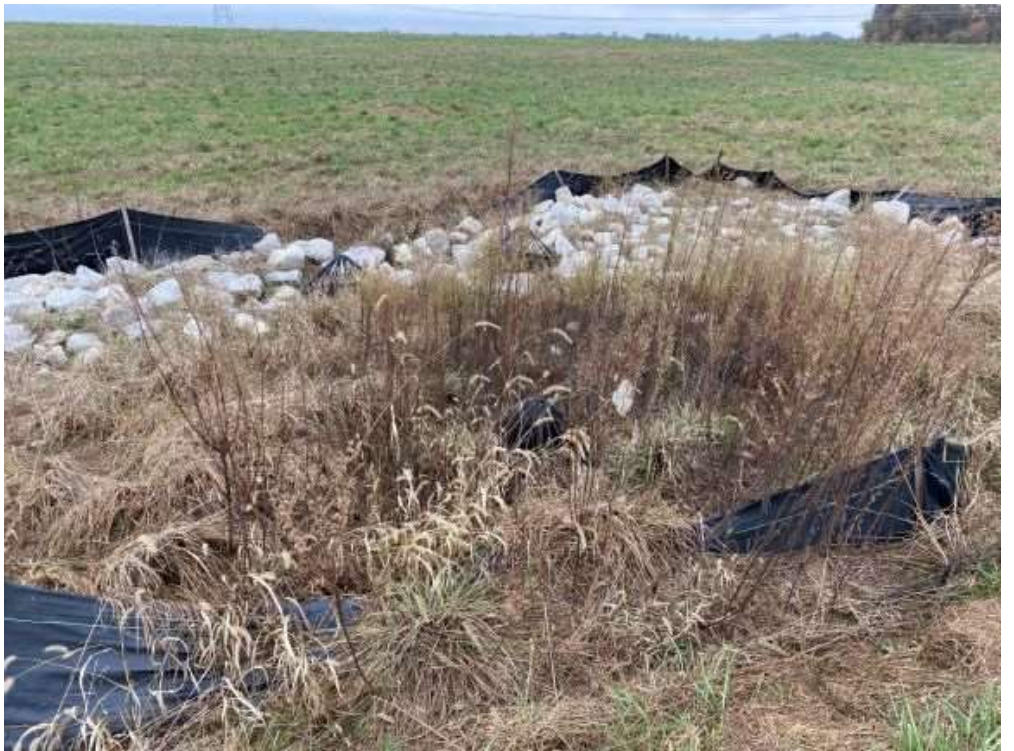
| Point ID G-11 | Photo ID 23 | |

| Description: Recommend removal of vegetation from riprap area at down drain inlets at south side of Ash Pond B, photo looking north. | | |

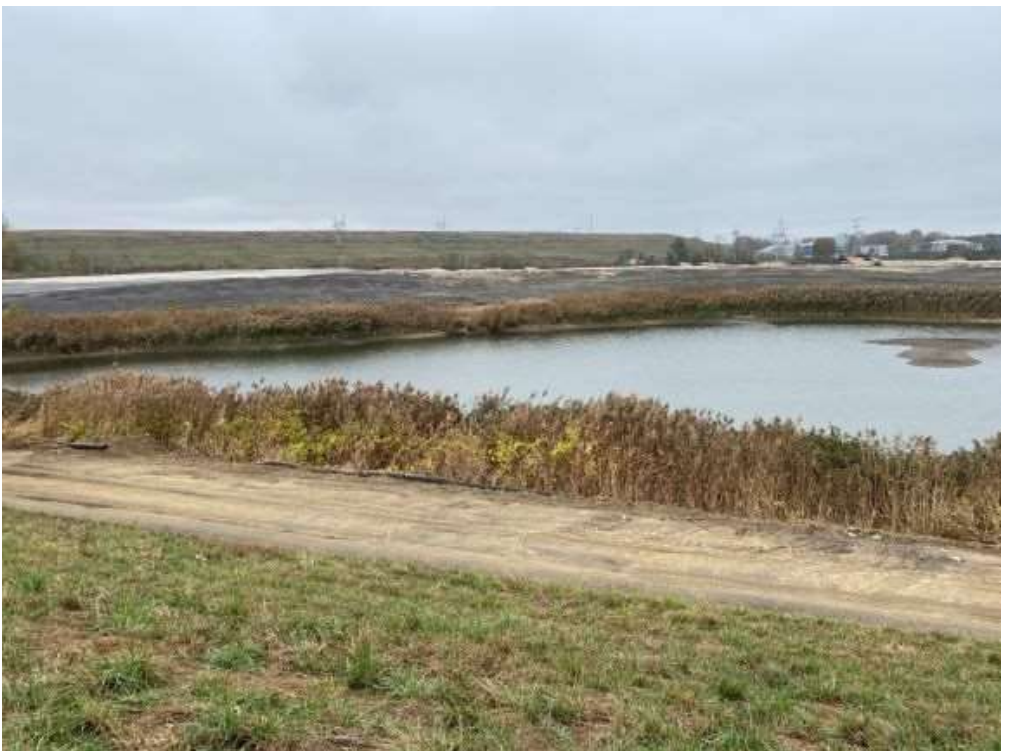
| Point ID D-12 | Photo ID 24 | |

| Description: Middle section of Ash Pond A', vegetation is well established along north and south sides, photo looking southeast. | | |

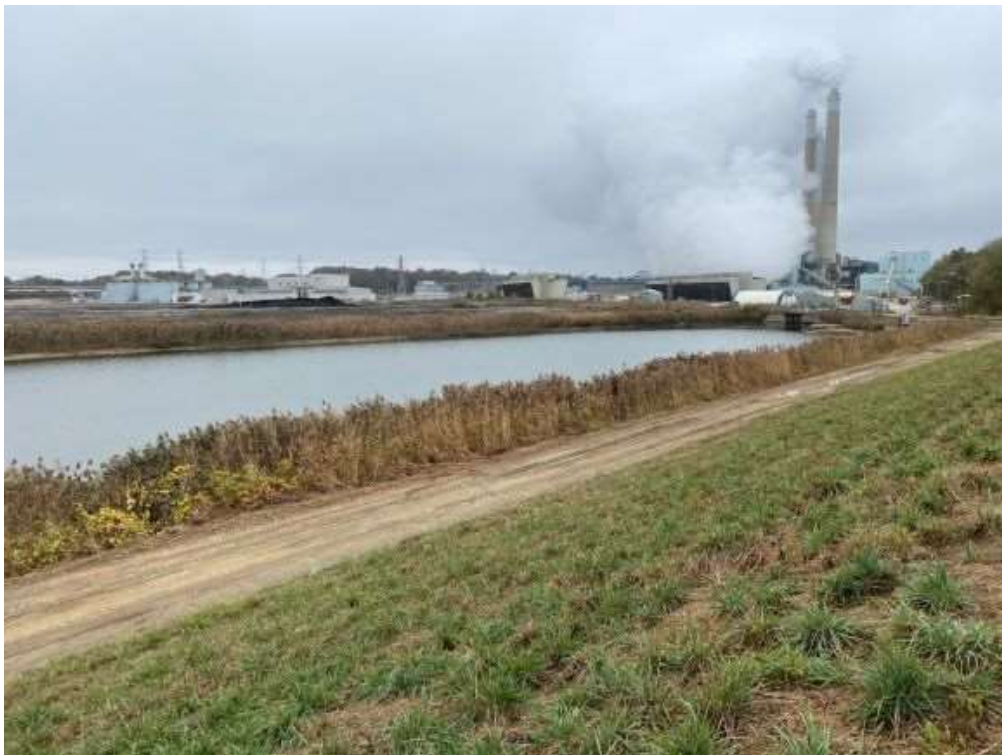
| Point ID D-12 | Photo ID 25 | |

| Description: West section of Ash Pond A', vegetation is well established along north and south sides, photo looking southwest. | | |

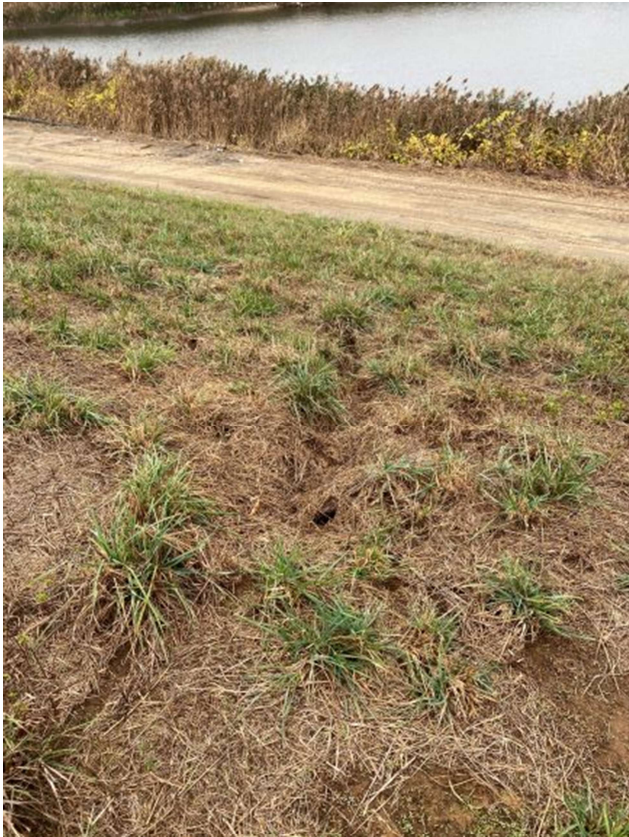
| Point ID D-12 | Photo ID 27 | |

| Description: Erosion gullies formed at side slope of southwest section of Ash Pond B, photo looking southeast. | | |

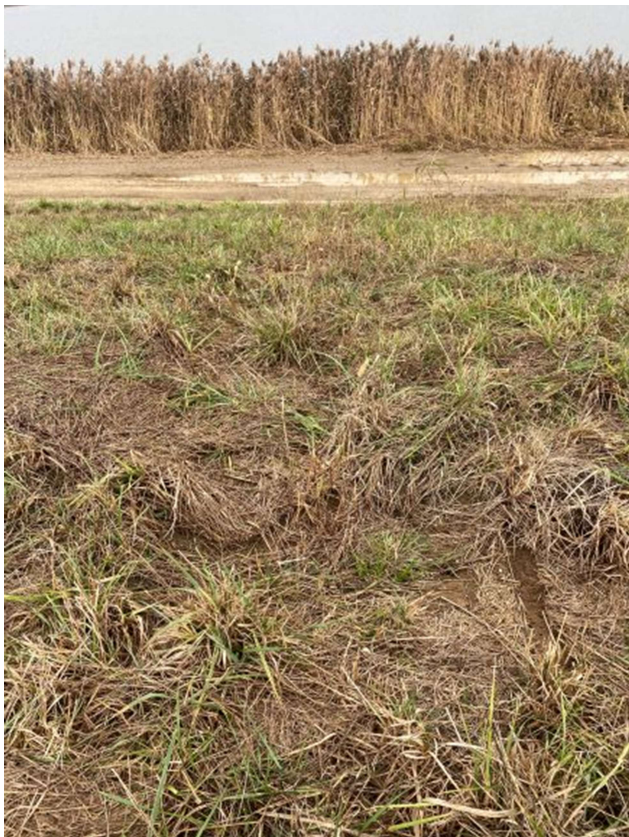
| Point ID C-13 | Photo ID 28 | |

| Description: Erosion gullies formed at side slope of southwest section of Ash Pond B, photo looking southeast. | | |

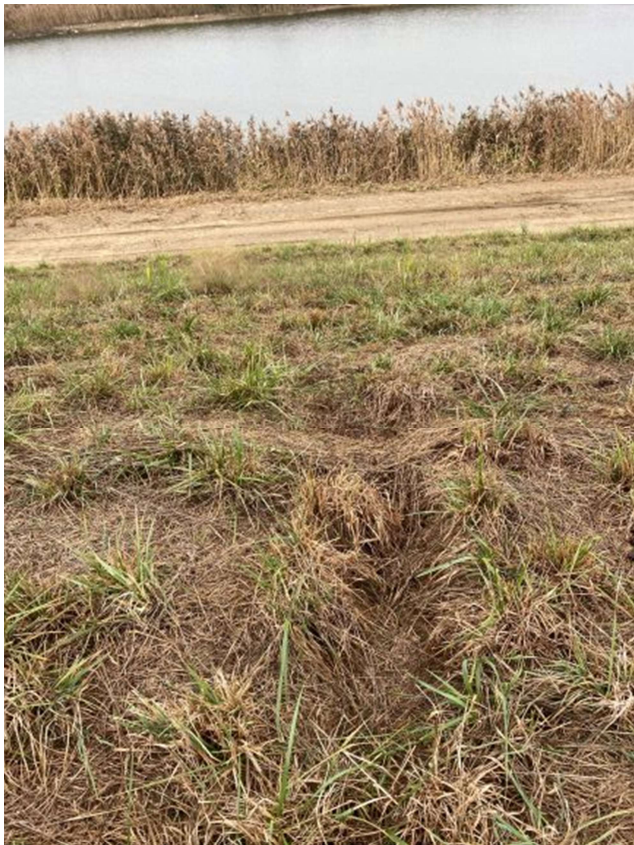
| Point ID C-13 | Photo ID 29 | |

| Description: Erosion gullies formed at side slope of southwest section of Ash Pond B, photo looking southeast. | | |

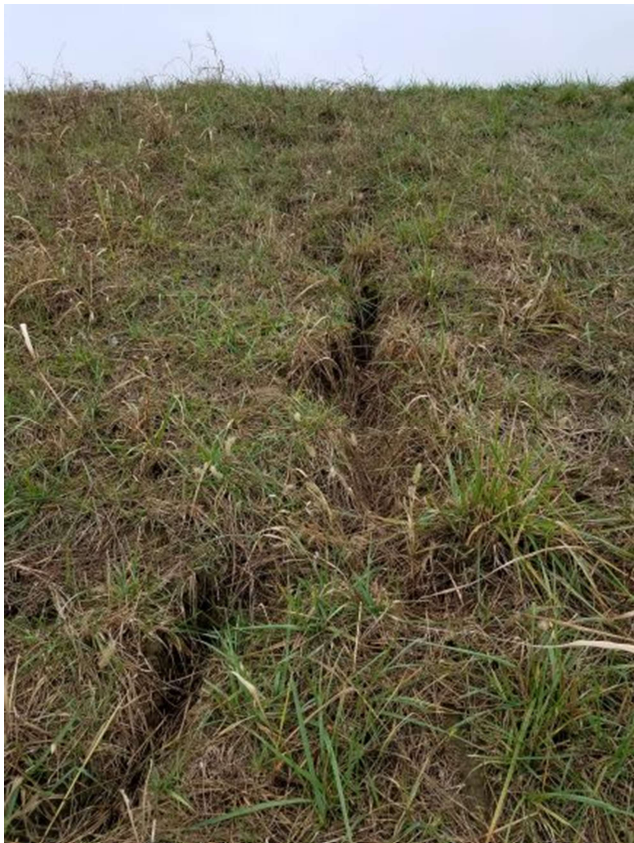
| Point ID H-8 | Photo ID 30 | |

| Description: Erosion gully formed at south side of drainage swale along power line corridor between Ash Pond B and C, photo looking west. | | |

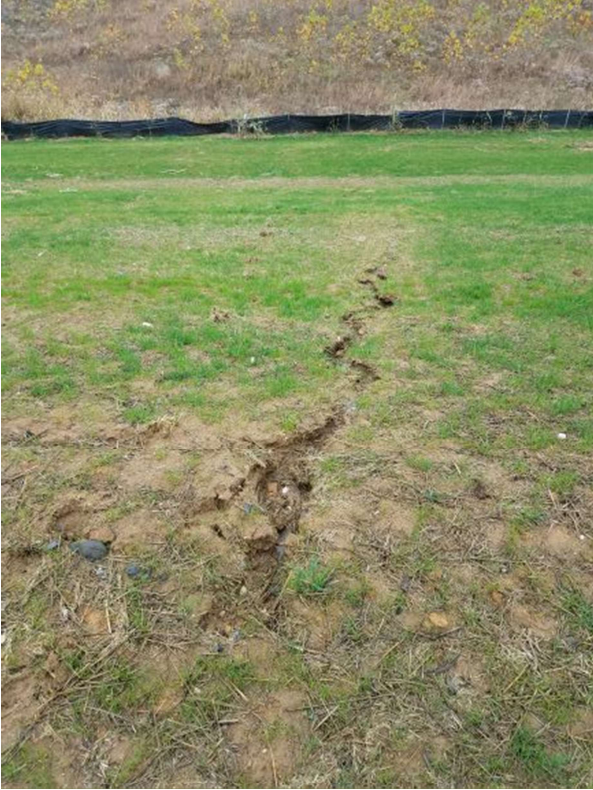
| Grid ID L-2 | Photo ID 33 | |

1. Good vegetation exists along the side slopes of the basin.
2. At the side slopes along the western, and north there were erosion rills and gullies observed at certain locations as shown in grid M-1, L-2, I-2, and H-3.

| Description: Erosion gullies formed along northern slope of Ash Pond C, photo looking north. | | |

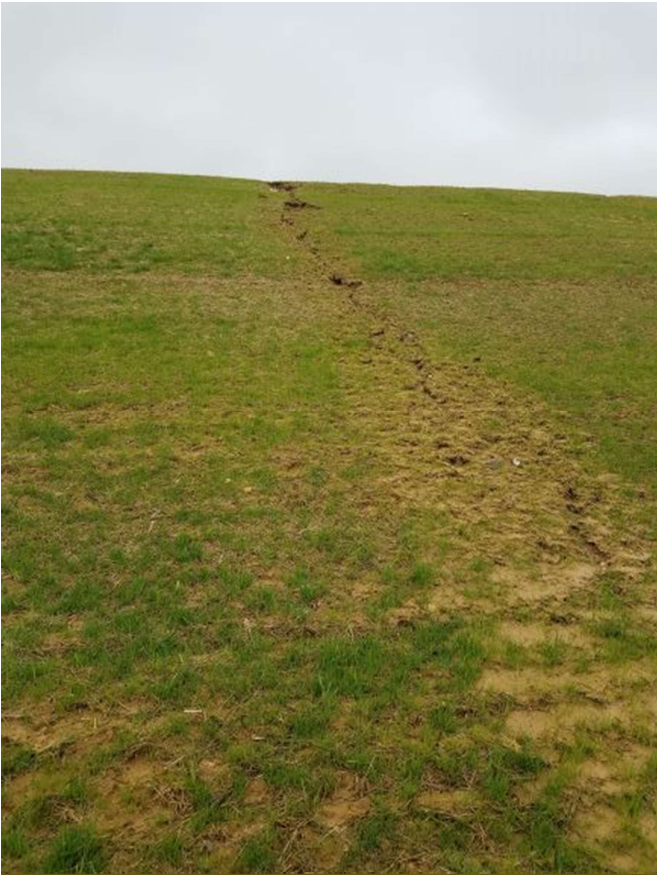
| Point ID I-2 | Photo ID 34 | |

| Description: Erosion gullies formed along northwest slope of Ash Pond C, photo looking south. | | |

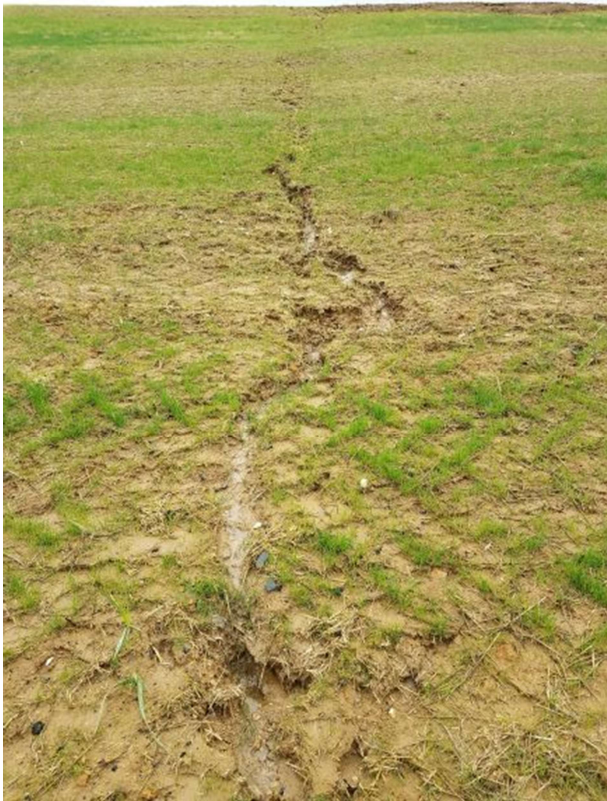
| Point ID H-3 | Photo ID 35 | |

| Description: Erosion gullies formed along northwest slope of Ash Pond C, photo looking southeast. | | |

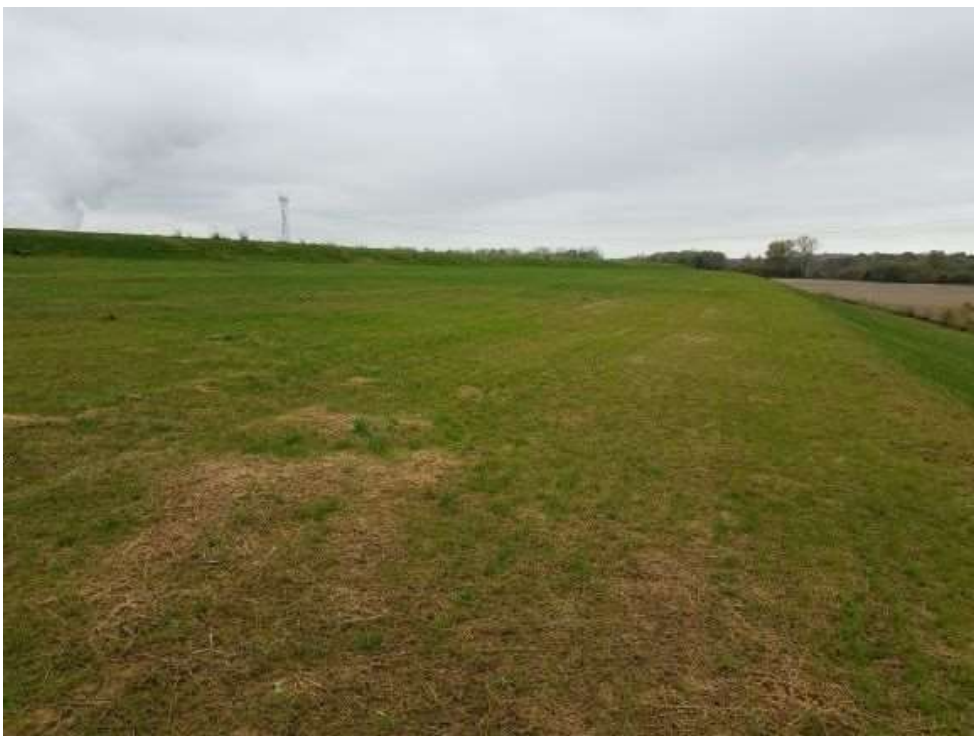
| Point ID M-2 | Photo ID 36 | |

| Description: Slope of top of north section of Ash Pond C, photo looking west. | | |

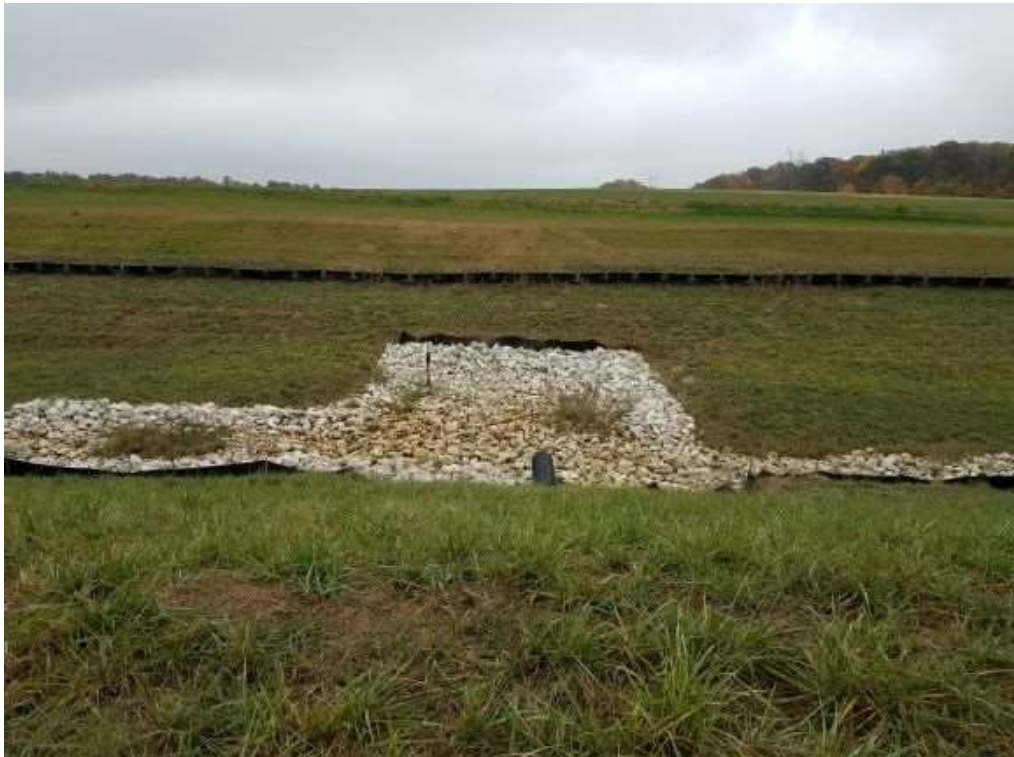
| Point ID H-6 | Photo ID 39 | |

| Description: Ash Pond B downdrain splash pad at power line corridor between Ash Ponds B and C, photo looking north. | | |

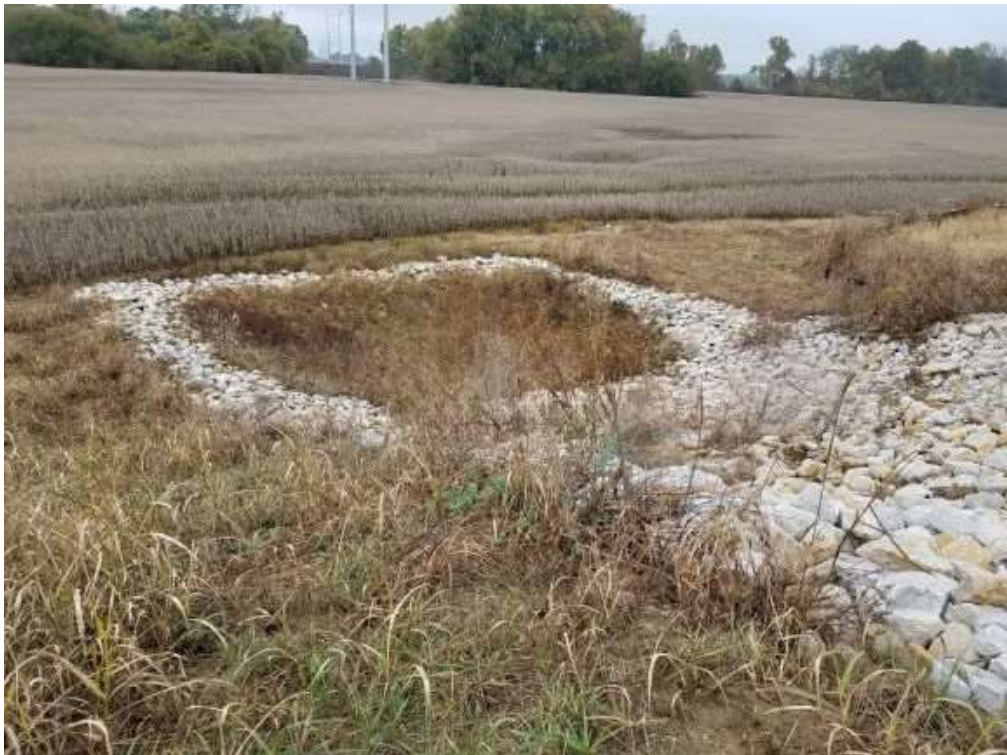
| Point ID G-3 | Photo ID 40 | |

| Description: Recommend removal of vegetation from riprap area, splash pad at power line corridor between Ash Ponds B and C, photo looking northwest. | | |

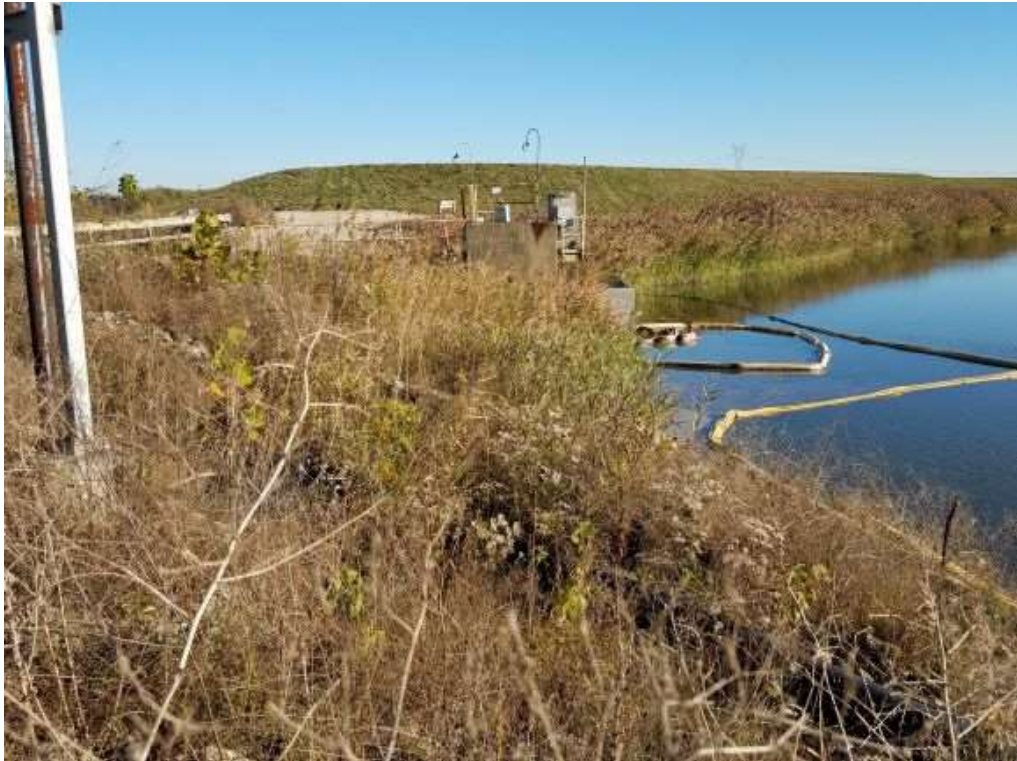
| Point ID B-14 | Photo ID 41 | |

| Description: Outfall control structure, Ash Pond A', photo looking north. | | |
