**2020 VISUAL SITE INSPECTION  
IPL PETERSBURG RESTRICTED WASTE TYPE III LANDFILL  
SOLID WASTE FACILITY PERMIT NO. FP63-02**

IPL PETERSBURG GENERATING STATION  
6925 NORTH STATE ROAD 57  
PETERSBURG, INDIANA 47567

ATC PROJECT NO. 170LF00972

DECEMBER 18, 2020

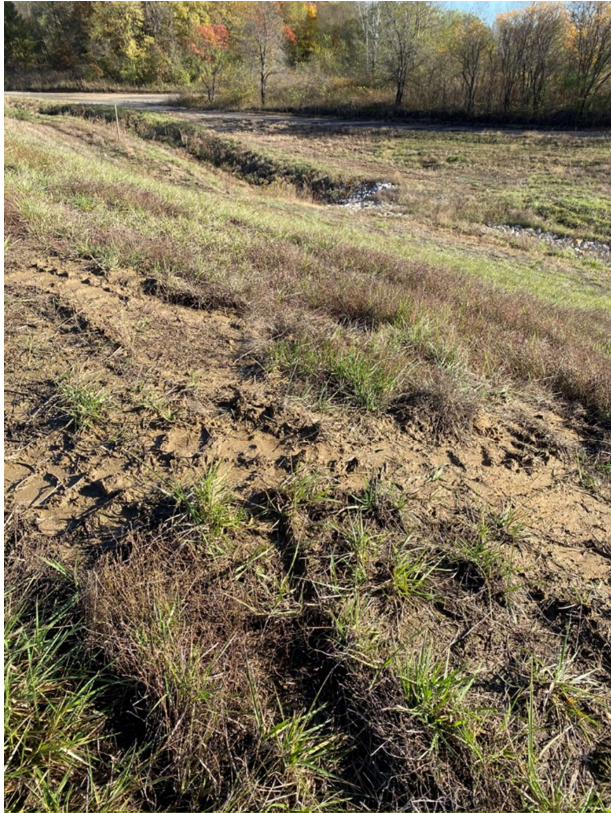
<b>Grid ID</b> Q-15	<b>Photo ID</b> 7

<b>Date</b> October 30, 2020		
<b>Description:</b>  Sparse vegetation and erosion rills along eastern section of landfill, photo looking northeast.		
<b>Grid ID</b> P-15	<b>Photo ID</b> 8

- Recommendation: Repair the soil cover and install erosion control mats in areas affected by erosion rills and gullies. Overseed these areas to establish a protective grass cover.

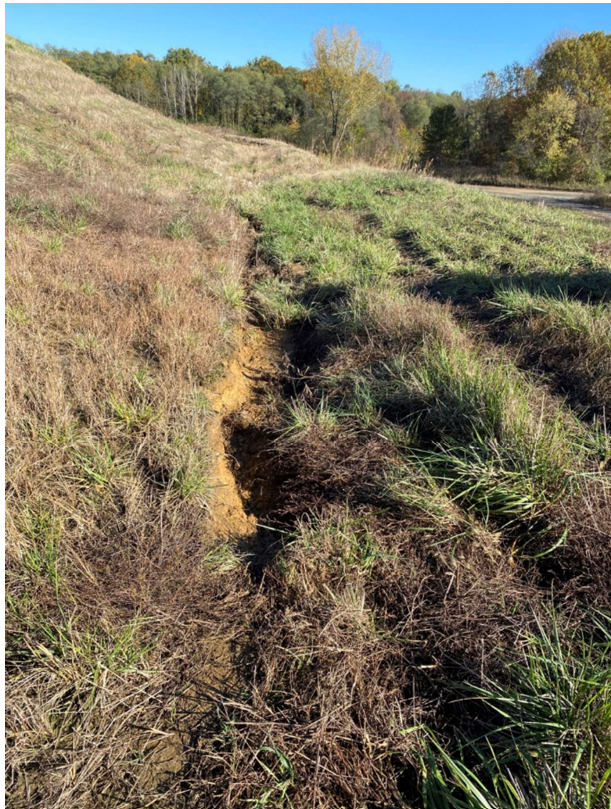
<b>Date</b> October 30, 2020		
<b>Description:</b>  Erosion gullies formed along drainage terrace on east section of landfill, photo looking north.

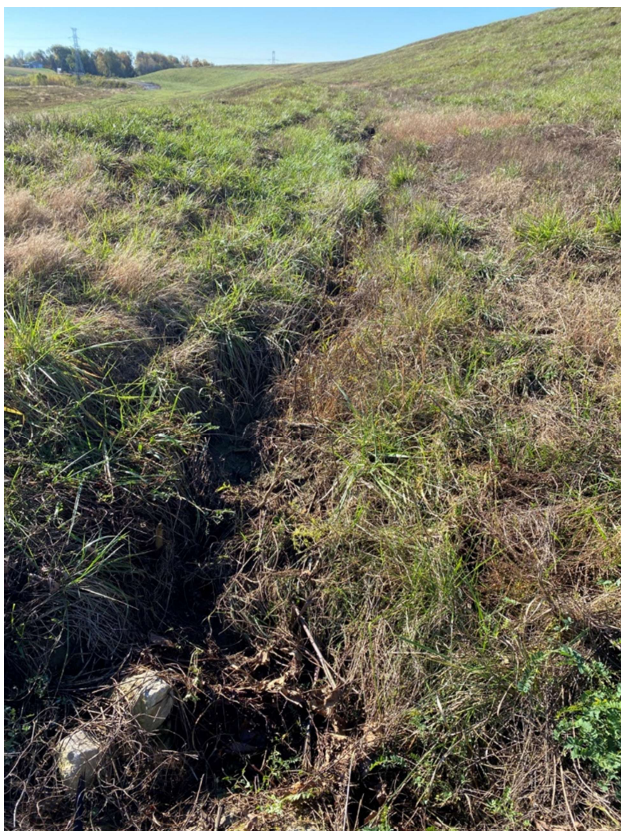
<b>Grid ID</b> Q-15	<b>Photo ID</b> 10

<b>Date</b> October 30, 2020		
<b>Description:</b>  Erosion gully formed along drainage swale on east section of landfill, photo looking south.

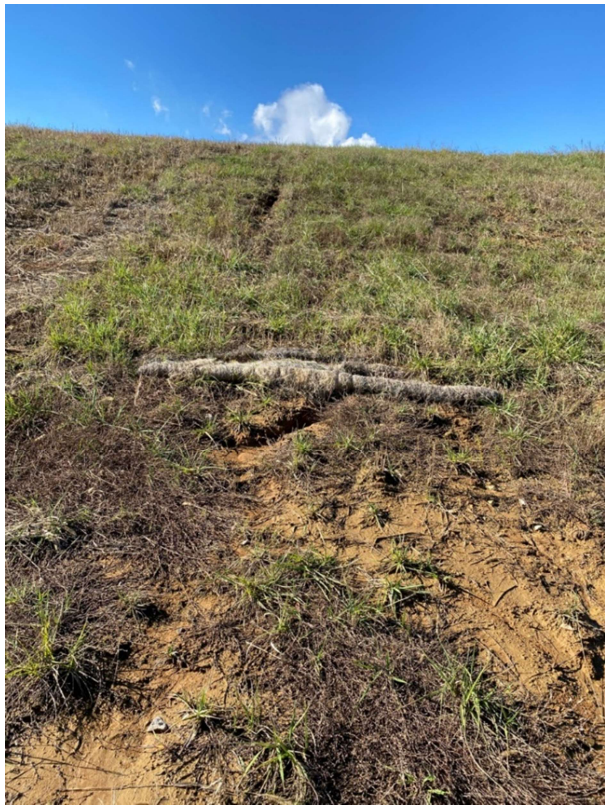
<b>Grid ID</b> P-13	<b>Photo ID</b> 17

<b>Date</b> October 30, 2020		
<b>Description:</b>  Sparse vegetation and erosion rills formed along east slope of landfill, photo looking west.		
<b>Grid ID</b> O-13	<b>Photo ID</b> 18

- Recommendation: Overseed these areas to establish a fuller grass cover.

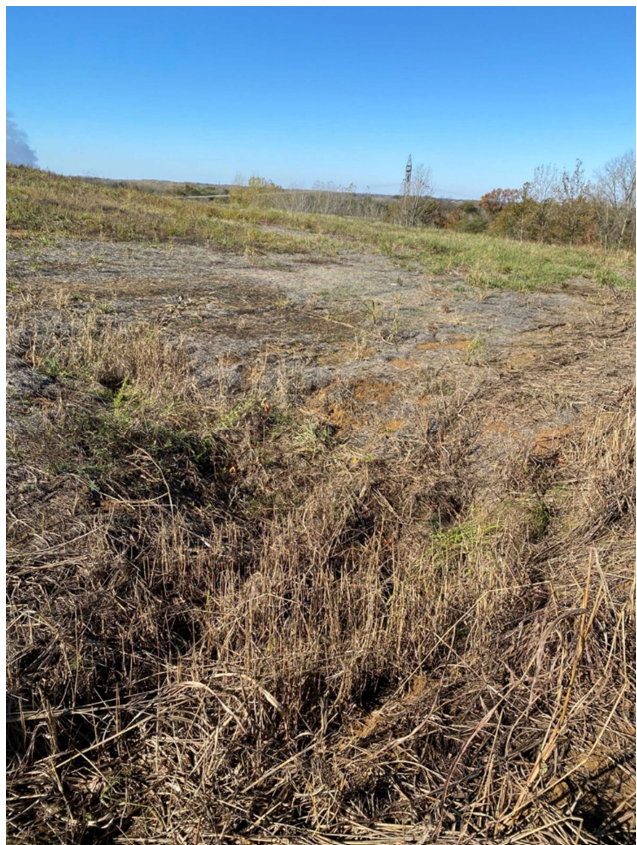
<b>Date</b> October 30, 2020		
<b>Description:</b>  Sparse vegetation and erosion rills formed along north section of landfill, photo looking west.

1. Good vegetation exists along the majority of the west and north slopes of the partial closure area.
2. The northeast corner of the landfill, there are areas with sparse vegetation and erosion rills and gullies, see grid locations O-13 and Q-14.
  - Recommendation: Install erosion control protection for this area such as erosion control mat to prevent further erosion. Overseed the bare soil cover area.
3. Along the western and southern side slope of the landfill, erosion rills and gullies were observed at locations as shown in grid M-18, M-23, M-24 and M-25.

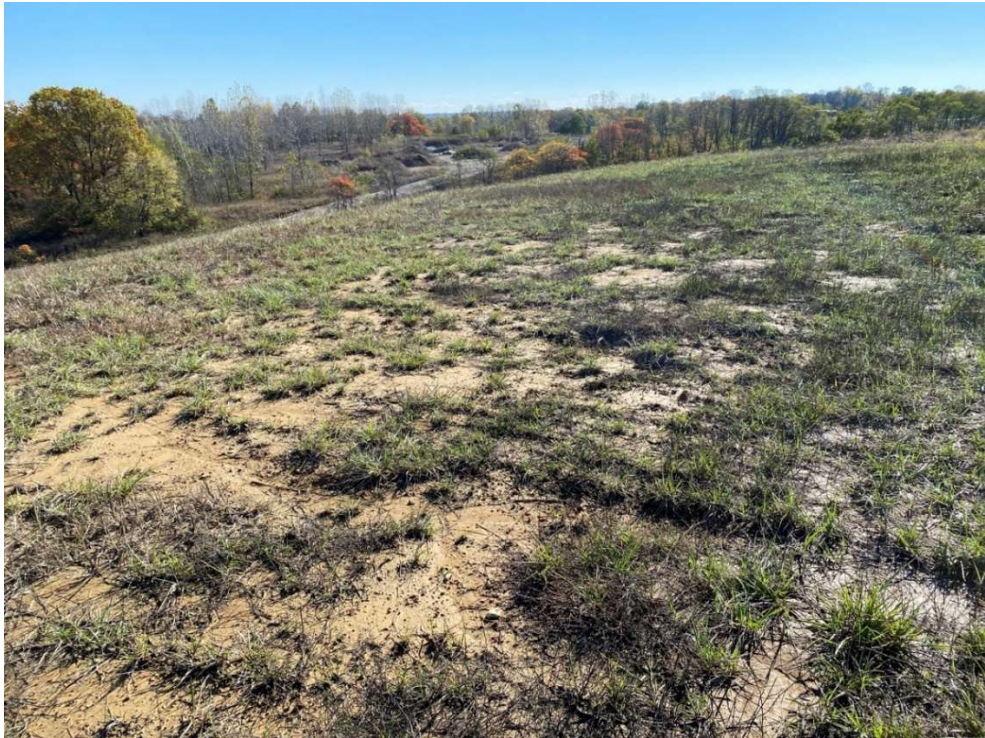
<b>Grid ID</b> O-14	<b>Photo ID</b> 19

<b>Date</b> October 30, 2020		
<b>Description:</b>  Sparse vegetation and erosion rills formed along north section of landfill, photo looking east.		
<b>Grid ID</b> P-14	<b>Photo ID</b> 20

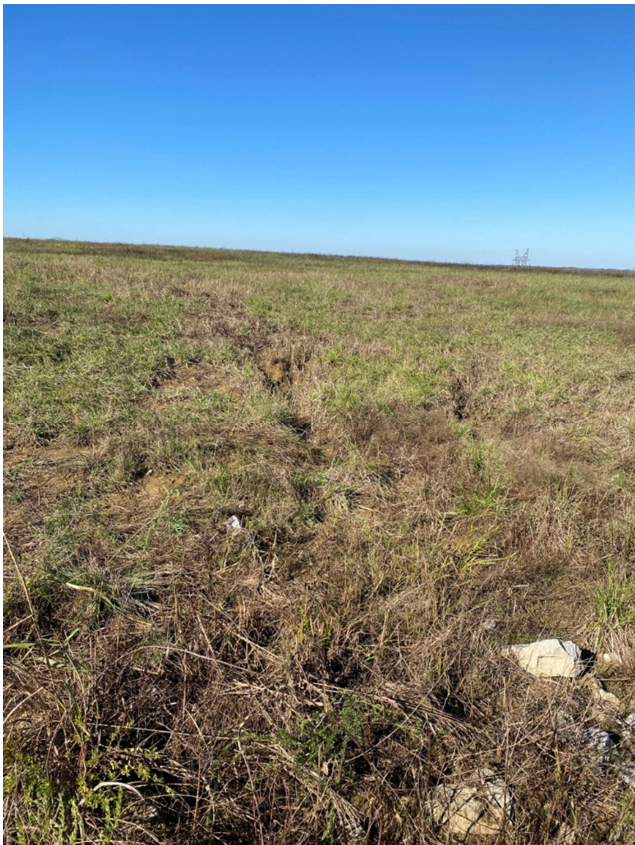
<b>Date</b> October 30, 2020		
<b>Description:</b>  Erosion gullies formed along slope on northwest section of landfill, photo looking east.

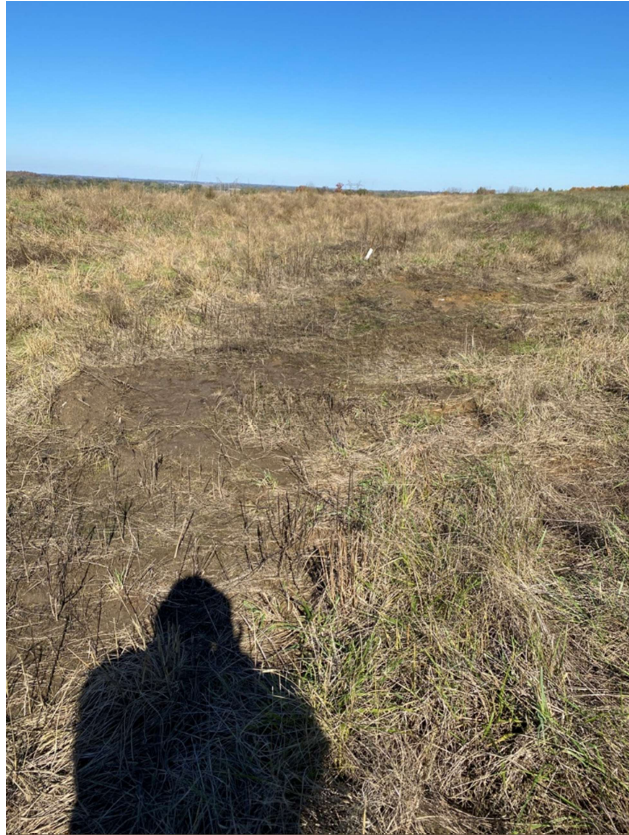
<b>Grid ID</b> M-23	<b>Photo ID</b> 25

<b>Date</b> October 30, 2020		
<b>Description:</b>  Erosion gullies and sparse vegetation along southern slope of landfill, photo looking northeast.		
<b>Point ID</b> O-19	<b>Photo ID</b> 26

- Recommendation: Repair the soil cover and install erosion control mats in areas affected by erosion rills and erosion cavities. Overseed these areas to establish a protective grass cover.
4. At the southwest corner of the landfill, erosion has occurred along the face of the slope, exposing underlying Poz-o-tec material, see grid locations M-23 and M-24.
- Recommendation: Repair the soil cover and regrade areas of the slope where erosion has occurred. Install erosion control mat in exposed areas and overseed areas of sparse vegetation once soil cover has been repaired.

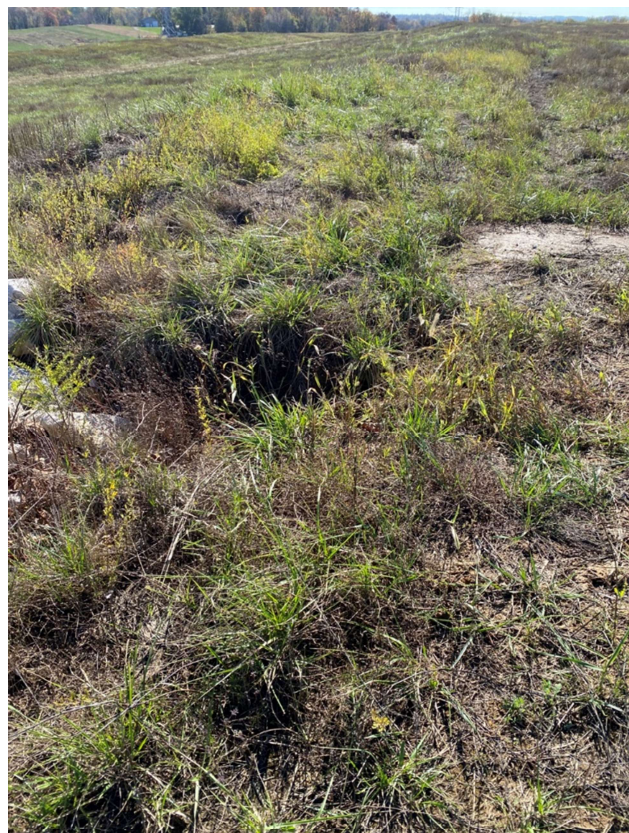
<b>Date</b> October 30, 2020		
<b>Description:</b>  Erosion gully formed upstream of riprap downchute, photo looking south.

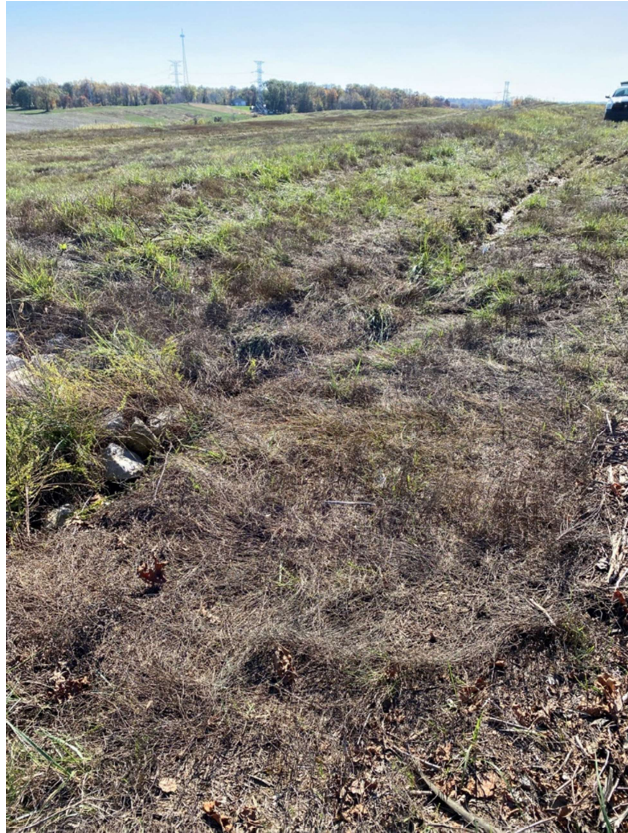
<b>Grid ID</b> O-18	<b>Photo ID</b> 27

<b>Date</b> October 30, 2020		
<b>Description:</b>  Erosion gullies formed along drainage swale at top tier of landfill, photo looking south.		
<b>Grid ID</b> O-17	<b>Photo ID</b> 28

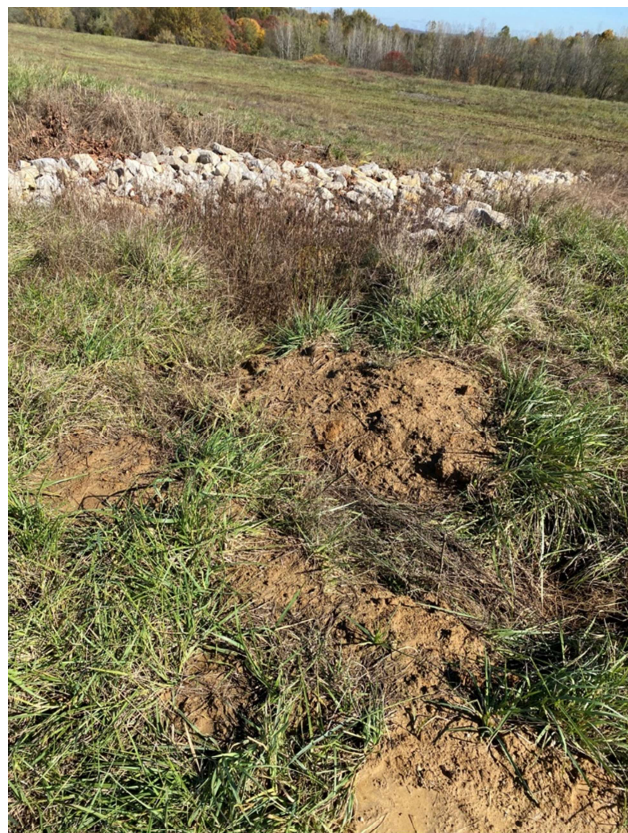
<b>Date</b> October 30, 2020		
<b>Description:</b>  Erosion gullies formed adjacent to riprap downchute, photo looking northeast.

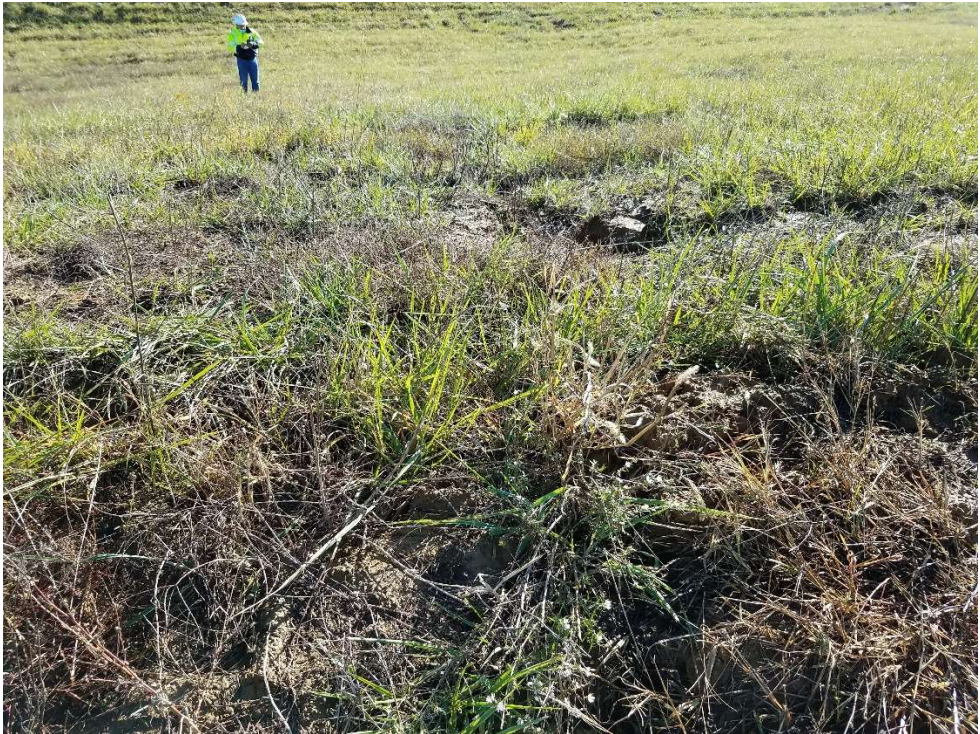
<b>Grid ID</b> P-21	<b>Photo ID</b> 33

<b>Date</b> October 30, 2020		
<b>Description:</b>  Erosion gullies formed in slope on east side of landfill, photo looking east.		
<b>Grid ID</b> P-20	<b>Photo ID</b> 34

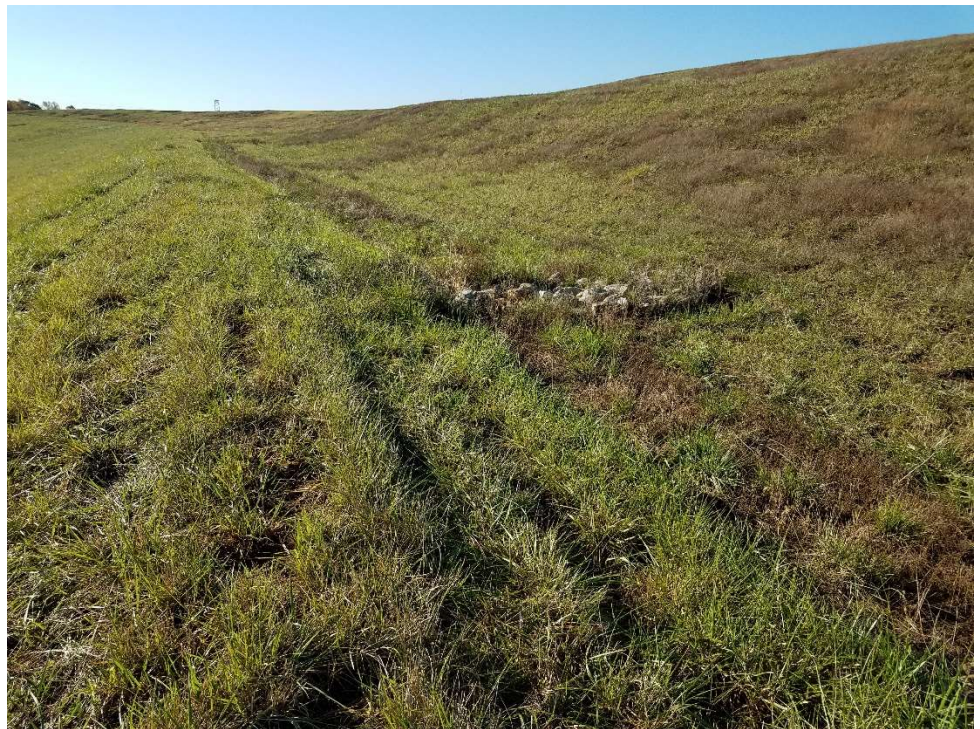
<b>Date</b> October 30, 2020		
<b>Description:</b>  Erosion rills formed along terrace swale on east section of Zone B, photo looking south.
