**2021 VISUAL SITE INSPECTION
AES INDIANA PETERSBURG RESTRICTED WASTE TYPE III LANDFILL
SOLID WASTE FACILITY PERMIT NO. FP63-02**

AES INDIANA PETERSBURG GENERATING STATION
6925 NORTH STATE ROAD 57
PETERSBURG, INDIANA 47567

ATC PROJECT NO. 170LF01140

DECEMBER 10, 2021

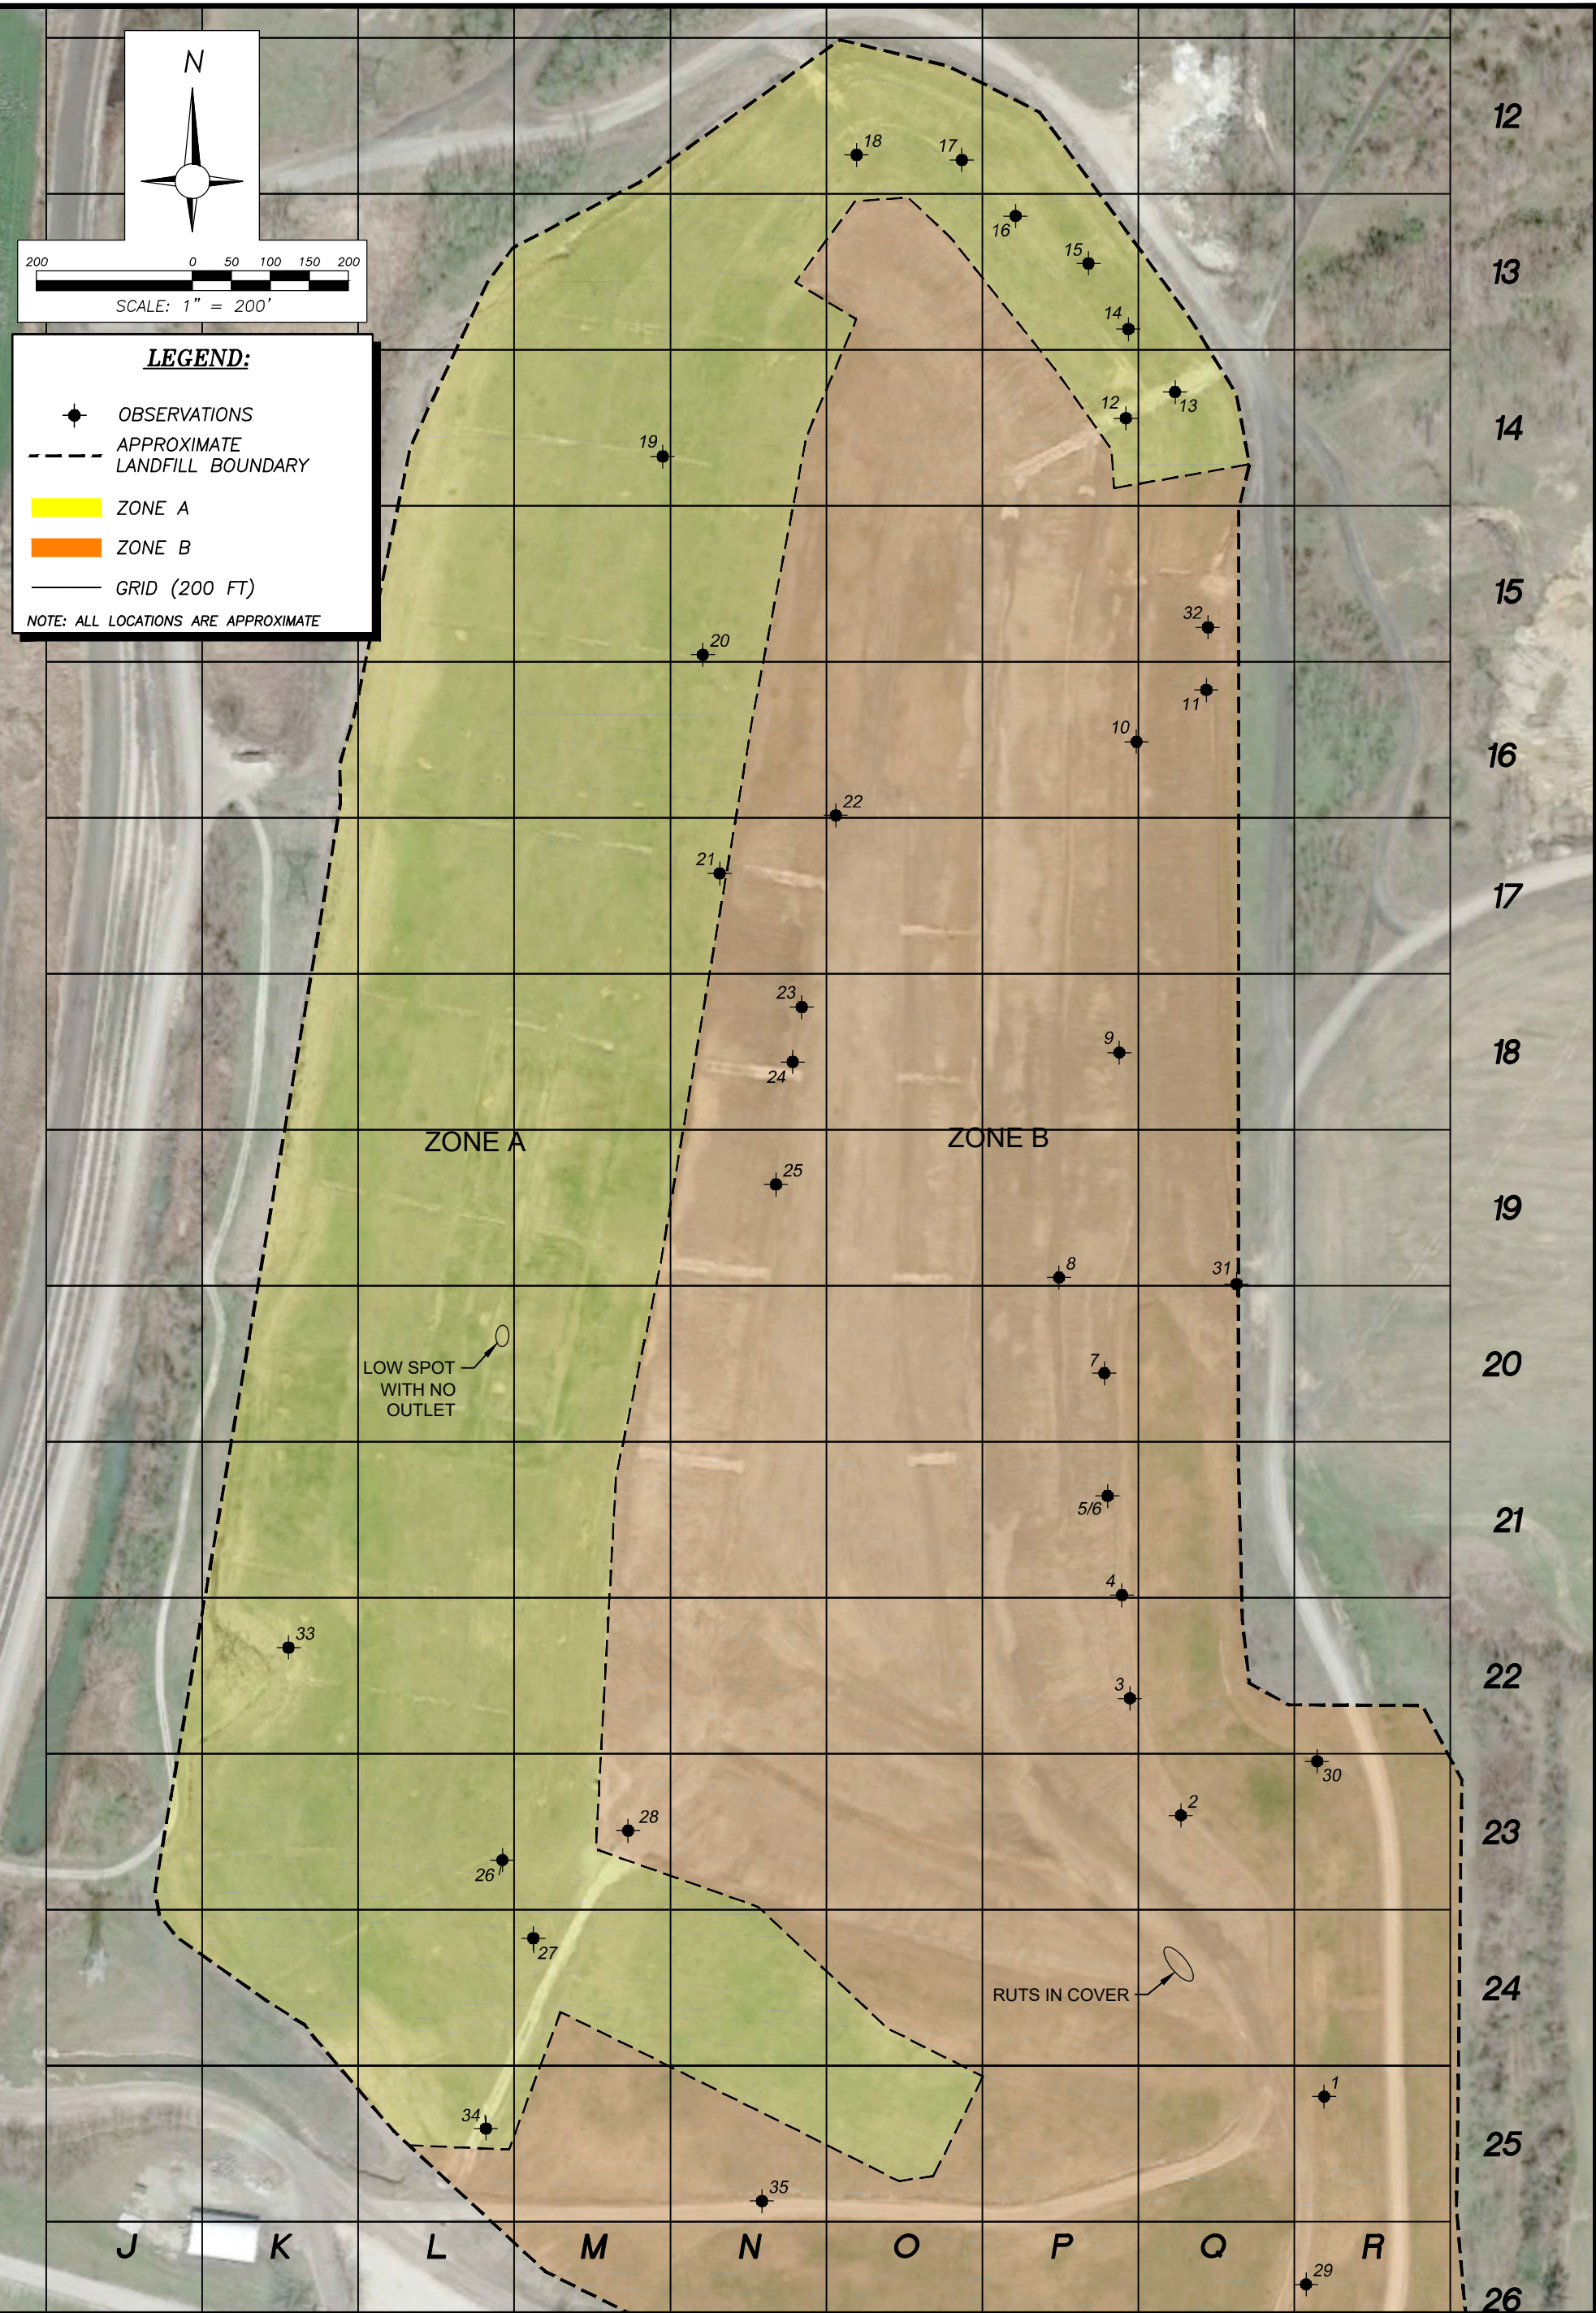
Figure: 3	Scale: AS SHOWN	Date: 12/09/2021	2021 VISUAL SITE INSPECTION GRID MAP			Project Number: 170LF01140		Drm. By: BH	
			AES PETERSBURG RESTRICTED WASTE TYPE III LANDFILL			Drawing File: SEE LOWER LEFT		Ckd. By: MB	
			AES INDIANA

There were no observed geometry changes during the 2021 Petersburg visual landfill inspection. Waste placement has paused at the landfill and all areas are under final or intermediate cover. Engineering observations were grouped into two inspection zones shown in Figure 3, 2021 Visual Site Inspection Grid Map.

1. Good vegetation exists along the majority of the west and north slopes of the partial closure area.
2. At the southwest corner of the landfill, erosion has occurred along the face of the slope, exposing underlying Poz-o-tec material, see grid locations M-23 and M-24. The riprap-lined stormwater channel has lost portions of its riprap and eroded into the Poz-o-tec.
 - o Recommendation: Replace the undersized riprap material in the channel to prevent erosion into the Poz-o-tec. Alternative erosion protection measures such as fabric-formed concrete or cellular linings, or reinforced membrane linings may be considered instead of using larger riprap replacement.

3. The stormwater downlet channel in grid location K-22 is very steep and discharge from the downlet pipes appears likely to displace the existing channel riprap.
 - Recommendation: Place additional large-diameter riprap in the channel to help dissipate the storm flow from the pipes.

1. Good vegetation exists along the majority of the south end of the landfill, top of landfill and east slope.
2. Overgrown, woody vegetation was observed in riprap downchutes and channels located in the along the eastern and northern landfill faces.
 - Recommendation: Remove or kill vegetation.
3. On the east side of the landfill low or sparse vegetation observed at certain locations as shown in grid P-21, P-20, P-19, and R-25.
 - Recommendation: Monitor areas for continued vegetation establishment and watch for erosion activity. Overseed and protect these areas if grass cover does not improve.
4. Deep erosion gullies into waste material were noted along the main landfill access road as shown in grids M25, N25, and O25.
 - Recommendation: Fill the gullies with gravel to reduce waste material erosion.

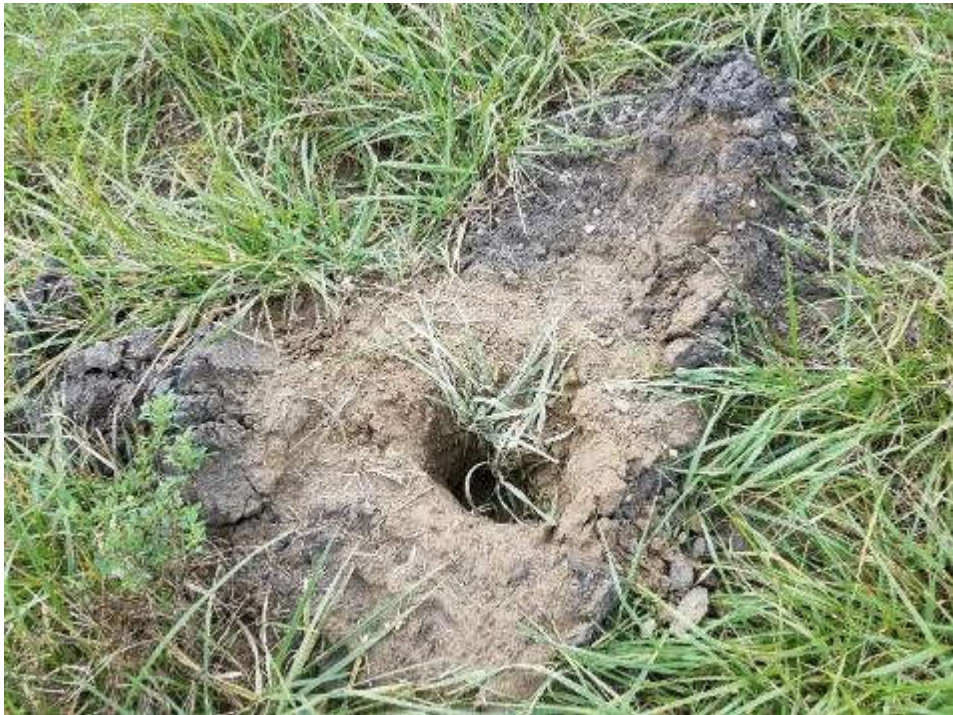
Grid ID P-18	Photo ID 9

Date November 2, 2021		
Description: East slope – hole in cover, exposed CCR

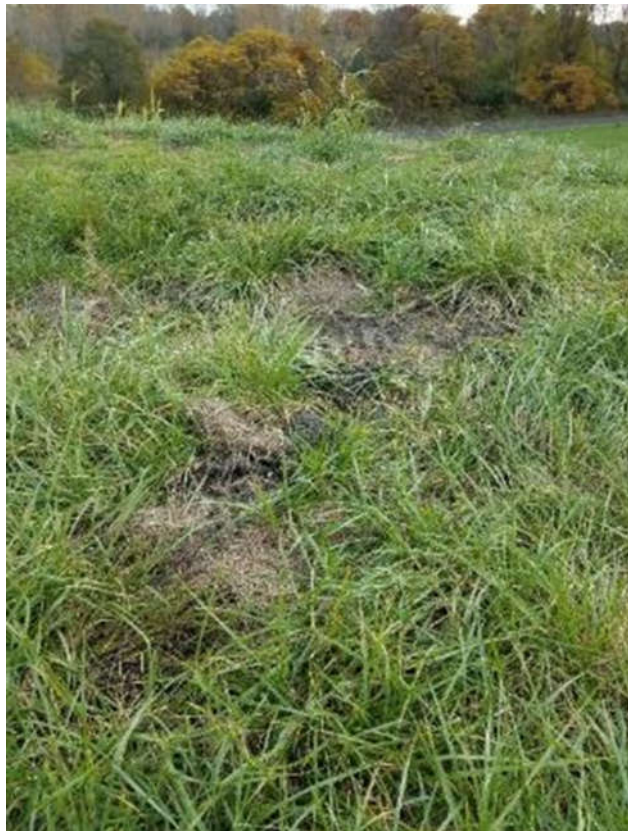
Grid ID P-16	Photo ID 10

Date November 2, 2021		
Description: East slope near north end – more exposed CCR

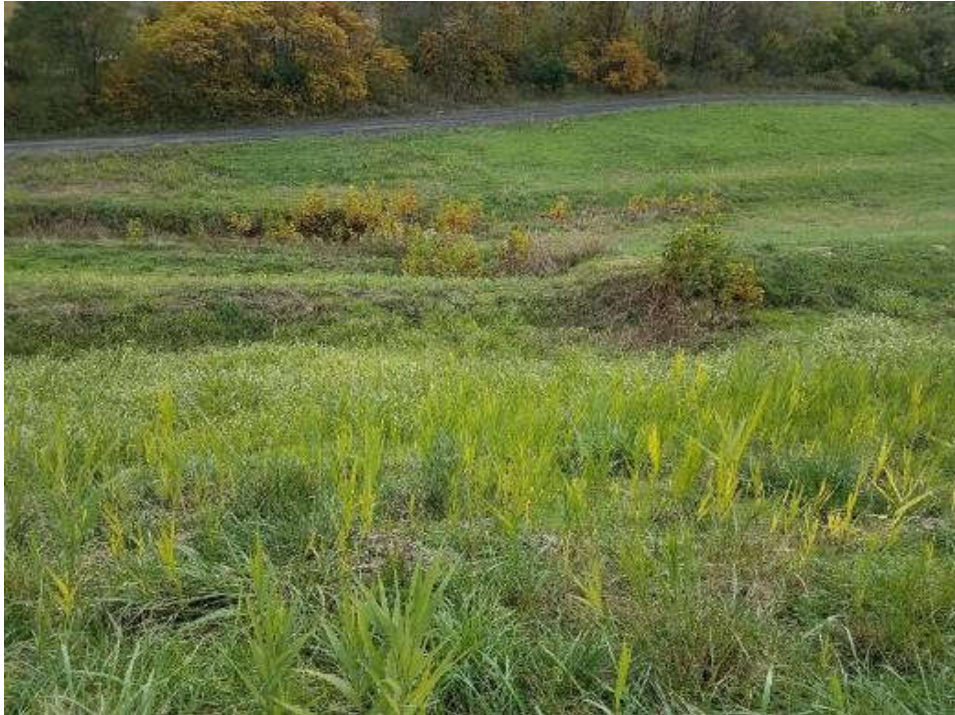
Grid ID Q-16	Photo ID 11

Date November 2, 2021		
Description: East slope near north end – drainage channel for lower berm

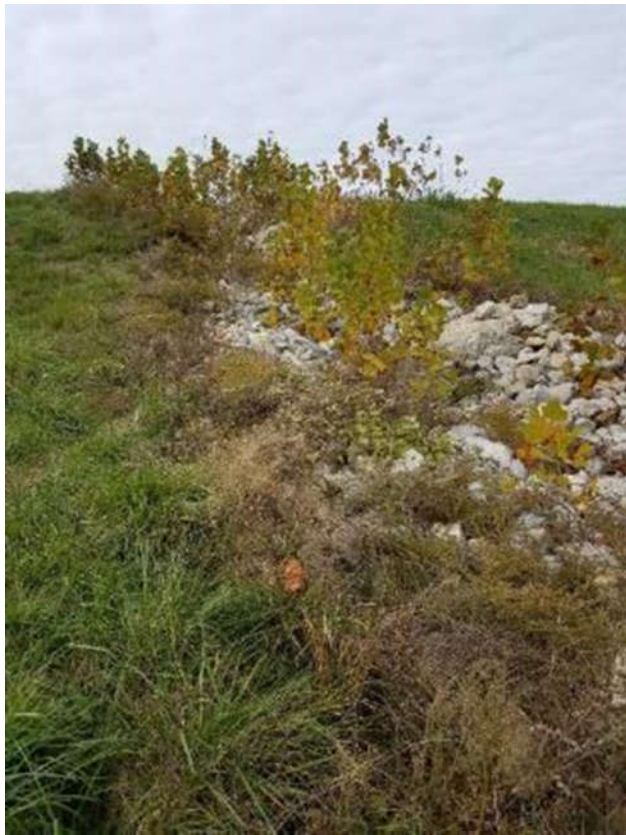
Grid ID P-14	Photo ID 12

Date November 2, 2021		
Description: NE corner – rip rap channel

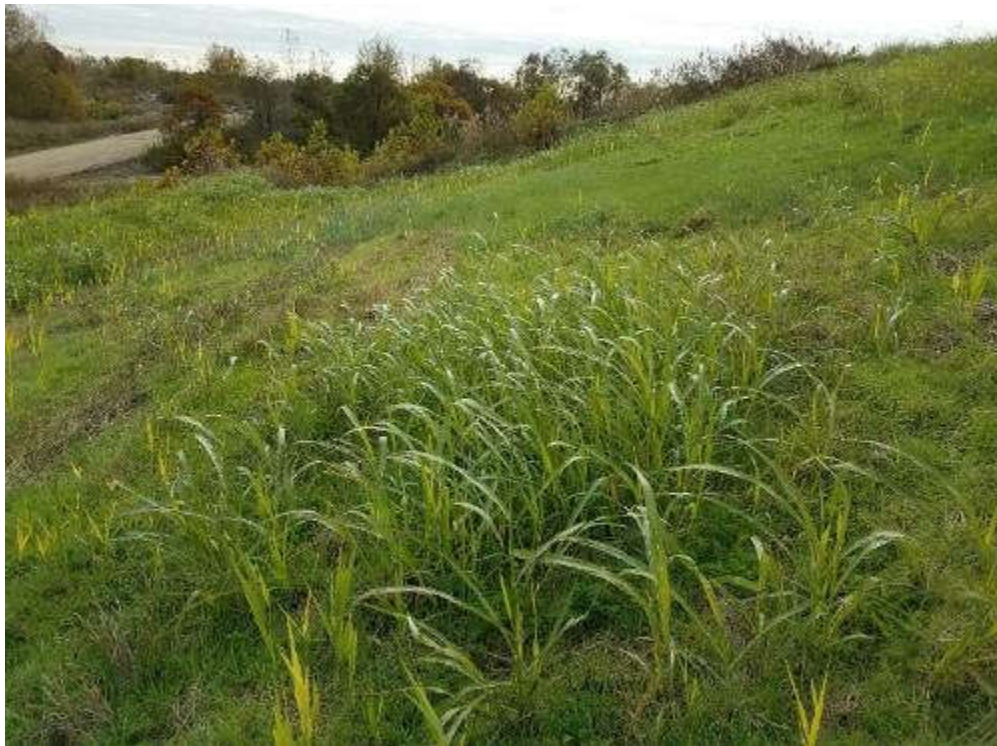
Grid ID P-13	Photo ID 15

Date November 2, 2021		
Description: N slope – appears to have been re-seeded this year. More vegetation cover than last year

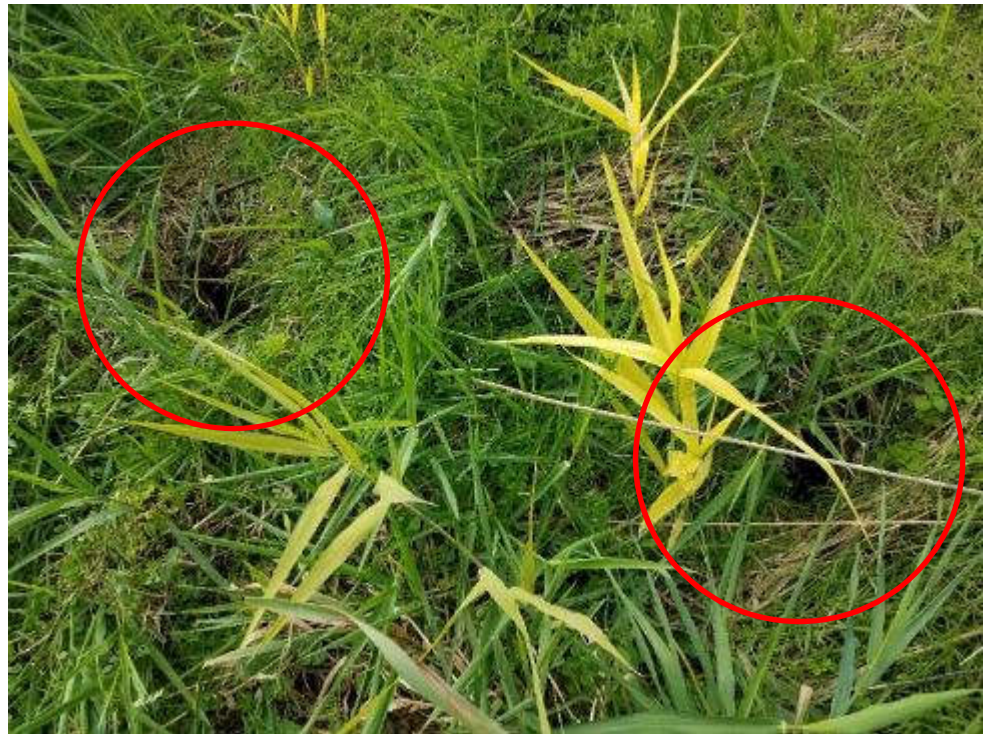
Grid ID O-12	Photo ID 17

Date November 2, 2021		
Description: NW corner – hole in cover near down drain pipes. Hole on left, drain pipe on right.

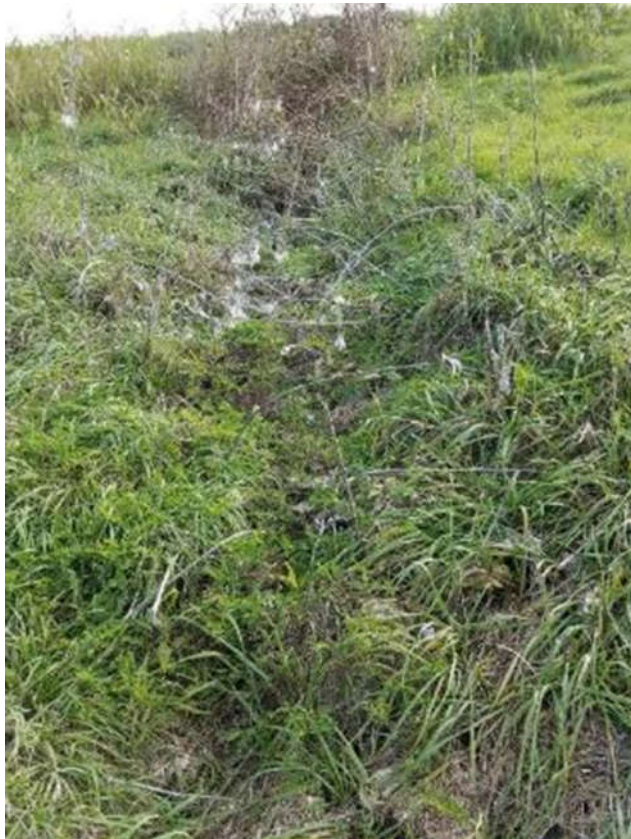
Grid ID O-12	Photo ID 18

Date November 2, 2021		
Description: NW corner – upper drain channel in decent condition

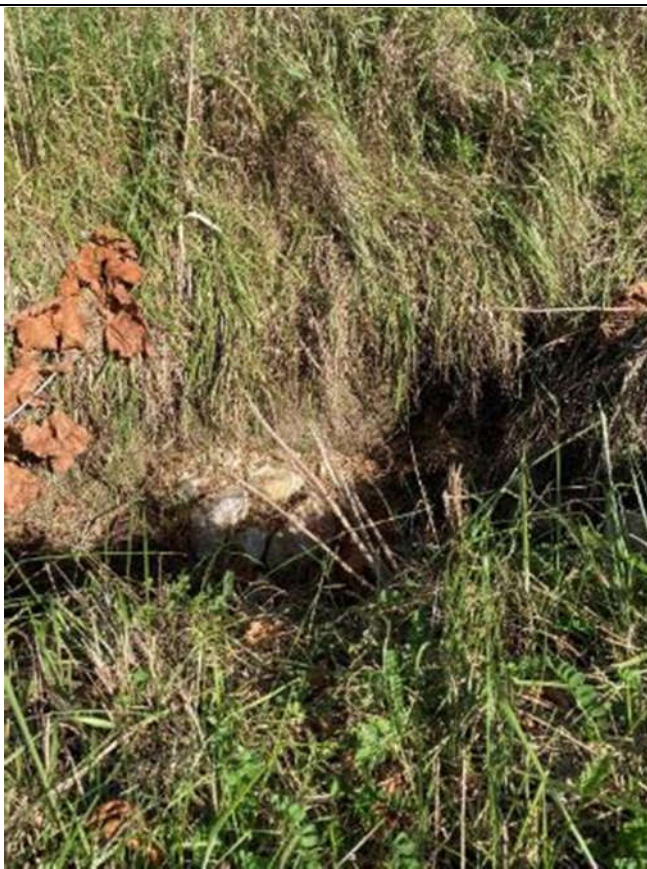
Grid ID L-25	Photo ID 35

Date November 2, 2021		
Description: Main LF access road – erosion along road side
