SCS ENGINEERS

December 21, 2017
File No. 25211357.33

Subject: Dike Inspection - Petersburg Generating Station Ash Pond Facilities
2017-1, November 17, 2017

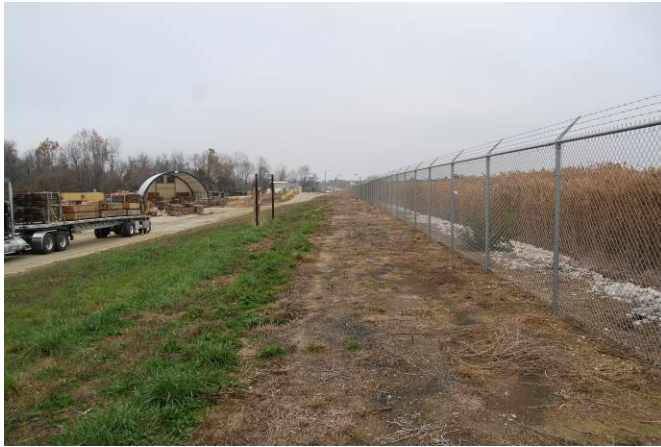
- a. No significant problems were observed during the inspection.
- b. Pond A had limited capacity at the time of this inspection.
- c. There was sluicing of bottom ash and scrubber sludge going on into Pond A at the time of the inspection. This sluicing is scheduled to continue until April 2018 at the present time.
- d. There has been an emergency spillway constructed in the intermediate dike between Pond A and Pond A'. The spillway was recommended and designed by CH2MHill. The spillway was constructed and operational at the time of this inspection.

Photo 1: Pond A west dike, looking north

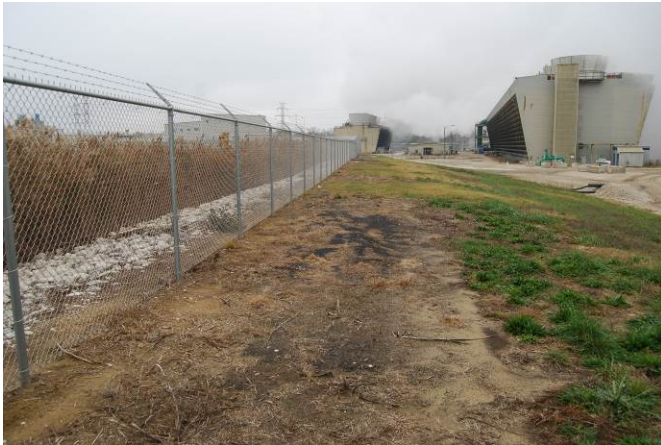
Photo 2: Same as Photo 1, looking south

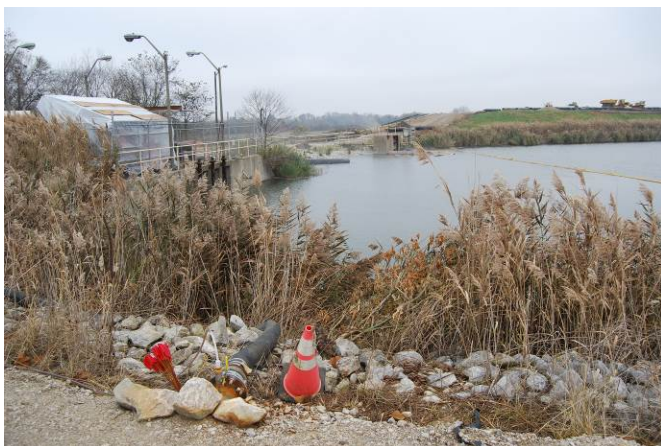
- a. No significant problems were observed during the inspection.
- b. Discharge pipe from Pond A Discharge to Lick Creek was visible at the time of this inspection. Rip rap on the downstream slope of Pond A Discharge dike appeared stable. The exposed end of the discharge pipe looked in good condition.
- c. CH2MHill also recommended and designed an emergency spillway on top of the downstream dike for Pond A'. The spillway was constructed and operational at the time of this inspection.

Photo 3: Pond A Discharge, looking north

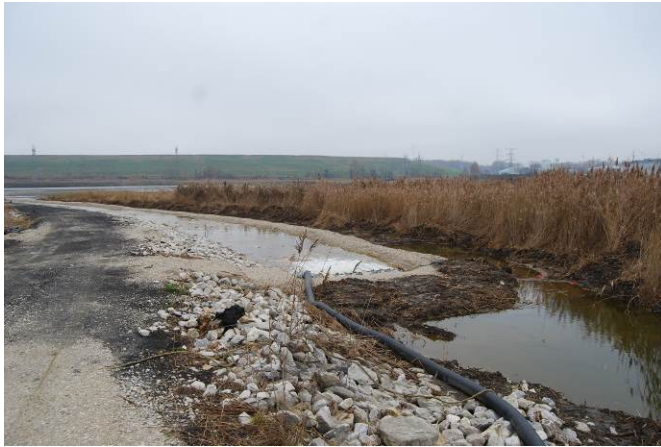
Photo 4: Discharge into Pond A from plant, looking east from south dike of Pond A Discharge

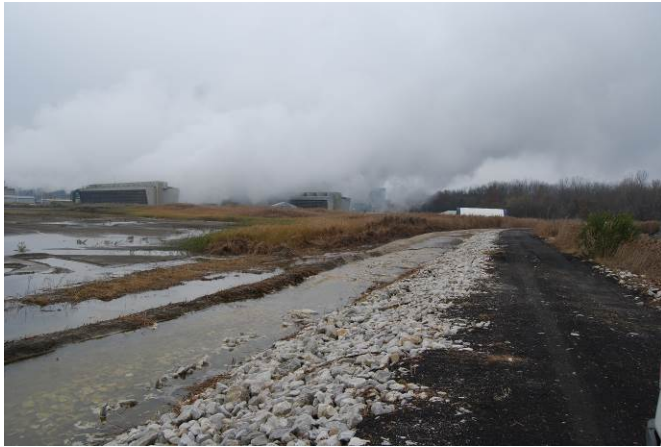
Photo 7: Pond A, looking southwest from south dike of Pond A Discharge

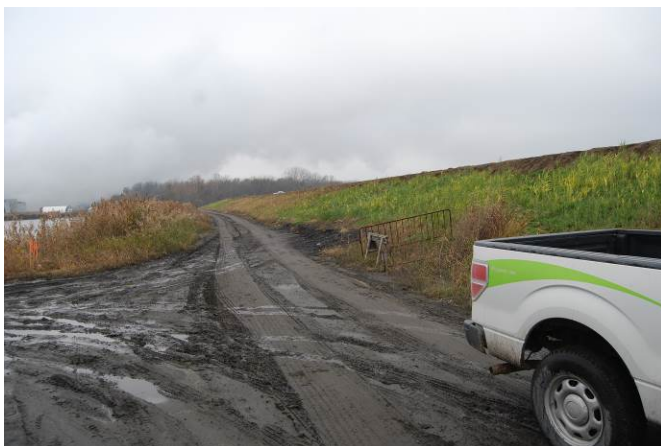
Photo 12: South upper lift of perimeter dike of Pond B, looking west

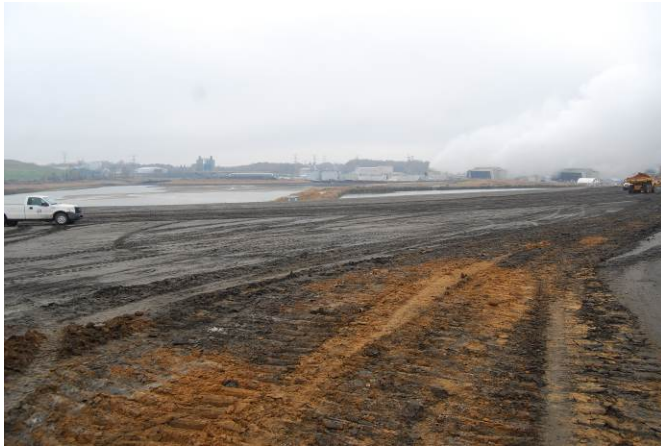
Photo 13: Pond B closure activities, looking south from the center of Pond B

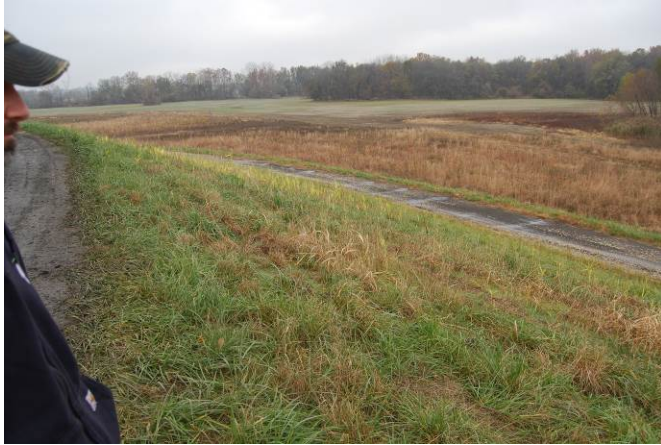
Photo 22: Typical conditions on the exterior of the west side of the lower dike of Pond B, looking southwest

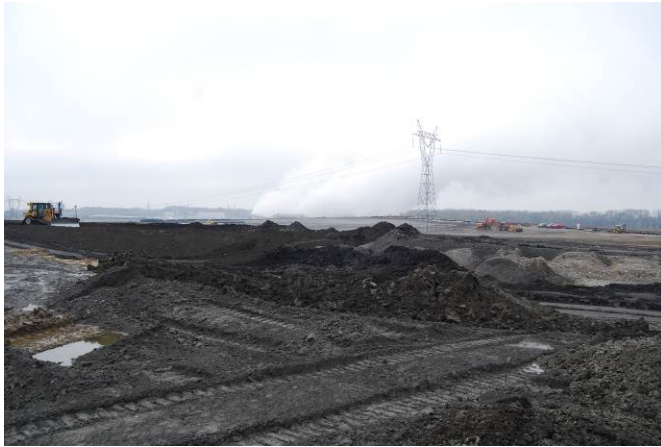
Photo 25: Closure activities on the top of Pond C, looking south

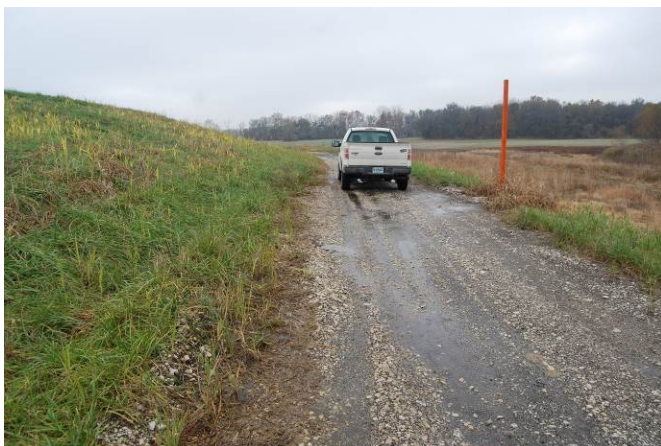
Photo 33: Fluid conditions at the toe of the upper dike of the northeast corner of Pond C. Heavy rainfall occurred in the days prior to the inspection. No active visual seepage occurring at the time of the inspection. Looking west.

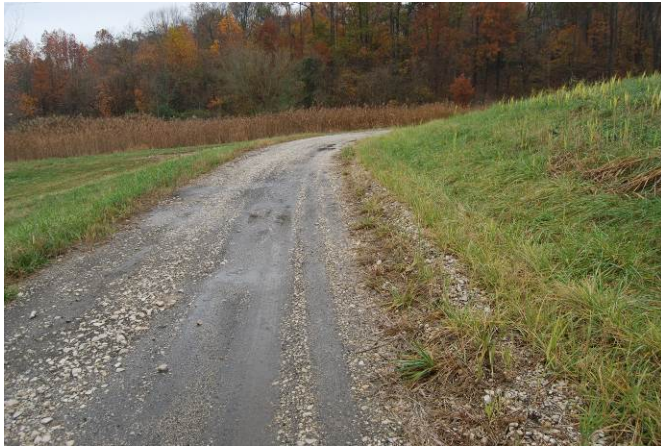
Photo 34: Same as Photo 33, looking east

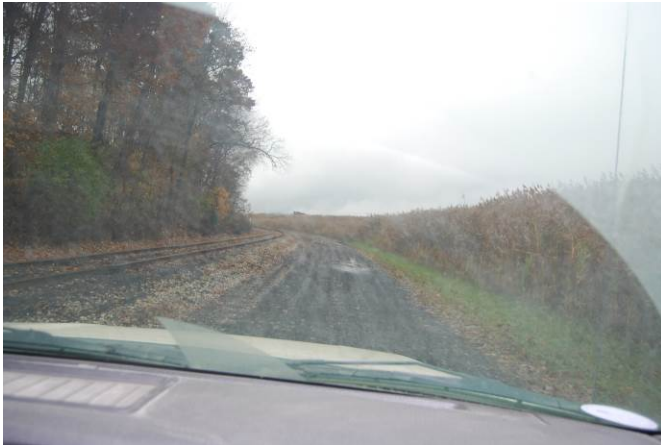
Photo 35: Typical conditions along west perimeter dike of Pond C, looking south

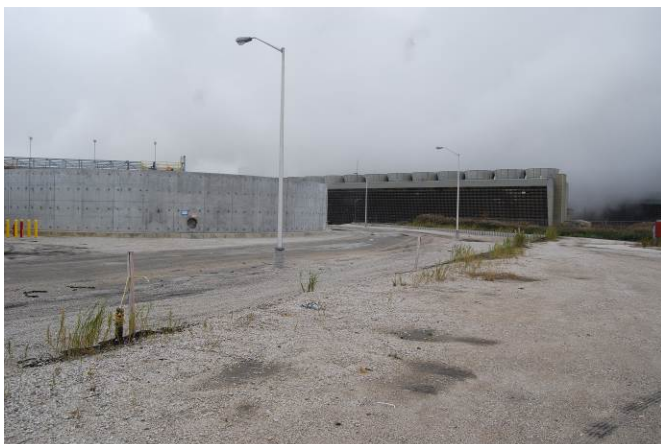
Photo 36: Fill surface of former Pond D – bottom ash storage area. Area is presently paved with a gravel surface and not being used for ash processing. Looking west.
