**2016 VISUAL SITE INSPECTION
IPL PETERSBURG RESTRICTED WASTE TYPE III LANDFILL**

IPL PETERSBURG GENERATING STATION
6925 NORTH STATE ROAD 57
PETERSBURG, INDIANA 47567

ATC PROJECT NO. 170LF00279

DECEMBER 27, 2016

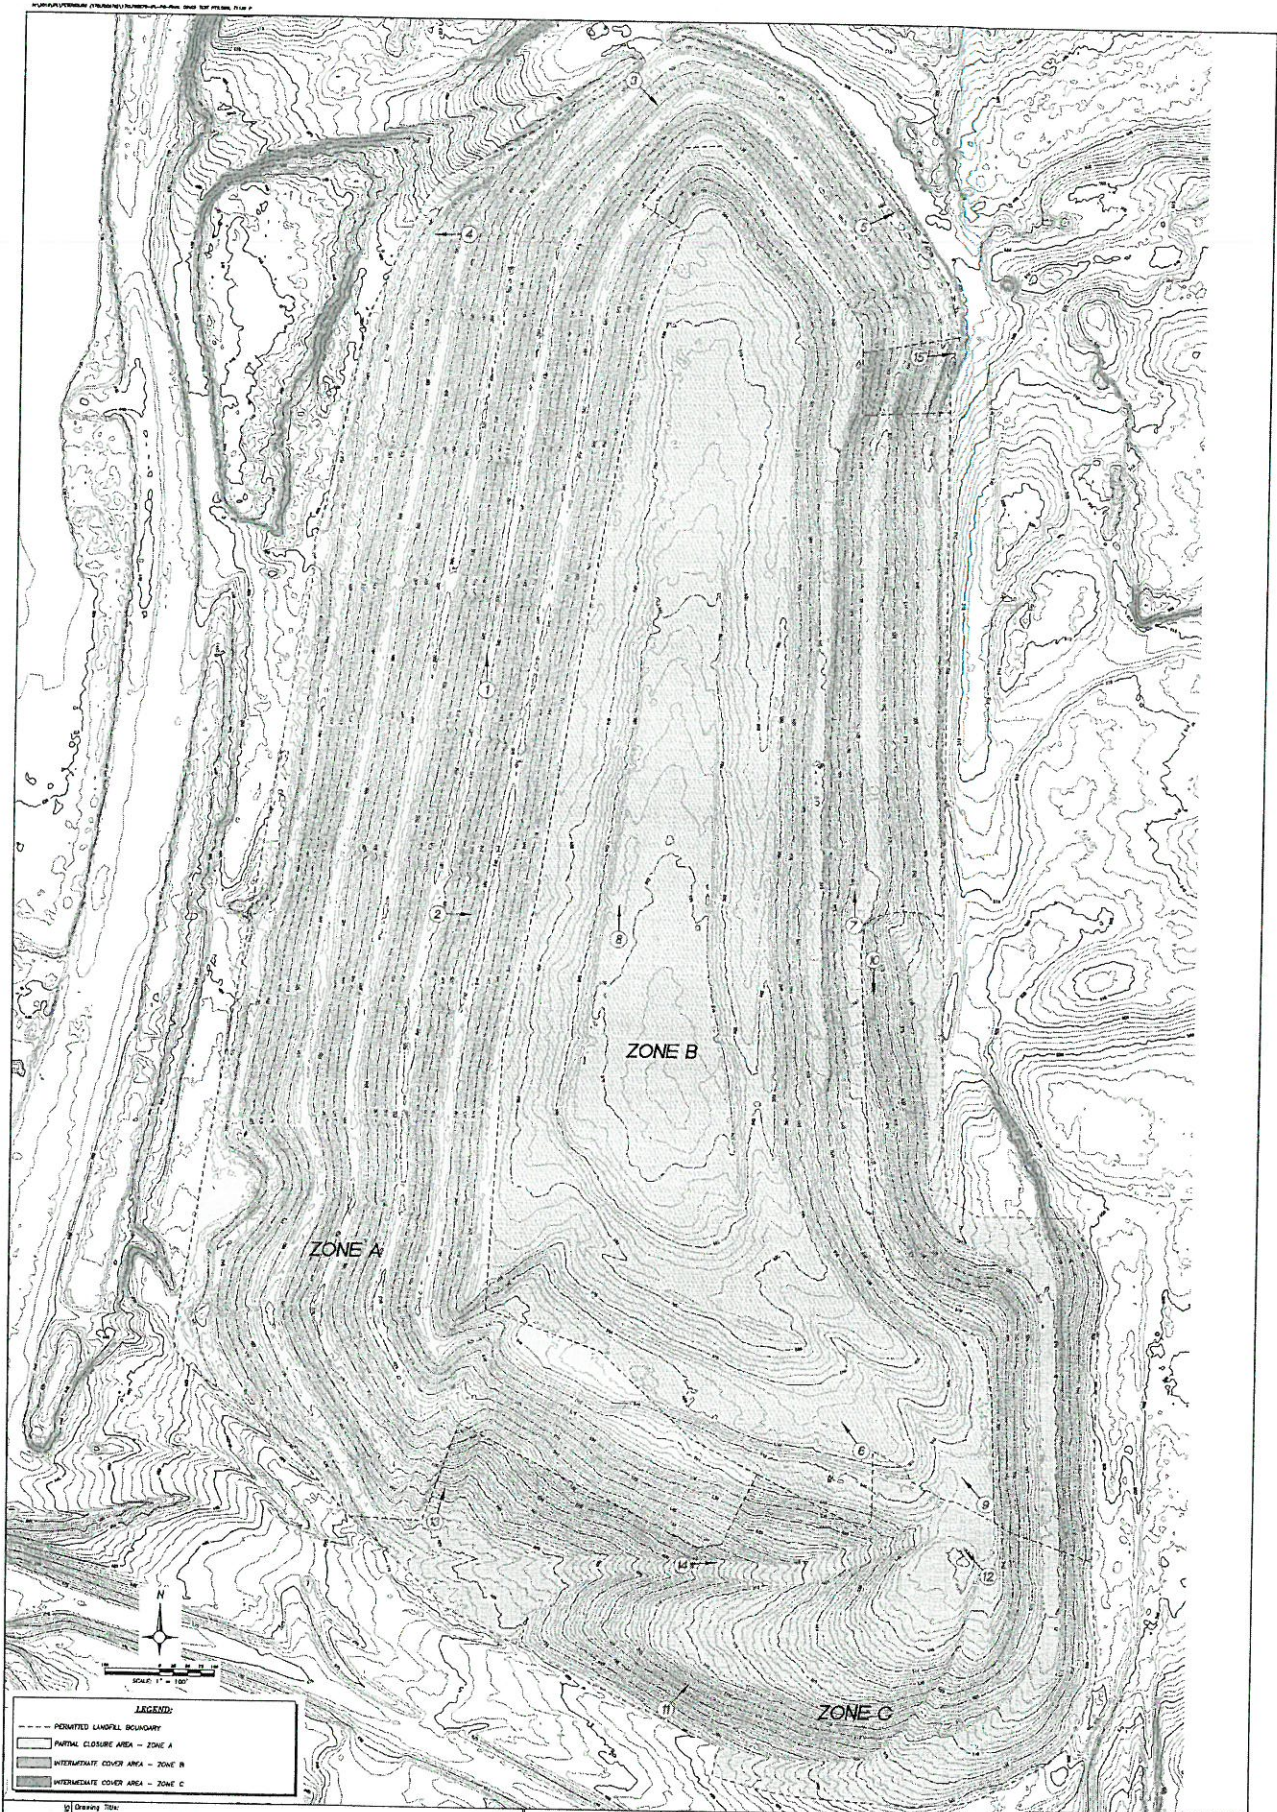
1
 Drawing Title:
 2016 LANDFILL INSPECTION
 IFL PETERSBURG GENERATING STATION

1. Good vegetation exists along the majority of the west and north slopes (Location 1).
2. A few areas along the west-central slope still have bare soil areas and/or ruts.

- o Recommendation: Fill in ruts and overseed bare soil areas as needed (See Location 3).
4. Some culvert inlets passing through erosion control berms along downchute alignments have become partially blocked due to settlement of riprap and debris accumulation (See Location 4). One culvert on the northeast corner of the landfill has been damaged. (See Location 5).

1. At the time of inspection, the intermediate cover was well compacted with areas of minor erosion noted (See Locations 6, 7, and 8).
 - Recommendation: Repair erosion features and control transport of eroded material until soil cover is applied.
2. Downcutting has occurred along the left side (oriented facing uphill) of the haul road leading to the top of the slope (See Location 9).
 - Recommendation: Fill in the downcutting channel, place erosion protection and overseed the bare soil.

1. Good vegetation exists along the majority of the south slope and southeast corner (Locations 10 and 11).
2. An area of sparse vegetation was noted near the convergence of haul roads on the south sideslope (See Location 12).

- Recommendation: Overseed the bare soil surface.
3. Gully erosion has formed along the left overbank (oriented facing downstream) of the riprap downchute channel at the southwest corner of the landfill. Flow is bypassing the channel at the base and creating a separate overland flow channel which undermines the soil cover for that area (See Location 13).

4. Downcutting has occurred in ditches along both sides of the haul road leading up to the top of the landfill (See Location 14).

- o Recommendation: Fill in ruts and overseed bare soil areas as needed (See Location 2).
3. An improvised access road at the northwest corner of the landfill has caused some minor rutting and erosion.

- o Recommendation: Establish a regular visual inspection and maintenance program for all culverts along downchute paths and perimeter ditches. Remove blockage and repair damaged culverts to restore proper flow.

- Recommendation: Fill in the erosion gully and regrade soil along the bank to slope towards channel center. Overseed the area and utilize an erosion control mat until vegetation is established.

- Recommendation: Fill in undercut areas in channels adjacent to the haul road and repair vegetative cover. Utilize erosion control mat until vegetation is established.
5. The perimeter ditch near the haul road entrance at the northeast corner of the landfill has erosion along the overbank (Location 15).
- Place erosion control protection along the side of the channel bank where erosion has occurred and revegetate.
