SCS ENGINEERS

January 27, 2017
File No. 25211357.33

Subject: Dike Inspection - Petersburg Generating Station Ash Pond Facilities
2016-1, August 23, 2016

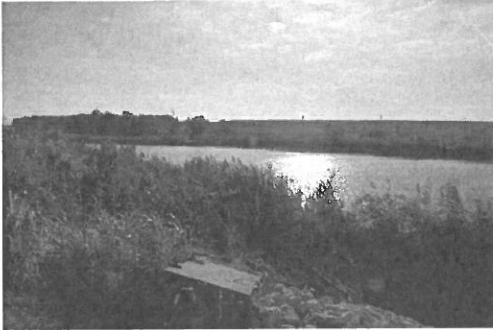
Photo 1: Pond A Discharge, looking southeast from northwest corner.

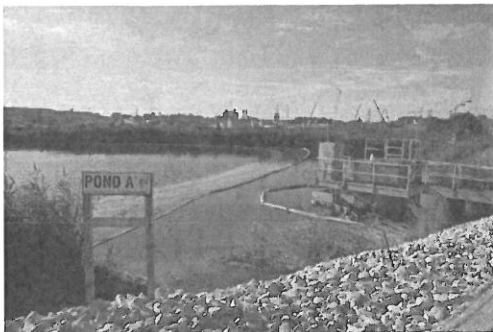
Photo 2: Same as Photo 1, looking south.

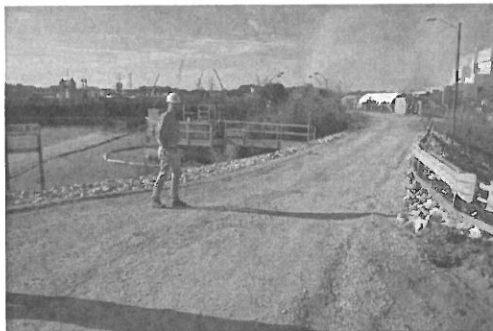
Photo 3: West Perimeter Dike of Pond A Discharge.

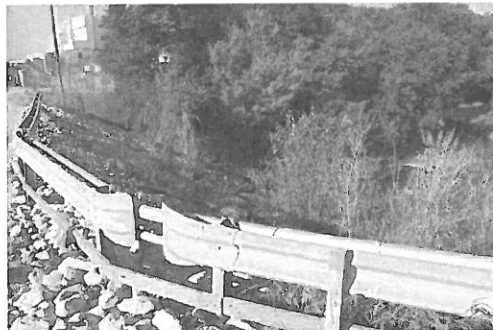
- a. No significant problems observed during the inspection.
- b. Discharge pipe from Pond A Discharge to Lick Creek was visible at the time of this inspection. Rip-rap on the downstream slope of Pond A Discharge dike appeared stable. The exposed end of the discharge pipe looked in good condition.

Photo 4: Downstream slope of Pond A Discharge, looking south.

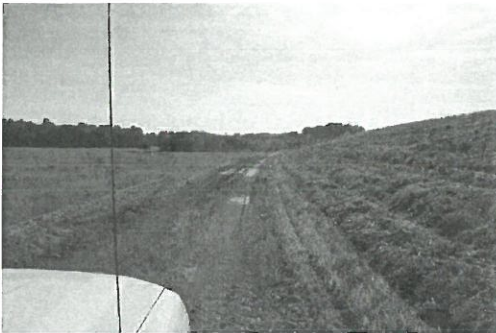
Photo 5: West Upper Perimeter Dike of Pond C, looking north from center of Pond C. Note seepage on roadway. No signs of fine material present.

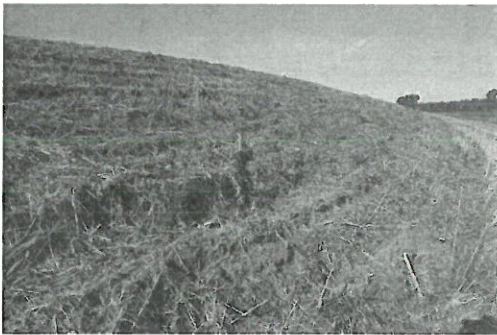
Photo 6: Typical condition of downstream slope of Upper Perimeter Dike of Pond C at the time of the inspection. Looking south. Recently mowed.

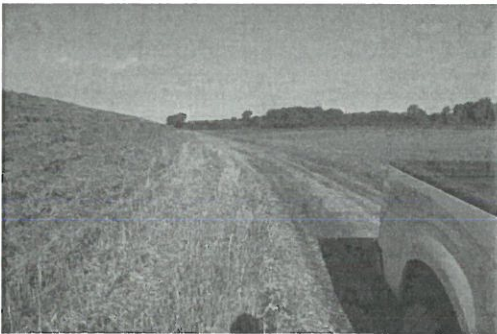
Photo 7: Same as Photo 6, looking south.

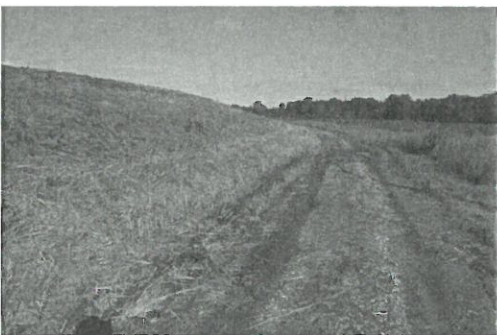
1. There were continuing visual signs of seepage occurring in the northeast corner of Pond C. The amount of seepage appeared to be somewhat less than amounts observed during previous uses of Pond C. We recommend close observation of the toe of the upper lift of Pond C be continued and that any changes to the nature and extent of seepage or movement of materials be identified to Mr. Hendron immediately.

Flow Rate **Significant seepage noted on toe of upper lift of Pond C as described earlier in this report.**

Photo 8: Same as Photo 7 taken in the northeast corner of Pond C, looking southwest. Note seepage along the toe of the slope. No fine materials observed. Water levels in Pond C had been significantly reduced below maximum levels.

1. We recommend that daily inspections of the perimeter dike of Pond C be accomplished until the water accumulation from the last dredging of Pond A is eliminated and the visual signs of seepage and loss of any fine material are also eliminated. If any visual changes in the seepage or movement of materials are detected, we recommend that IPL call Mr. Hendron immediately to discuss in detail.

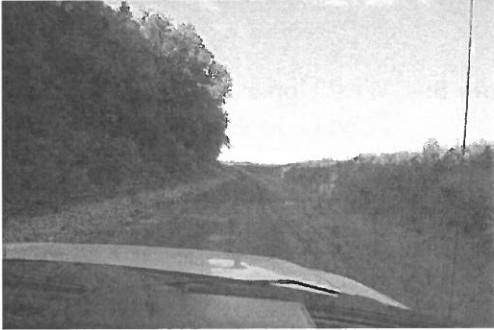
Photo 9: Typical conditions along the eastern perimeter slope of Pond C. No significant seepage noted.

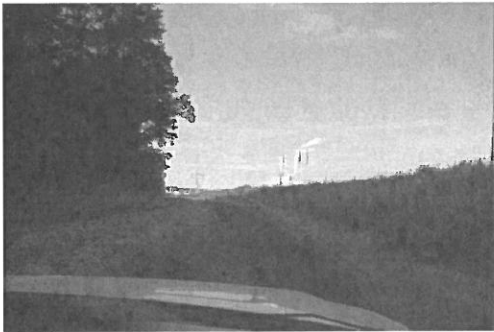
Photo 10: Same as Photo 9 further south along the perimeter dike.

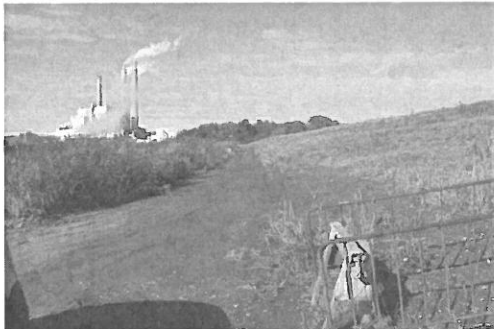
Photo 11: Roadway along the northern boundary of Pond A adjacent to the upper dike of Pond B. No seepage noted. Looking west from the northeast corner of Pond A.

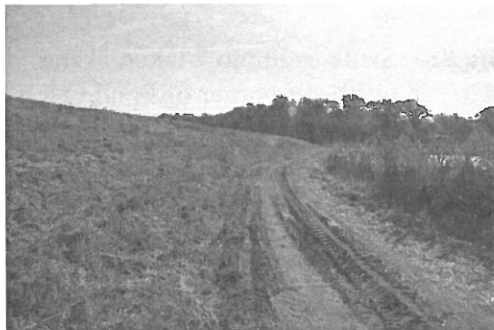
Photo 12: Same as Photo 11, looking east from center of Pond A.

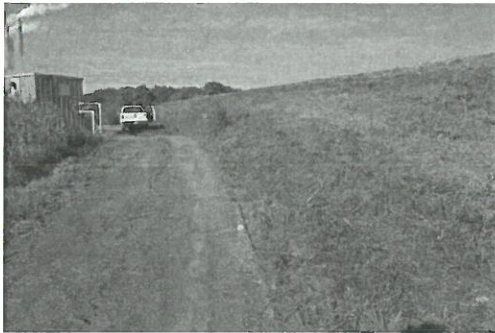
Photo 13: Same as Photo 12, looking west from center of Pond A.

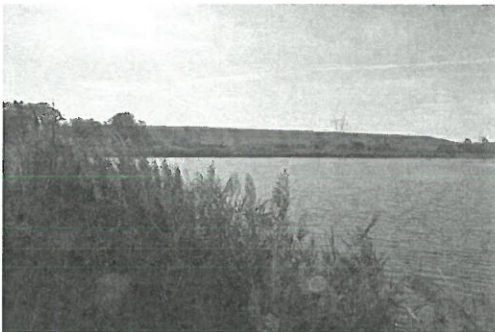
Photo 14: Pond A, looking east from center of the north perimeter of Pond A.

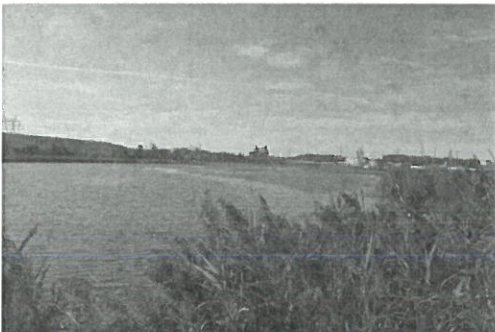
Photo 15: Same as Photo 14, looking southeast.

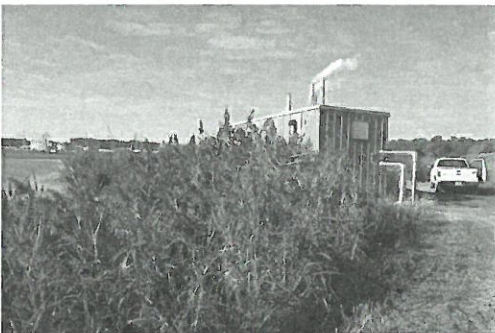
Photo 16: Water treatment facilities along the north perimeter road of Pond A.

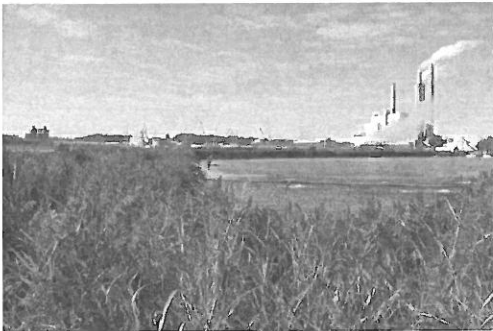
Photo 17: Pond A Discharge, looking south from the northeast corner of Pond A Discharge.

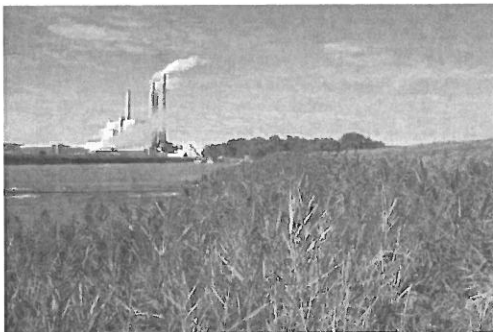
Photo 18: Same as Photo 17, looking southwest.
