SCS ENGINEERS

February 17, 2016
File No. 25211357.33

Subject: Dike Inspection - Petersburg Generating Station Ash Pond Facilities
2015-2, November 12, 2015

**Petersburg Plant – Photos from 15-2 Inspection
2600 State Highway 57 North
SCS Engineers Project #25211357.33**

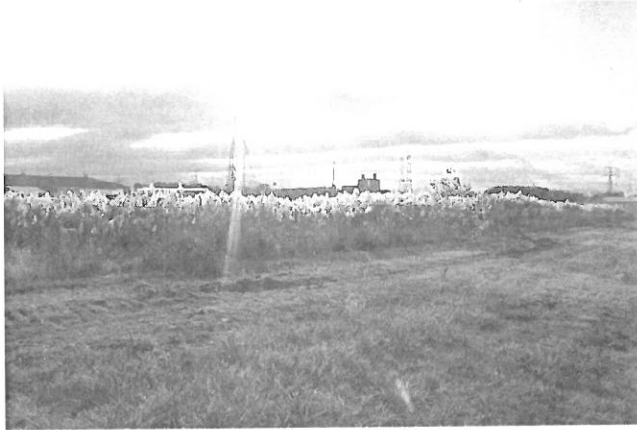
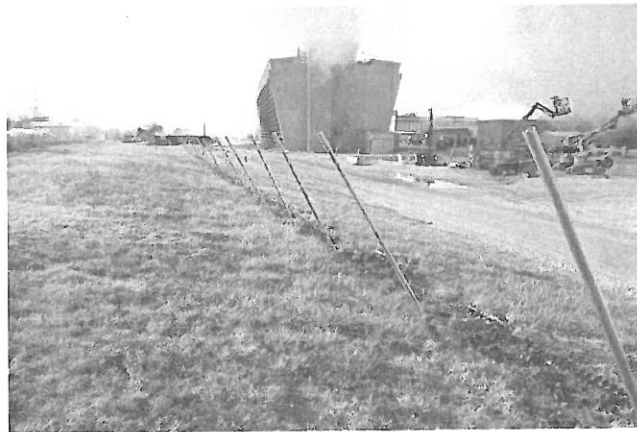
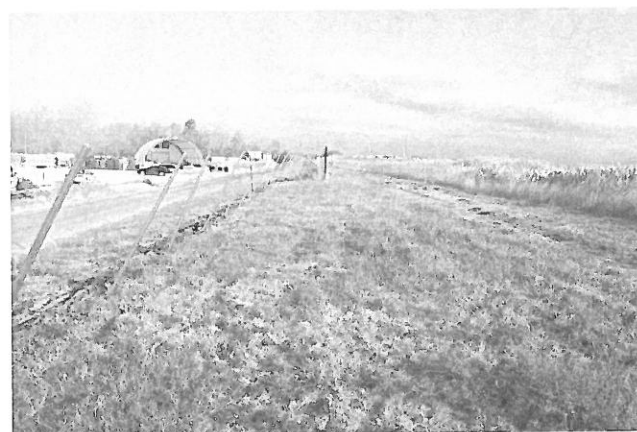
Photo 1: Downstream slope of Pond A, looking south.

Photo 2: Same as Photo 1, looking southwest.

Photo 3: Same as Photo 1, looking north.

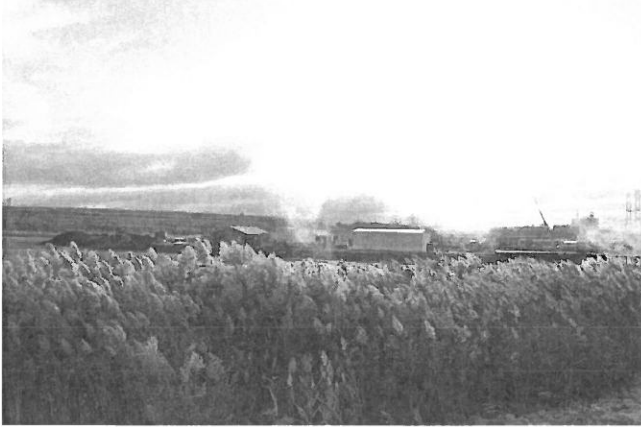
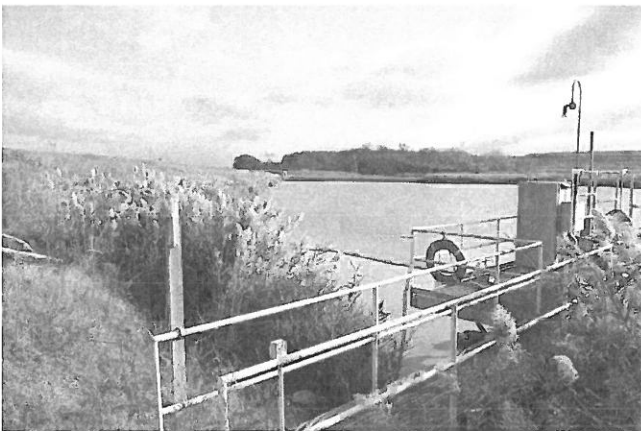
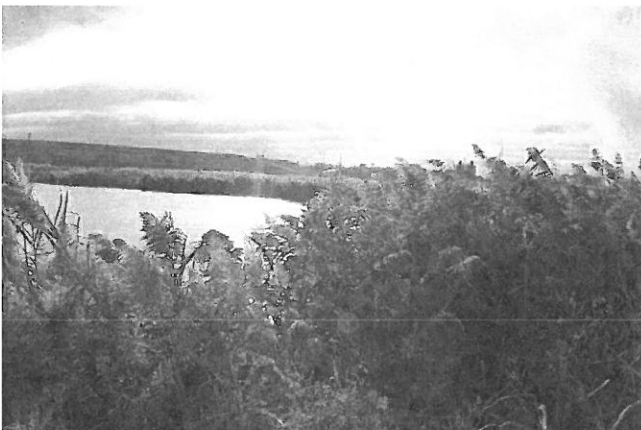
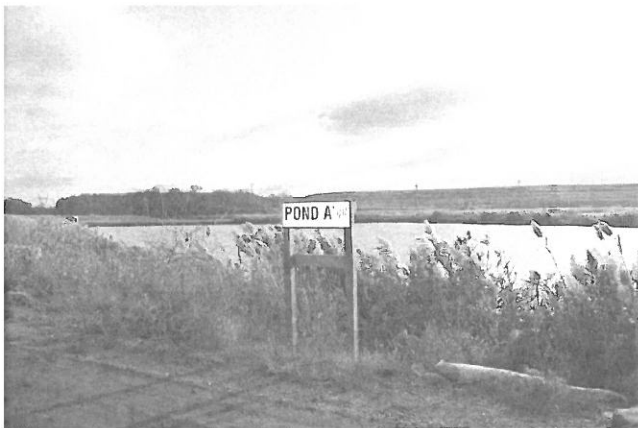
1. No significant problems were observed during the inspection.
2. Pond A dredging was completed about two weeks prior to the time of the inspection.
3. There will be no further ash sluicing into Pond A except for bottom ash.

Photo 4: Looking southeast across Pond A.

Photo 5: Pond A. looking east.

Photo 6: Pond A, looking south.

Photo 8: Pond A, looking southeast.

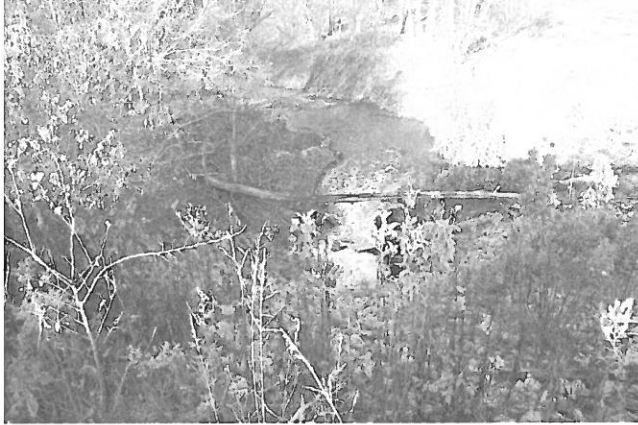
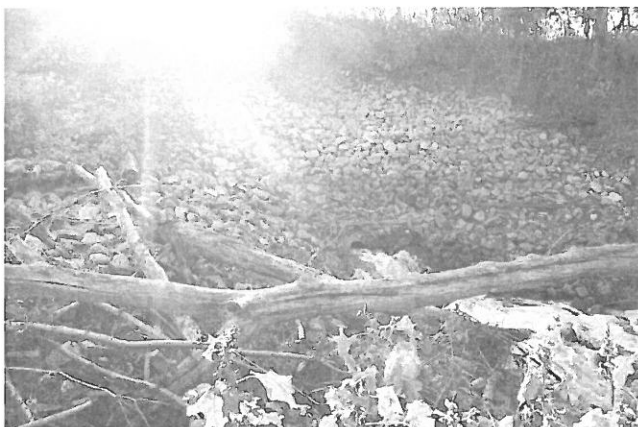
1. No significant problems were observed during the inspection.
2. Discharge pipe from Pond A Discharge to Lick Creek was visible at the time of this inspection. Rip-rap on the downstream slope of Pond A Discharge dike appeared stable. The exposed end of the discharge pipe appeared to be in good condition.

Photo 7: Discharge from Pond A into Lick Creek.

Photo 9: Pond A discharge into Lick Creek, looking southeast into the discharge pipe and rip-rap.

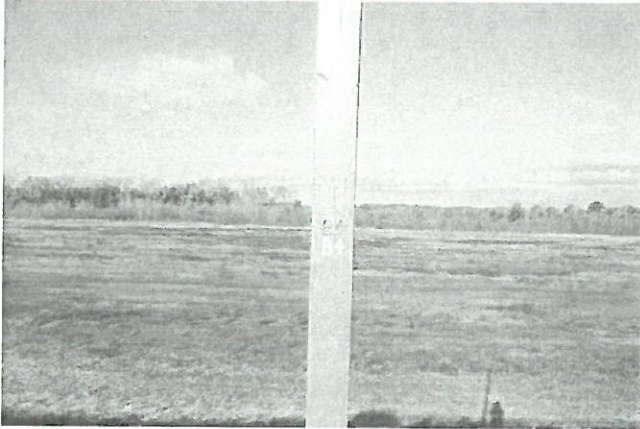
Photo 10: Marker for Piezometer B-4.

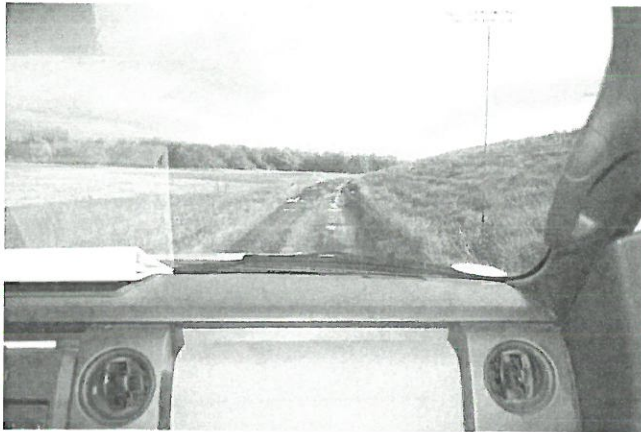
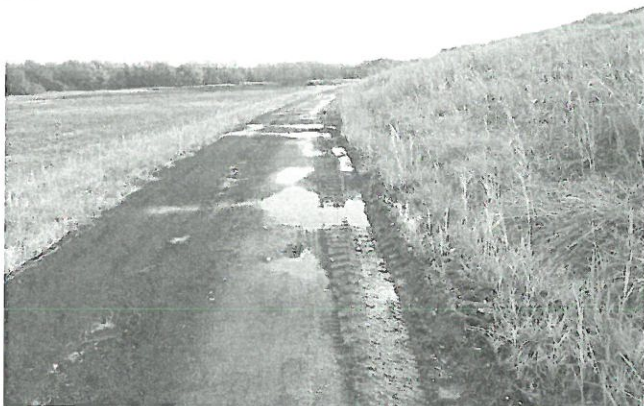
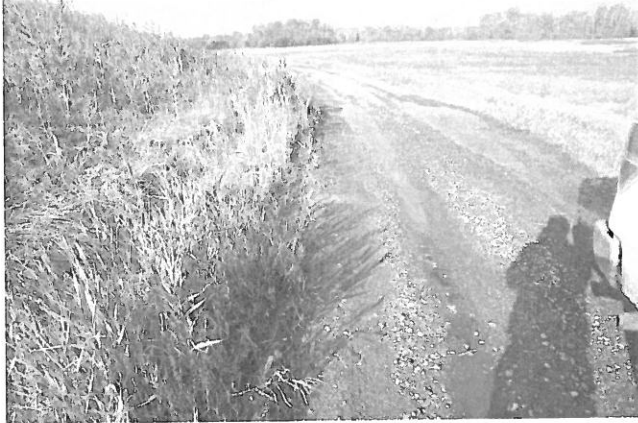
1. There were continuing visual signs of seepage occurring in the northeast corner of Pond C. The amount of seepage appeared to be somewhat greater than amounts observed during previous uses of Pond C. Additionally, there was substantial evidence of discoloration of the seepage fluids caused by the presence of fine material observed in the seepage occurring in this area of Pond C at the time of the inspection. We recommend close observation be continued to observe any changes to the nature and extent of seepage or movement of materials. IPL should notify Mr. Hendron immediately if changes are observed.

Photo 11: West slope of Pond C, looking north. Note seepage on the intermediate roadway.

Photo 12: Same as photo 11.

Photo 13: Same as Photo 12, looking southwest from the Northwest corner of Pond C.

1. We recommend that daily inspections of the perimeter dike of Pond C be accomplished until the water accumulation from the last dredging of Pond A is eliminated and the visual signs of seepage and loss of fine material are also eliminated. If any visual changes in the seepage or movement of materials are detected, we recommend that IPL call Mr. Hendron immediately to discuss in detail.

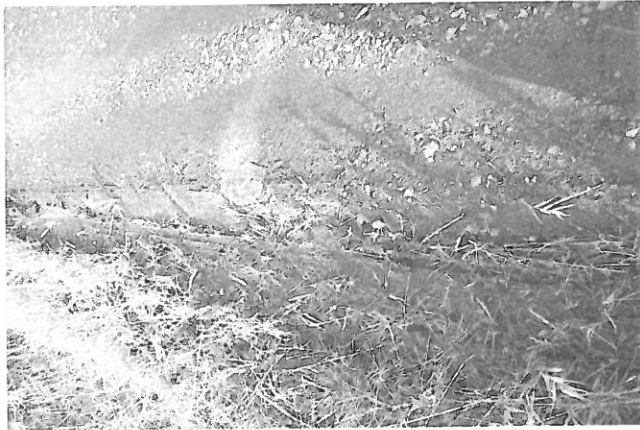
discoloration also noted in the seepage.

Notes/Causes: The seepage is a result of the accumulation of water in Pond C during last dredging of material from Pond A. This dredging work had been completed at time of the inspection. Monitoring of the nature and extent of the seepage and movements in the area of seepage are recommended. If changes occur, it is recommended that IPL notify Mr. Hendron immediately.

Photo 14: Close up of seepage showing white discoloration.

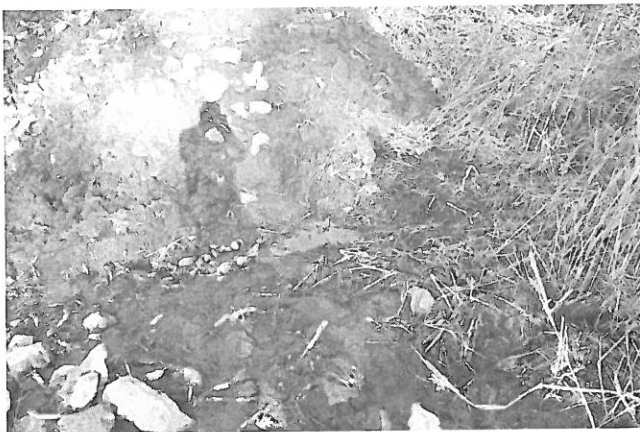
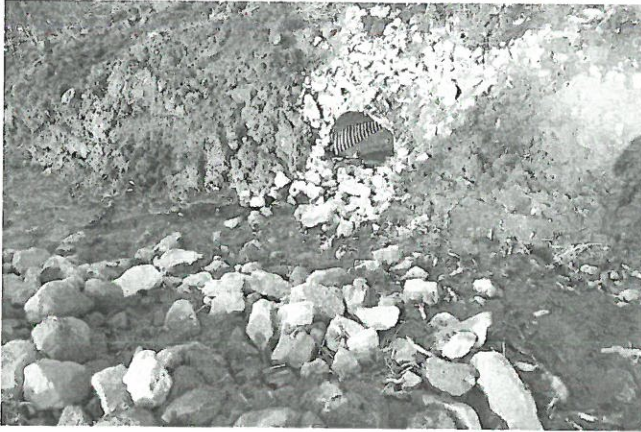
Photo 15: Flow in the ditch along the East perimeter dike of Pond C.

Photo 16: Same as photo 15.

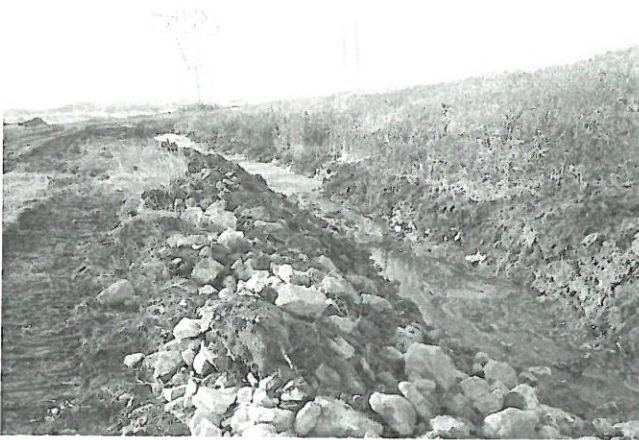
Photo 17: Excavation of the perimeter ditch along the East perimeter dike of Pond C, looking south.

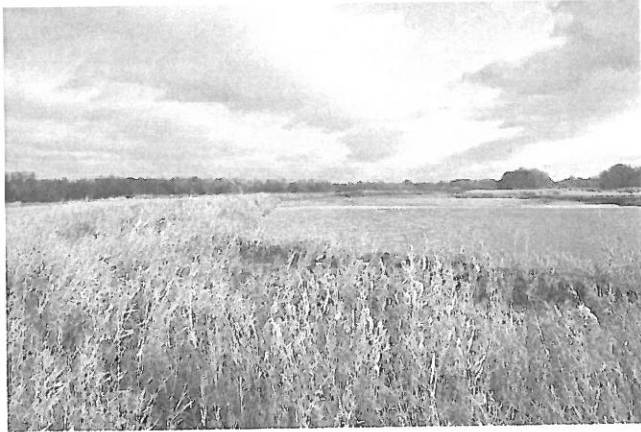
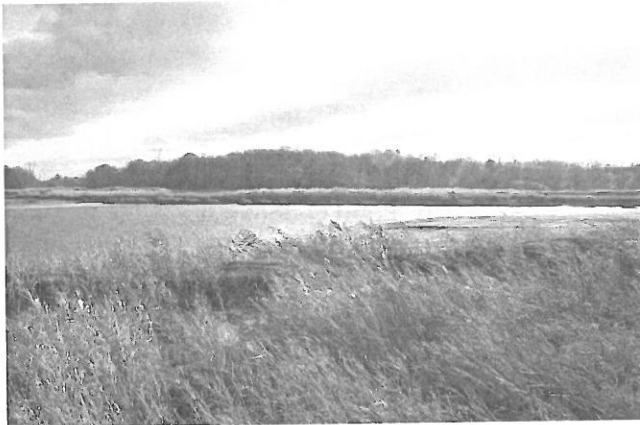
Photo 20: Surface water collecting in Pond C.

Photo 21: Surface water collecting in Pond C, looking northeast.

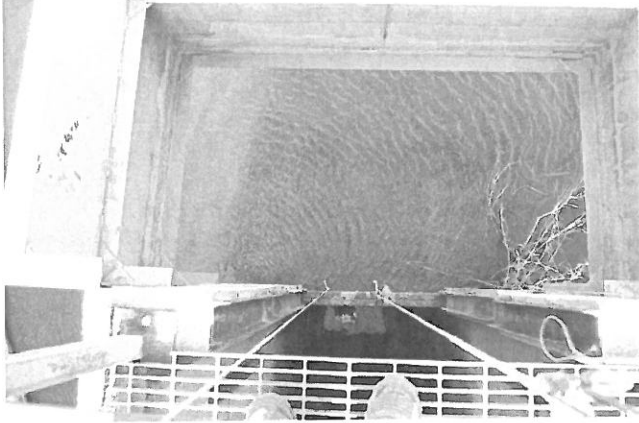
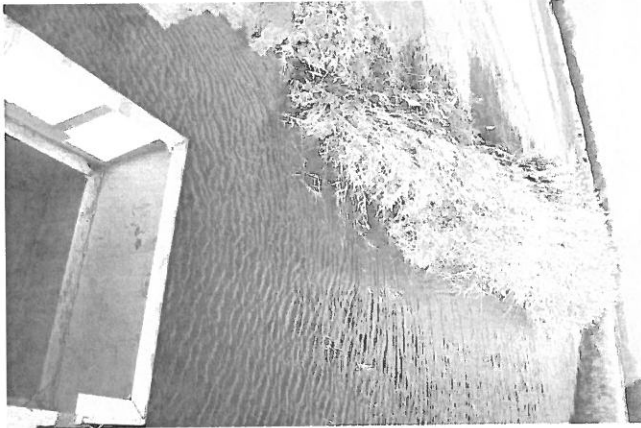
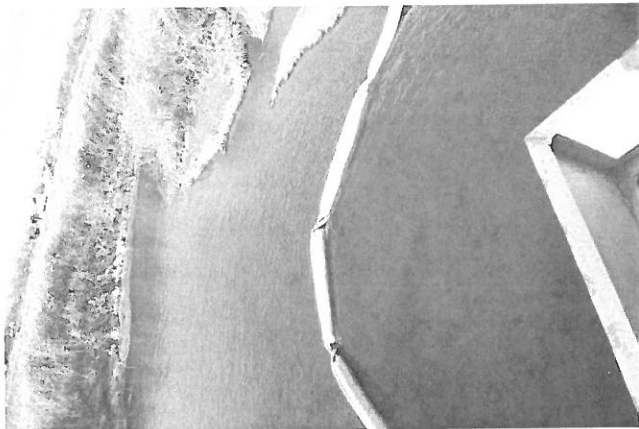
Photo 25: Water level in the discharge box from Pond C.

Photo 26: Same as Photo 25.

Photo 27: Same as Photo 25.
