**2022 VISUAL SITE INSPECTION
AES INDIANA PETERSBURG RESTRICTED WASTE TYPE III LANDFILL
SOLID WASTE FACILITY PERMIT NO. FP63-02**

AES INDIANA PETERSBURG GENERATING STATION
6925 NORTH STATE ROAD 57
PETERSBURG, INDIANA 47567

ATLAS PROJECT NO. 170LF01358

DECEMBER 23, 2022

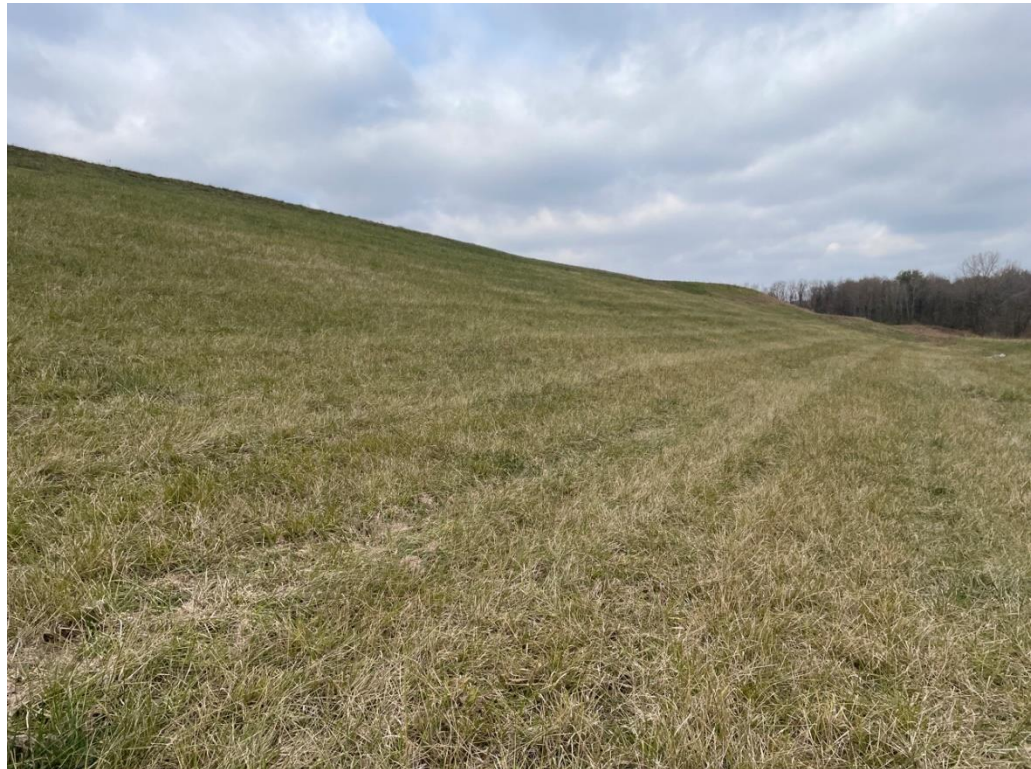
Grid ID P-18	Photo ID 3

Date November 17, 2022		
Description: Vegetation well established on the east side of the landfill. Lower east slope. Photo looking north.

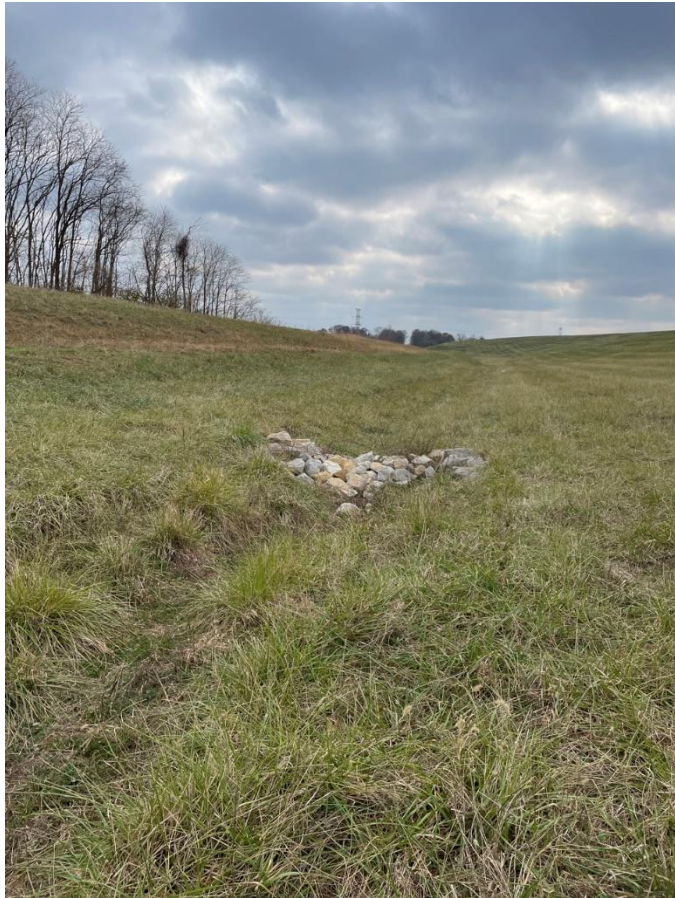
Grid ID Q-17	Photo ID 4

Date November 17, 2022		
Description: Vegetation well established along the east slope of the landfill and around a rock check dam. Lower east slope. Photo looking south.

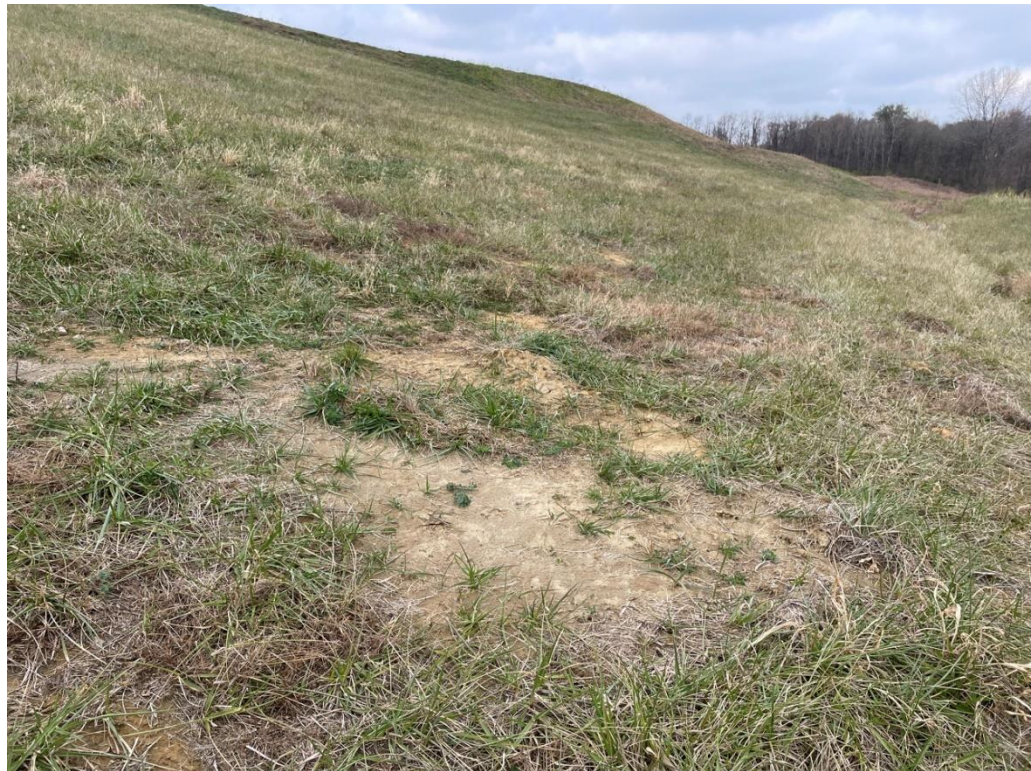
Grid ID P-17	Photo ID 5

1. Good vegetation exists along the majority of the south end of the landfill, top of landfill and east slope (e.g., locations Q-23, P-21, P-18, Q-17 of Figure 3).
2. A minor sparse vegetation area (location P-17 of Figure 3) and an animal burrow area (location P-16 of Figure 3) were observed on the east side of the landfill.
 - Recommendation: Repair the soil cover and overseed these areas to establish a protective grass cover.

Date November 17, 2022		
Description: Sparse vegetation on the east section of the landfill. Photo looking north.

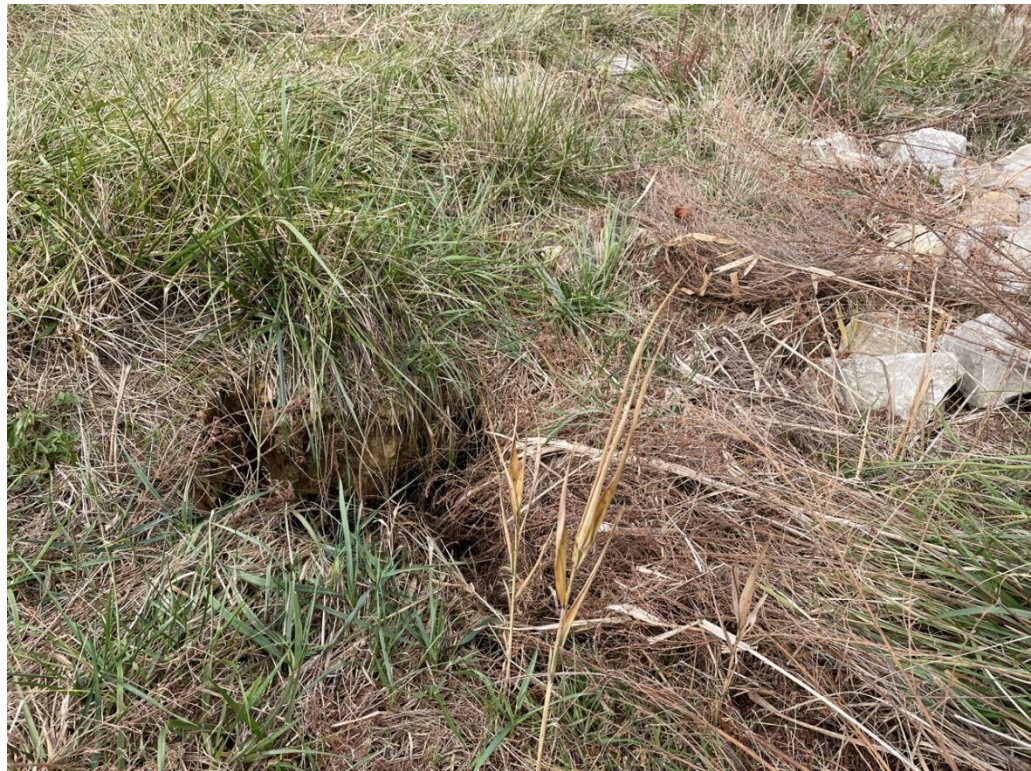
Grid ID P-16	Photo ID 6

Date November 17, 2022		
Description: Animal burrow on the east side of the landfill.

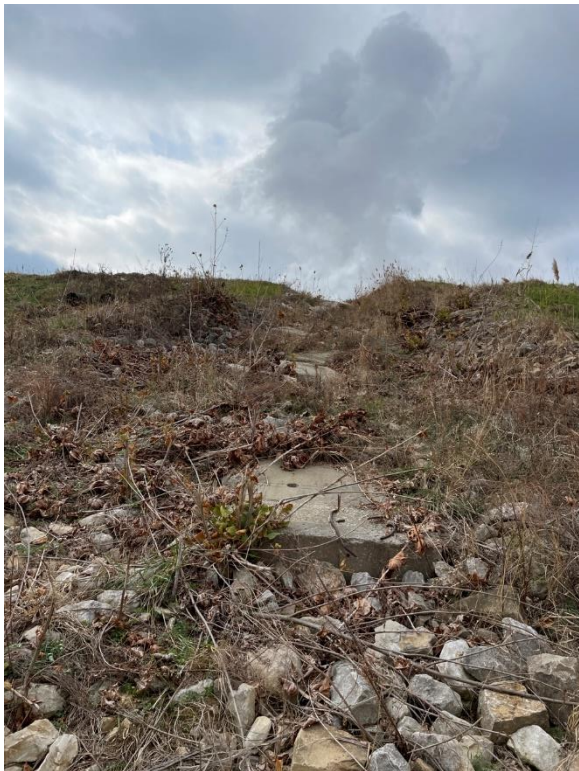
Grid ID Q-14	Photo ID 7

Date November 17, 2022		
Description: Drainage channel on the northeast side of the landfill. Overgrown vegetation reported on the 2021 report has been removed. Photo looking southwest.

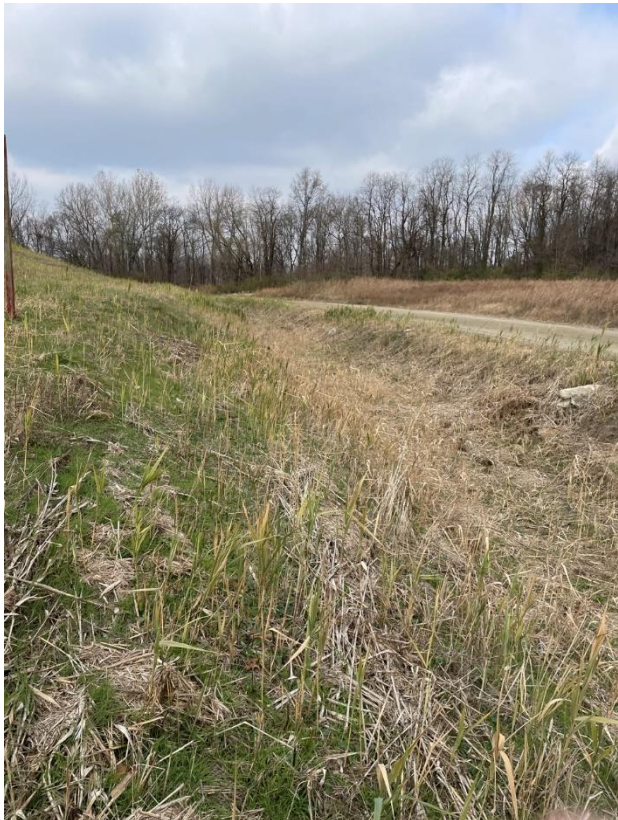
Grid ID Q-13	Photo ID 8

Date November 17, 2022		
Description: Drainage channel on the northeast side of the landfill. Photo looking northwest.

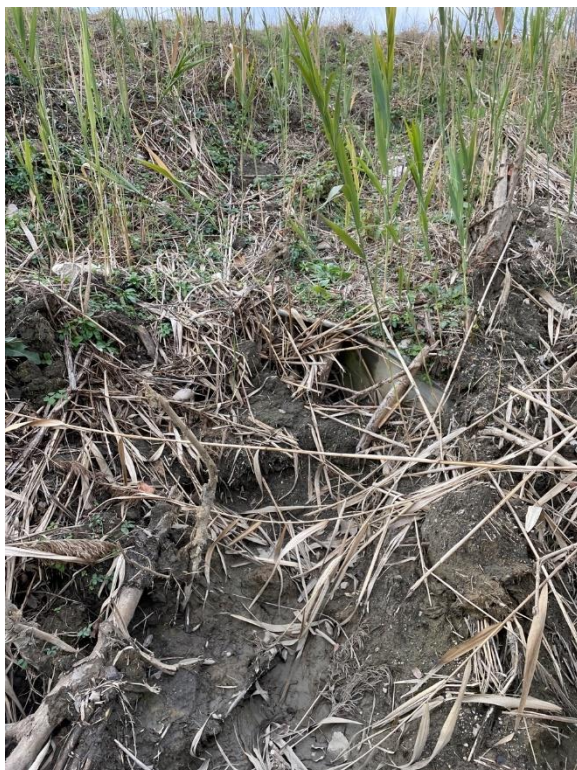
Grid ID O-12	Photo ID 9

4. Sediment accumulation was observed inside a culvert located on the north side of the landfill (location O-12 of Figure 3).
 - Recommendation: Remove sediment accumulation to allow flow into the culvert.
5. Overgrown vegetation was observed around drainage pipe inlets along the top of the landfill (location M-22 of Figure 3).
 - Recommendation: Vegetation around the inlets to the pipes should be maintained to allow for free flow of runoff into the pipes.

Date November 17, 2022		
Description: Sediment accumulation preventing flow into a culvert. Photo looking southwest.

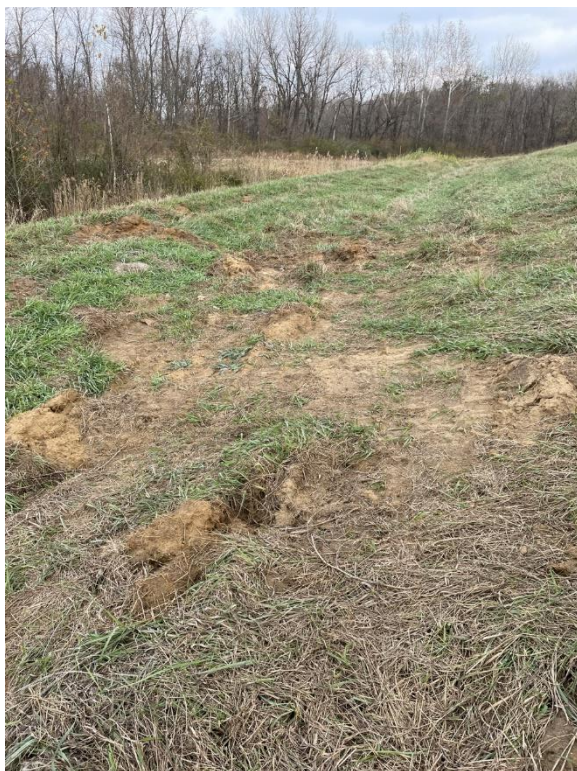
Grid ID M-13	Photo ID 10

Date November 17, 2022		
Description: Sparse vegetation on the northwest side of the landfill. Photo looking northeast.

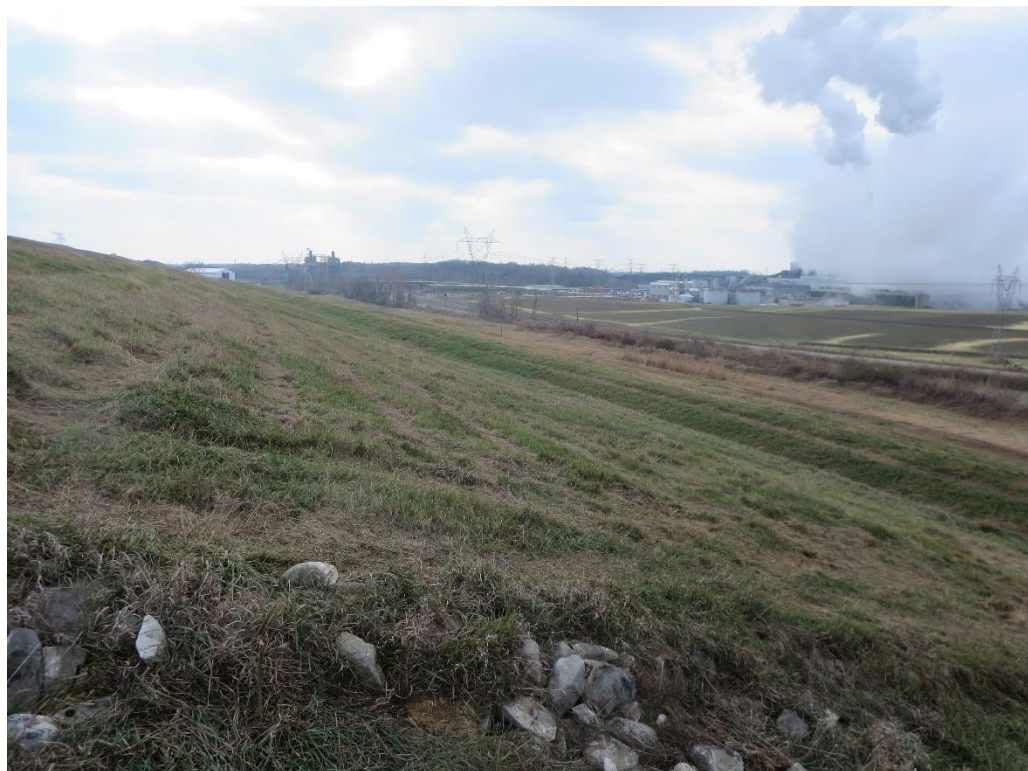
Date November 17, 2022		
Description: Vegetation well established on the west side of the landfill. Photo looking south.

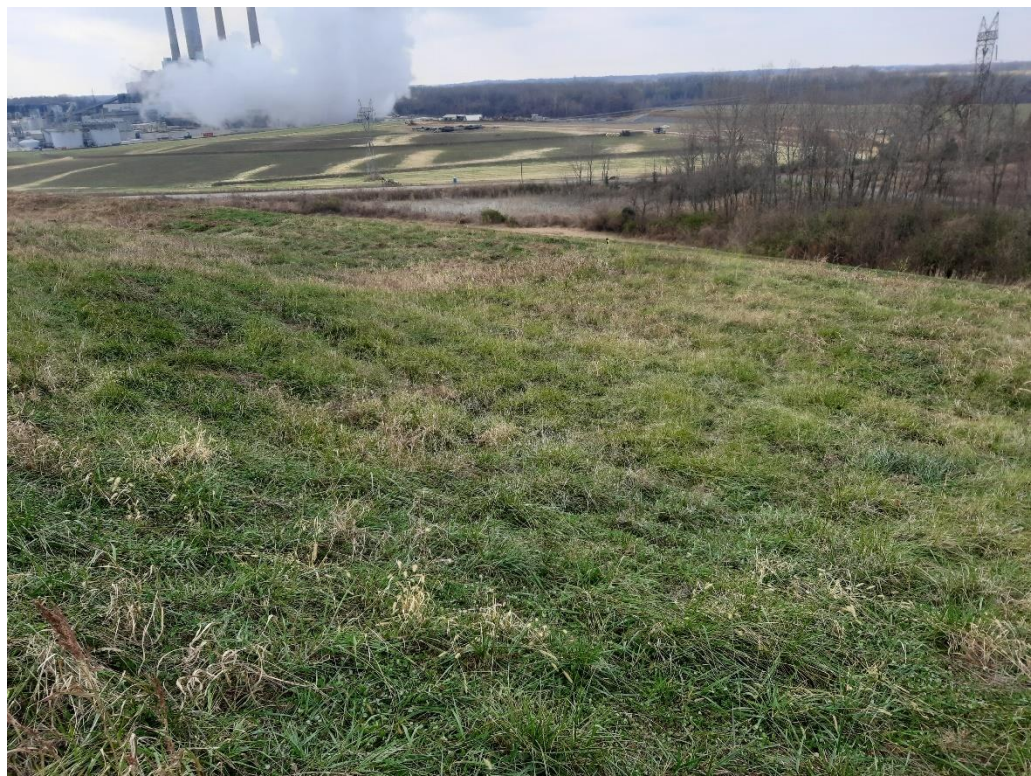
Date November 17, 2022		
Description: Vegetation well established on west side slope of the landfill. Photo looking southwest.

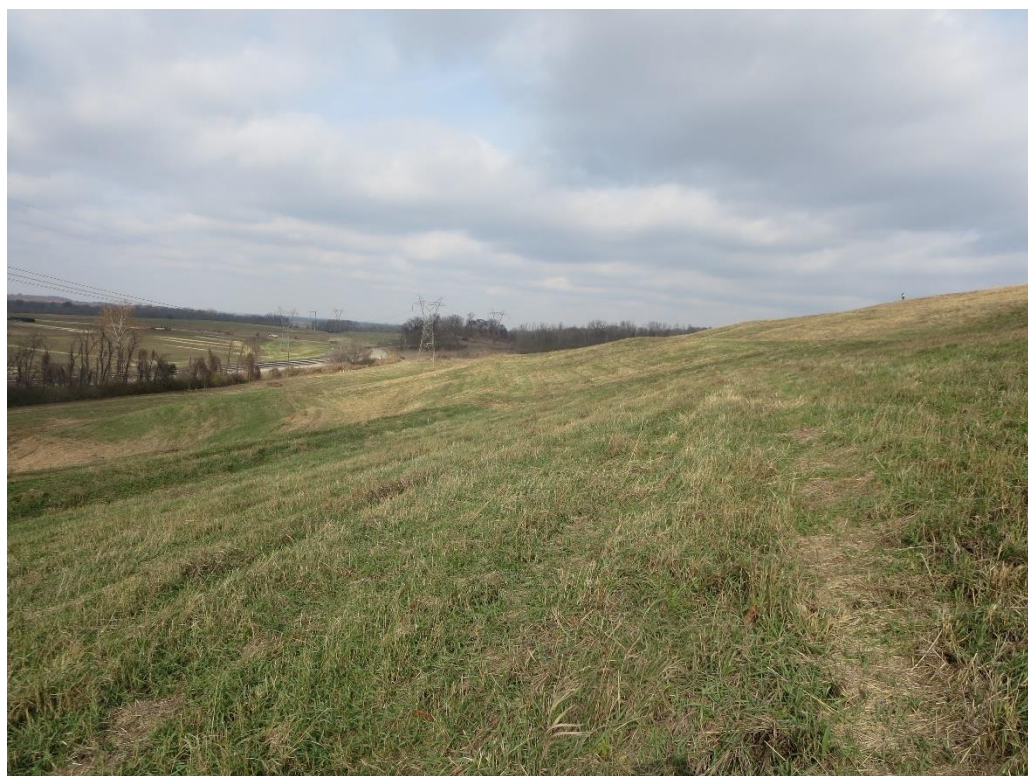
Grid ID M-18	Photo ID 15

Date November 17, 2022		
Description: Vegetation well established along the west side slope of the landfill. Photo looking north east.

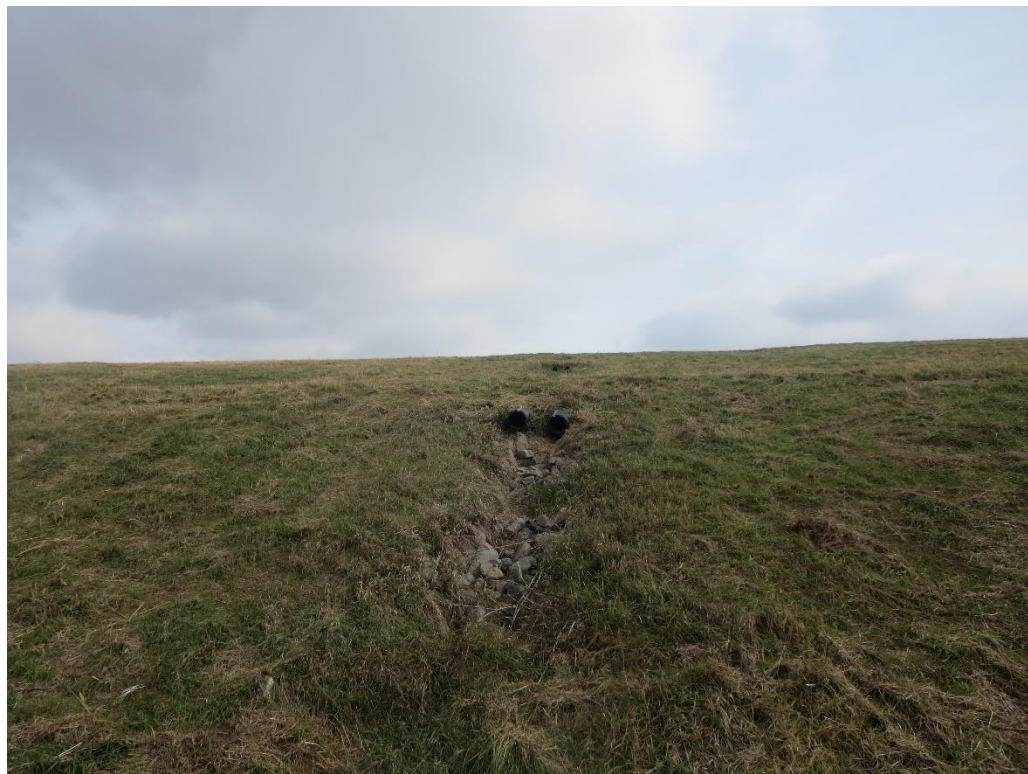
Grid ID K-19	Photo ID 16

Date November 17, 2022		
Description: Drainage channel on the west side of the landfill. Photo looking east.

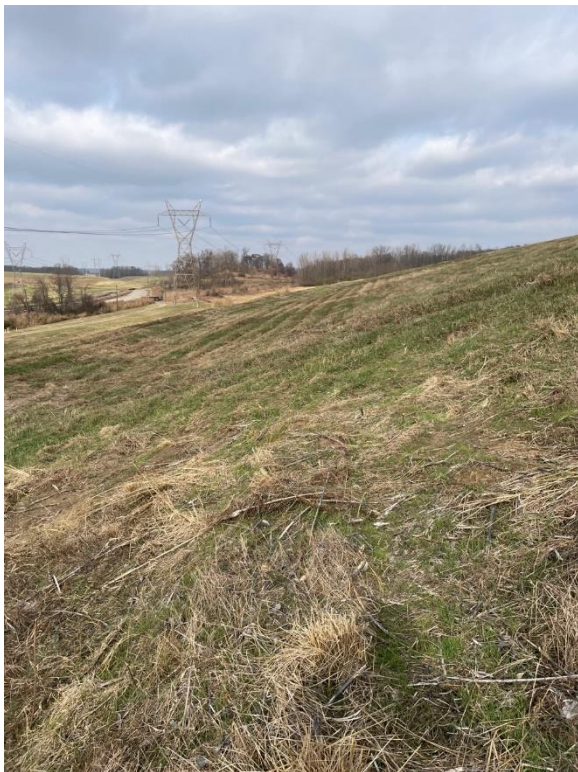
Grid ID K-20	Photo ID 17

Date November 17, 2022		
Description: Vegetation well established on the west slope of the landfill. Photo looking north.

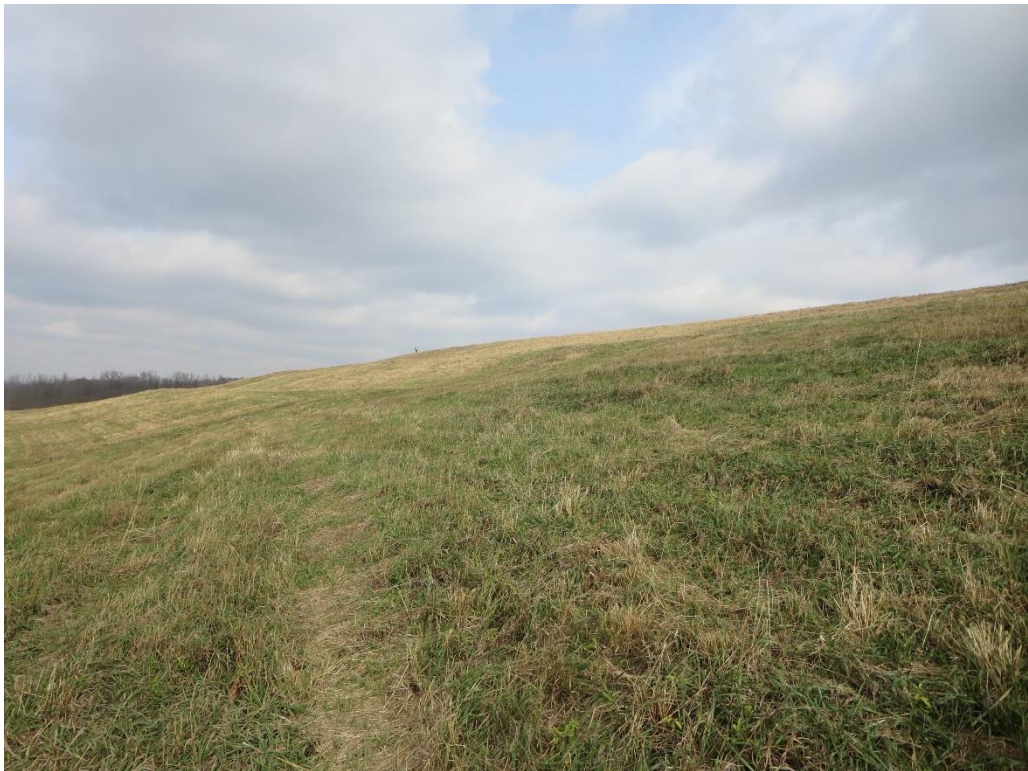
Grid ID L-20	Photo ID 18

Date November 17, 2022		
Description: Vegetation well established on the west slope of the landfill. Photo looking north.

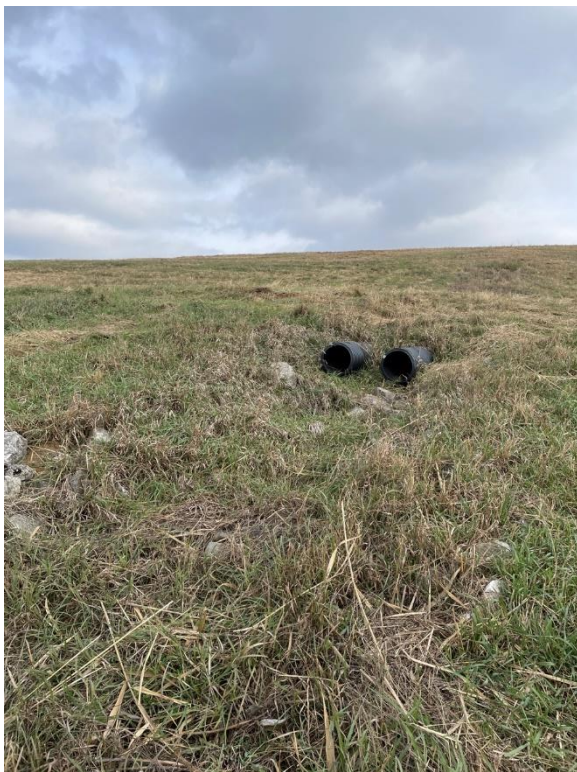
Date November 17, 2022		
Description: Drainage pipes on the west slope of the landfill. Photo looking northeast.

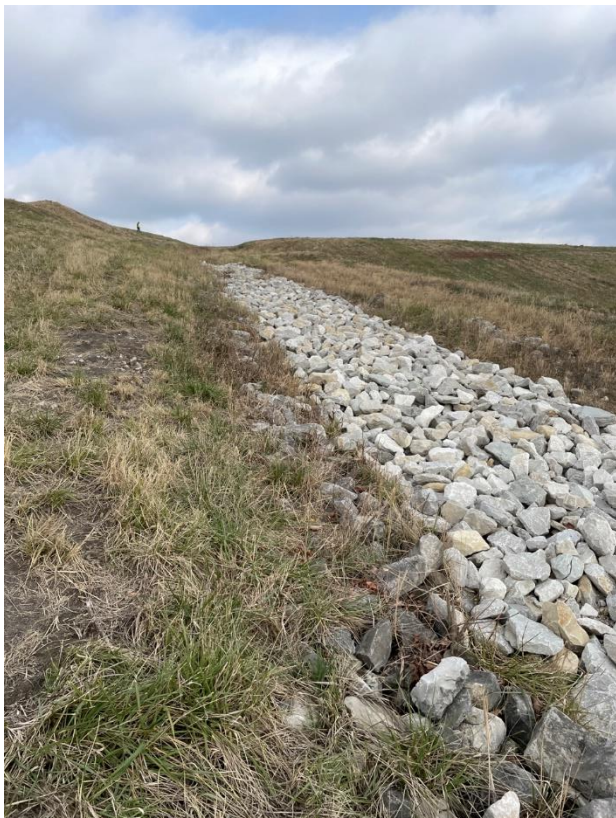
Date November 17, 2022		
Description: Drainage channel on the southwest slope of the landfill. Photo looking northeast.

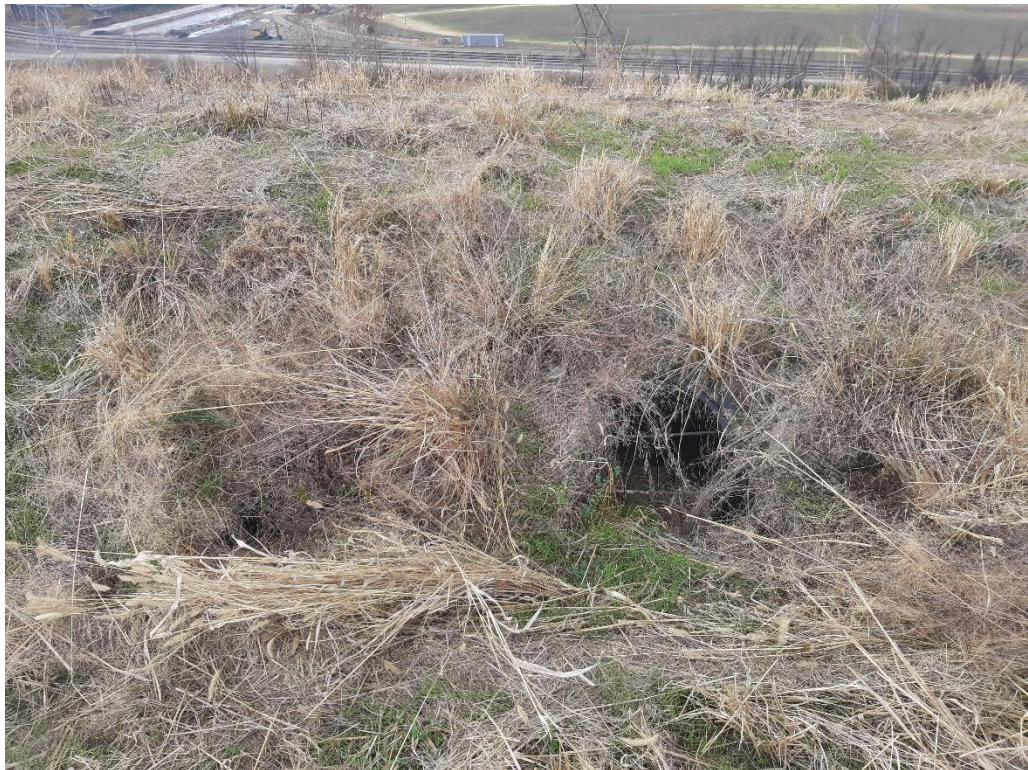
Grid ID M-22	Photo ID 23

Date November 17, 2022		
Description: Overgrown vegetation around drainage pipe inlets along the top of the landfill. Photo looking west.
