**2022 VISUAL INSPECTION OF ASH POND EMBANKMENTS
AES PETERSBURG ASH POND SYSTEM**

AES INDIANA PETERSBURG GENERATING STATION
6925 NORTH STATE ROAD 57
PETERSBURG, INDIANA 47567

ATLAS PROJECT NO. 170LF01359

DECEMBER 23, 2022

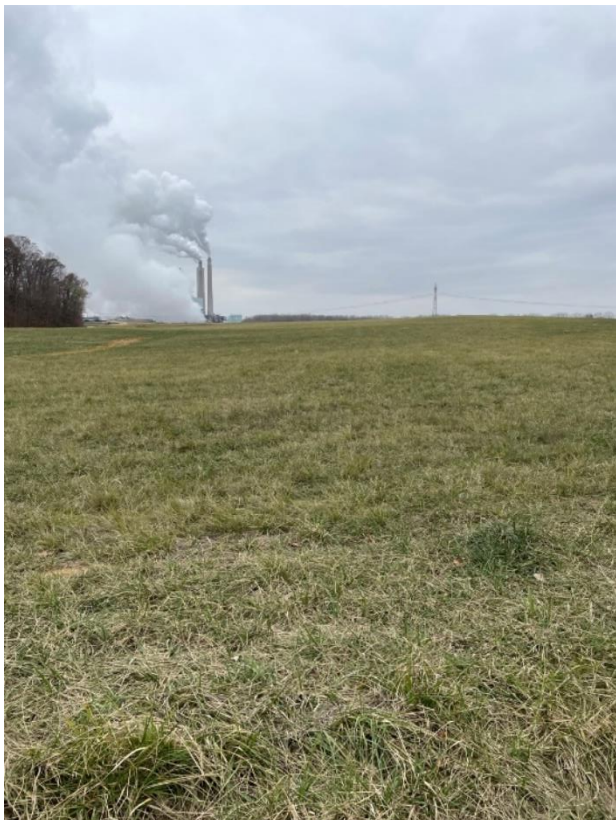
Grid ID P-2	Photo ID 1

Date November 17, 2022		
Description: Vegetation well established on the top northeast side of Ash Pond C. Photo looking south.

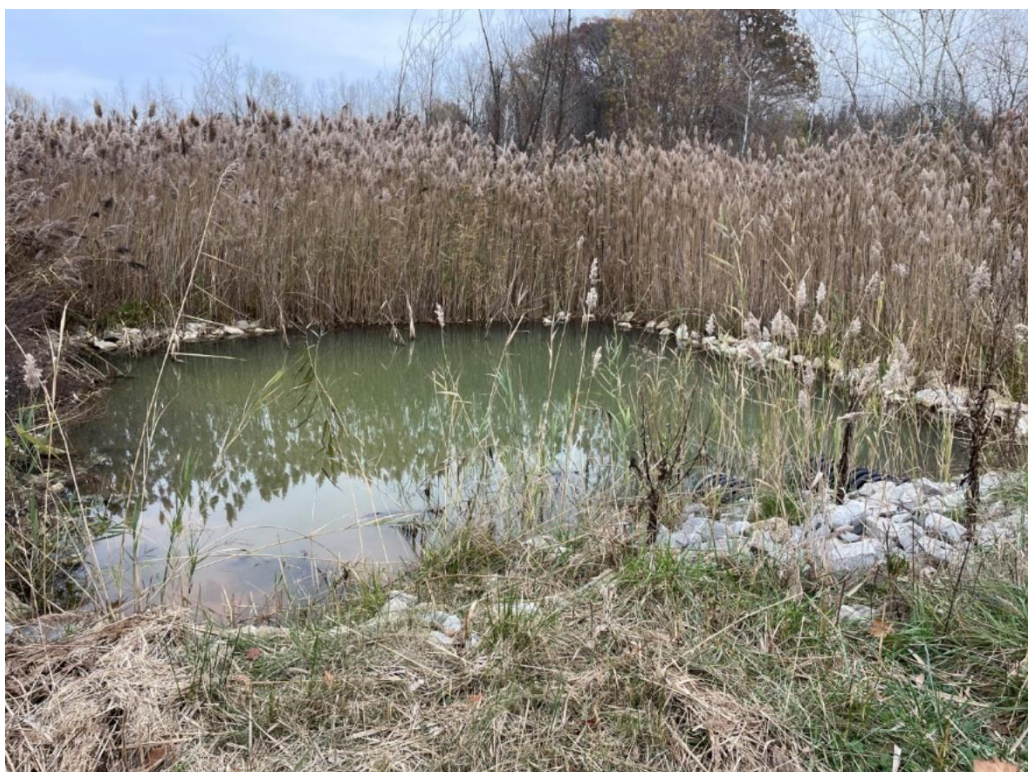
Grid ID Q-2	Photo ID 2

Date November 17, 2022		
Description: Splash pad for drainage on the northeast section of Ash Pond C. Photo looking north.

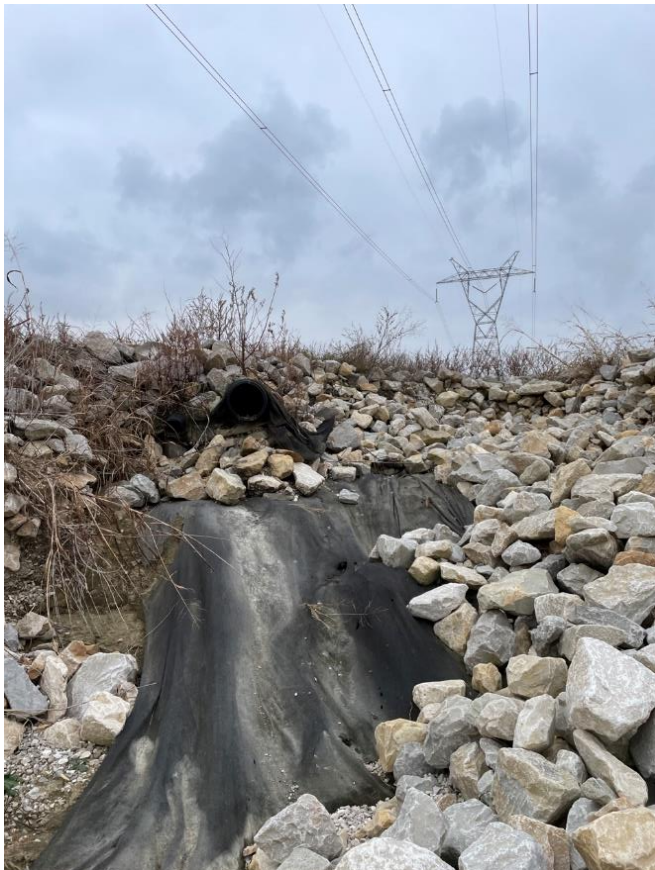
1. The riprap-lined stormwater channel, located on the west side of Ash Pond C and the north side of Ash Pond B, has lost portions of its riprap and eroded (location G-3 of Figure 4). The affected area is the outlet for the valley drain between Ash Pond B and C.
 - o Recommendation: Repair the damaged area and replace the riprap material in the channel to prevent erosion.

Date November 17, 2022		
Description: Displaced rip rap at the outlet drainage pipes on the northwest side of Ash Pond C. Photo looking south.

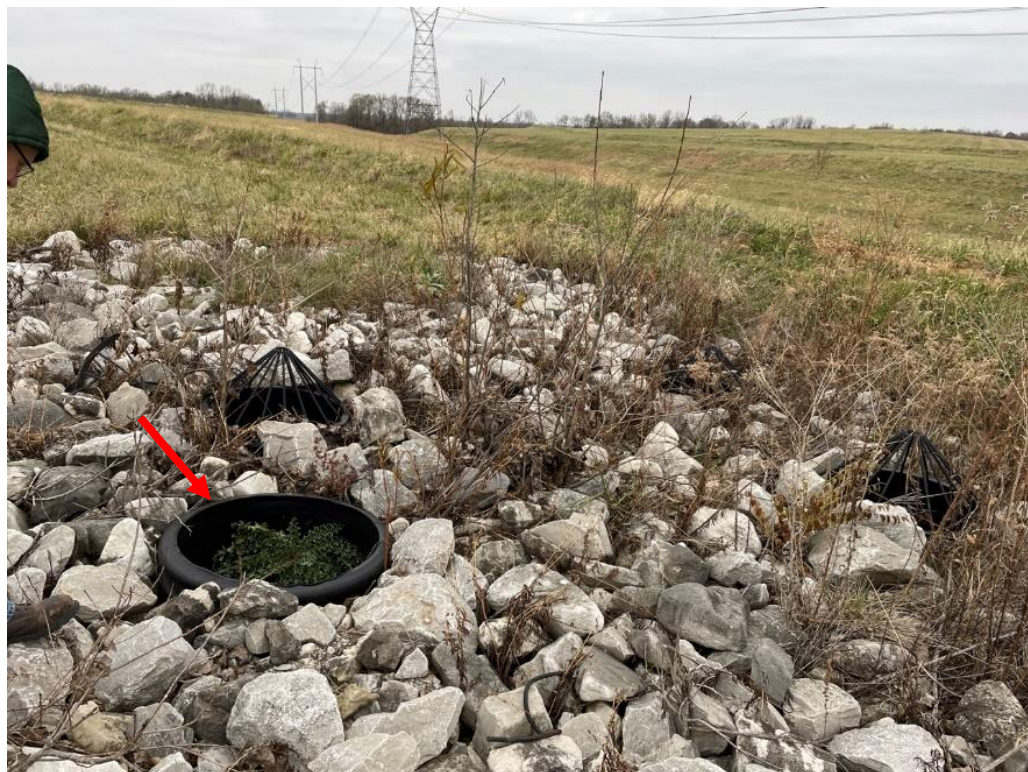
1. Trash racks are missing on drop inlets located on the east side of Ash Pond B (location H-9 of Figure 4) and the northeast side of Ash Pond B (location D-7 of Figure 4).
 - o Recommendation: Repair or install new trash rack on the tops of the drop inlets.

Date November 17, 2022		
Description: Drop inlets on the top northeast side of Ash Pond B. A trash rack is missing. Photo looking north.

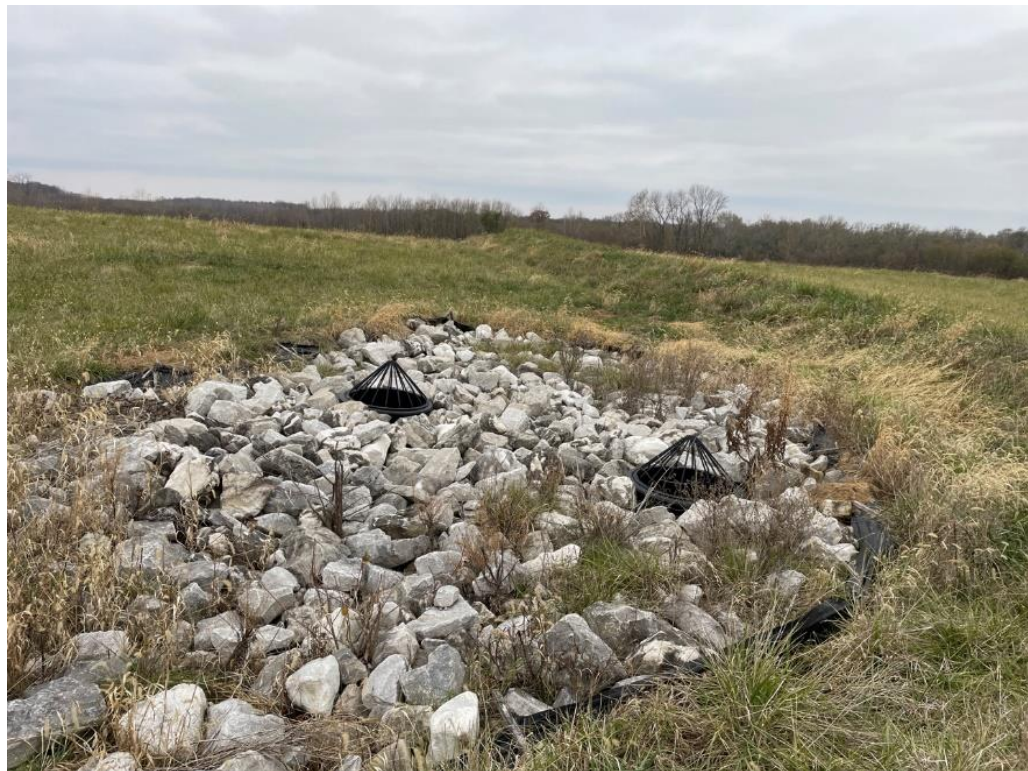
Point ID H-9	Photo ID 9

Date November 17, 2022		
Description: Drop inlets on the top of northeast side of Ash Pond B. Photo looking north.

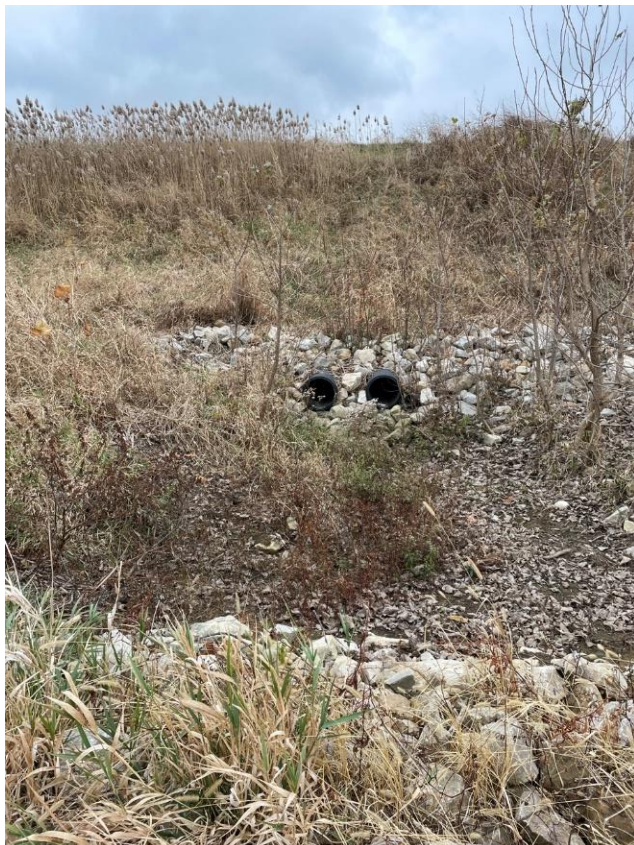
Point ID C-7	Photo ID 10

Date November 17, 2022		
Description: Drainage outlet pipes on the northeast side of Ash Pond C. Photo looking east.

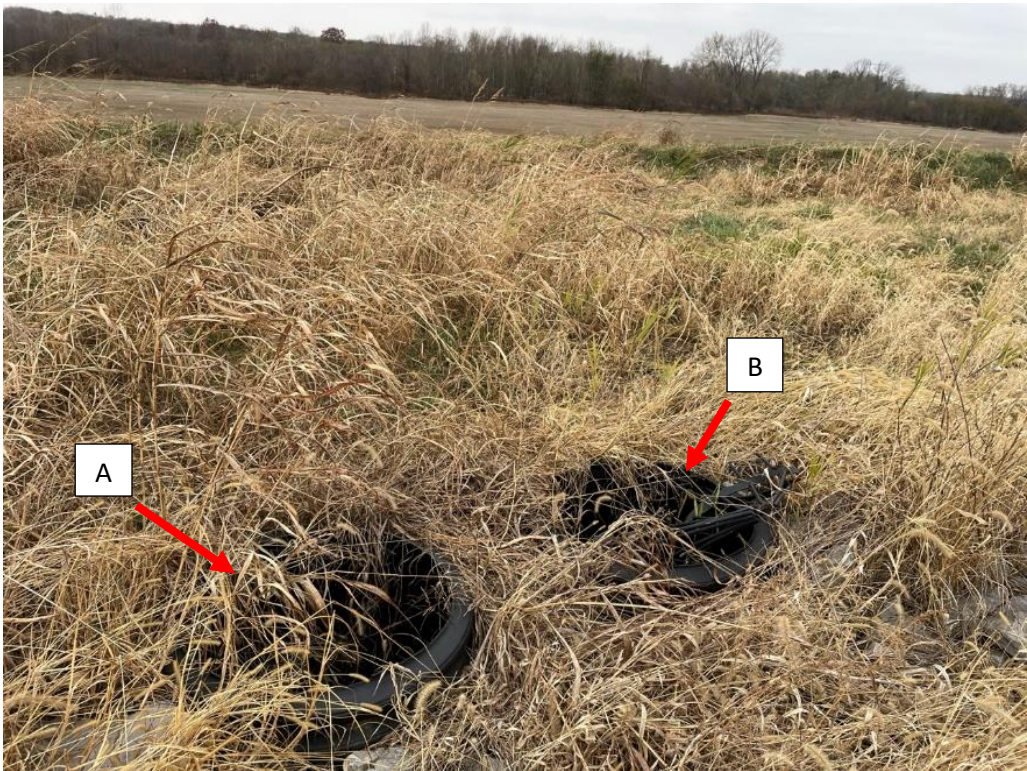
Point ID D-7	Photo ID 11

Date November 17, 2022		
Description: Drop inlets on the top northwest side of Ash Pond B. A trash rack (A) is missing, and another is damaged (B). Photo looking north.

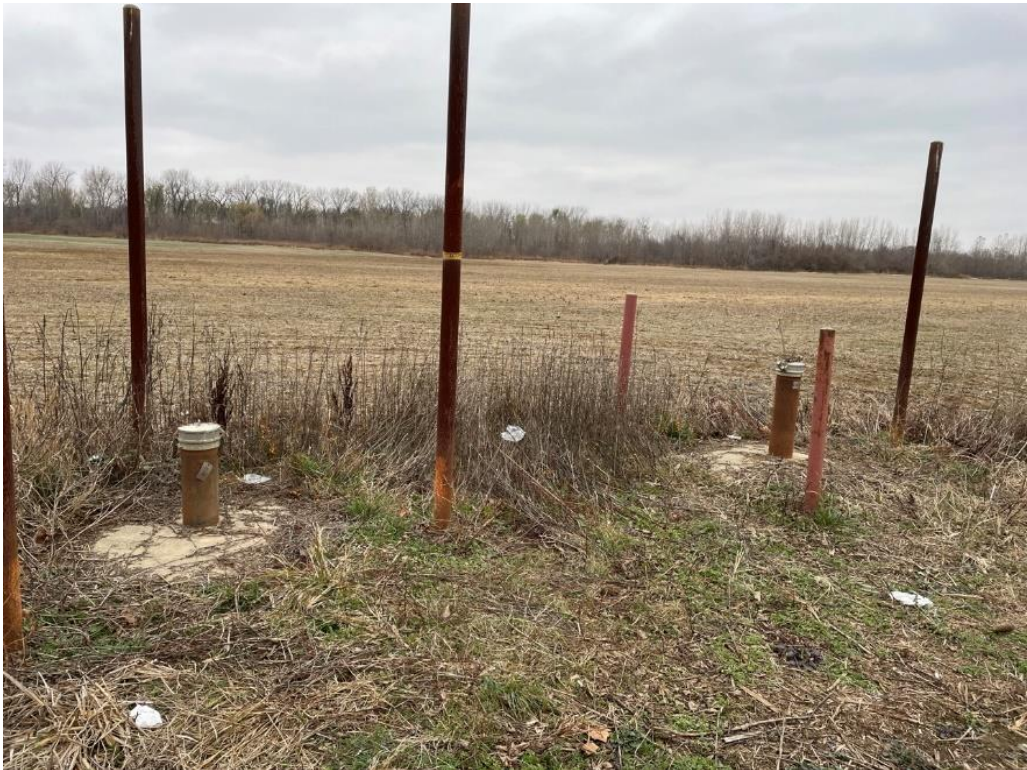
Point ID A-12	Photo ID 12

Date November 17, 2022		
Description: Monitoring wells AP-3 and AP-3A on the southwest side of Ash Pond B. Photo looking northwest.

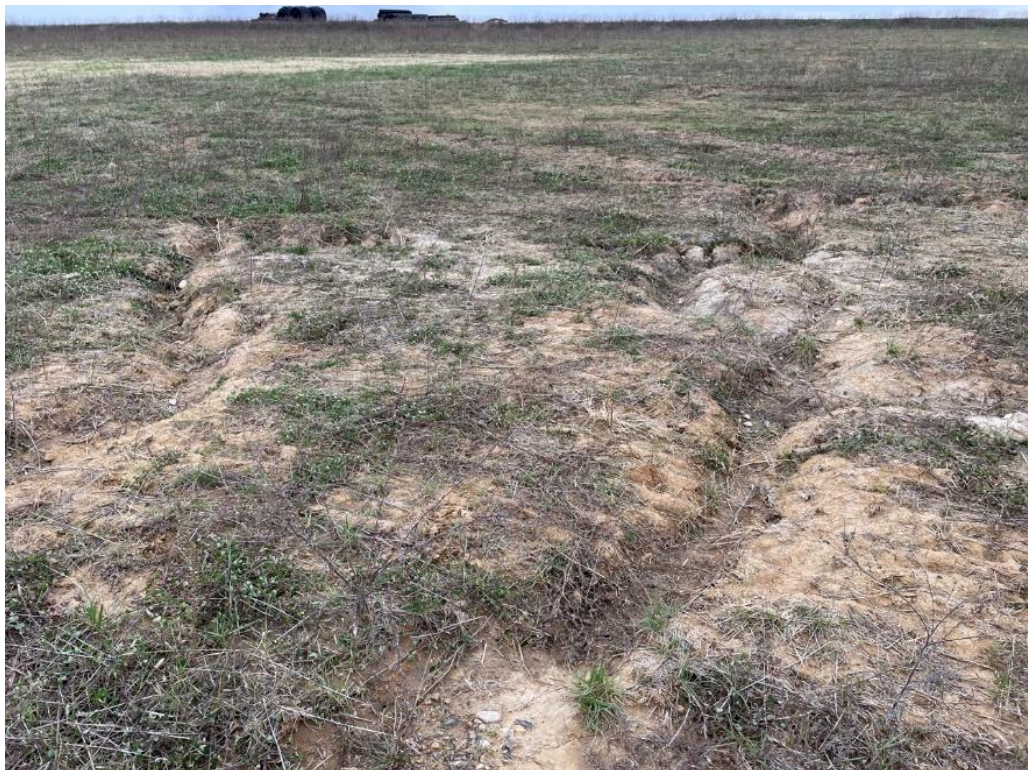
Date November 17, 2022		
Description: Erosion rills formed on the northeast section of Ash Pond A. Photo looking west.

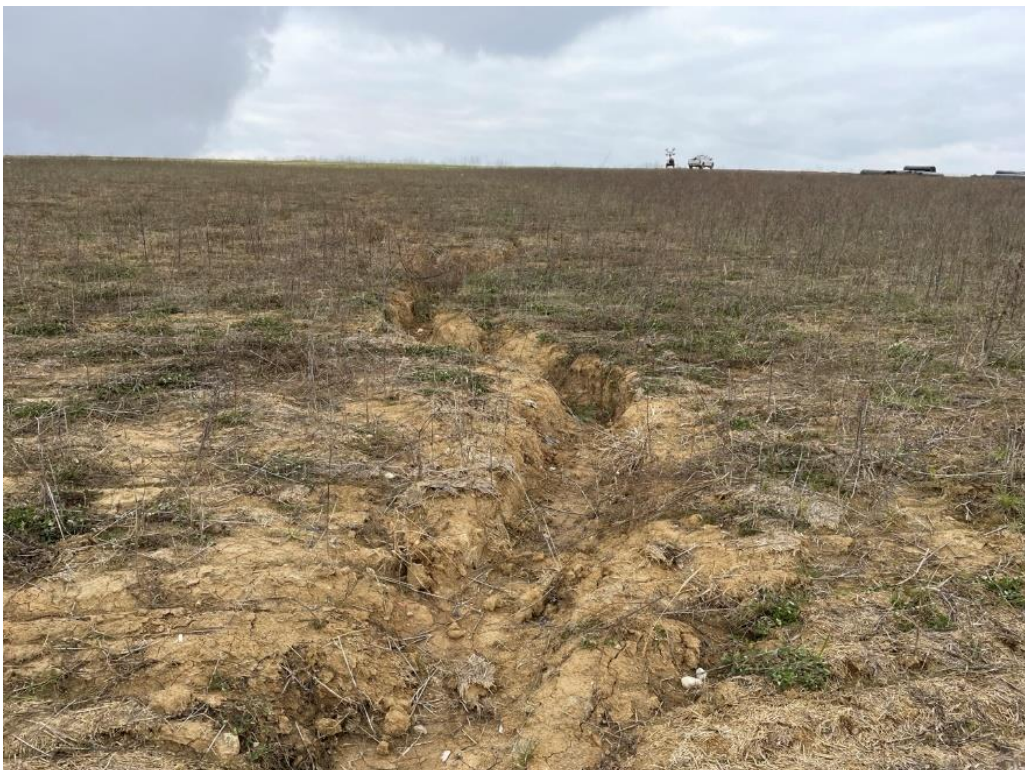
Date November 17, 2022		
Description: Erosion rills formed on the top of Ash Pond A. Photo looking west.

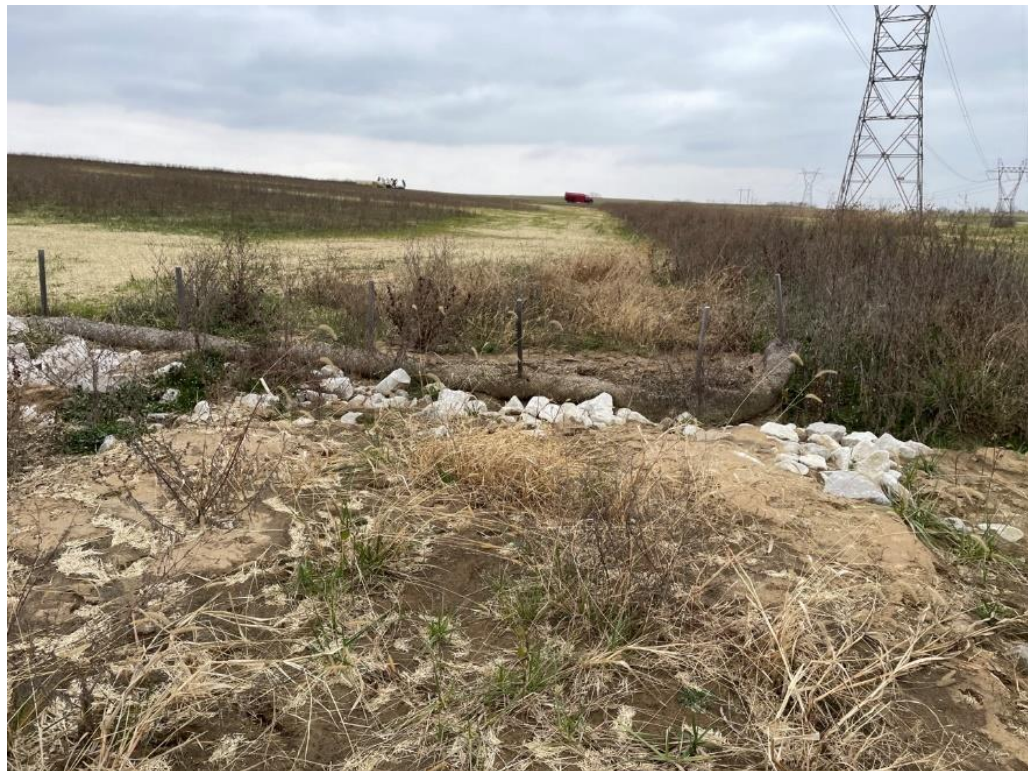
Point ID I-16	Photo ID 19

1. New erosion controls have been installed along the east and south sides of Ash Pond A (locations H-13, I-16, I-19, G-23 of Figure 4).
 - o Recommendation: Overseed and add fertilizer as necessary to help establish a full vegetative cover.
2. Minor erosion rills were observed along the east section of Ash Pond A (locations H-14, G-16, H-17 of Figure 4).
 - o Recommendation: Repair the soil cover and overseed these areas to establish a protective grass cover.

Date November 17, 2022		
Description: Erosion controls and new vegetation on the east side of Ash Pond A. Photo looking northeast.

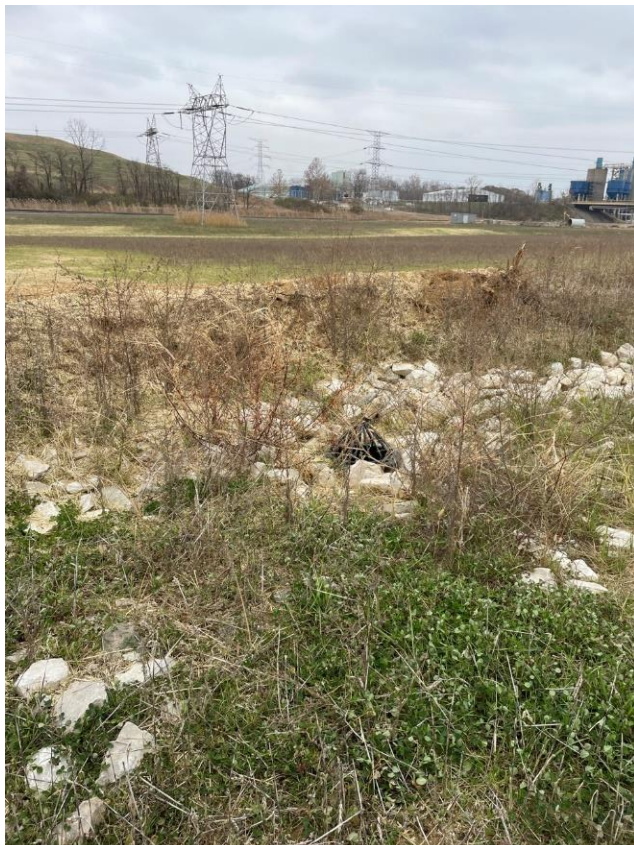
Point ID G-18	Photo ID 20

Date November 17, 2022		
Description: Drop inlets on top of Ash Pond A. Photo looking southwest.

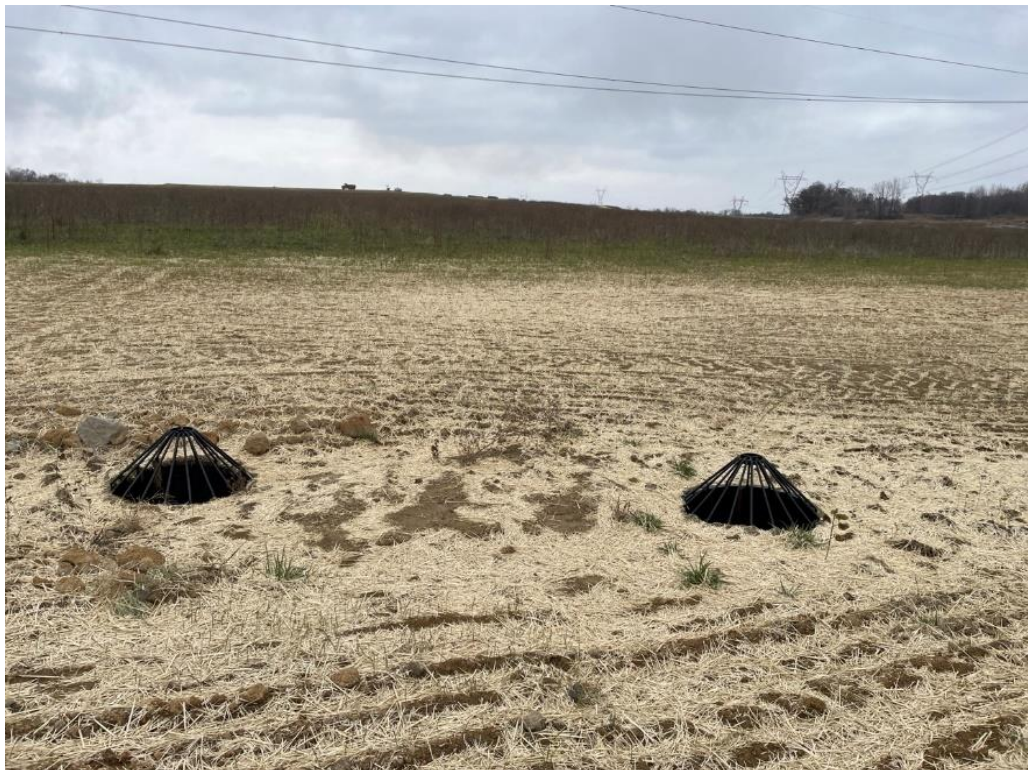
Date November 17, 2022		
Description: Newly vegetated area near drop inlets on the south side of Ash Pond A. Photo looking south.
