### 2017 VISUAL SITE INSPECTION IPL PETERSBURG RESTRICTED WASTE TYPE III LANDFILL

IPL PETERSBURG GENERATING STATION 6925 NORTH STATE ROAD 57 PETERSBURG, INDIANA 47567

ATC PROJECT NO. 170LF00444

JANUARY 8, 2018

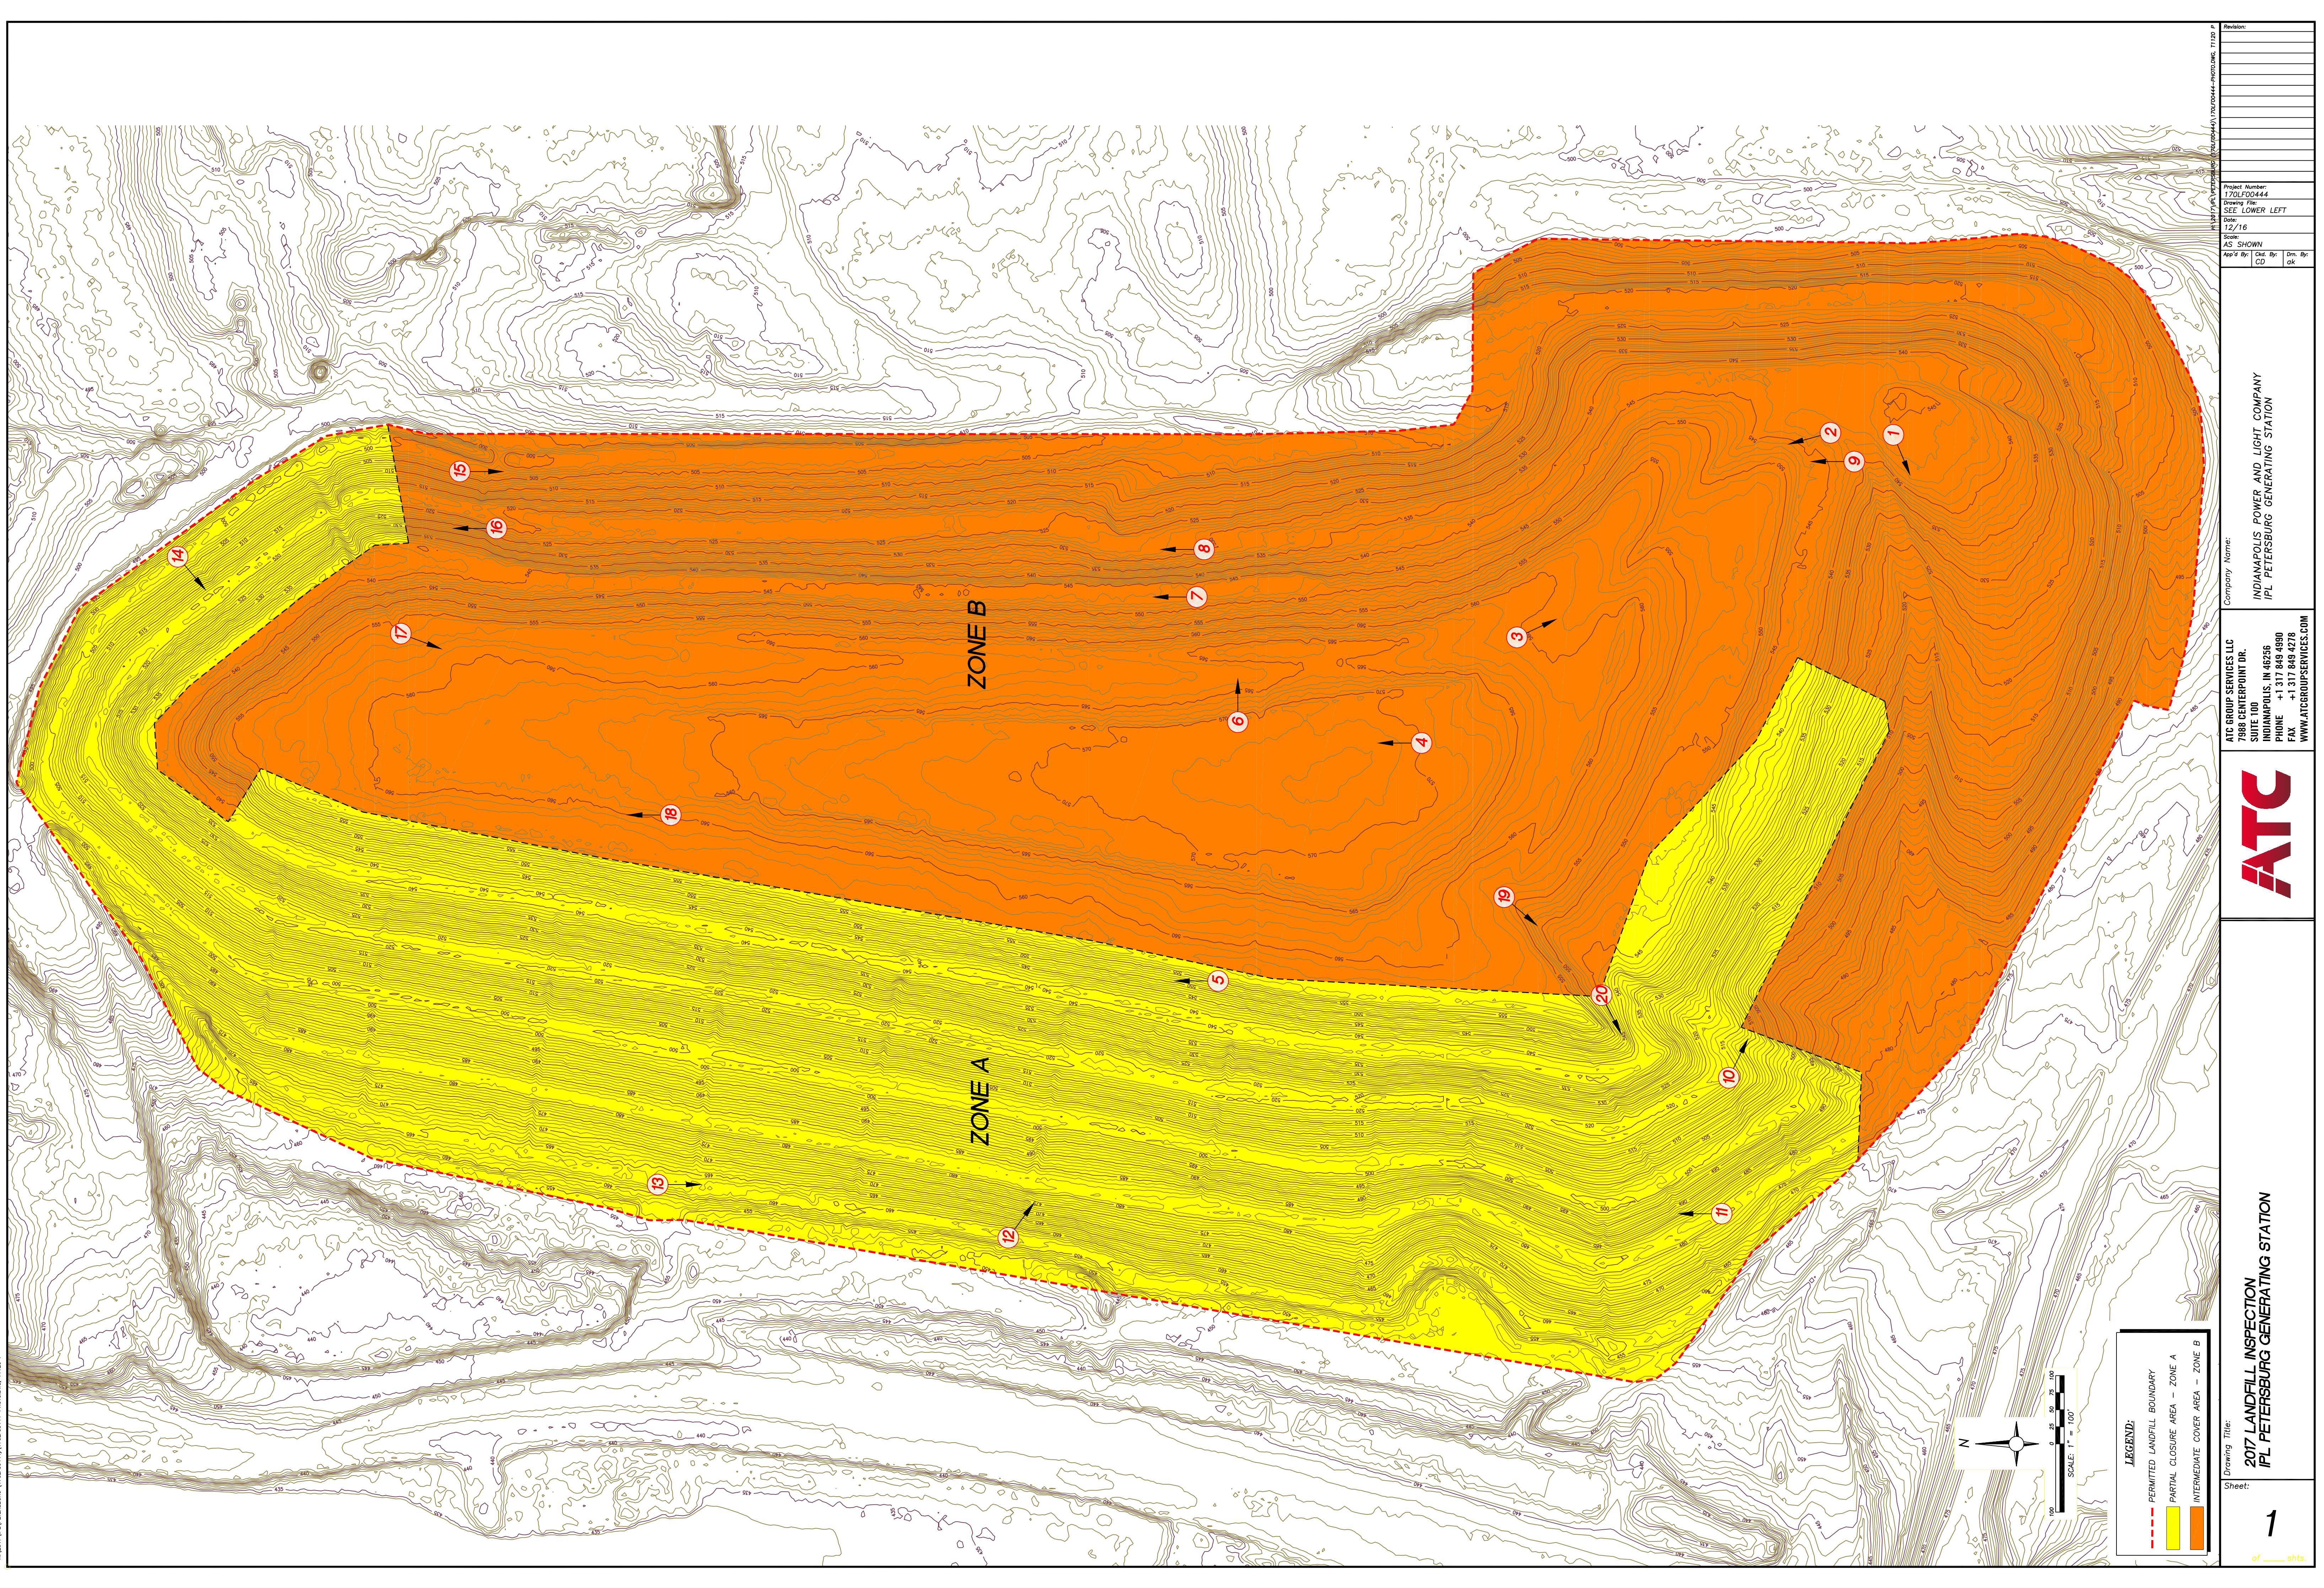
Appendix A: Site Plan

Observed geometry changes during the 2017 Petersburg landfill inspection consisted mainly of grading measures and vegetation improvements. In the past year, intermediate cover was added to the east slope of the landfill. Engineering observations were grouped into two inspection zones called out on the Site Map in Appendix A. The zone descriptions, observations, and recommendations are as follows:

- 1. Good vegetation exists along the majority of the west and north slopes of the partial closure area (Locations 5, 11 and 13).
- 2. A sapling has grown at the base of one of the riprap downchute channels along the west slope of the landfill (See Location 12).
  - Recommendation: Remove the sapling to prevent root undermining of the soil cover. Continue an ongoing maintenance program to remove trees and shrubs from the cover system.

- 3. At the northeast corner of the landfill, at the base of a riprap downchute channel, a washout erosion area has formed (See Location 14).
  - Recommendation: Install erosion control protection for this area such as erosion control mat to protect the integrity of the soil liner. Overseed the bare soil area.
- 4. At the southwest corner of the landfill, erosion has occurred along the face of the slope, exposing underlying poz-o-tec material (Location 20).
  - Recommendation: Repair the soil cover and regrade areas of the slope where erosion has occurred. Install erosion control mat in exposed areas and overseed areas of sparse vegetation once soil cover has been repaired.

- 1. Good vegetation exists along the majority of the south end of the landfill, top of landfill and east slope, where new soil cover has been installed (Locations 1, 4, 7, and 18).

- 2. Downcutting has occured along a flowpath leading to the top of the landfill (See Locations 2 and 3). Some hay bales and riprap piles have been used to control flow however, much of the channel is exposed with no armouring.

- 3. Downcutting has occured along the ditch adjacent to the haul road along the south side of the landfill (See Location 9). Some riprap has been used to control flow however much of the channel is exposed with no armouring.

- 4. Erosion has formed along the riprap downchute channel at the southwest corner of the landfill. Flow has eroded the channel and sections of riprap armouring have been displaced, leaving soil cover vulnerable in that area (See Location 10).

- 5. Riprap downchute channels on the top of the landfill are in good condition with no obvious erosion (Location 6).
- 6. Downcutting has occurred along the lower level terrace berm channel on the landfill east slope (See Location 8).

- 7. The perimeter ditch near the northeast corner of the landfill has channel erosion. Silt fence check dams have been installed in some locations to prevent erosion however, flow has overtopped and bypassed the silt fencing, creating undercutting of soil cover (Location 15).

- 8. Erosion has formed along the backside of lower level terrace berms near the northeast corner of the landfill (Locations 16 and 17). In some areas pooling has occurred where terrace channels are unable to connect with riprap downchute channels.

- 9. A sapling has grown along the backside of one of the lower level terrace berms near the northeast corner of the landfill (See Location 17).
  - Remove the sapling to prevent root undermining of the soil cover. Continue an ongoing maintenance program to remove trees and shrubs from the cover system.

- 10. An erosion gulley has formed along a flow path at the top of the landfill leading towards the southwest corner. Flow in the gulley has undermined soil cover to the point of exposing the underlying poz-o-tec material (See Location 19).

- Recommendation: Repair the soil cover in areas where downcutting has occurred in the channel. Install erosion control mat and additional armouring on exposed reaches of the channel.

- Recommendation: Repair the soil cover in areas of the channel where erosion has occurred and install additional riprap armouring overtop gravel or erosion control mat in exposed areas. Overseed areas adjacent to the channel at the edge of riprap.

- Recommendation: Repair the soil cover in areas where downcutting has occurred in the channel. Install erosion control mat and gravel check dams where needed to control excessive velocities. Overseed on exposed reaches of the channel.

- Recommendation: Repair soil cover and regrade channel slopes in areas where erosion has occurred. Armour the channel with erosion control mat and gravel in areas with the most significant erosion. Consider replacement of the silt fence control sections with a more effective best management practice such as rock check dams to reduce channel velocities.

- Recommendation: Repair the soil cover, install erosion control mat and overseed areas of sparse vegetation. Consider regrading terrace berms where necessary to adequately convey flow to riprap downchute channels.

- Recommendation: Repair the soil cover to fill in the erosion gulley. Install erosion control mat and gravel or riprap armouring, where needed, to prevent future erosion.
