2021 VISUAL INSPECTION OF ASH POND EMBANKMENTS AES PETERSBURG ASH POND SYSTEM

AES INDIANA PETERSBURG GENERATING STATION 6925 NORTH STATE ROAD 57 PETERSBURG, INDIANA 47567

ATC PROJECT NO. 170LF01141

DECEMBER 28, 2021

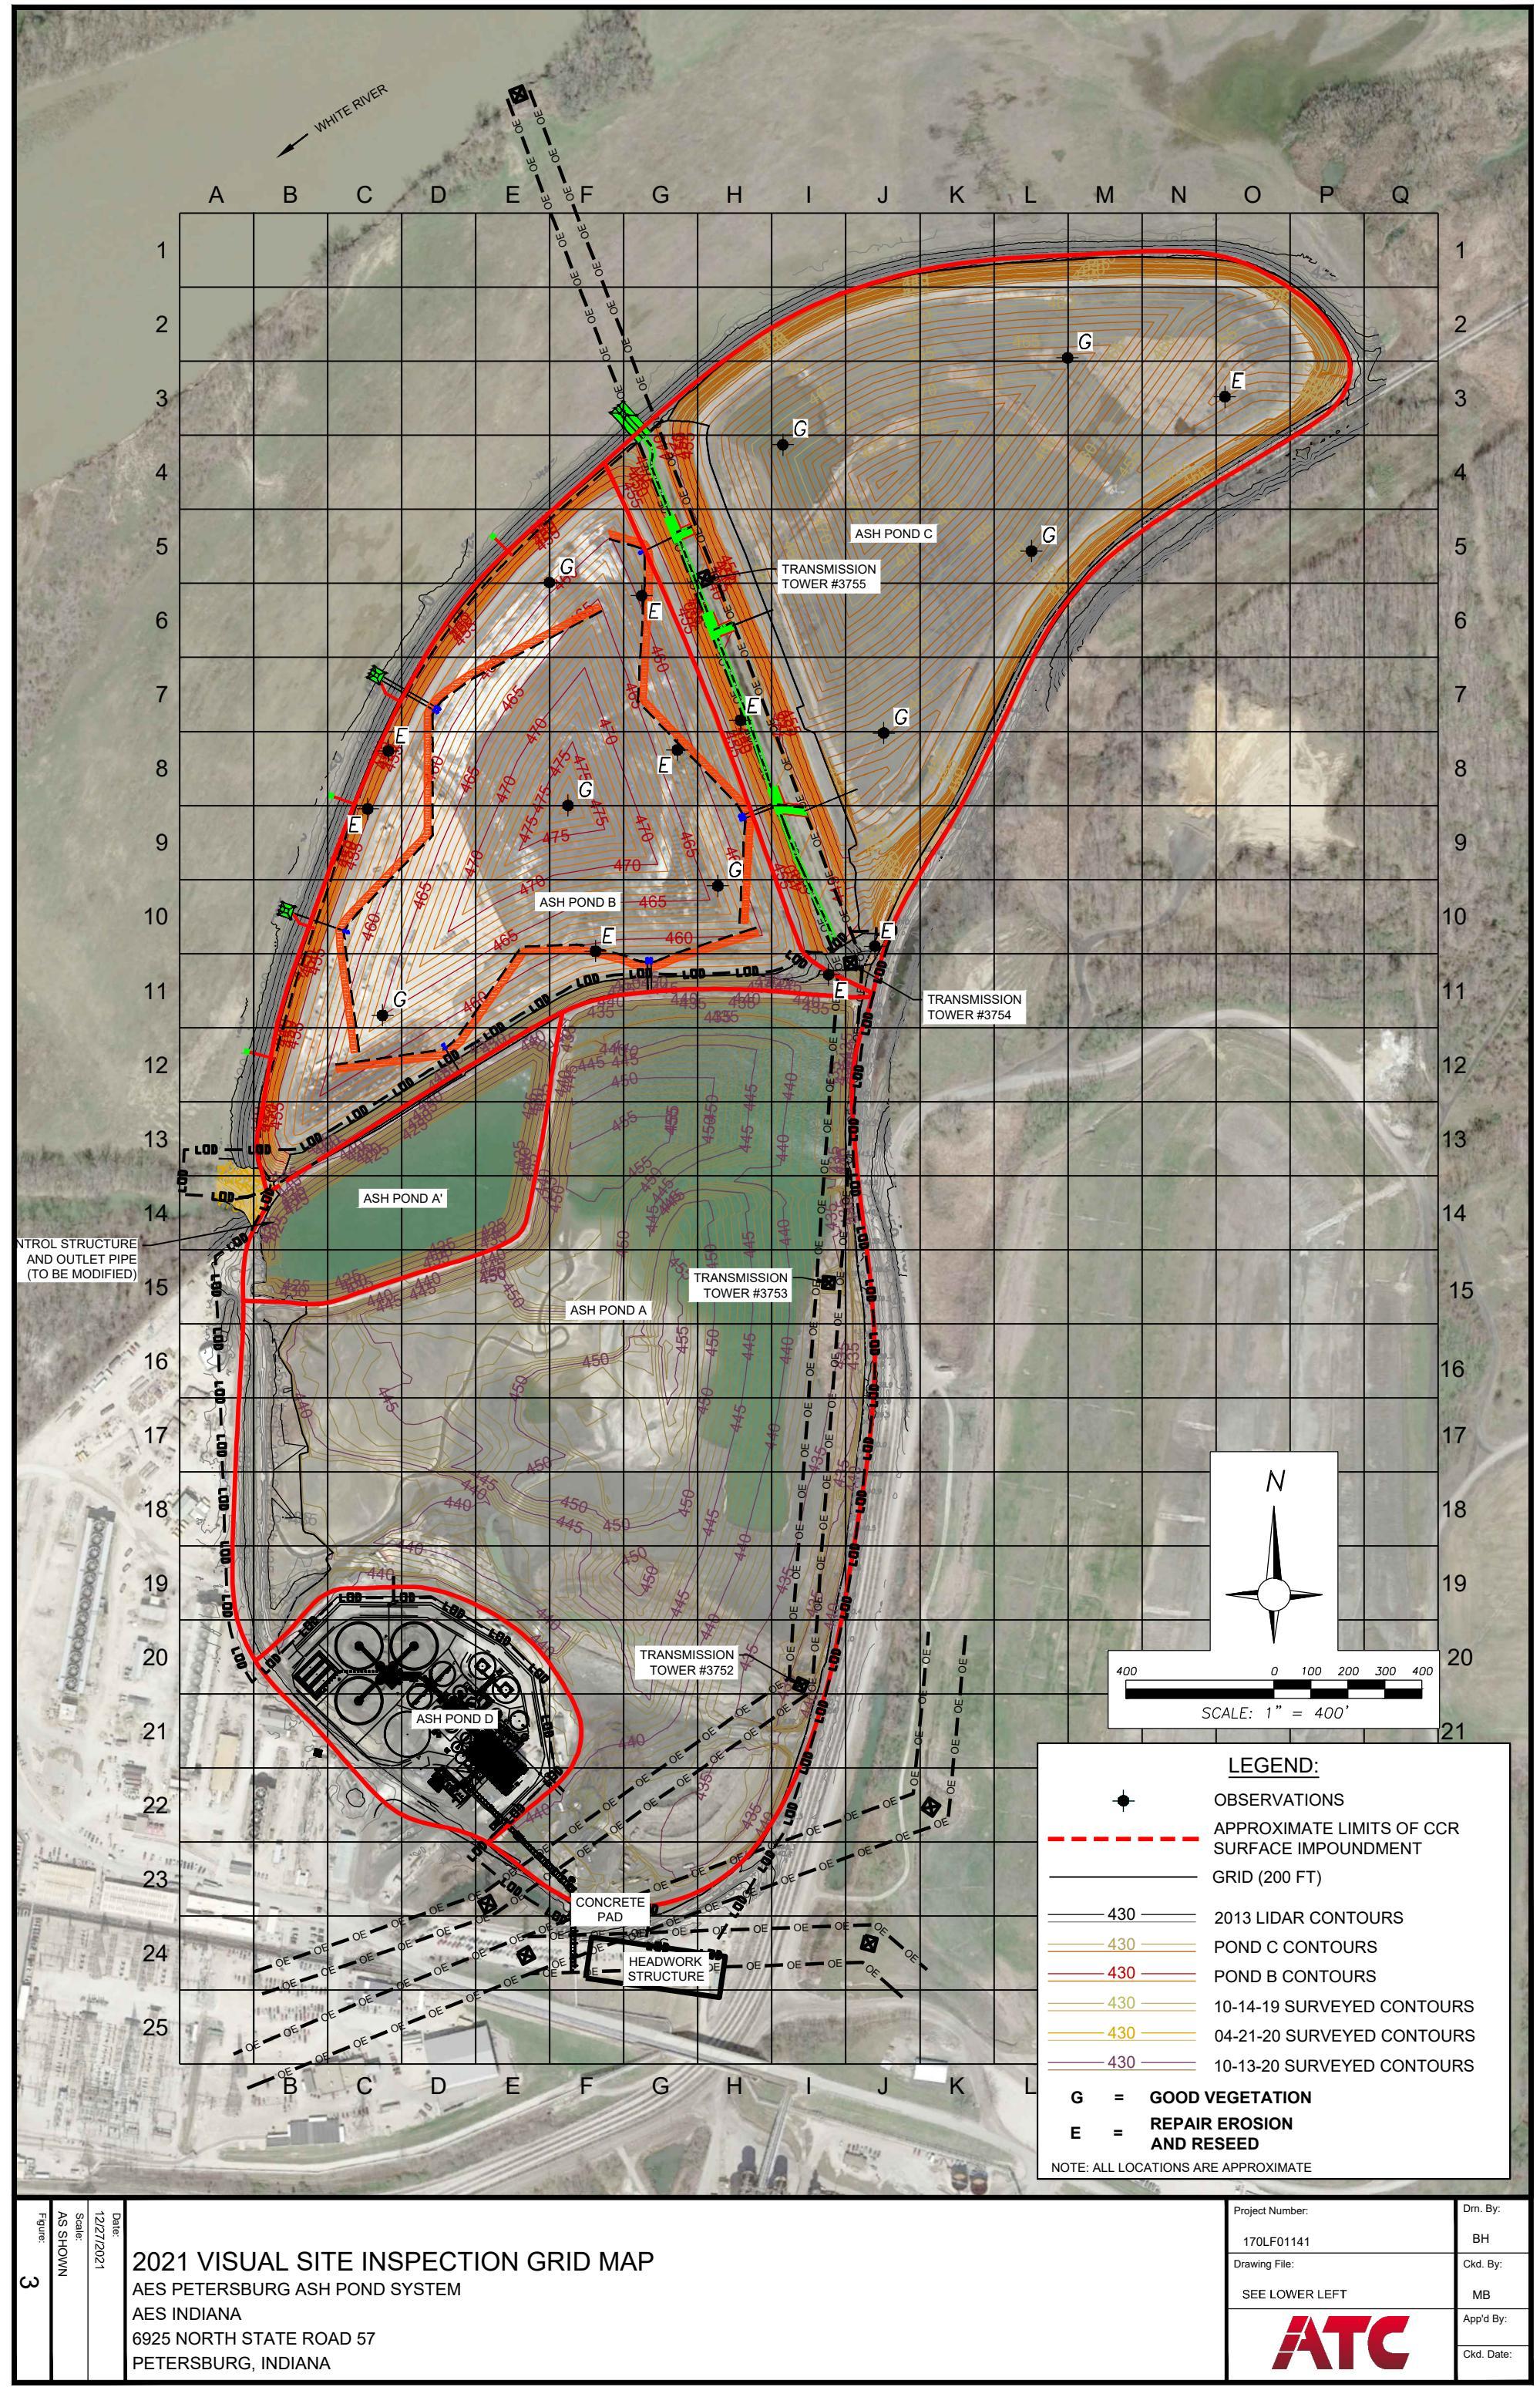
| Figure 1 | Vicinity Map |
|---|---|
| Figure 3 | Visual Site Inspection Grid Map |

Engineering observations performed on November 16, 2021 are shown in Figure 3, 2021 Visual Site Inspection Grid Map. ATC visually inspected the embankments for Ash Ponds A, A', B, C, and D and found no areas of instability. However, there were several areas with concerns relating to the erosion of final cover soils over Ash Ponds B & C as shown in the photos. Figures 3 & 4 present the locations for the photos included with this report.

- 1. The side slopes along the northwestern and northeastern faces of Ash Pond B had significant erosion rills and gullies observed generally in grids C-8, C-9 and H-7.

- 2. Along the side slopes on the southeastern side of Ash Pond B, minor erosion and rills were observed at locations shown in grid I-11.
 - Recommendation: Repair the soil cover and overseed these areas to establish a protective grass cover.

- 3. Along the diversion berm swales on the south and east sides of Ash Pond B, significant erosion and rills were observed at locations shown in grids F-10, G-6, and G-8.

- 1. Along the side slopes on the southeastern side of Ash Pond C, poor vegetation cover was observed in grid J-10.
 - Recommendation: Overseed the area to enhance the protective grass cover.
- 2. Along the diversion berm swales on the southeast side of Ash Pond C, minor erosion and rills were observed at locations shown in grids N-3 and O-3.
 - Recommendation: Repair the soil cover and overseed these areas to establish a protective grass cover.

- Recommendation: Repair the soil cover and install erosion control mats as needed in areas affected by erosion rills and gullies. Overseed these areas to establish a protective grass cover. As an alternative to the repair recommendation above, these areas apparently receive concentrated storm flow and constructing riprap-lined downchutes may be suitable for those rill locations.

- Recommendation: Repair the soil cover and overseed these areas to establish a protective grass cover.
