Indianapolis Power & Light Company Harding Street Generating Station

History of Construction of CCR Surface Impoundments

S&L Project No. 10572-085

Rev. 0
Issue Date: October 14, 2016
Issue Purpose: Use

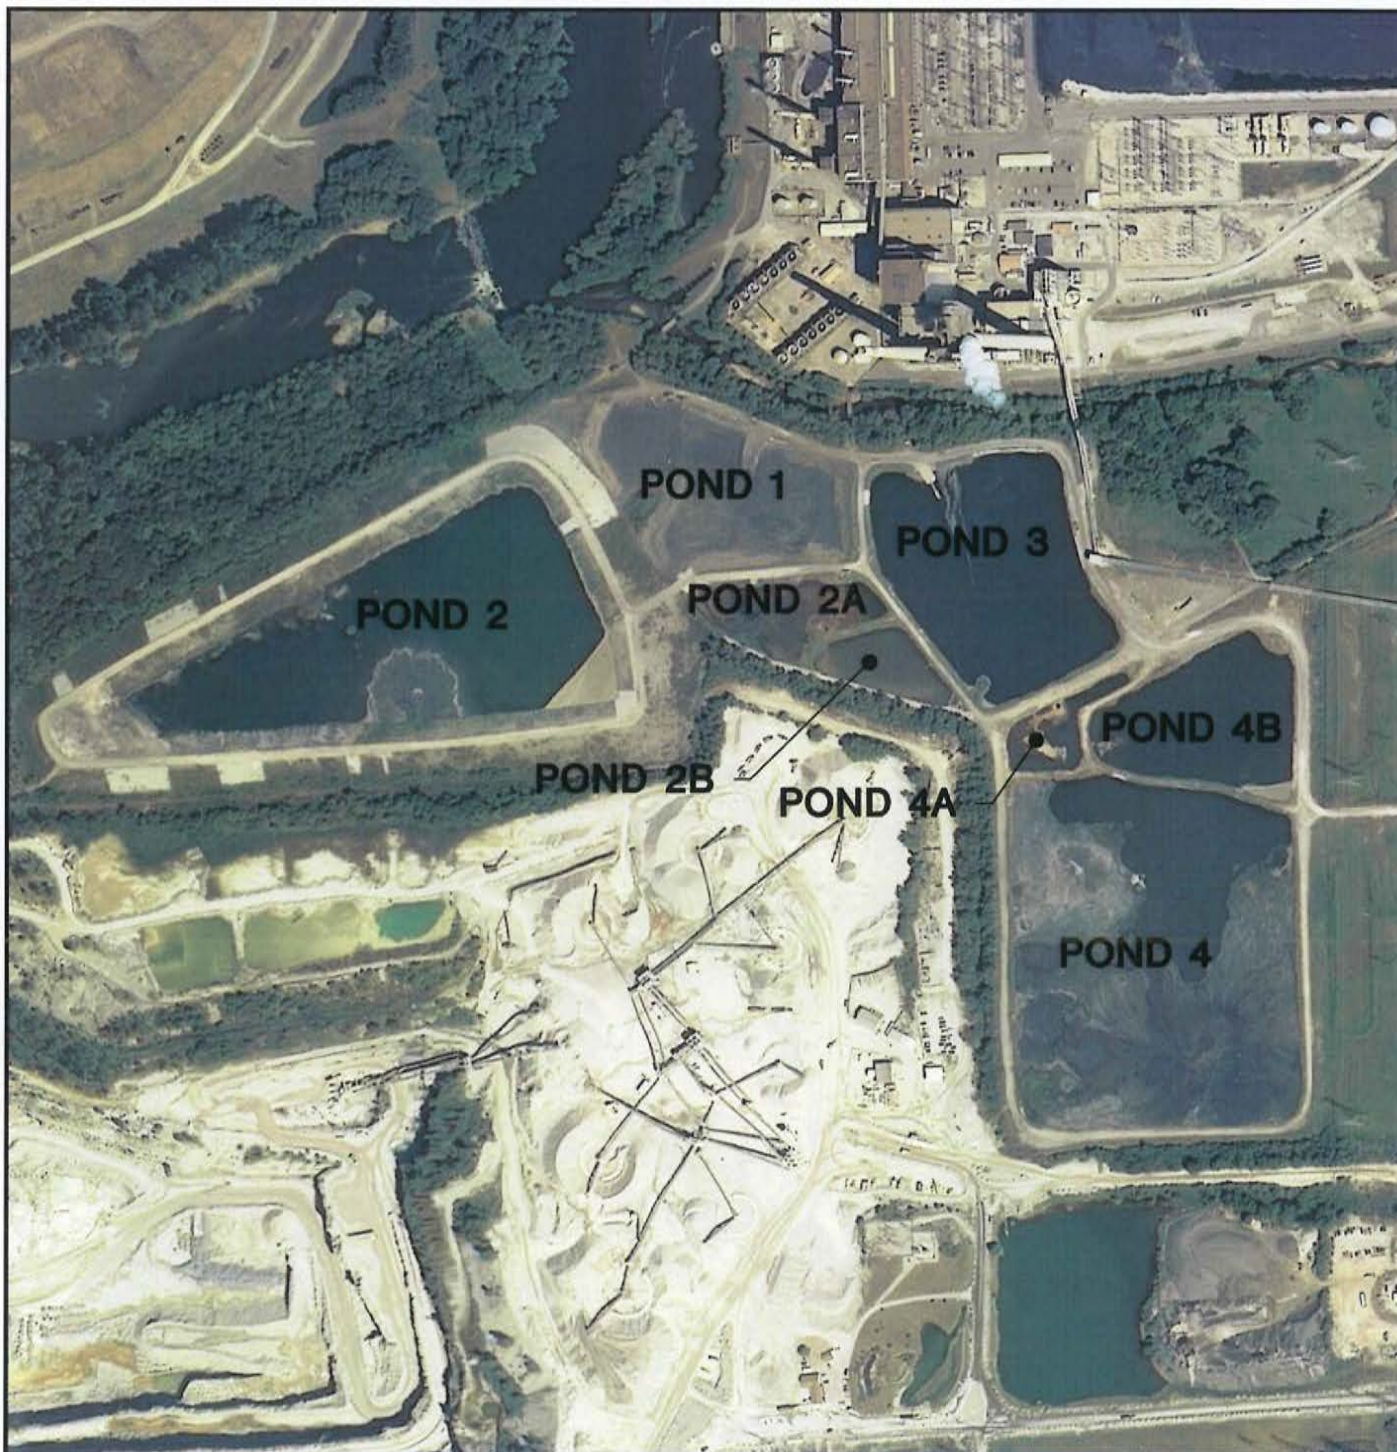
2830 DAIRY DRIVE MADISON, WI 53718-6751 PHONE: (608) 224-2830	FIGURE 1	
		DRAWN: 02/07/11		CHECKED BY: KG			
		REVISED: 09/23/11		APPROVED BY: DH 04/09/12

1. AERIAL PHOTOGRAPH FROM INDIANA SPATIAL DATA PORTAL, DATED 08/16/2010.

This O&M Plan is for the eight ash ponds (Ponds 1, 2, 2A, 2B, 3, 4, 4A, and 4B) located south of the generating station. Ash generated by burning coal at the generating station is mixed with water and may be pumped to either Pond 1 or Pond 4 where initial sedimentation occurs. The supernatant fluid from Pond 1 then flows to Ponds 2A, 2B, 4A, 4B and finally to Pond 3 for final sedimentation, or the supernatant fluid from Pond 4 flows to 4B and finally to Pond 3 for final sedimentation. After sedimentation in Pond 3 is complete, the fluid is discharged via a National Pollutant Discharge Elimination System (NPDES) permitted outfall to the Lick Creek that flows to the White River. The ponds were created by berms constructed of native site soils including clay and sand and ash. There is an access road on the top of each berm, and the outside of each berm is vegetated. The layout of the ponds is shown on **Figure 1**.
