PROJECT: Petersburg Generating Station

CLIENT: Sargent & Lundy

**Ash Pond Operations and
Maintenance Plan**

**Indianapolis Power & Light Company
Petersburg Generating Station
Petersburg, Indiana**

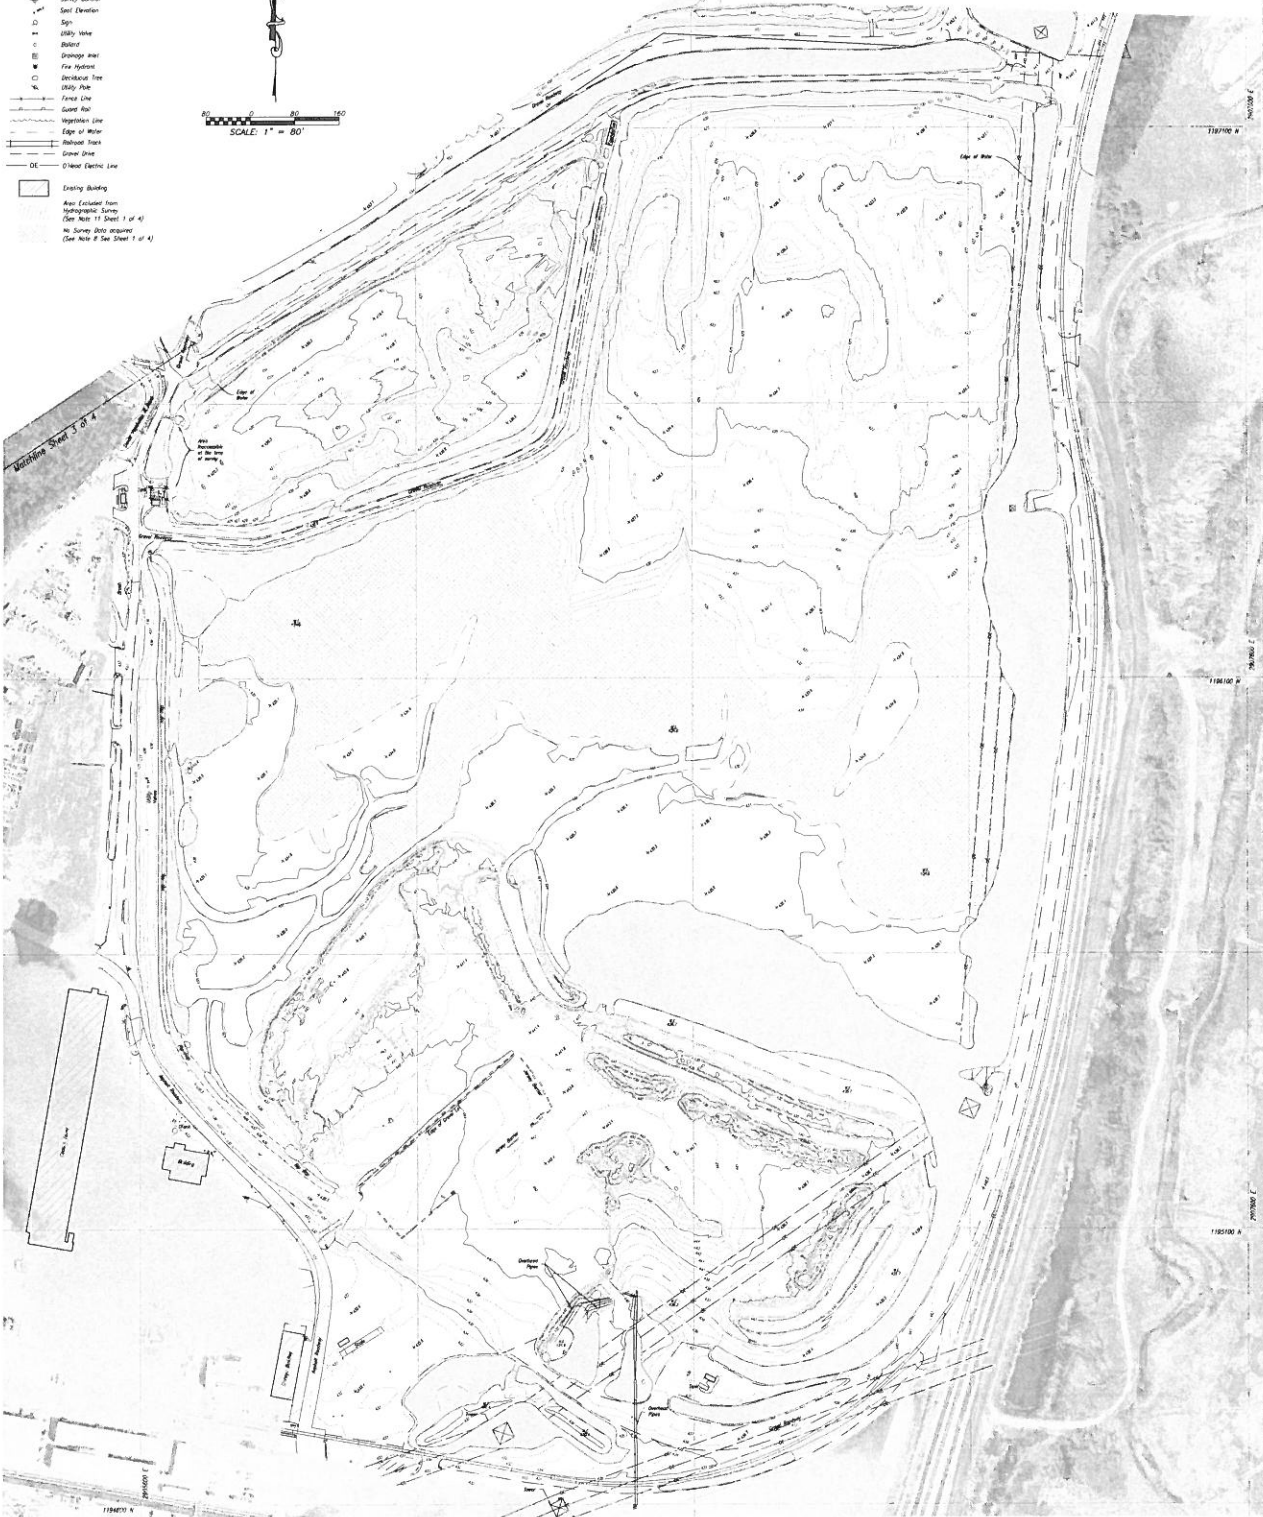
SHEET 4
 OF 4
 DRAWING NUMBER
8113PETE

Petersburg
Sargent & Lundy, LLC
Indianapolis Power & Light (IPL)
Petersburg Generating Station
Overall Ash Pond Survey
