January 9, 2026

CCR Annual Inspection

Ash Ponds 1, 2A/2B, 3, Former
Pond 2 and Former Pond 4

Harding Street Station

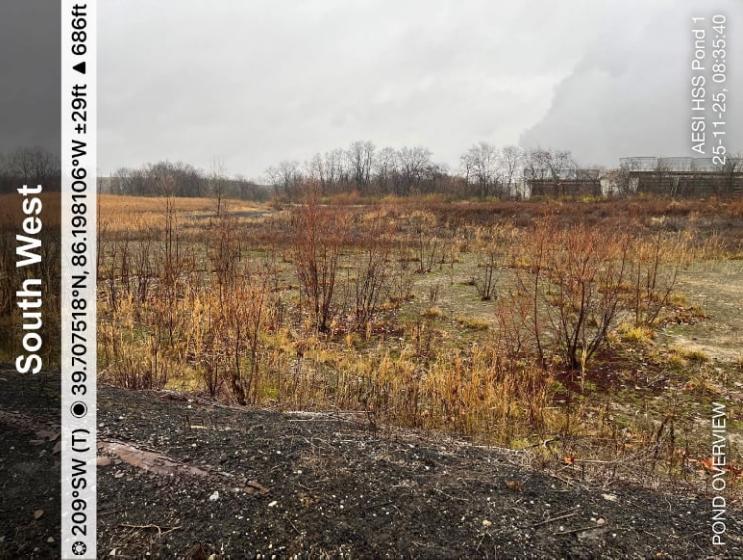
<p>AESI HSS Pond 1 25-11-25, 08:35:40</p> <p>POND OVERVIEW</p>
	Location: Harding Street Station, Indiana, Ash Pond 1	
	Description: Facing Northeast, plant. No issues observed.

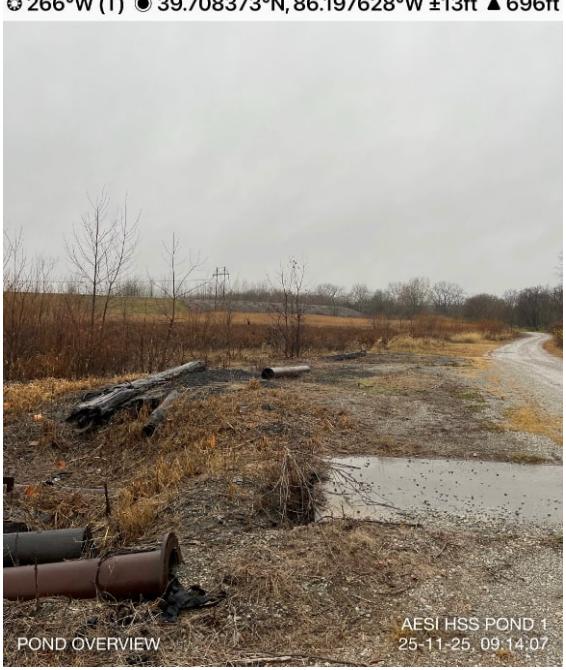
<p>POND OVERVIEW</p> <p>AESI HSS POND 1 25-11-25, 09:14:07</p>
Location: Harding Street Station, Indiana, Ash Pond 1	Description: Facing East, pond overview. No issues observed.	
Photo 4	Date: 11/25/2025	<p>South West Elevation</p> <p>⌚ 27°NE (T) ⚩ 39.708980°N, 86.199820°W ±32ft ▲ 6922ft</p>

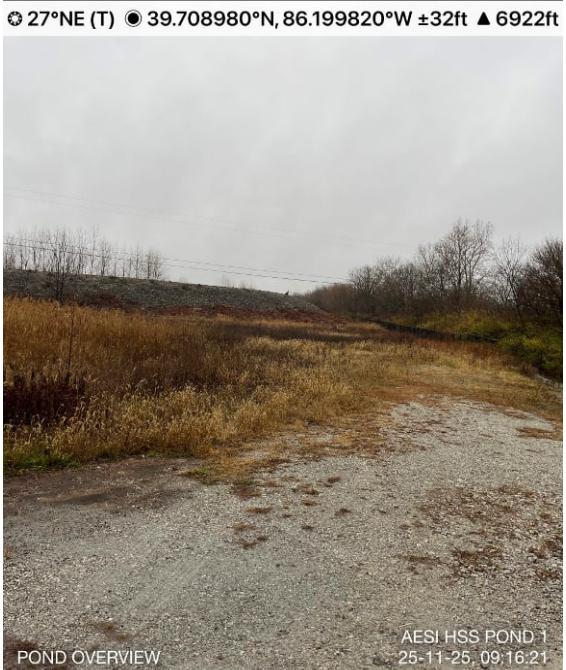
<p>POND OVERVIEW</p> <p>AESI HSS POND 1 25-11-25, 09:16:21</p>
Location: Harding Street Station, Indiana, Ash Pond 1	Description: Facing Southwest, pond overview. No issues observed.

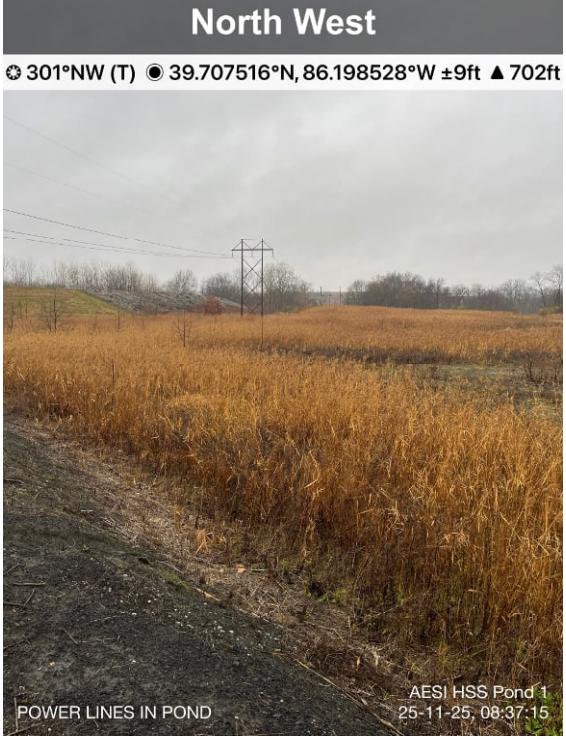
<p>POWER LINES IN POND</p> <p>AESI HSS Pond 1 25-11-25, 08:37:15</p>
	Location: Harding Street Station, Indiana, Ash Pond 1	
	Description: Facing Northwest, power lines running through ponds. No issues observed.	
Photo 6	Date: 11/25/2025	<p>South</p> <p>⌚ 176°S (T) ● 39.706951°N, 86.200093°W ±13ft ▲ 735ft</p>

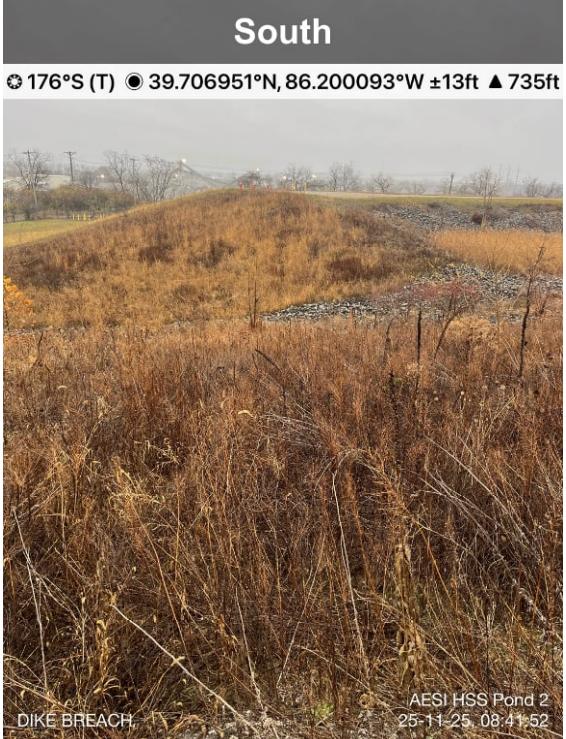
<p>DIKE BREACH</p> <p>AESI HSS Pond 2 25-11-25, 08:41:52</p>
	Location: Harding Street Station, Indiana, Former Pond 2	
	Description: Facing South, dike breach. No issues observed.

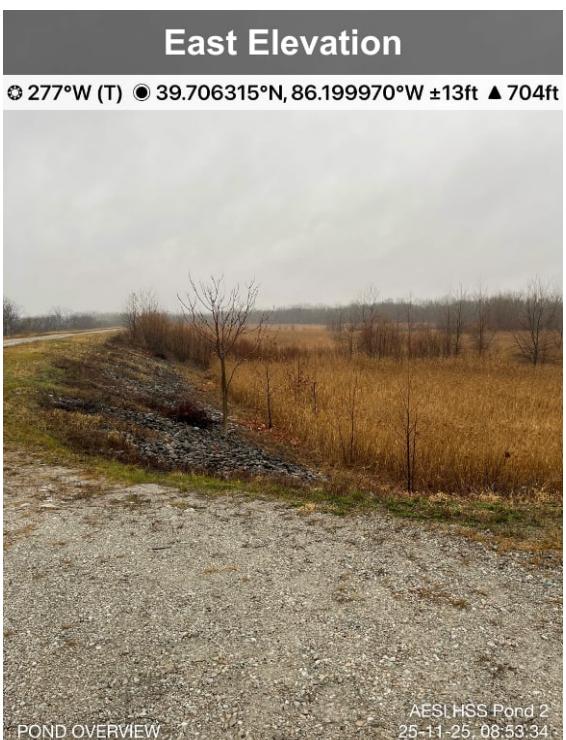
<p>POND OVERVIEW</p> <p>AESI HSS Pond 2 25-11-25, 08:53:34</p>
	Location: Harding Street Station, Indiana, Former Pond 2	
	Description: Facing Southwest, plant and ponds overview. No issues observed.

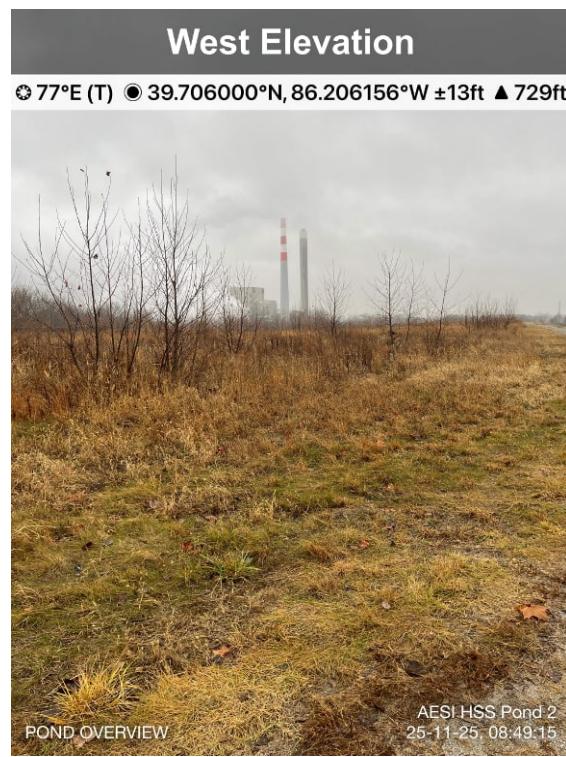
Photo 9	Date: 11/25/2025
Location: Harding Street Station, Indiana, Former Pond 2	
Description: Facing West, pond overview. No issues observed.

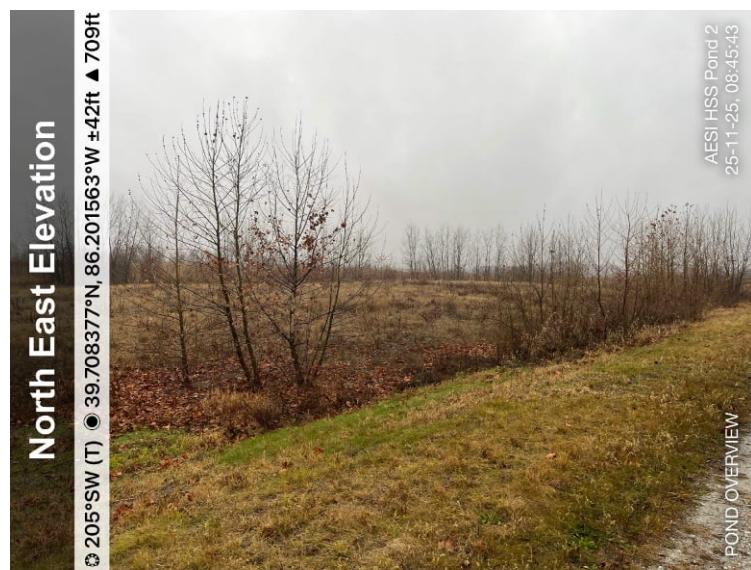
Photo 10	Date: 11/25/2025
Location: Harding Street Station, Indiana, Former Pond 2	
Description: Facing Northeast, pond overview. No issues observed.

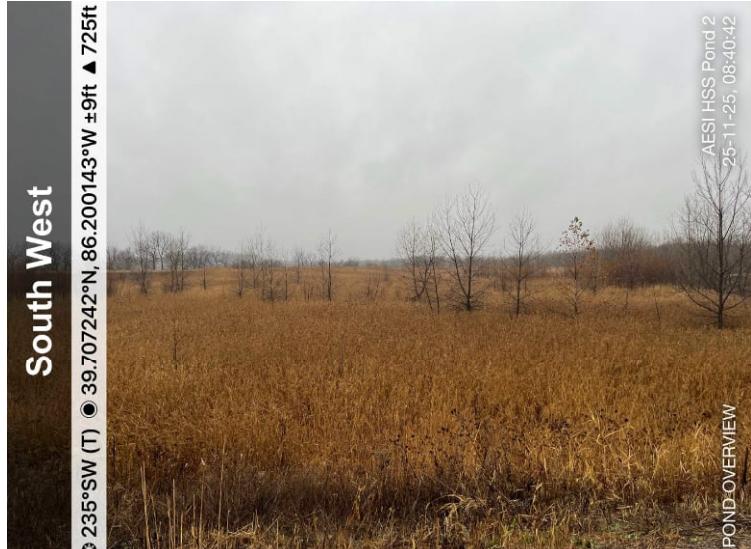
Photo 11	Date: 11/25/2025	<p>Location: Harding Street Station, Indiana, Former Pond 2</p> <p>Description: Facing Southwest, pond overview.</p> <p>No issues observed.</p>

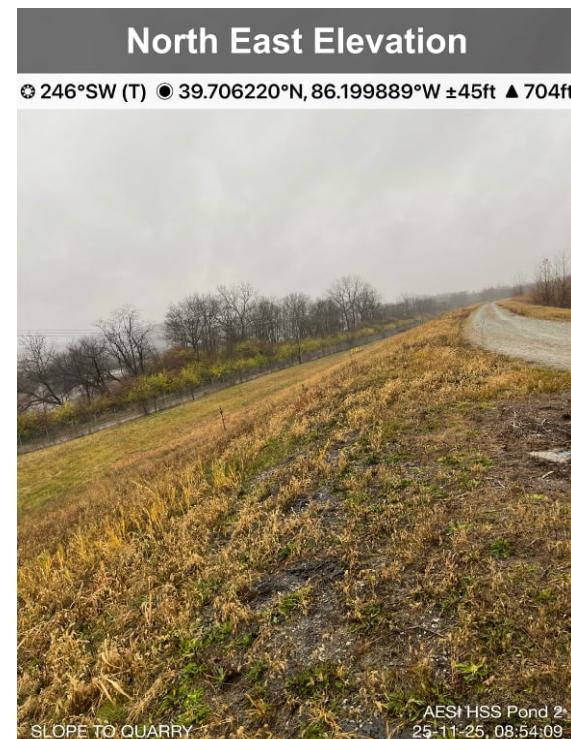
Photo 12	Date: 11/25/2025	<p>Location: Harding Street Station, Indiana, Former Pond 2</p> <p>Description: Facing Northeast, Slope to quarry.</p> <p>No issues observed.</p>

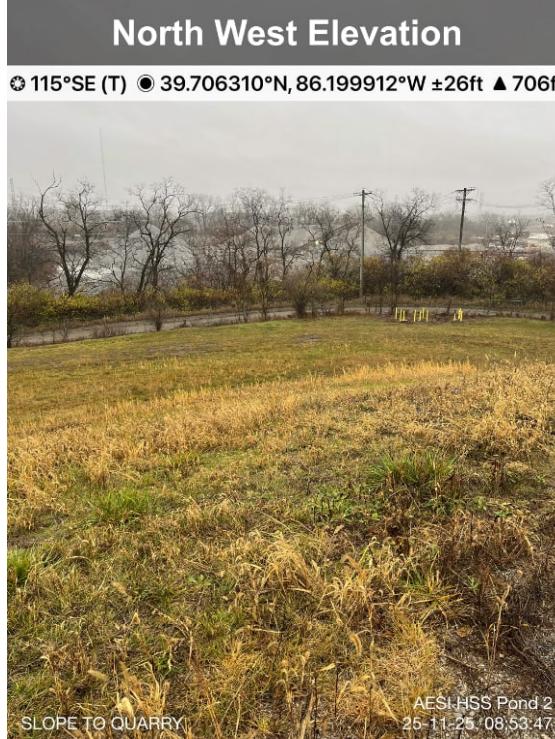
Location: Harding Street Station, Indiana, Former Pond 2		
Description: Facing Northwest, Slope to quarry.		
No issues observed.		
Photo 14	Date: 11/25/2025	<p style="text-align: center;">North West Elevation</p> <p>⌚ 149°SE (T) ● 39.705936°N, 86.206092°W ±13ft ▲ 728ft</p>

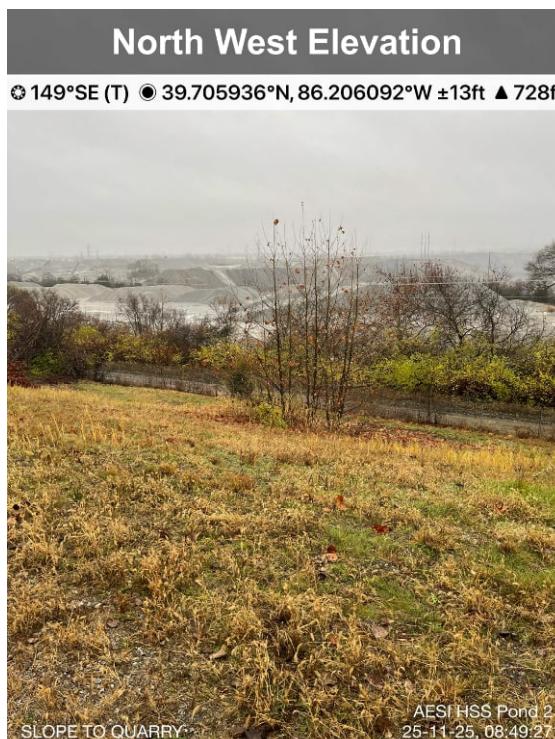
Location: Harding Street Station, Indiana, Former Pond 2		
Description: Facing Northwest, Slope to quarry.		
No issues observed.

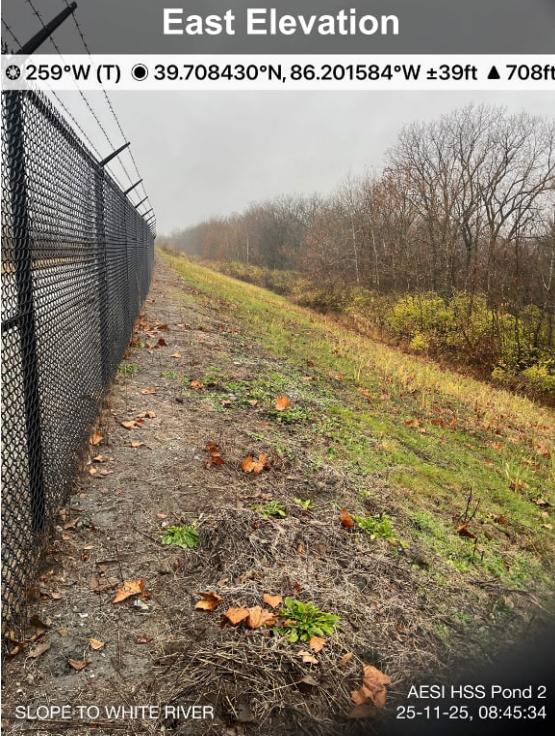
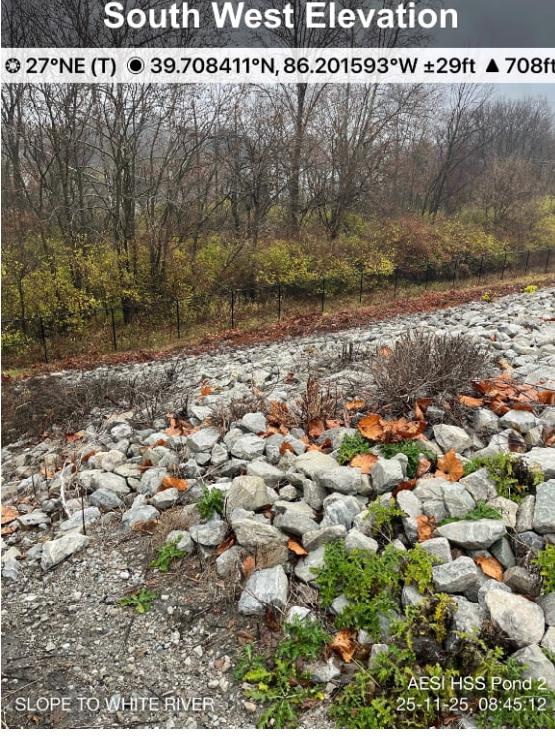
<p>SLOPE TO WHITE RIVER</p> <p>AESI HSS Pond 2 25-11-25, 08:45:12</p>
Location: Harding Street Station, Indiana, Former Pond 2	Description: Facing East, Slope to White River. No issues observed.	
Location: Harding Street Station, Indiana, Former Pond 2	Description: Facing Southwest, Slope to White River. No issues observed.

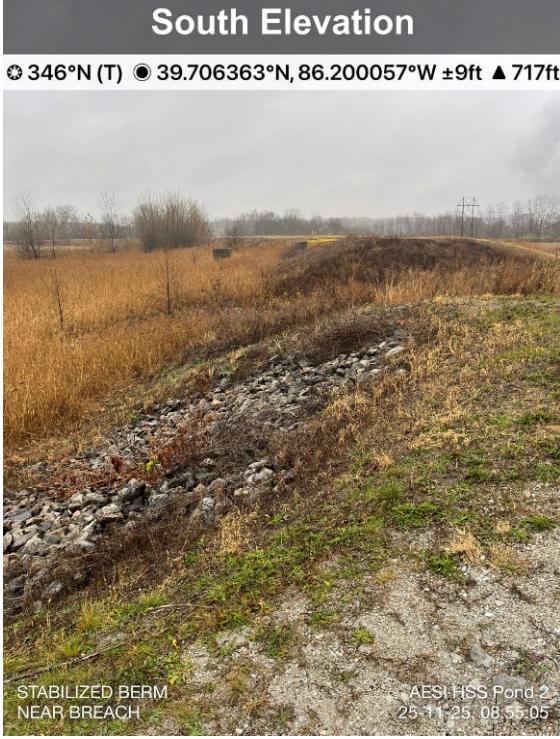
<p>STABILIZED BERM NEAR BREACH</p> <p>AESI HSS Pond 2 25-11-25 08:55:05</p>
Location: Harding Street Station, Indiana, Former Pond 2		
Description: Facing South, Stabilized berm near breach. No issues observed.		
Photo 18	Date: 11/25/2025	<p>East</p> <p>⌚ 96°E (T) ⚩ 39.706948°N, 86.200057°W ±13ft ▲ 754ft</p>

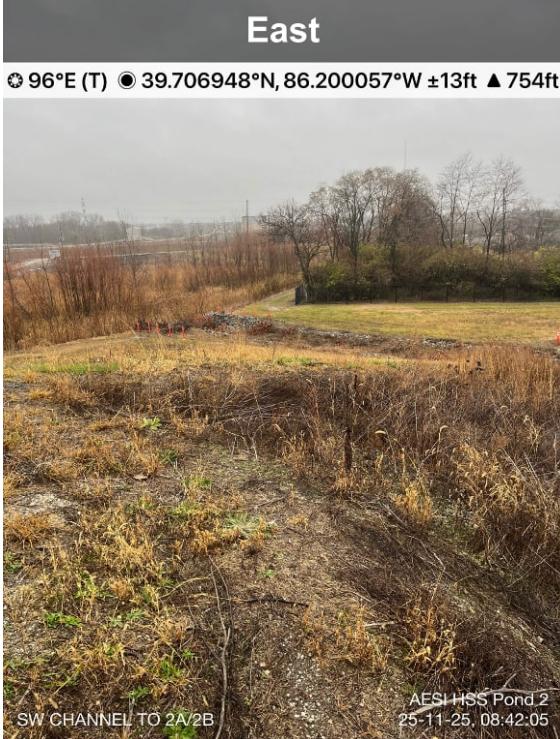
<p>SW CHANNEL TO 2A/2B</p> <p>AESI HSS Pond 2 25-11-25 08:42:05</p>
Location: Harding Street Station, Indiana, Ash Pond 2A/2B		
Description: Facing East, Stormwater channel from Former Pond 2 to 2A/2B. No issues observed.

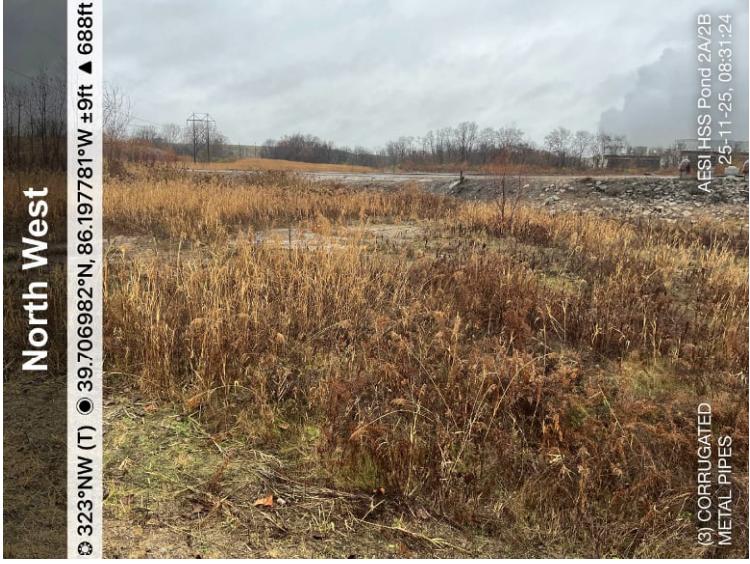
Photo 19	Date: 11/25/2025

<p>North West</p> <p>⌚ 323°NW (T) ● 39.706982°N, 86.197781°W ±9ft ▲ 688ft</p> <p>AESI HSS Pond 2A/2B 25-11-25, 08:31:24</p> <p>(3) CORRUGATED METAL PIPES</p>
	Location: Harding Street Station, Indiana, Ash Pond 2A/2B	
	Description: Facing Northwest, (3) Corrugated metal pipes. No issues observed.	
Photo 20	Date: 11/25/2025

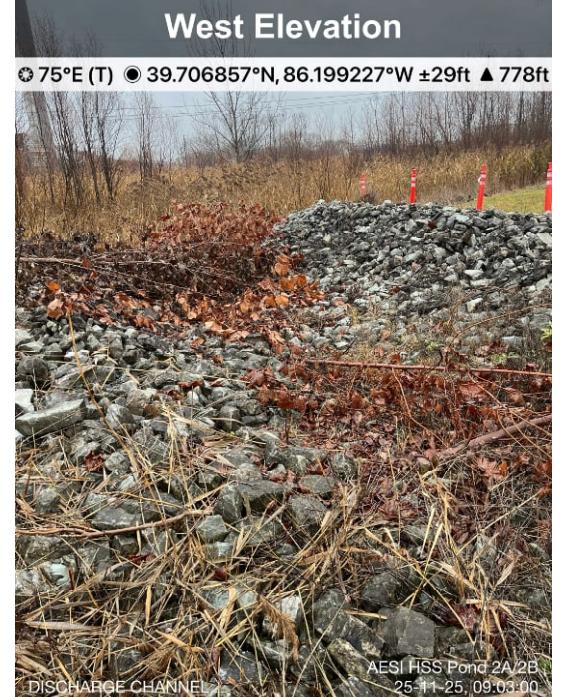
<p>DISCHARGE CHANNEL</p> <p>AESI HSS Pond 2A/2B 25-11-25, 09:03:00</p>
	Location: Harding Street Station, Indiana, Ash Pond 2A/2B	
	Description: Facing West, discharge channel. No issues observed.

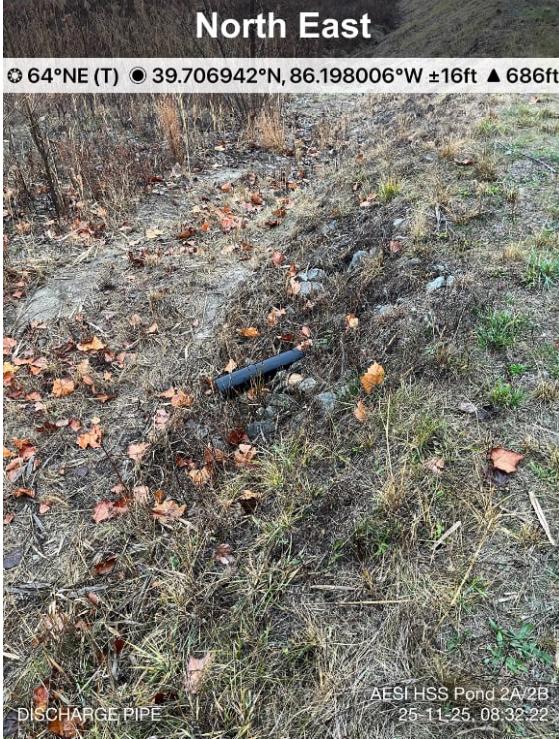
Photo 23	Date: 11/25/2025	<p>Location: Harding Street Station, Indiana, Ash Pond 2A/2B</p> <p>Description: Facing Northeast, discharge pipe.</p> <p>No issues observed.</p>

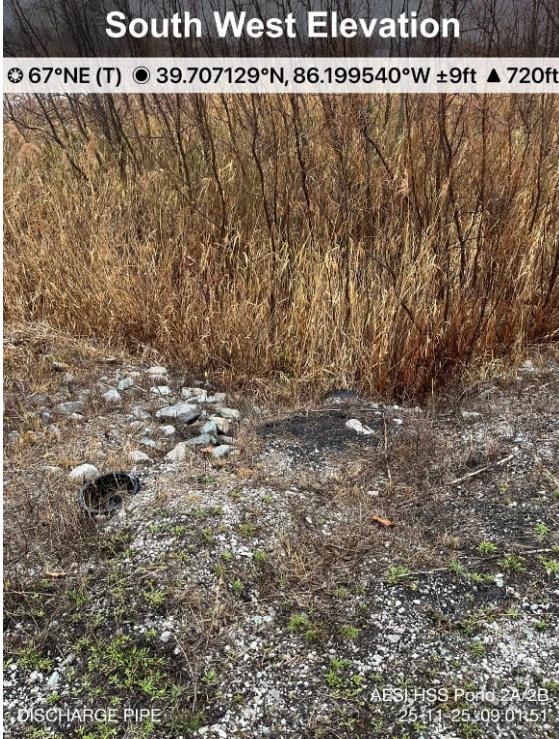
<p>North East</p> <p>64°NE (T) 39.706942°N, 86.198006°W ±16ft ▲ 686ft</p> <p>AESI HSS Pond 2A/2B 25-11-25 08:32:22</p> <p>DISCHARGE PIPE</p>
Photo 24	Date: 11/25/2025	<p>Location: Harding Street Station, Indiana, Ash Pond 2A/2B</p> <p>Description: Facing Southwest, discharge pipe.</p> <p>No issues observed.</p>

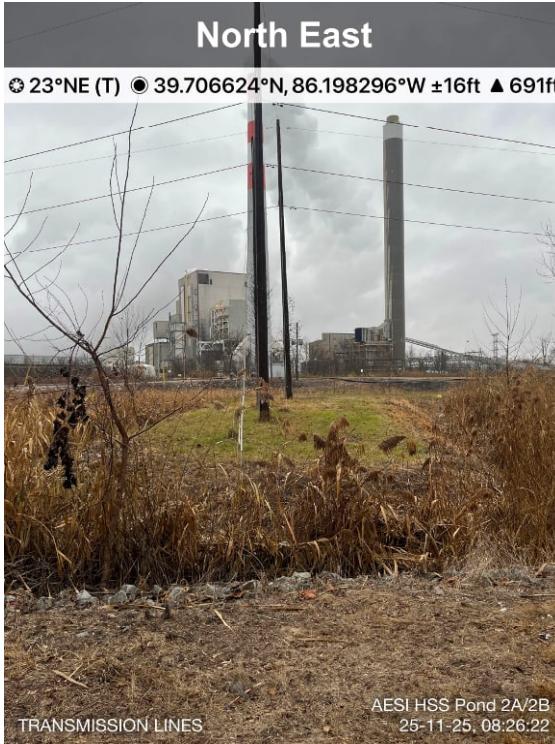
Photo 25	Date: 11/25/2025	<p>Location: Harding Street Station, Indiana, Ash Pond 2A/2B</p> <p>Description: Facing Northeast, Transmission lines in ponds.</p> <p>No issues observed.</p>

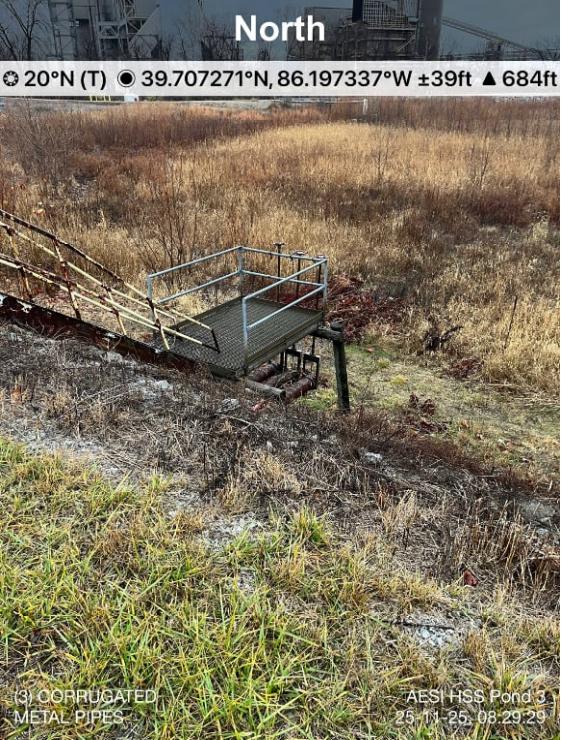
<p>North</p> <p>● 20°N (T) ● 39.707271°N, 86.197337°W ±39ft ▲ 684ft</p> <p>AESI HSS Pond 3 25-11-25 08:29:29</p> <p>(3) CORRUGATED METAL PIPES</p>
	Location: Harding Street Station, Indiana, Ash Pond 3	
	Description: Facing North, (3) Corrugated metal pipes. No issues observed.

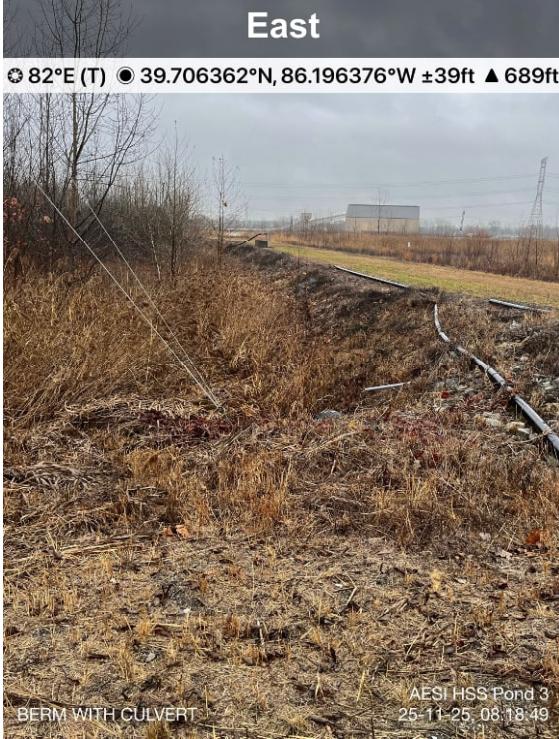
Location: Harding Street Station, Indiana, Ash Pond 3		
Description: Facing East, berm with culvert. No issues observed.		
Photo 30	Date: 11/25/2025	<p style="text-align: center;">North West</p> <p>⌚ 309°NW (T) ● 39.706491°N, 86.196460°W ±9ft ▲ 694ft</p>

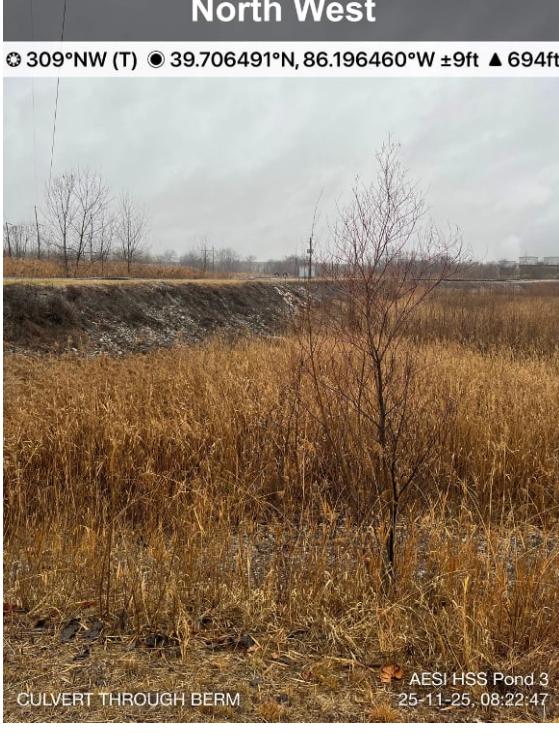
Location: Harding Street Station, Indiana, Ash Pond 3		
Description: Facing Northwest, culvert through ash berm. No issues observed.

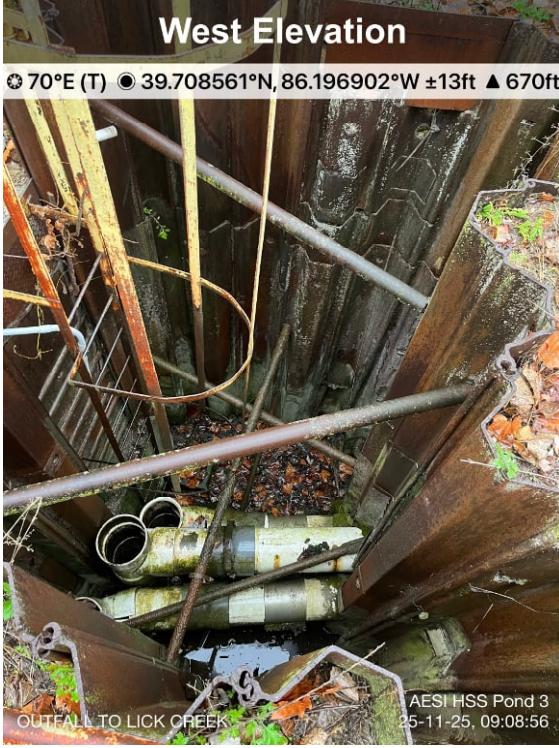
<p>AESI HSS Pond 3 25-11-25, 09:08:56</p>
Location: Harding Street Station, Indiana, Ash Pond 3	Description: Facing West, outfall to Lick Creek. No issues observed.	
Photo 32	Date: 11/25/2025	<p>South West Elevation</p> <p>⌚ 25°NE (T) ⚔ 39.708484°N, 86.197125°W ±9ft ▲ 709ft</p>

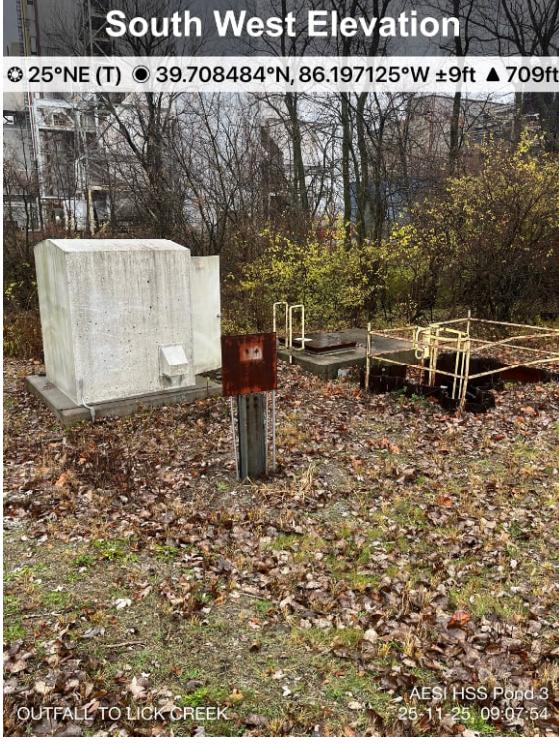
<p>AESI HSS Pond 3 25-11-25, 09:07:54</p>
Location: Harding Street Station, Indiana, Ash Pond 3	Description: Facing Southwest, outfall to Lick Creek. No issues observed.

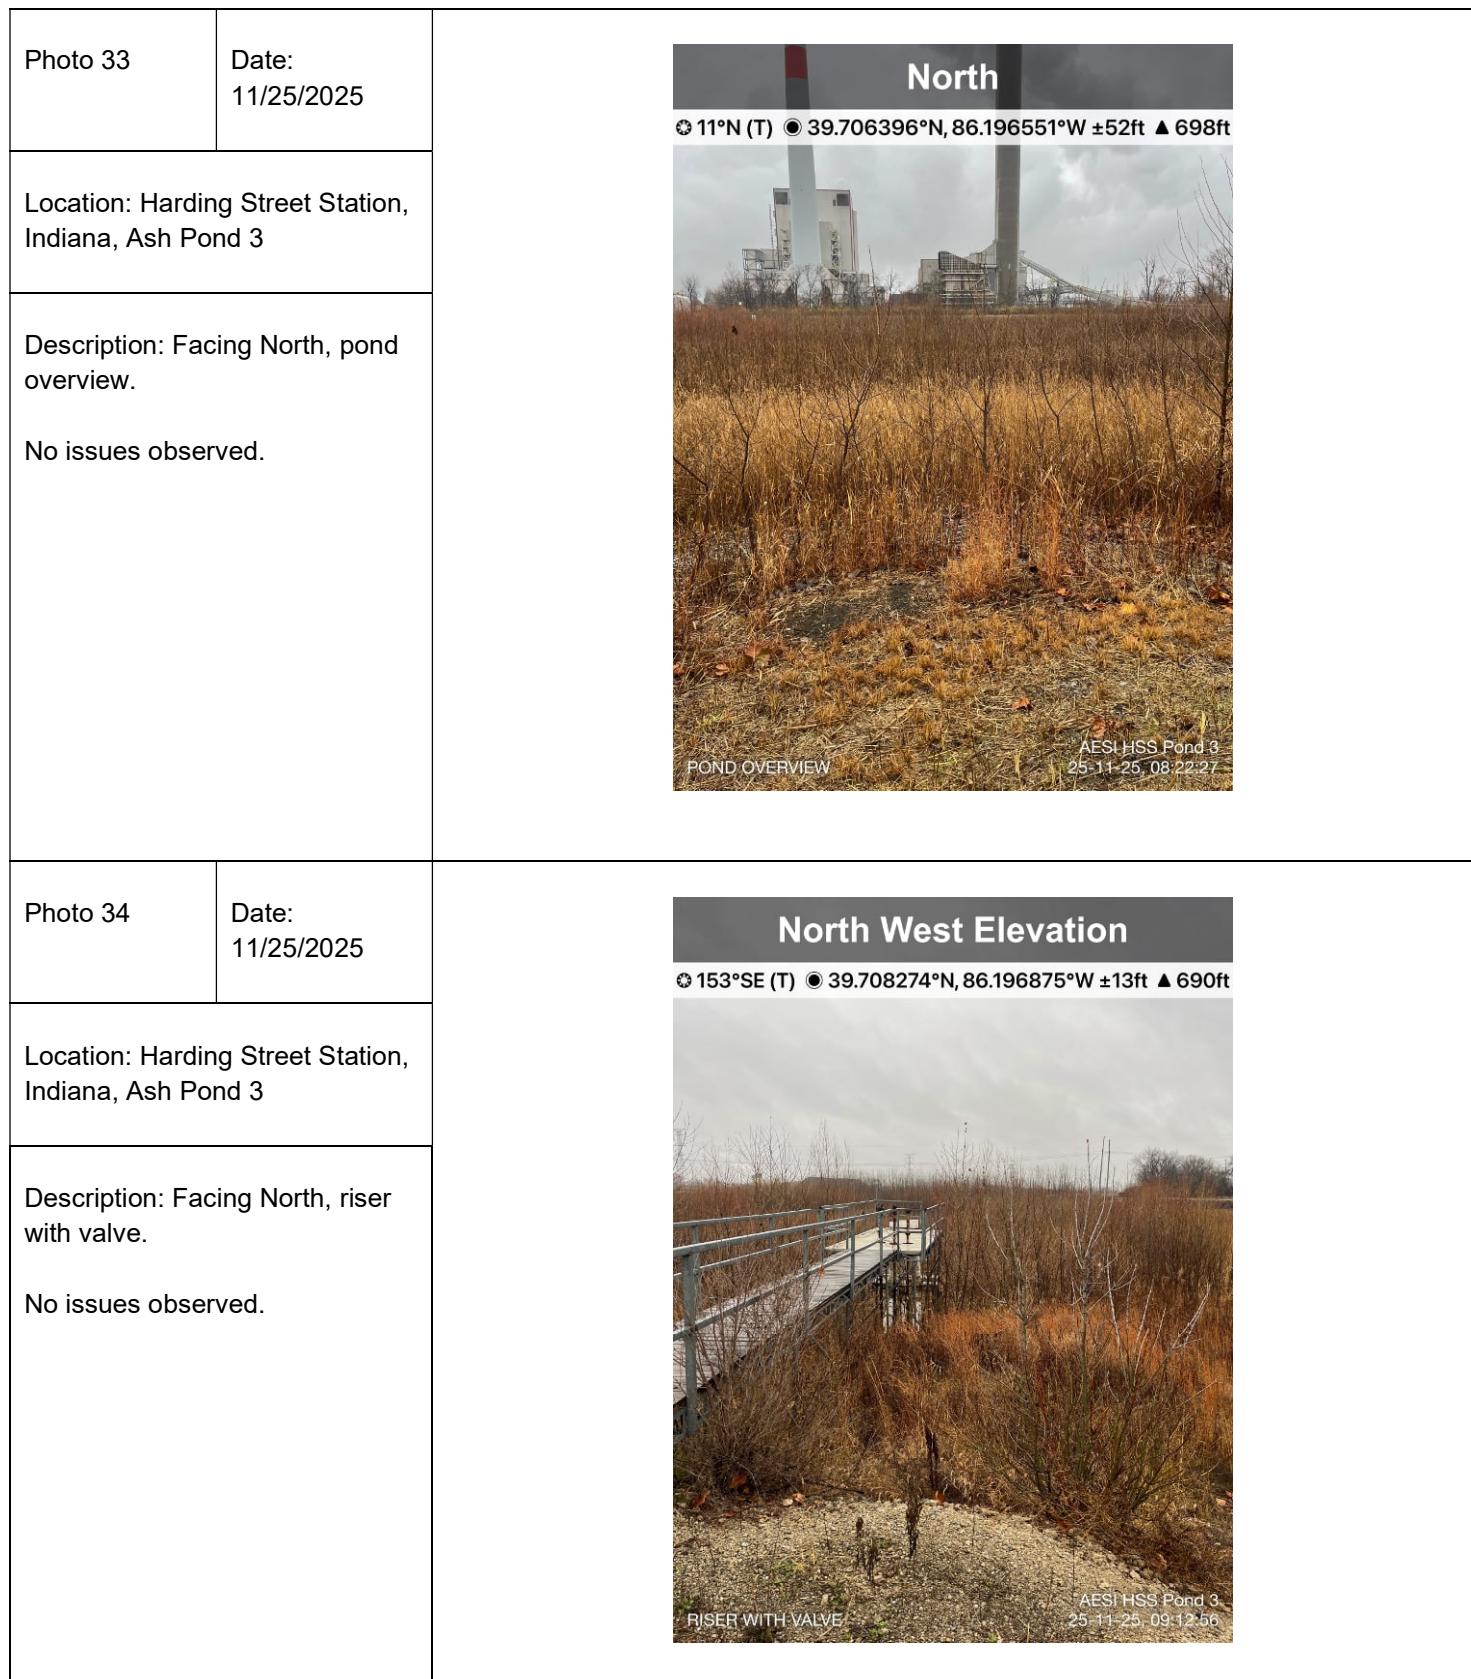
Photo 33	Date: 11/25/2025

<p>North</p> <p>● 11°N (T) ● 39.706396°N, 86.196551°W ±52ft ▲ 698ft</p> <p>POND OVERVIEW</p> <p>AESI HSS Pond 3 25-11-25, 08:22:27</p>
Location: Harding Street Station, Indiana, Ash Pond 3		
Description: Facing North, pond overview.		
No issues observed.		
Photo 34	Date: 11/25/2025

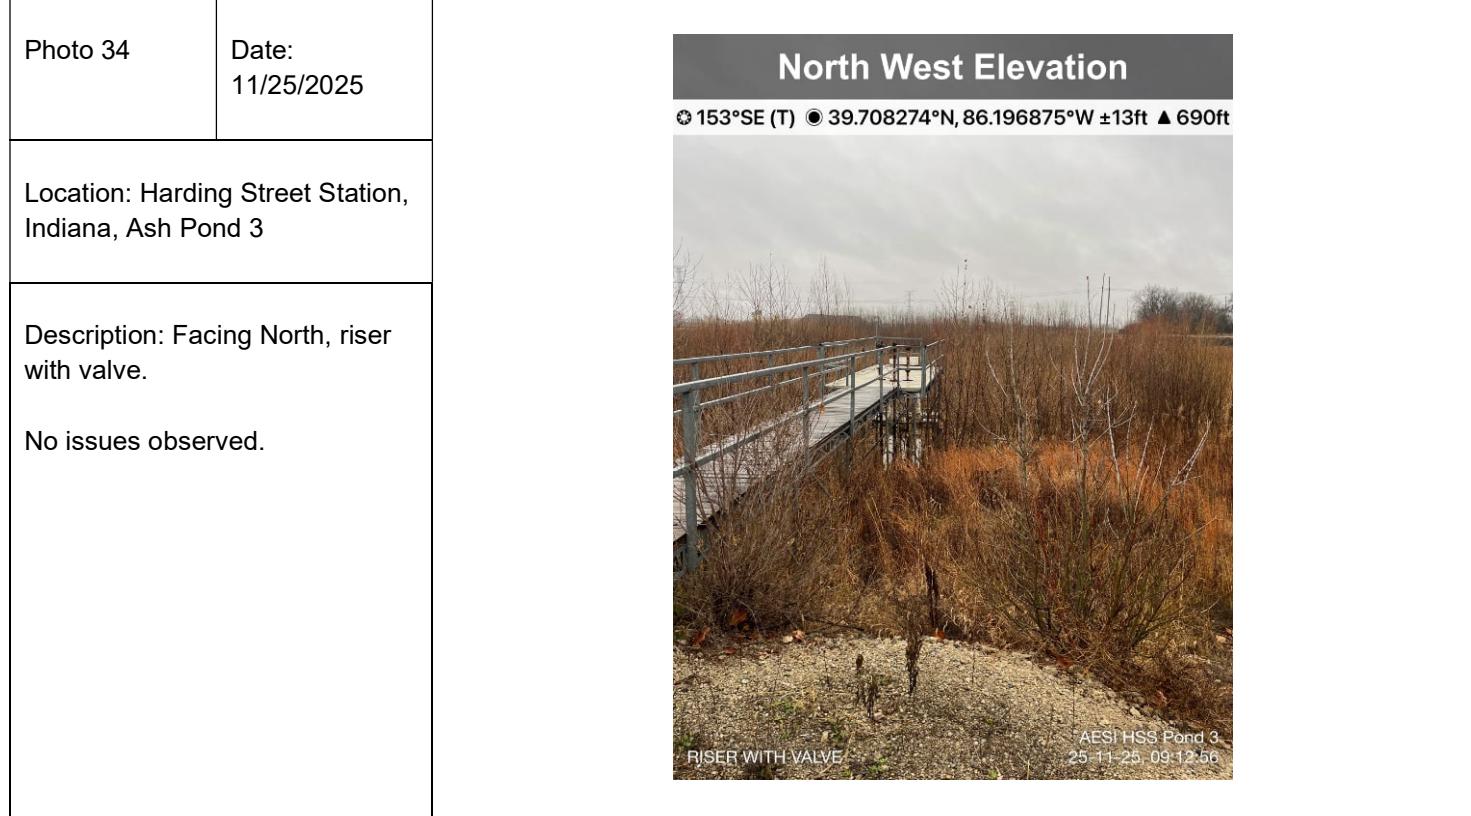
<p>North West Elevation</p> <p>● 153°SE (T) ● 39.708274°N, 86.196875°W ±13ft ▲ 690ft</p> <p>RISER WITH VALVE</p> <p>AESI HSS Pond 3 25-11-25, 09:12:56</p>
Location: Harding Street Station, Indiana, Ash Pond 3		
Description: Facing North, riser with valve.		
No issues observed.

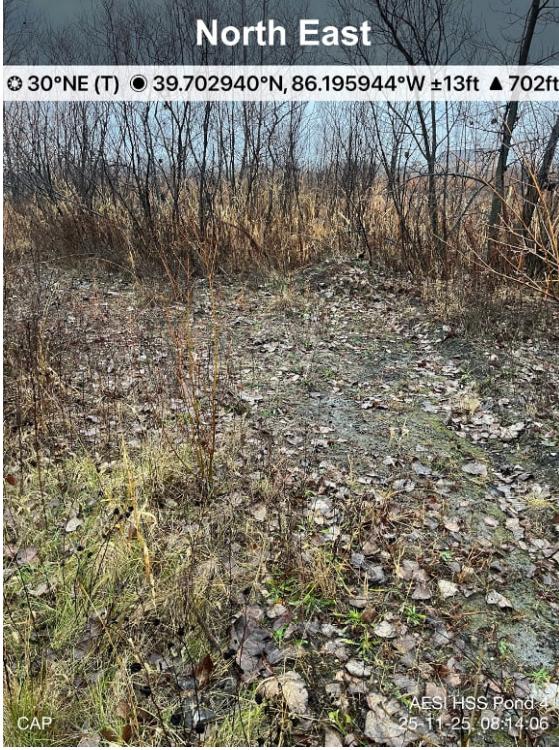
Photo 35	Date: 11/25/2025	<p>Location: Harding Street Station, Indiana, Former Pond 4</p> <p>Description: Facing Northeast, pond overview.</p> <p>No issues observed.</p>

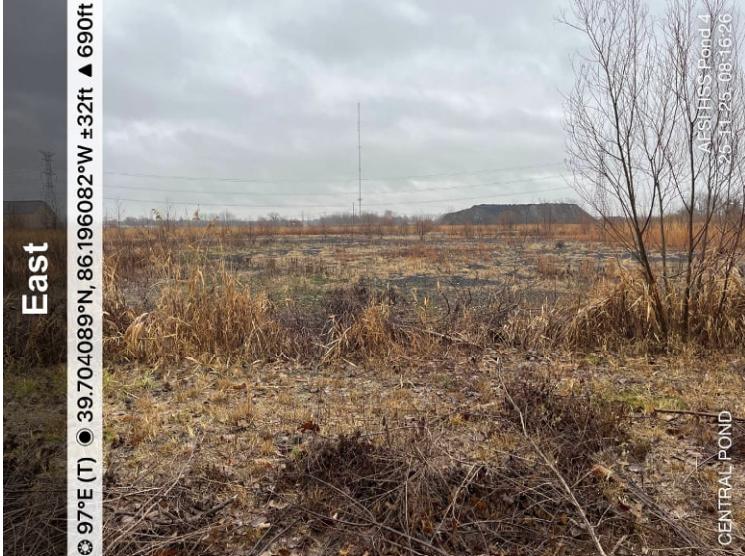
<p>North East</p> <p>⌚ 30°NE (T) ⚩ 39.702940°N, 86.195944°W ±13ft ▲ 702ft</p> <p>CAP</p> <p>AESI HSS Pond 4 25-11-25 08:14:06</p>
Photo 36	Date: 11/25/2025	<p>Location: Harding Street Station, Indiana, Former Pond 4</p> <p>Description: Facing East, pond overview.</p> <p>No issues observed.</p>

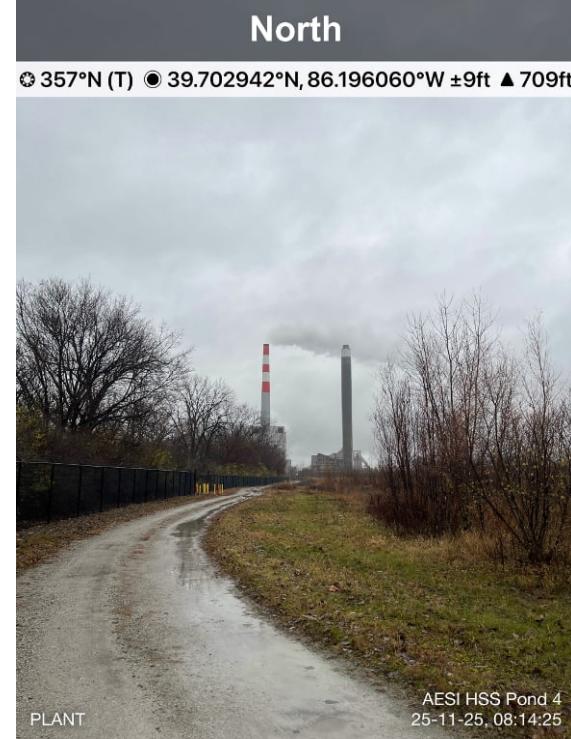
Photo 38	Date: 11/25/2025	<p>Location: Harding Street Station, Indiana, Former Pond 4</p> <p>Description: Facing North, plant and pond overview.</p> <p>No issues observed.</p>
