**2023 VISUAL INSPECTION OF ASH POND EMBANKMENTS  
AES PETERSBURG ASH POND SYSTEM**

AES INDIANA PETERSBURG GENERATING STATION  
6925 NORTH STATE ROAD 57  
PETERSBURG, INDIANA 47567

ATLAS PROJECT NO. 170LF01359

JANUARY 3, 2024

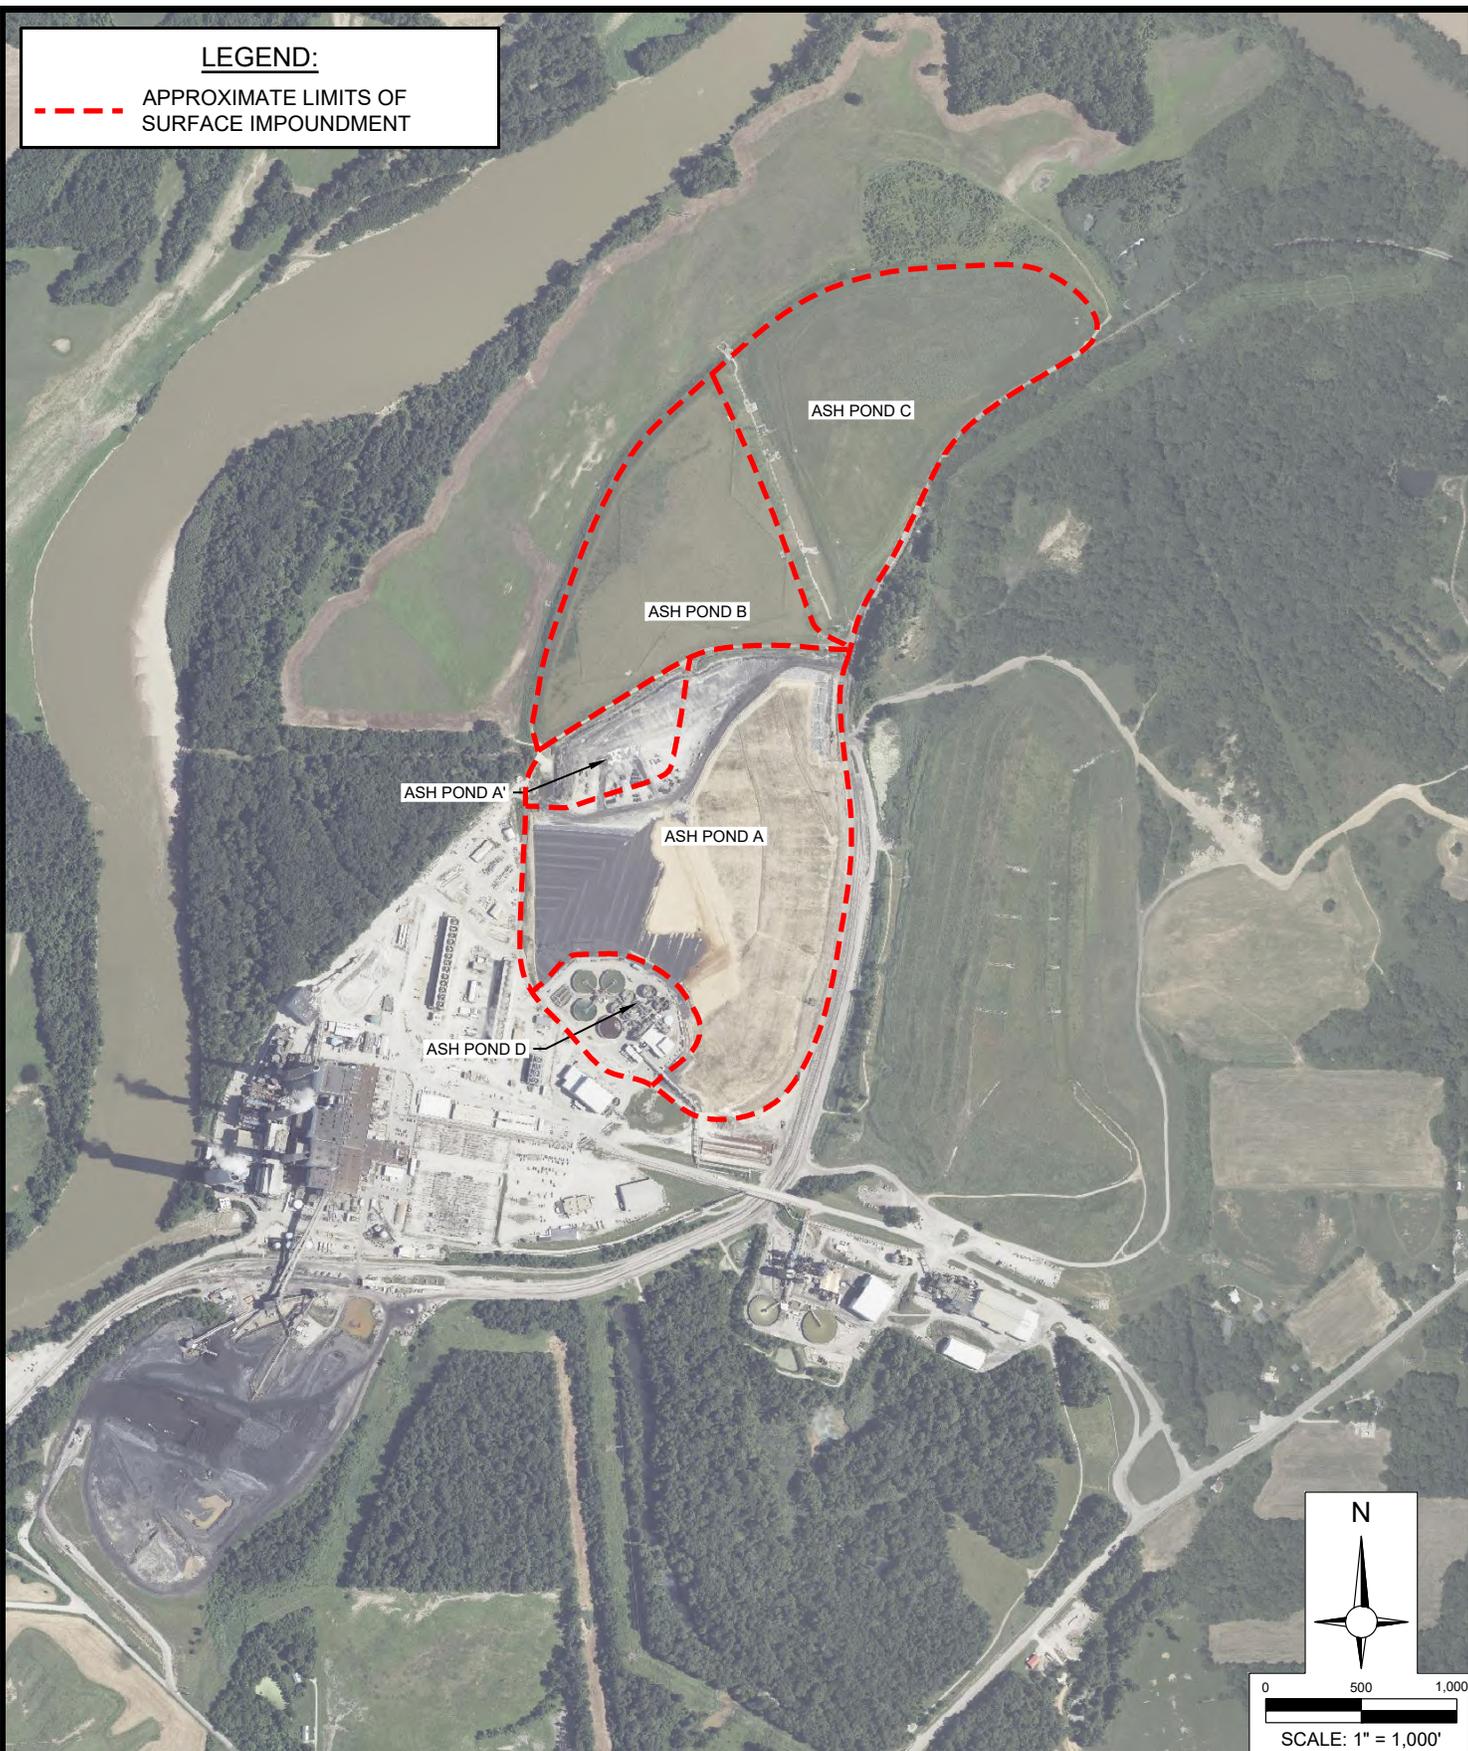
Engineering observations performed on December 28, 2023 are shown in Figure 3, 2023 Visual Site Inspection Grid Map. Atlas visually inspected the embankments for Ash Ponds A, A', B, C, and D and found no areas of instability. However, there were few areas with concerns relating to minor erosion on sections of Ash Pond B (Figure 3).

- G/E OBSERVATIONS
- G = GOOD VEGETATION
- E = REPAIR EROSION AND RESEED
- APPROXIMATE LIMITS OF CCR SURFACE IMPOUNDMENT
- GRID (200 FT)
