**2024 VISUAL INSPECTION OF ASH POND EMBANKMENTS
AES PETERSBURG ASH POND SYSTEM**

AES INDIANA PETERSBURG GENERATING STATION
6925 NORTH STATE ROAD 57
PETERSBURG, INDIANA 47567

ATLAS PROJECT NO. 170AES0005

NOVEMBER 12, 2024

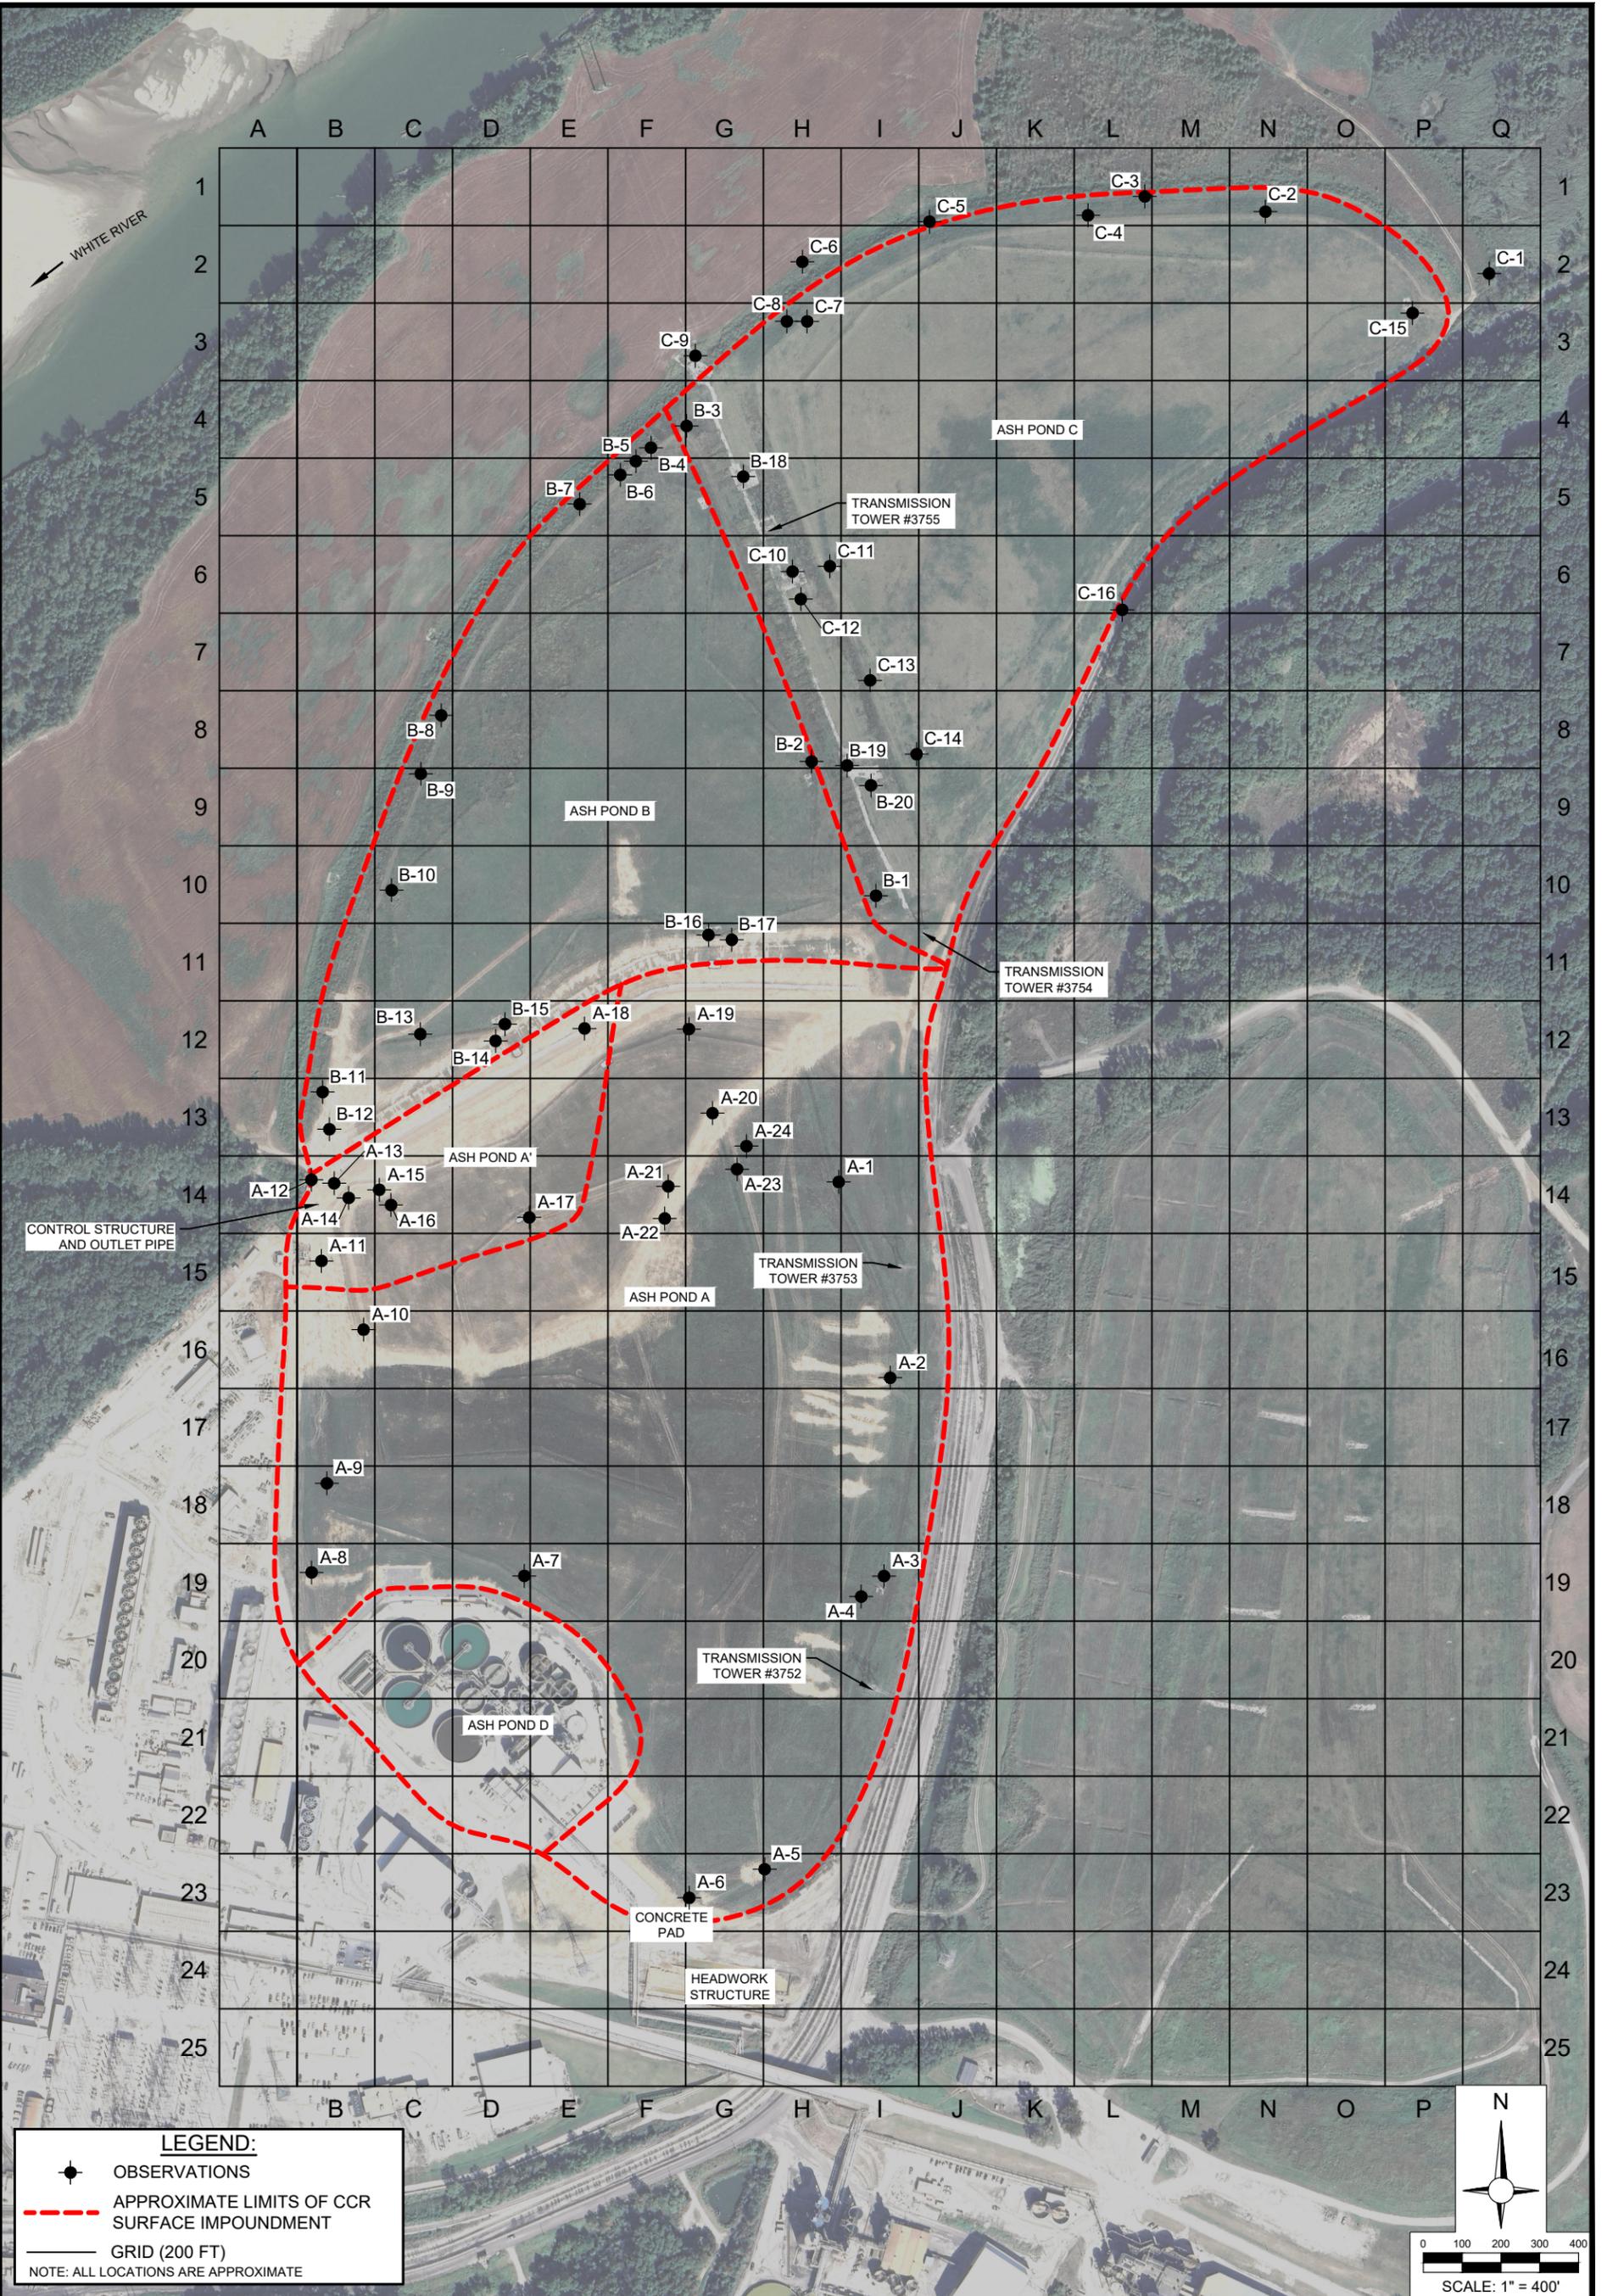
3. Accumulated sediments/debris and/or tall vegetation observed at three separated drop inlets located on the Ash Pond B (locations B-2, B-15, and B-16 of Figure 4).
 - Recommendation: Cut down tall vegetation and remove debris from the drop inlets.
4. Minor erosion rills were observed at six separate locations on the west section of Ash Pond B (locations B-3, B-4, B-5, B-6, B-8, and B-9 of Figure 4).
 - Recommendation: Repair the soil cover and overseed these areas to establish a protective grass cover.
5. The drop inlet domed grate cover is damaged at location B-10 and B-15, on the west side of the Ash Pond B.
 - Recommendation: Replace the drop inlet domed grate cover.

6. Accumulated sediments/debris and/or tall vegetation observed at five separate locations on the Ash Pond C (locations C-1, C-5, C-11, C-14, and C-15, of Figure 4).
 - Recommendation: Cut down tall vegetation and remove debris from the drop inlets.

7. Minor erosion rills were observed at two separate locations on the north section of Ash Pond C (locations C-2, and C-8 of Figure 4).
 - o Recommendation: Repair the soil cover and overseed these areas to establish a protective grass cover.
