Submitted to  
AES Indiana  
Petersburg Generating Station  
6925 North State Road 57  
Petersburg, IN 47567

Submitted by  
AECOM  
1300 E 9<sup>th</sup> Street  
Suite 500  
Cleveland, OH 44114

November 12, 2025

CCR Annual Inspection  
§257.83 (b)  
for the  
Ash Ponds A, A', B, C, and D  
at the  
Petersburg Generating Station  
Revision 0

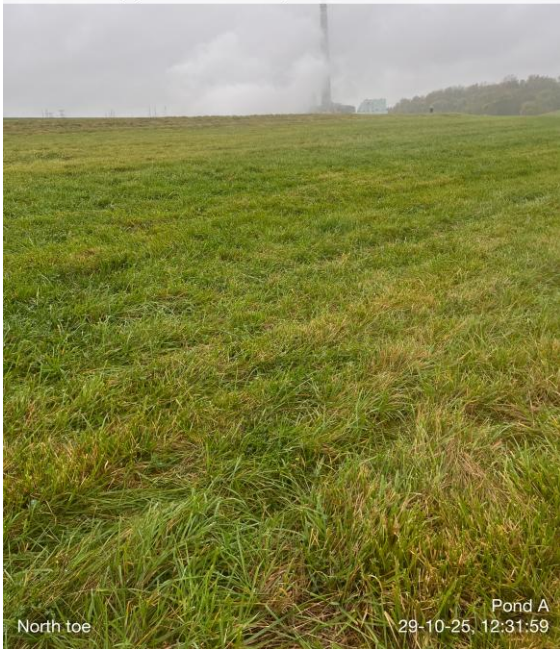
<div><div>North toe</div><div>Pond A 29-10-25, 12:31:59</div></div></div></div>

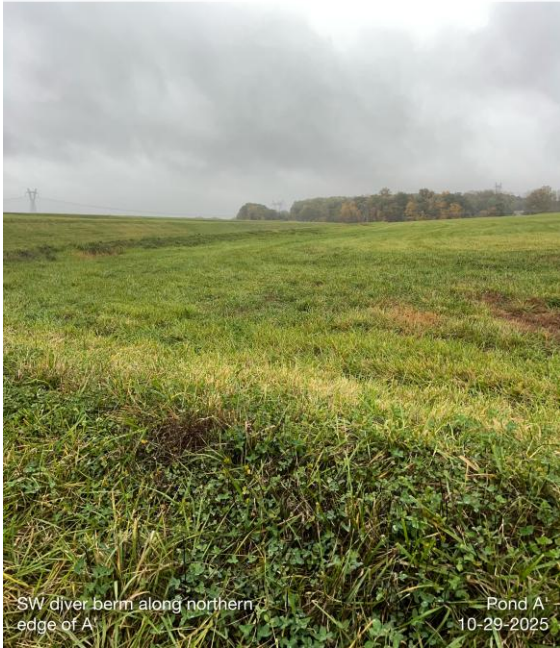
Photo A-7	Date: 10/29/2025	<div><div><div>N030NE60E90120</div><div>BRG: 57°NE (T) LAT: 38.533315 LON: -87.247830 ±29ft ALT: 440ft</div><div>

</div></div></div>
Location: Indiana Petersburg, Ash Pond A		
Description: Facing Northeast, Stormwater berms and proper vegetation.  No issues observed.		
Photo B-1	Date: 10/29/2025	<div><div><div>West</div><div>276°W (T) 38°32'12"N, 87°14'45"W ±13ft 476ft</div><div>

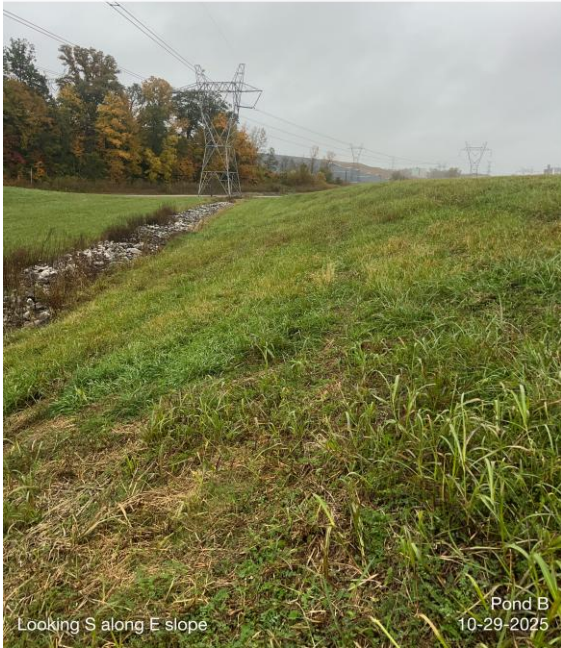
Photo B-10	Date: 10/29/2025	<div><div>Petersburg IN</div><div>BRG: 138°SE (T) LAT: 38.536204 LON: -87.243084 ±13ft ALT: 455ft</div>

<div>Looking S along E slope</div><div>Pond B 10-29-2025</div></div>
Location: Indiana Petersburg, Ash Pond B		
Description: Facing Southeast, East slope well vegetated.  No issues observed.		
Photo B-11	Date: 10/29/2025	<div><div><div>S180SW210240270300W</div><div>BRG: 234°SW (T) LAT: 38.534068 LON: -87.247280 ±13ft ALT: 455ft</div>

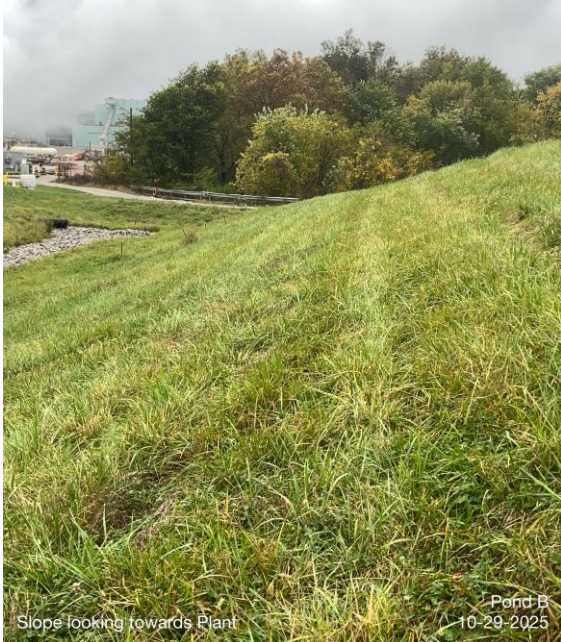
<div>Slope looking towards Plant</div><div>Pond B 10-29-2025</div></div></div>
Location: Indiana Petersburg, Ash Pond B		
Description: Facing Southwest south slope towards plant, well vegetated.  No issues observed.
