**2018 VISUAL SITE INSPECTION
IPL PETERSBURG RESTRICTED WASTE TYPE III LANDFILL
SOLID WASTE FACILITY PERMIT NO. FP63-02**

IPL PETERSBURG GENERATING STATION
6925 NORTH STATE ROAD 57
PETERSBURG, INDIANA 47567

ATC PROJECT NO. 170LF00626

JANUARY 16, 2019

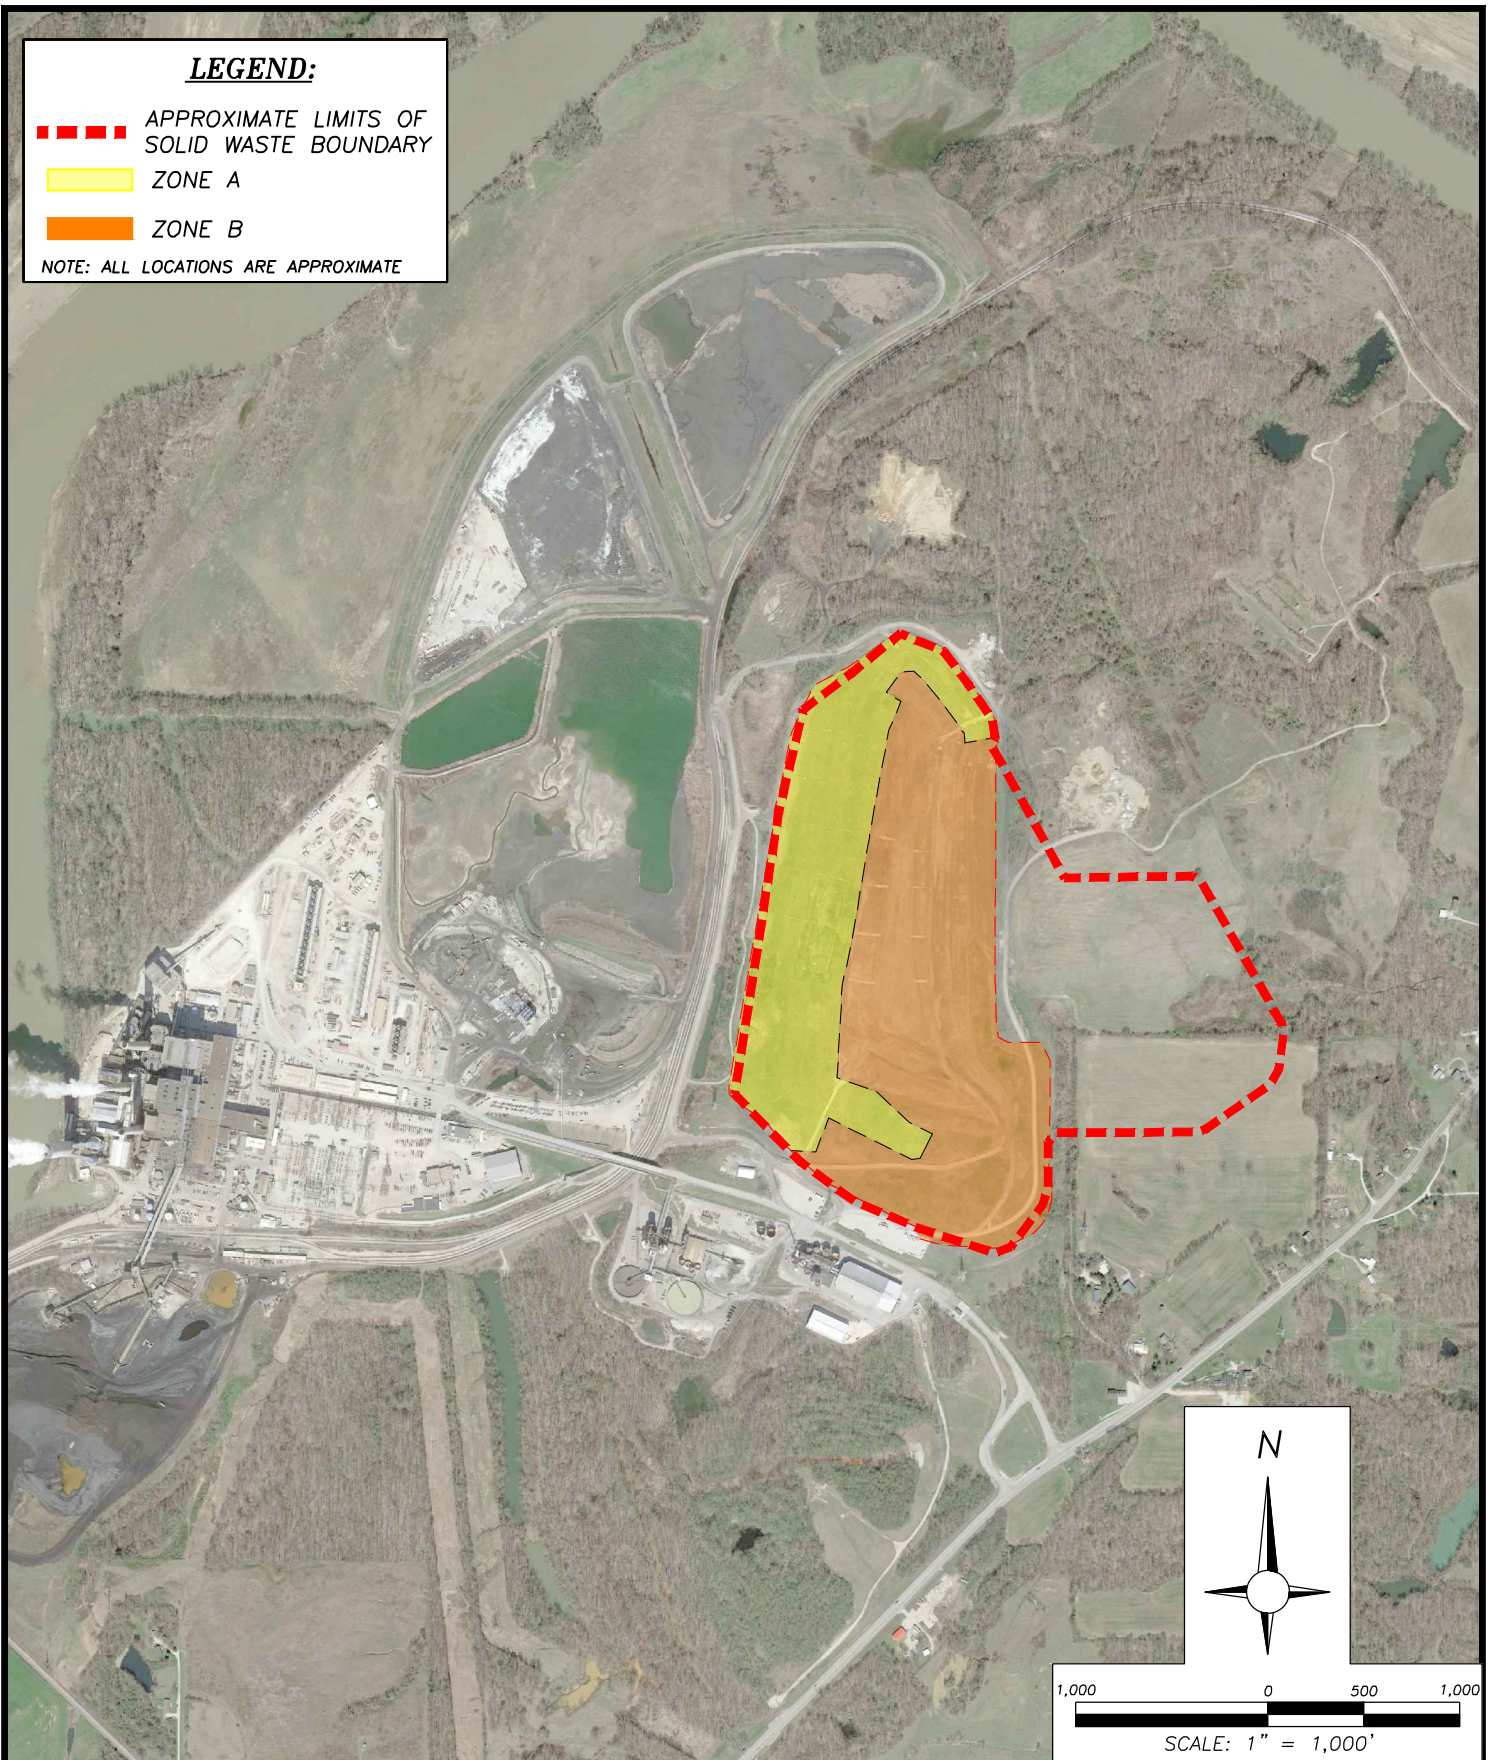
ZONE B

1. Good vegetation exists along the majority of the west and north slopes of the partial closure area as shown in Figure 3, grid locations L23, L22, K19, M15, and M14.
2. A sapling has grown at the base of one of the riprap down chute channels along the west slope of the landfill, see grid location K19.
 - Recommendation: Remove the sapling to prevent root undermining of the soil cover. Continue an ongoing maintenance program to remove trees and shrubs from the cover system.

3. The northeast corner of the landfill, at the base of a riprap down chute channel, a washout erosion area has formed, see grid location Q13.
 - Recommendation: Install erosion control protection for this area such as erosion control mat to protect the integrity of the soil liner. Overseed the bare soil cover area.
4. At the southwest corner of the landfill, erosion has occurred along the face of the slope, exposing underlying poz-o-tec material, see grid location M23.
 - Recommendation: Repair the soil cover and regrade areas of the slope where erosion has occurred. Install erosion control mat in exposed areas and overseed areas of sparse vegetation once soil cover has been repaired.

2. Exposed and bare spot areas were observed on soil cover section next to the haul road, see grid location Q25.
 - Recommendation: Repair the soil cover in exposed bare area and regrade it to improve drainage flow to haul road swale.

3. Downcutting has occurred along the ditch adjacent to the haul road along the south side of the landfill, see grid locations O25, and Q25.
 - Recommendation: Repair the soil cover in the affected areas and install erosion control mat and where downcutting has occurred in the channel. Install erosion control mat and additional riprap armouring with non-woven geotextile on exposed reaches of the channel.

4. At the top of landfill erosion rills and gullies were observed at certain locations as shown in grid N23, M23, N22, O22, O21, N20, O20, N19, N18, O18, O17, N16, N15, O15, and O14.

5. Along the eastern and northern side slope of the landfill, erosion rills and gullies were observed at locations as shown in grid P22, Q22, P21, Q20, Q19, Q18, Q17, P16, Q16, P15, Q15, P14, P13, O13 and N13.
 - Recommendation: Repair the soil cover and install erosion control mats in areas affected by erosion rills and erosion cavities. Overseed these areas to establish a protective grass cover.
6. Along the eastern and northern side slopes of the landfill there are areas of minor sparse vegetation cover as show in grid locations O13, P13, and Q15.
 - Recommendation: Overseed these areas to establish a fuller grass cover.

- Recommendation: Repair the soil cover and install erosion control mats in areas affected by erosion rills and gullies. Overseed these areas to establish a protective grass cover.
