**2020 VISUAL INSPECTION OF ASH POND EMBANKMENTS
IPL PETERSBURG ASH POND SYSTEM**

IPL PETERSBURG GENERATING STATION
6925 NORTH STATE ROAD 57
PETERSBURG, INDIANA 47567

ATC PROJECT NO. 170LF00973

DECEMBER 18, 2020

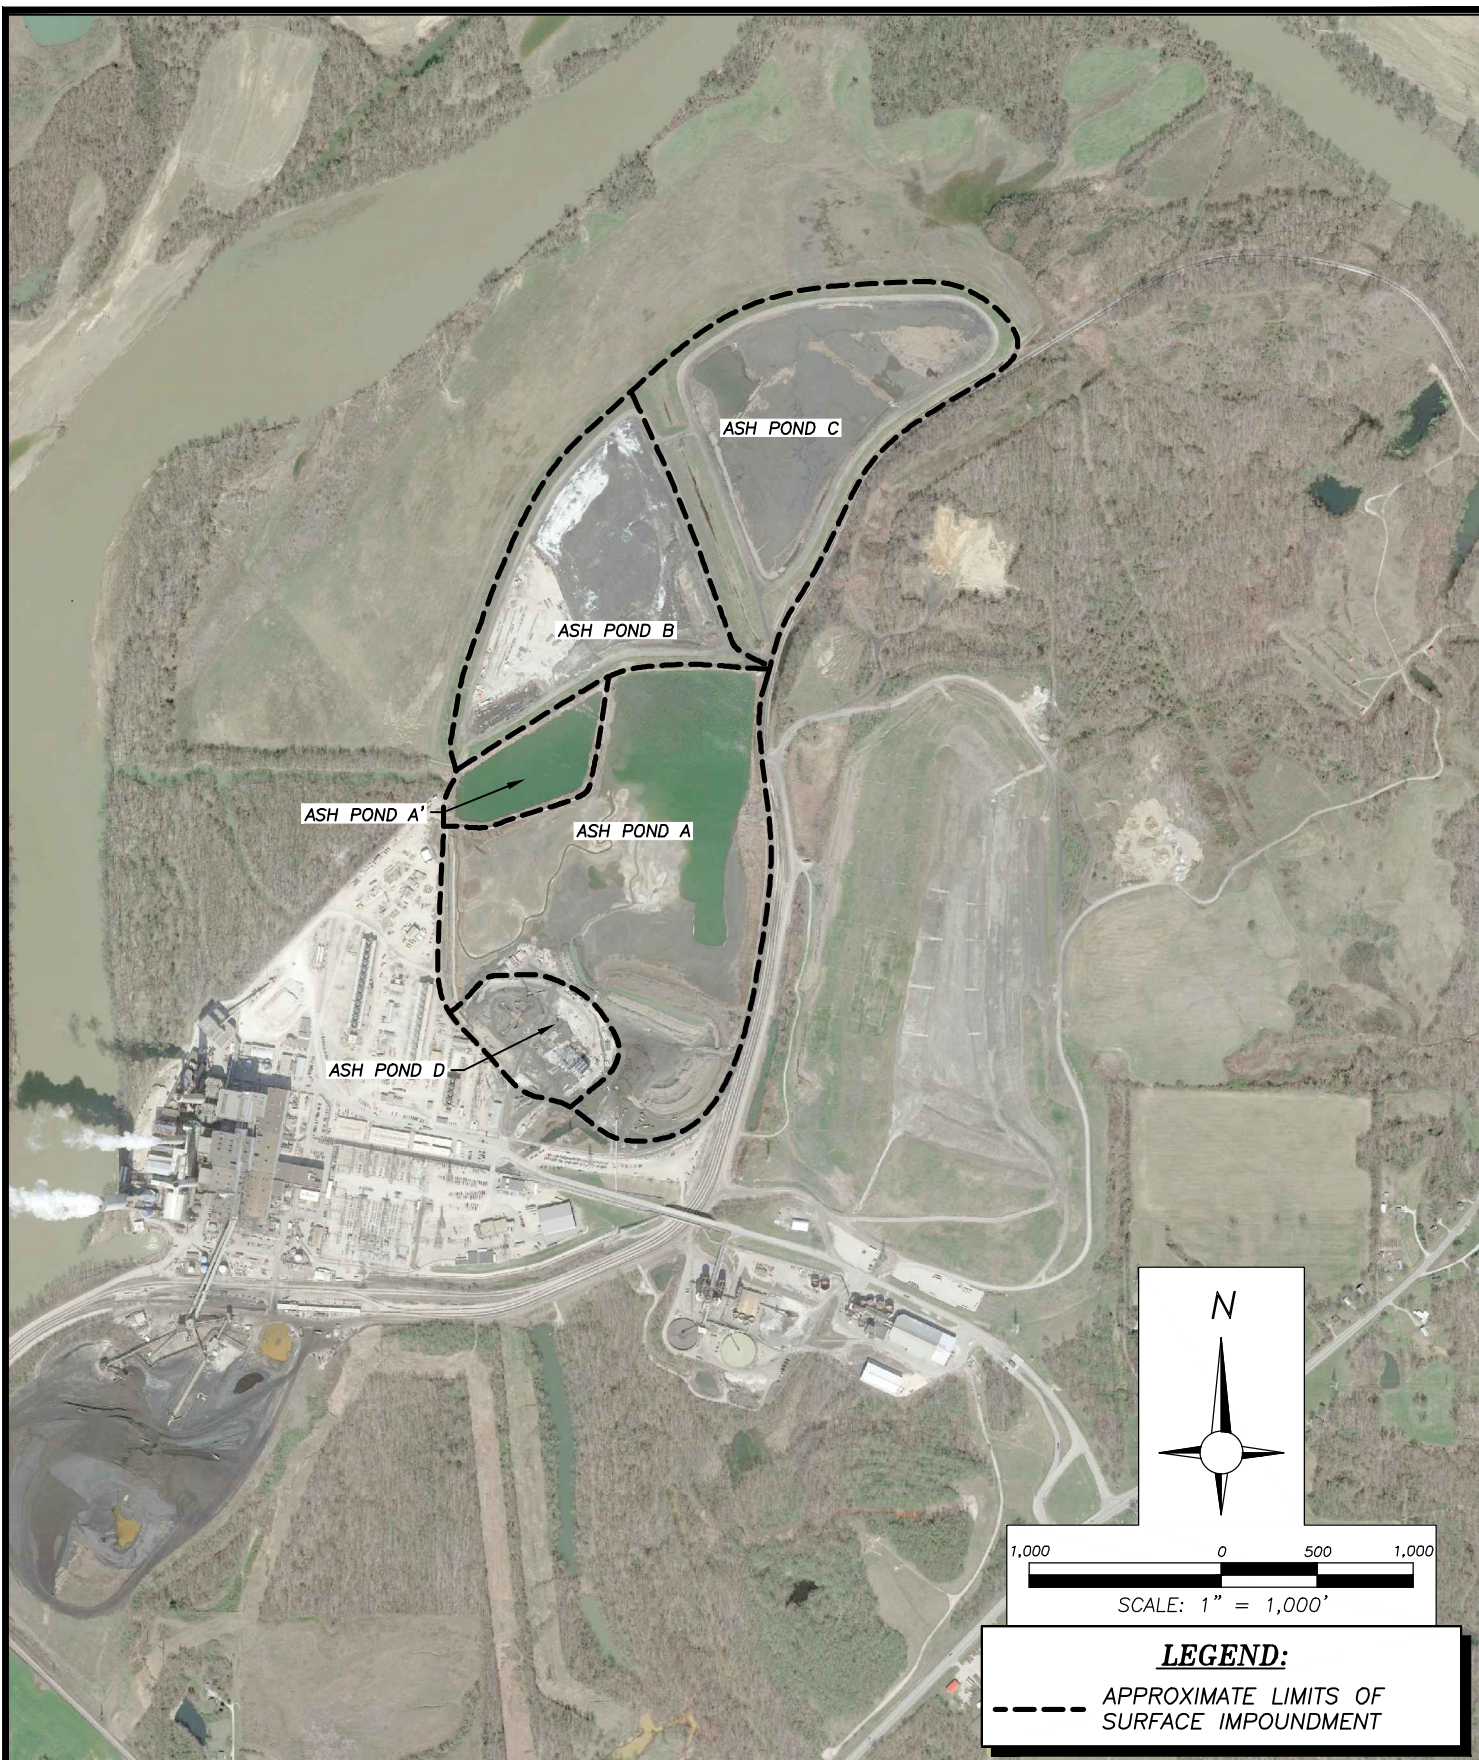
Engineering observations performed on October 28, 2020 are shown in Figure 3, 2020 Visual Site Inspection Grid Map. ATC visually inspected the embankments for Ash Ponds A, A', B, C, and D, and found no areas of instability or of concerns to the proper functioning of the ash basin system.

1. Well established vegetation exists along the ponding areas in Ash Pond A' as shown in Figure 3, grid D-12.
2. Ash Pond A is being filled in with structural fill as part of closure work as shown in grid locations H-11.

1. Good vegetation exists along the side slopes of the basin.
2. At the side slopes along the western, and north there were erosion rills and gullies observed at certain locations as shown in grid M-1, L-2, I-2, and H-3.

- Recommendation: Repair the soil cover and install erosion control mats as needed in areas affected by erosion rills and gullies. Overseed these areas to establish a protective grass cover.
3. Overgrown weedy vegetation was observed at down drain riprap chutes and inlet located in the east and south sections of Ash Pond B, see grid locations C-7, G-3, and G-11.
- Recommendation: Remove vegetation.
