**2020 VISUAL SITE INSPECTION  
IPL PETERSBURG RESTRICTED WASTE TYPE III LANDFILL  
SOLID WASTE FACILITY PERMIT NO. FP63-02**

IPL PETERSBURG GENERATING STATION  
6925 NORTH STATE ROAD 57  
PETERSBURG, INDIANA 47567

ATC PROJECT NO. 170LF00972

DECEMBER 18, 2020

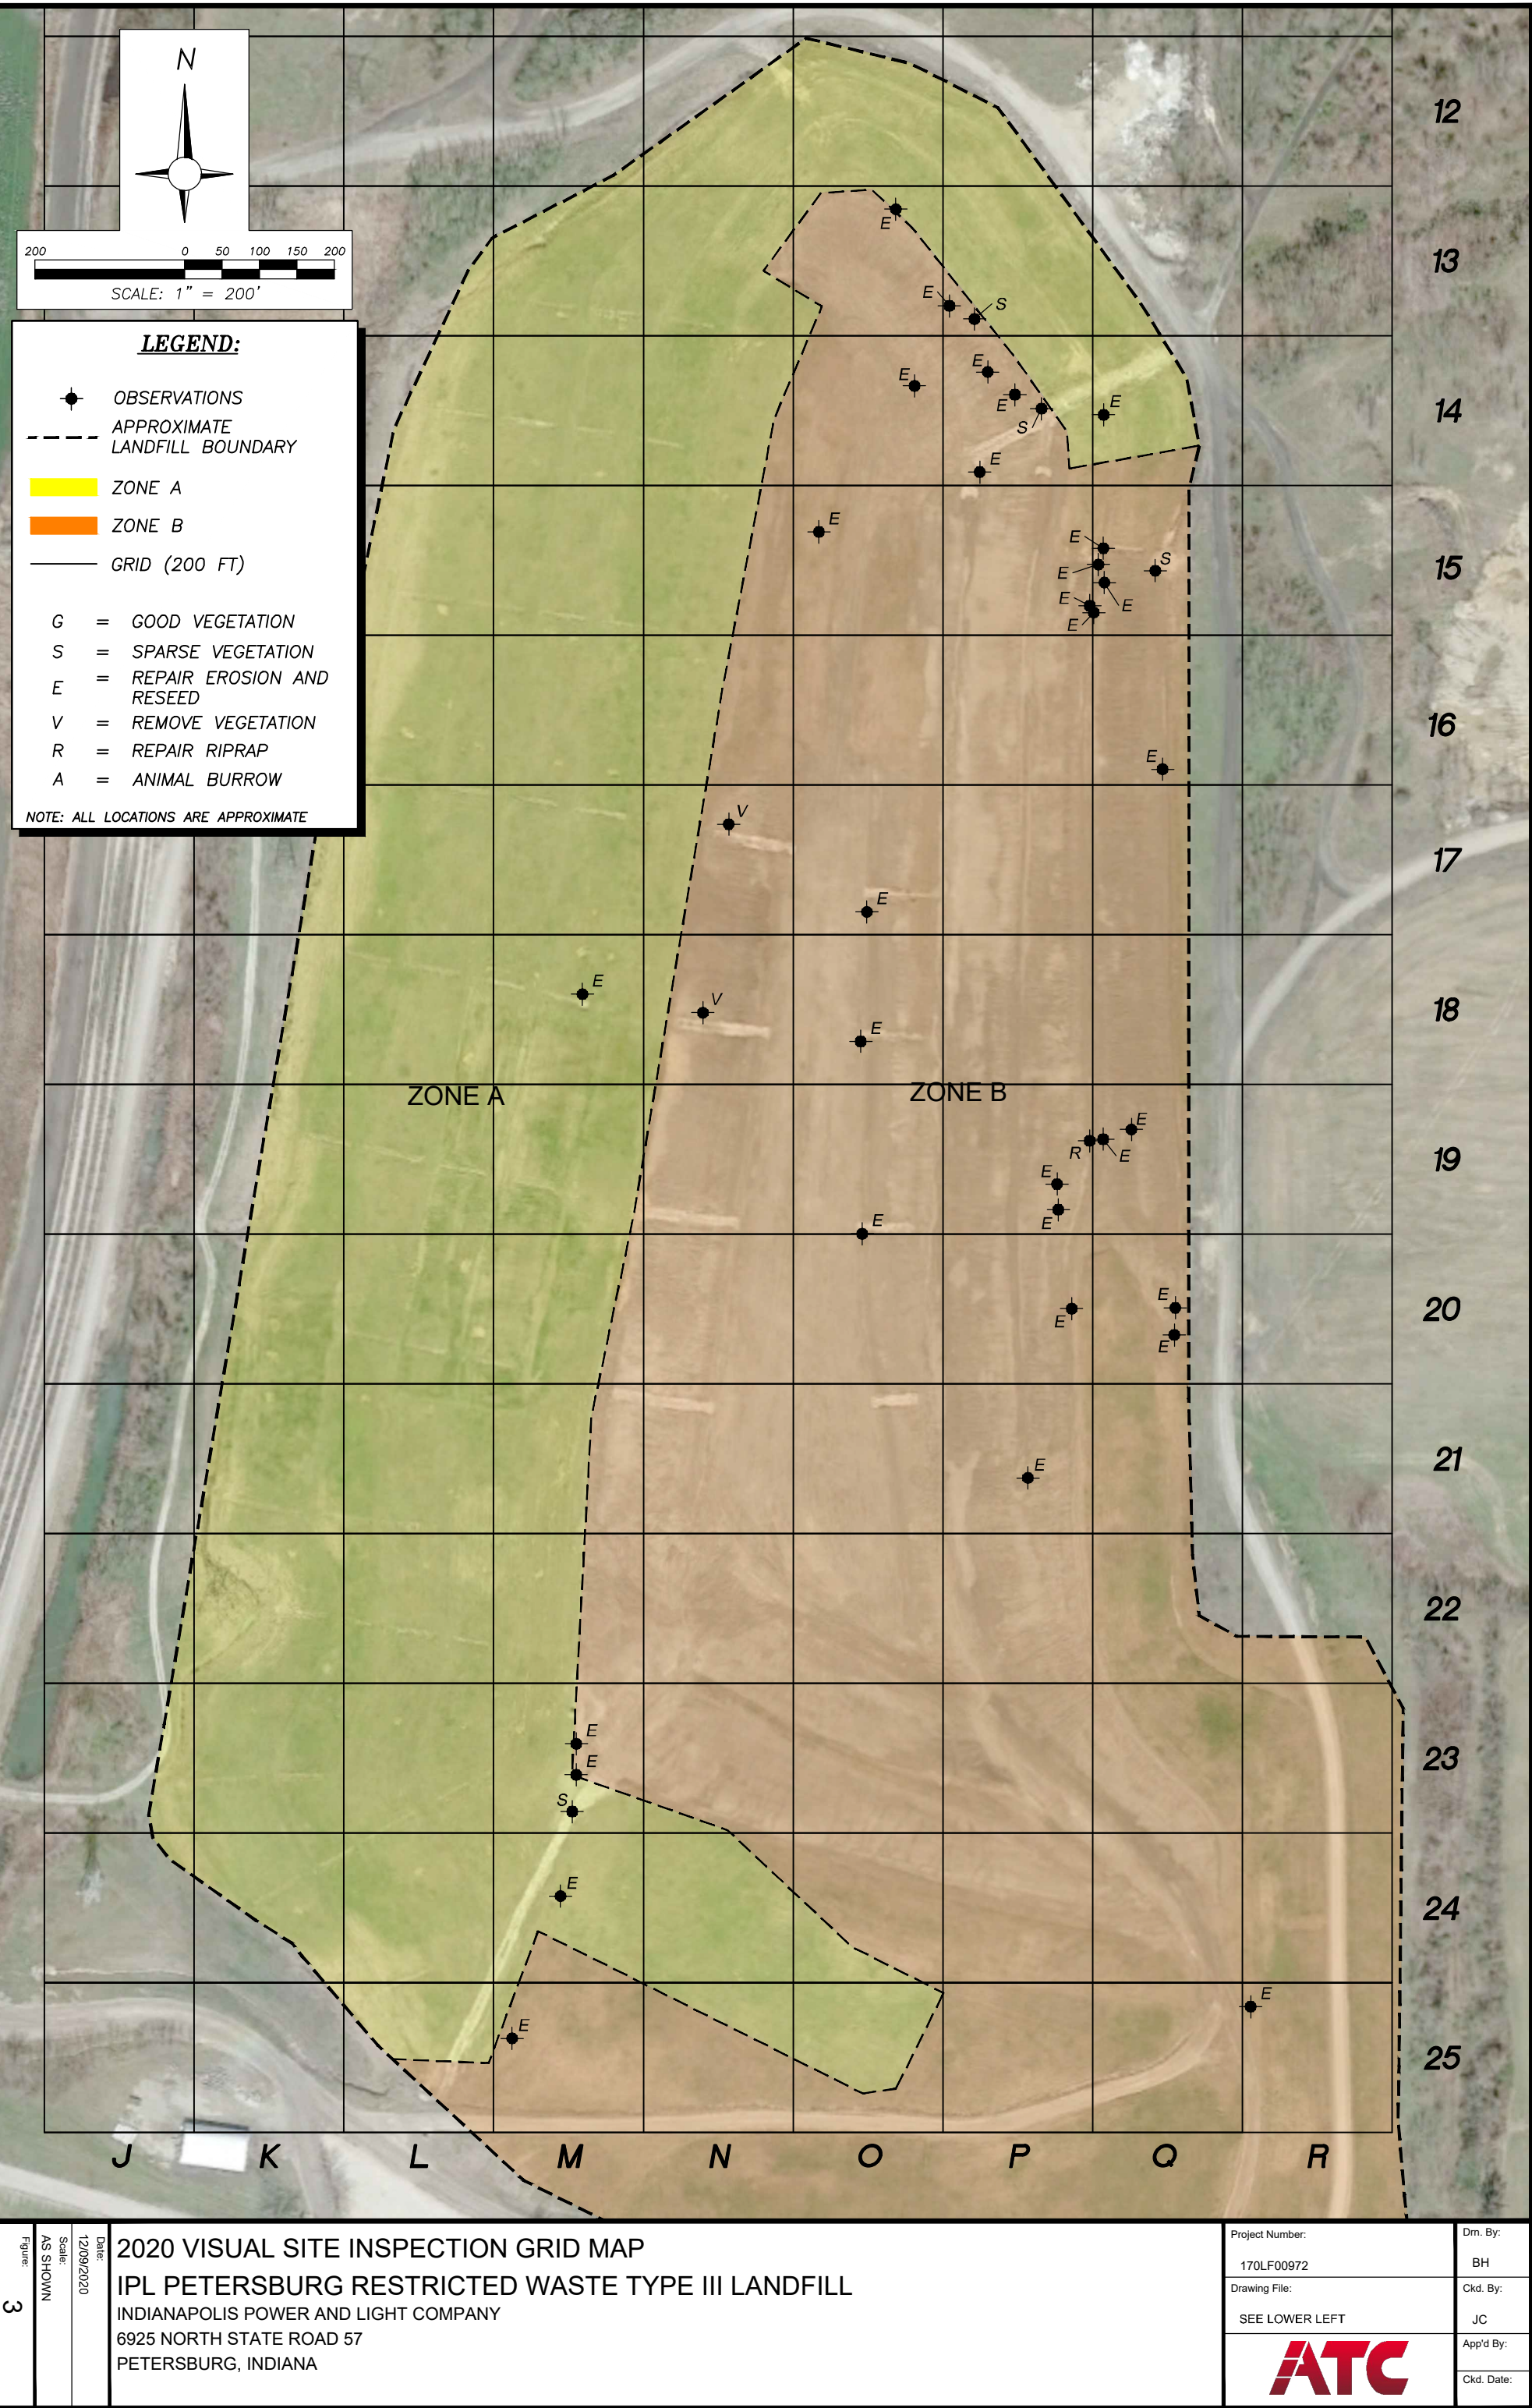
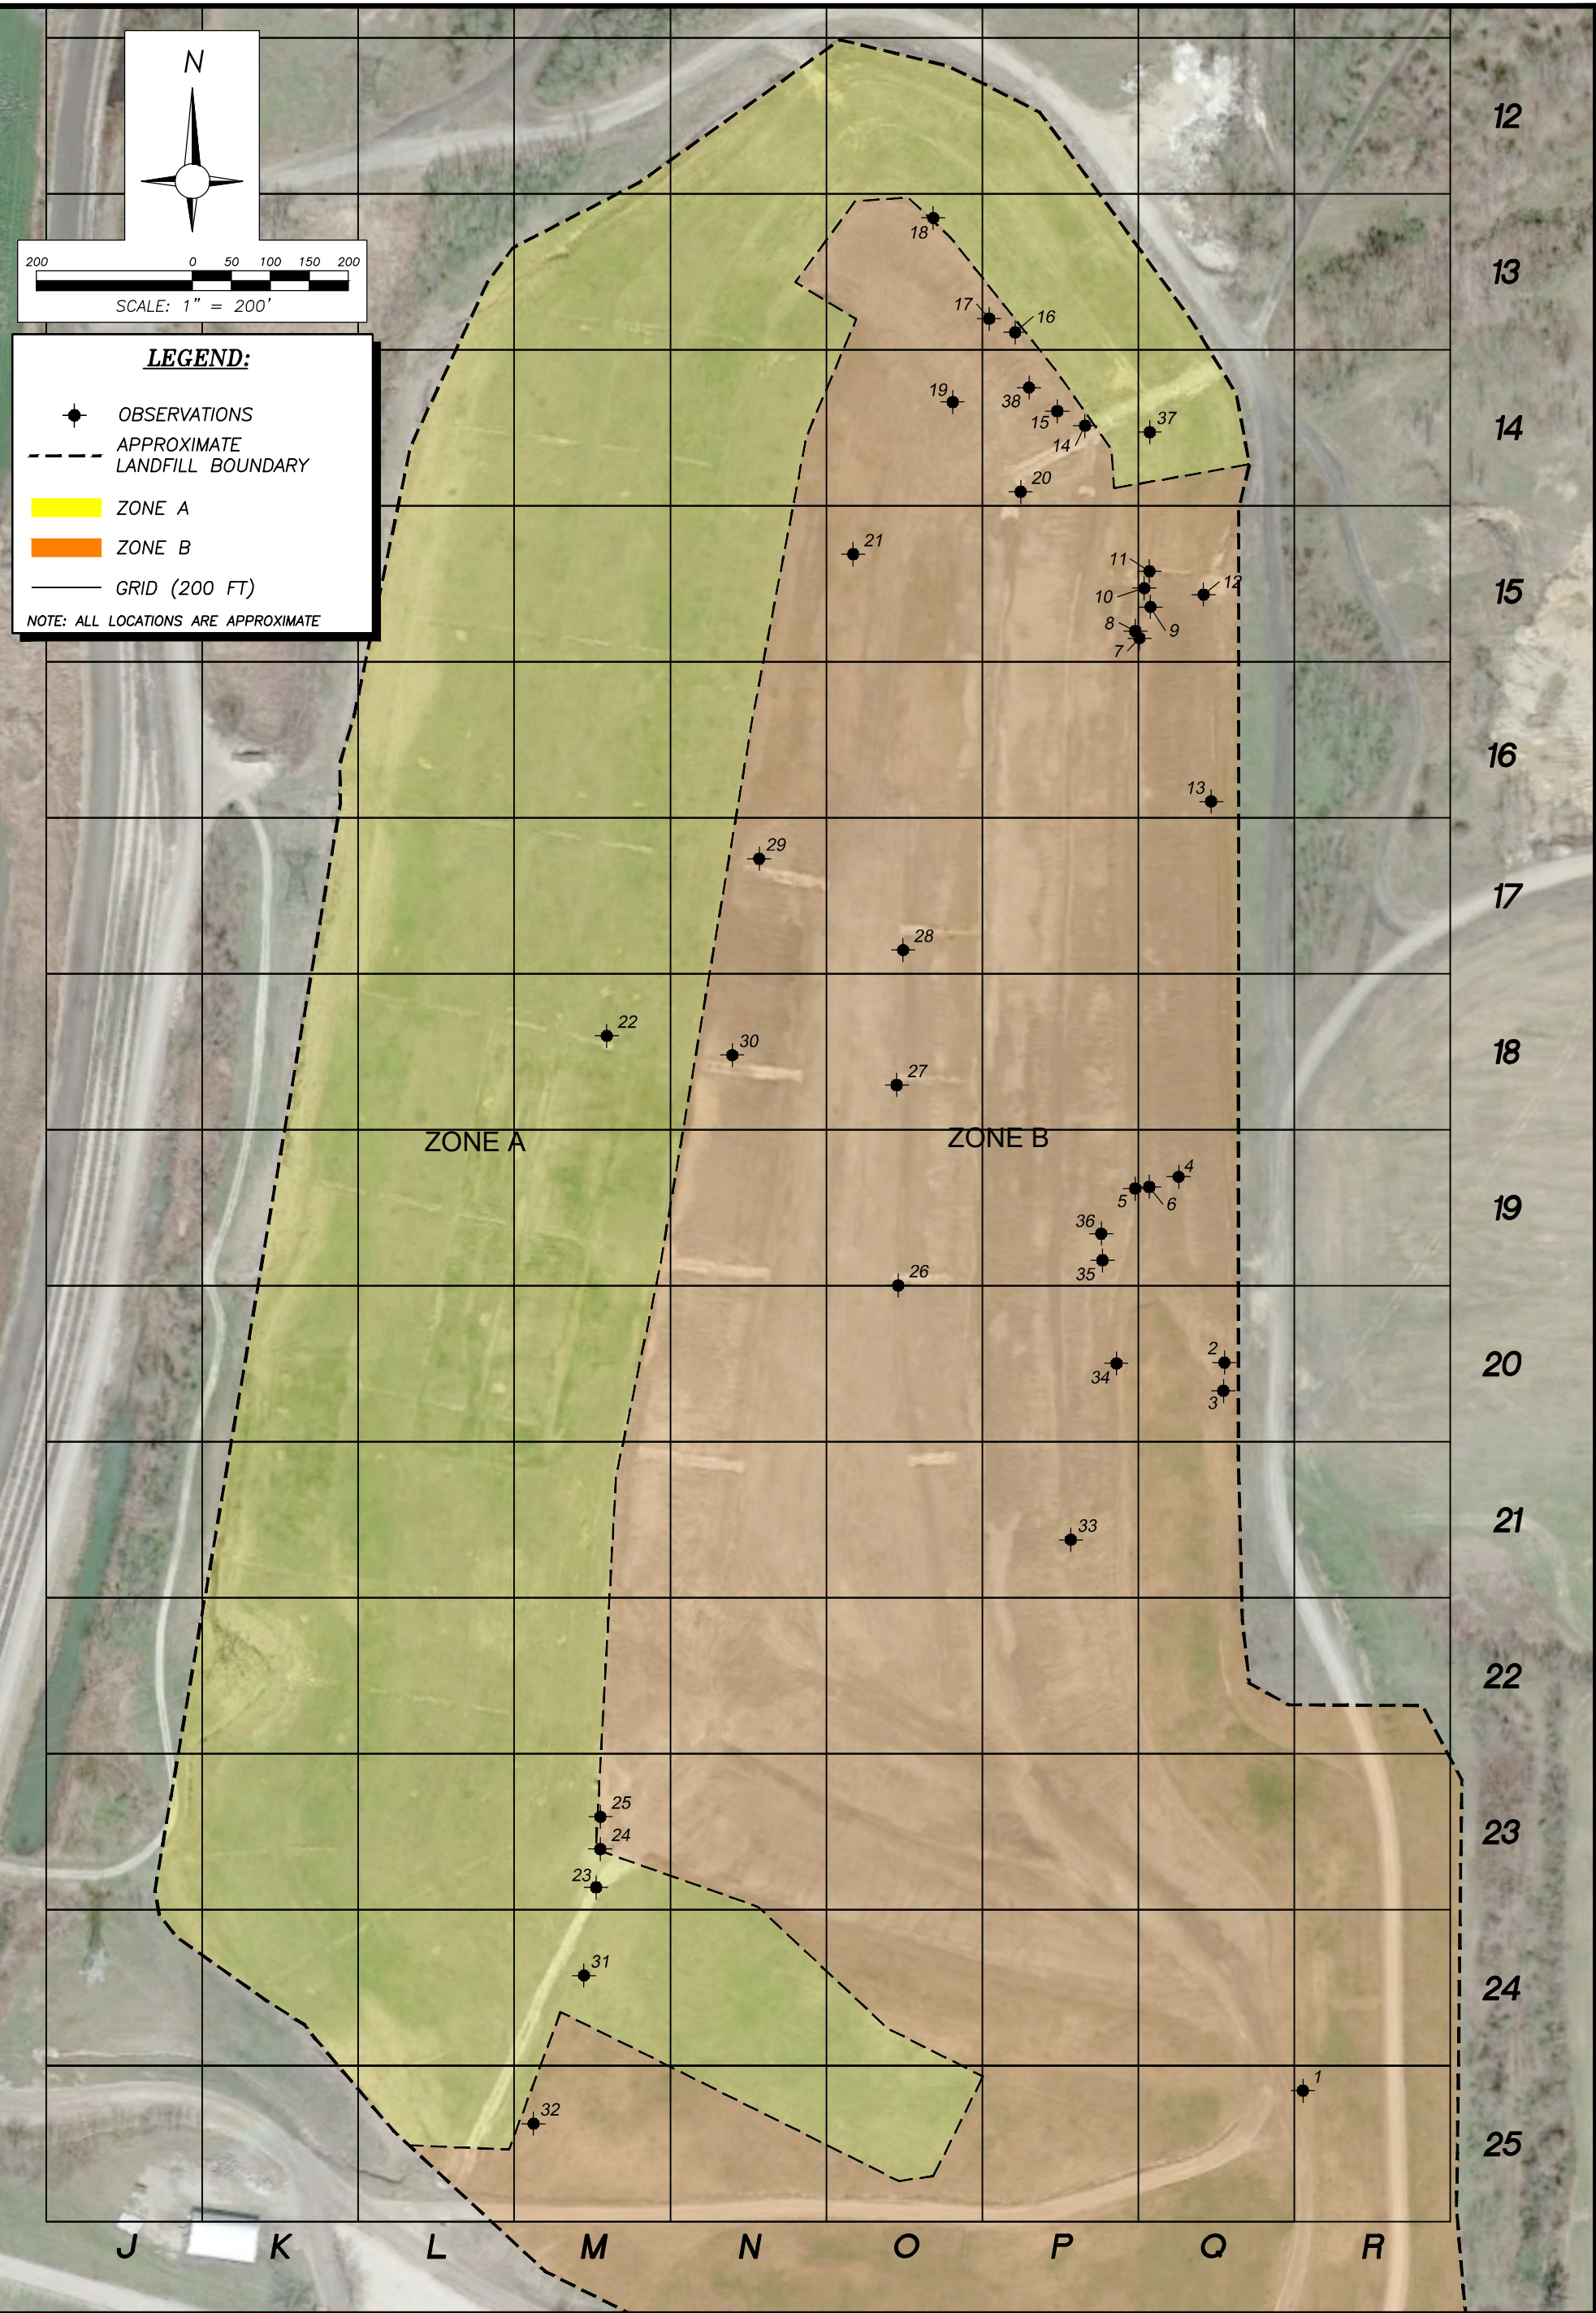
Observed geometry changes during the 2020 Petersburg visual landfill inspection consisted mainly of small grading measures and vegetation improvements. Engineering observations were grouped into two inspection zones shown in Figure 3, 2020 Visual Site Inspection Grid Map.

2. Overgrown weedy vegetation was observed at down drain riprap chutes located in the middle section of the landfill, see grid locations N-17, and N-18.

- Recommendation: Remove vegetation.
3. Erosion rills and tire rutting has occurred along the haul road on the south side of the landfill, see grid locations R-25.

- Recommendation: place rock base material to support a gravel road and repair haul road.
4. On the east side of the landfill erosion rills and gullies were observed at certain locations as shown in grid P-21, P-20, Q-20, O-19, P-19, Q-19, O-18, O-17, Q-16, O-15, P-15, Q-15, O-14, P-14, and P-13.

- Recommendation: Repair the soil cover and install erosion control mats in areas affected by erosion rills and gullies. Overseed these areas to establish a protective grass cover.
