**2022 VISUAL SITE INSPECTION
AES INDIANA PETERSBURG RESTRICTED WASTE TYPE III LANDFILL
SOLID WASTE FACILITY PERMIT NO. FP63-02**

AES INDIANA PETERSBURG GENERATING STATION
6925 NORTH STATE ROAD 57
PETERSBURG, INDIANA 47567

ATLAS PROJECT NO. 170LF01358

DECEMBER 23, 2022

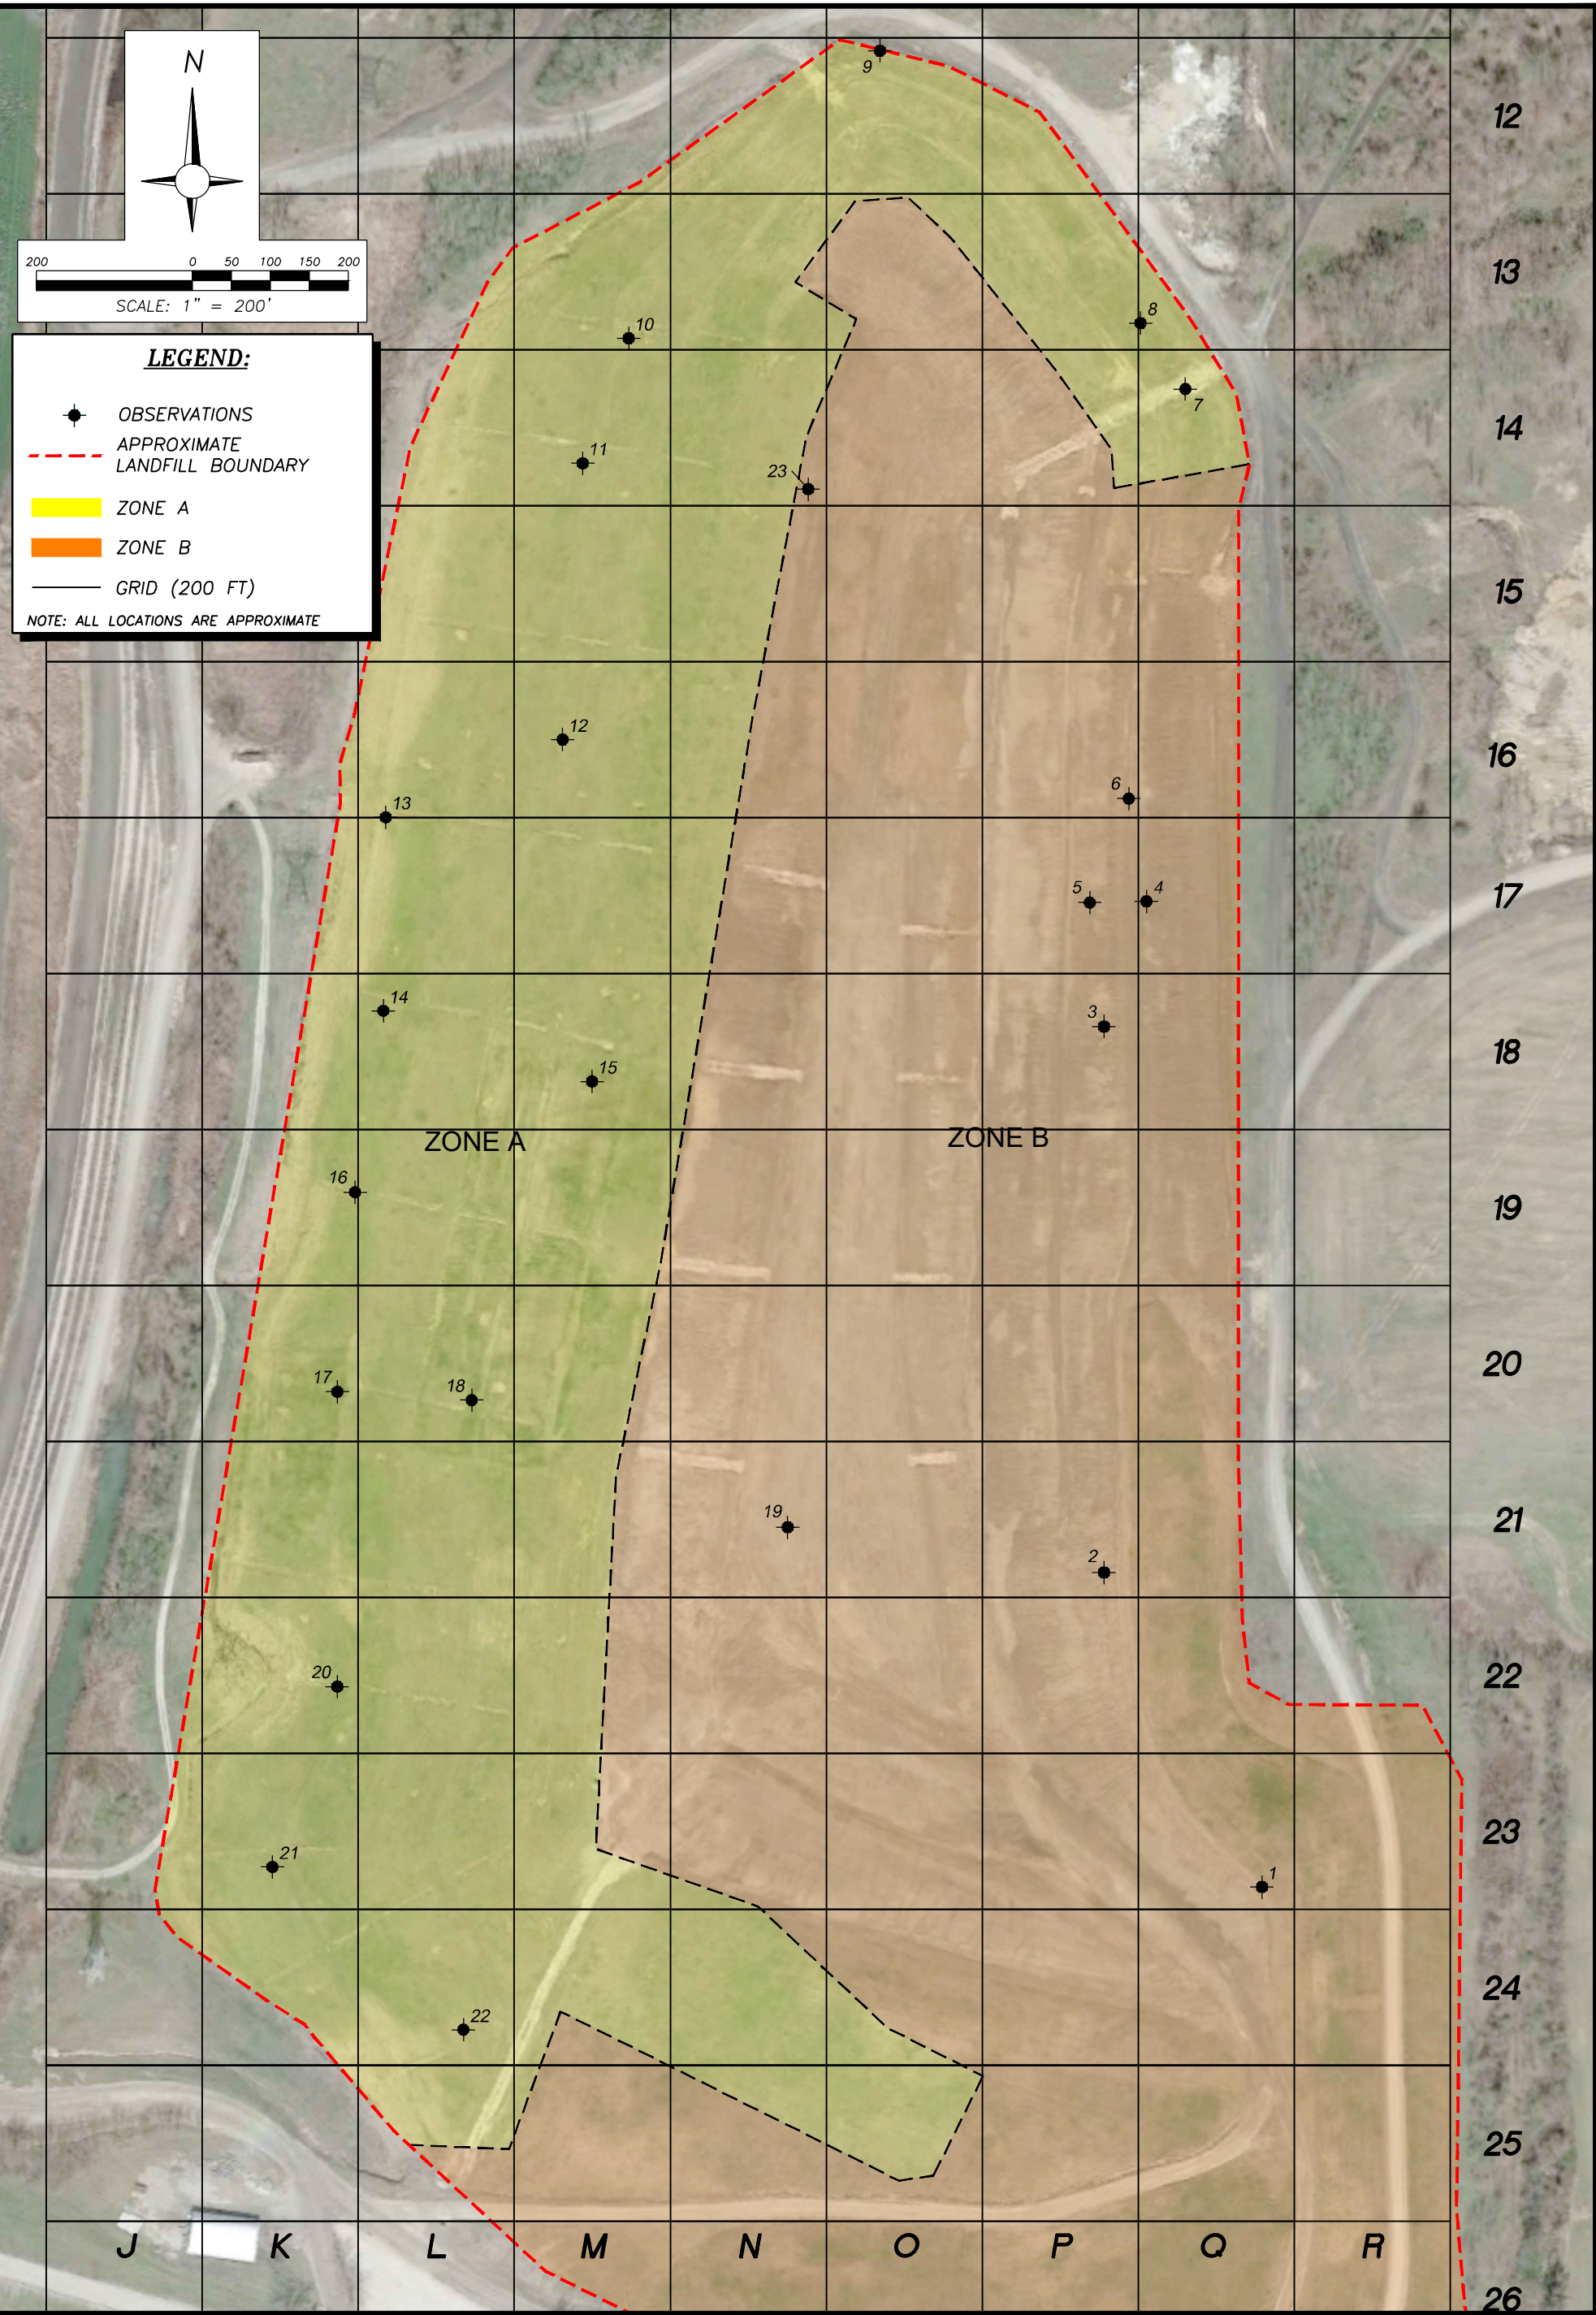
There were no observed geometry changes during the 2022 Petersburg visual landfill inspection. Waste placement has paused at the landfill and all areas are under final or intermediate cover. Engineering observations were grouped into two inspection zones shown in Figure 3, 2022 Visual Site Inspection Grid Map.

1. Good vegetation exists along the majority of the west and north slopes of the partial closure area (e.g., locations M-16, L-18, M-18, L-20 of Figure 3).
2. Overgrown vegetation on a drainage channel, located on the northeast side of the landfill (location Q-14), was reported on the 2021 inspection (Photo ID 12 of the 2021 inspection report). The overgrown vegetation on the channel has been trimmed.
3. Minor sparse vegetation areas (location K-23 and M-13 of Figure 3) were observed on the west side of the landfill.
 - o Recommendation: Repair the soil cover and overseed these areas to establish a protective grass cover.

4. Sediment accumulation was observed inside a culvert located on the north side of the landfill (location O-12 of Figure 3).
 - Recommendation: Remove sediment accumulation to allow flow into the culvert.
5. Overgrown vegetation was observed around drainage pipe inlets along the top of the landfill (location M-22 of Figure 3).
 - Recommendation: Vegetation around the inlets to the pipes should be maintained to allow for free flow of runoff into the pipes.

1. Good vegetation exists along the majority of the south end of the landfill, top of landfill and east slope (e.g., locations Q-23, P-21, P-18, Q-17 of Figure 3).
2. A minor sparse vegetation area (location P-17 of Figure 3) and an animal burrow area (location P-16 of Figure 3) were observed on the east side of the landfill.
 - Recommendation: Repair the soil cover and overseed these areas to establish a protective grass cover.
